**ON-SITE SIDE IMPACT AIR BAG DEPLOYMENT
FATAL DRIVER INVESTIGATION**

VERIDIAN ENGINEERING CASE NO. CA99-75

**VEHICLE #1 - 2000 CADILLAC SEVILLE SLS
VEHICLE #2 - 1994 FORD ECONOLINE E350 CARGO VAN**

CRASH DATE - DECEMBER, 1999

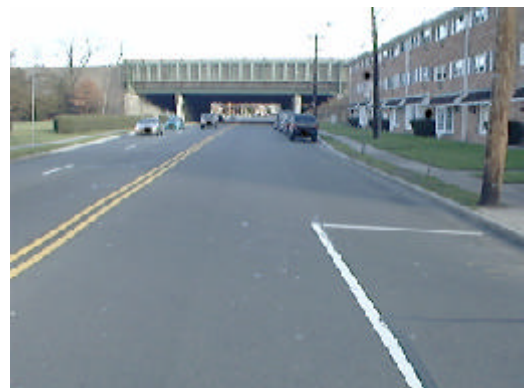
Figure 1 View of the Ford's northbound trajectory 30 m (100') from the POI

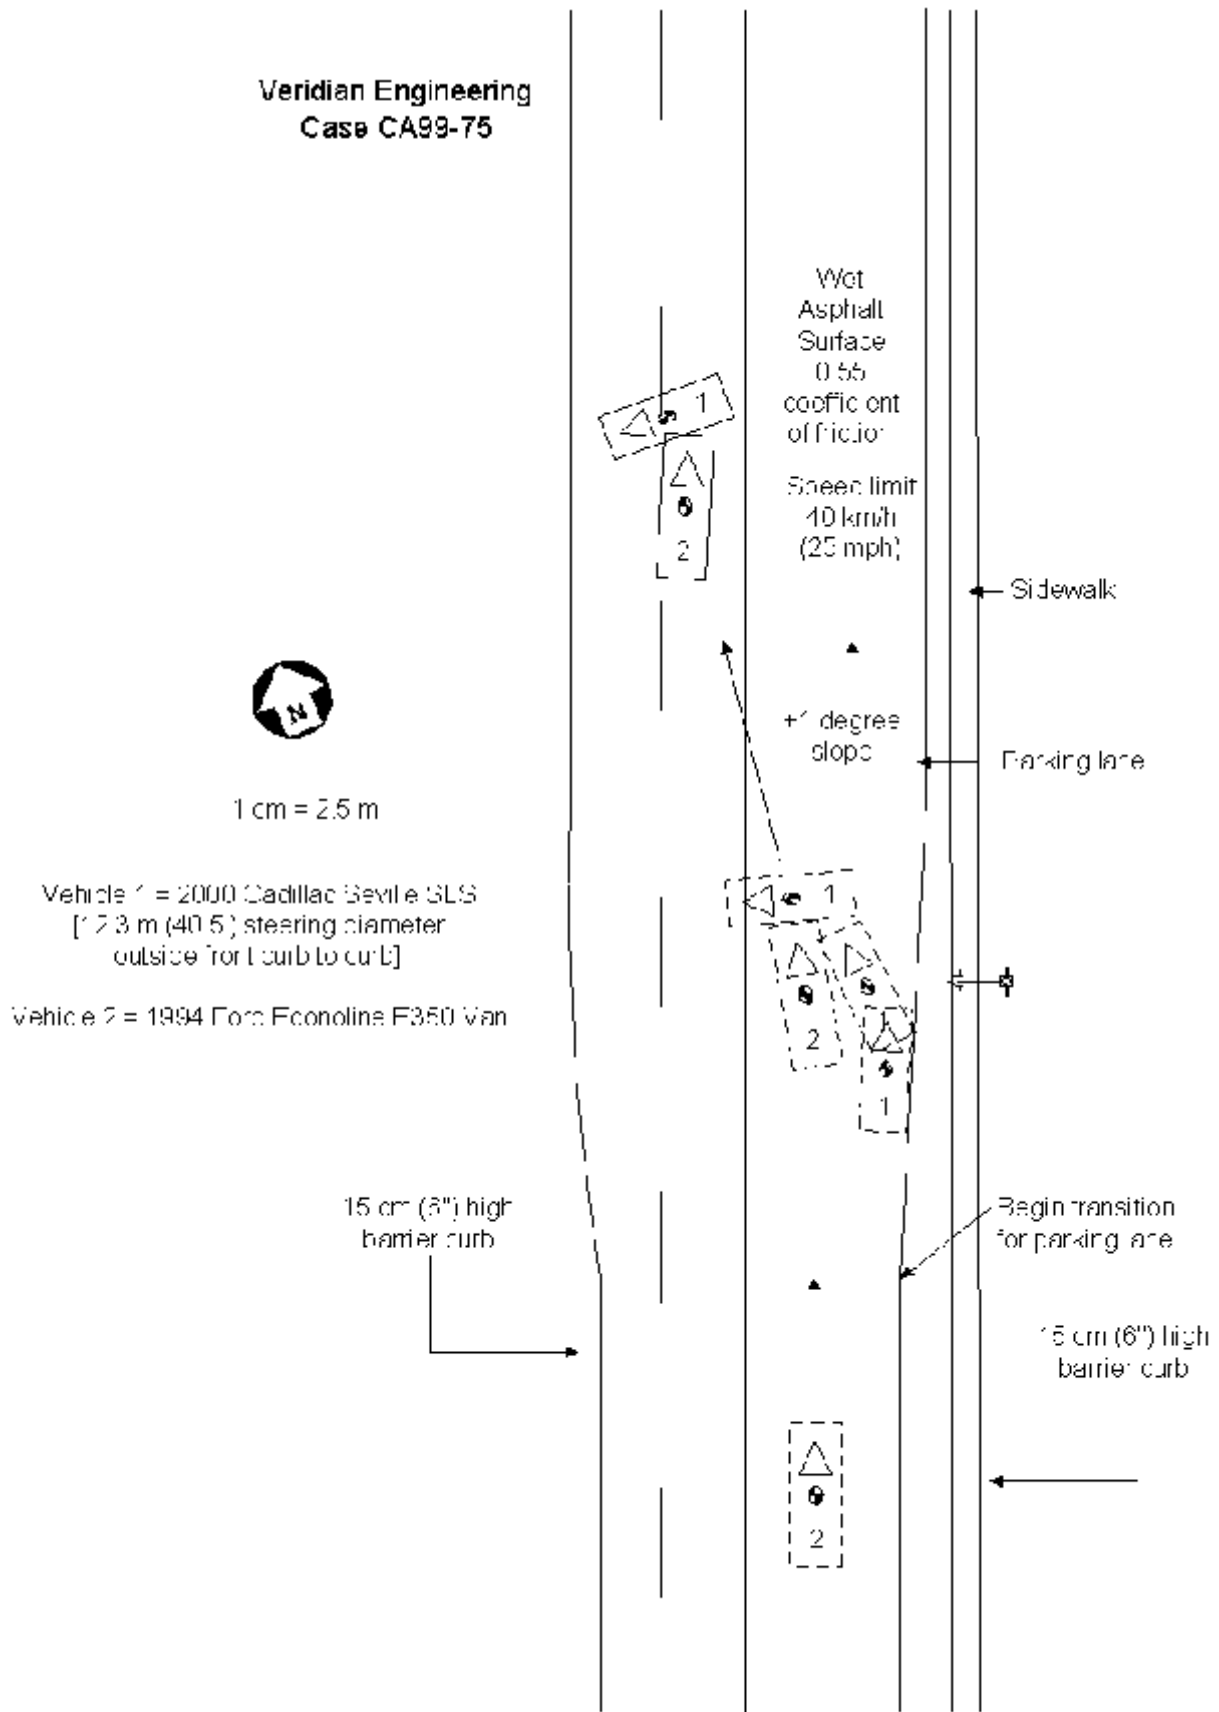
Figure 2 Scaled Scene Schematic

positive slope northbound at the point of impact (POI) with an estimated coefficient of 0.75 (dry)/0.55 (wet). The Cadillac was parked adjacent to the east curb within the transition area for the parking lane (**Figure 2**) prior to the crash.

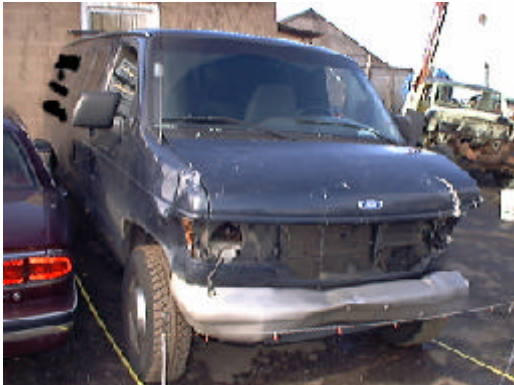
The frontal plane of the Ford (**Figure 3**) struck the left side plane of the Cadillac (**Figure 4**) at a WinSMASH computed impact speed of 64.7 km/h (40.2 mph) which resulted in a 38.9 km/h (24.2 mph) lateral delta V to the Cadillac. The Collision Deformation Classification (CDC) code assigned to the Ford was 12-FDEW-1 and 09-LPEW-4 for the Cadillac. Both vehicles traveled 20.6 m (67.6') from the POI to the final rest positions (FRP) in the southbound travel lanes where they remained locked together by damage. The location of the POI was determined by the police from the side glass debris field observed at the scene.

Figure 3 Frontal plane of the Ford Econoline

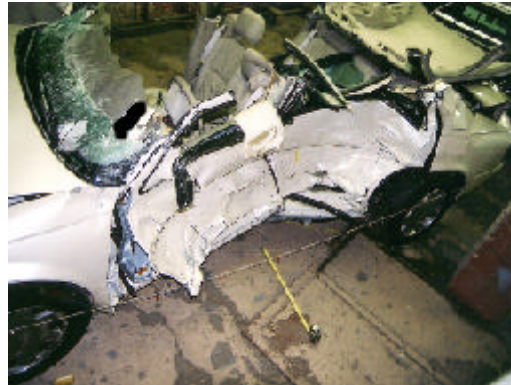
Figure 4 View of the left side impact damage to the Cadillac

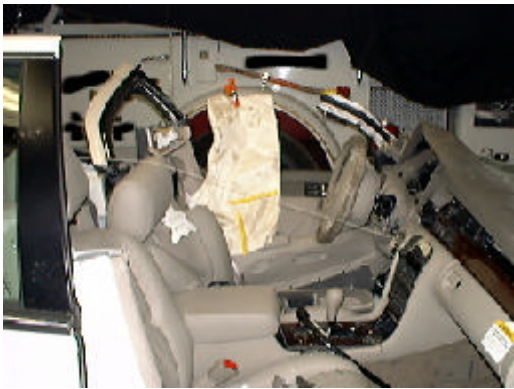
The Cadillac was equipped with a supplemental restraint system (SRS) which included dual front air bags and side impact air bags in restraint towers that were located along the outboard aspects of the front seat back supports. The driver's side air bag was the only air bag which deployed during the crash sequence (**Figure 5**). The side impact air bag was designed in a "J" deployment configuration which jutted forward 33.0 cm (13.0") and vertically 58.4 cm (23.0") from the forward leading edge of the seat back support during the deployment sequence. The longitudinal width of the vertical segment of the air bag measured 30.5 cm (12.0"). The air bag was not tethered or designed with external vent ports. There were no visible driver contact points noted on the surface of the air bag, however, there was a fabric artifact transfer field which measured 15.2 x 17.8 cm (6.0 x 7.0") along the inboard lower leading area of the air bag. This artifact was the result of contact with the fabric covered lower B-pillar during the air bag expansion sequence (**Figure 6**).

Figure 5 Lateral view of the front seat row of the Cadillac showing the “J” design left front side impact air bag

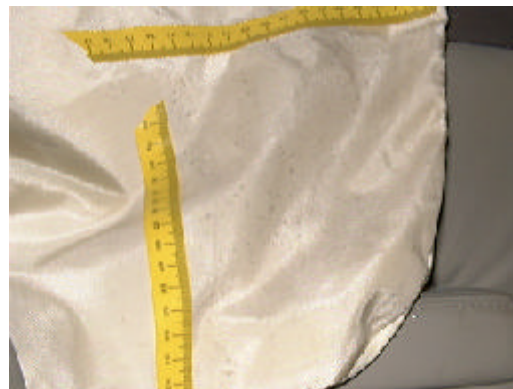
Figure 6 Close-up view of the fabric transfer from contact with the fabric covered lower left B-pillar during the air bag expansion sequence and located along the lower inboard leading area of the side impact air bag surface

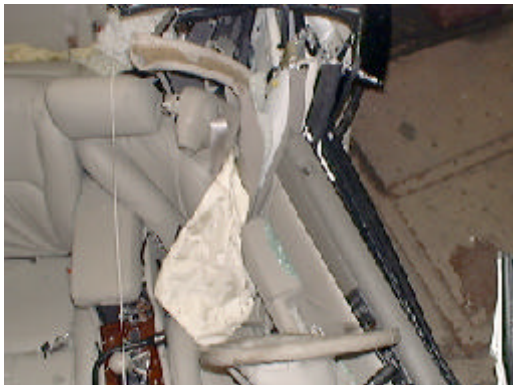
Interior damage to the 2000 Cadillac Seville SLS was attributed to the extensive lateral vehicle intrusion from the impact sequence with the Ford Econoline E350 cargo van (**Figures 8&9**) and the deployment of the Supplemental Restraint System (SRS). Intruded components included: the front left door panel and armrest; the B-pillar; the left front seat; the left floor sill; the front left kick panel; and the rear left door panel.

Figure 8 Overhead view of the driver’s seat and the left side intrusion looking rearward from the front of the Cadillac

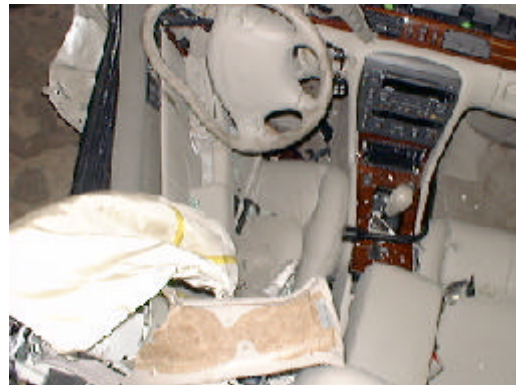
Figure 9 Another overhead view of the left side intrusion looking from the rear of the vehicle forward

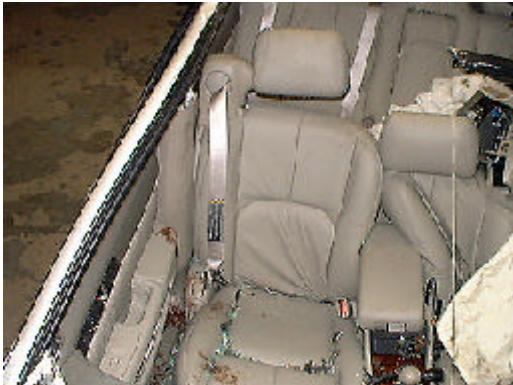
Figure 10 View of the front right seat back support showing the restraint tower incorporating the head restraint, manual belt restraint, and side impact air bag located along the outboard surface of the seat back support

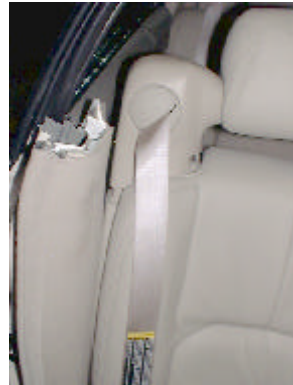
Figure 11 Closer view of the adjustable portion of the restraint tower

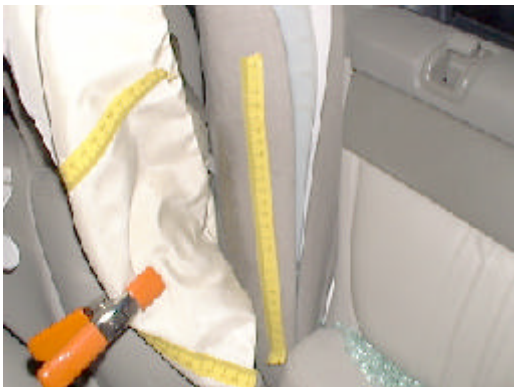
During the impact event, the left side impact air bag began the actuation sequence and exerted pressure against the inside wall of the restraint tower housing resulting in a separation of the vinyl adjacent to the seat fabric. As the air bag expanded, the leading lower edge contacted the intruding lower B-pillar resulting in a 15.2 cm (6.0") vertical abraded surface of the B-pillar cover and a fabric transfer on the air bag (**Figure 12**). The air bag deployed in a forward and upward direction as designed. The driver's side air bag was mounted in the restraint tower located along the outboard aspect of the driver seat back support.

Figure 12 View of the abraded area along the lower left B-pillar from contact by the expanding left front side impact air bag

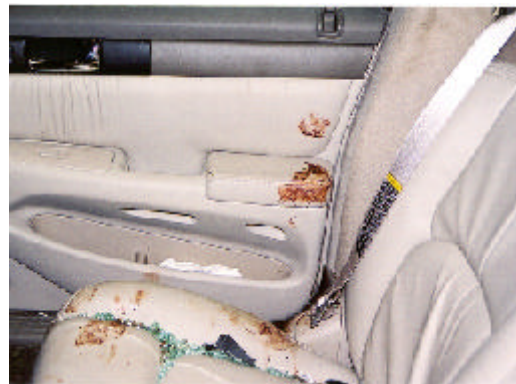
Figure 13 View of contact evidence to the front right door panel and armrest

The center console was deformed to the right as the result of contact by the driver who was displaced to the right by the intruding left side structure. The front right door surface and armrest exhibited copious bodily fluid deposits as the result of contact by the driver's head area (**Figure 13**). The transfer on the door surface measured 5 cm (2") in diameter and was located 5 cm (2") above the armrest. The horizontal width of the armrest measured 8.9 cm (3.5"). Both transfers were located 66.0 cm (26.0") rearward from the instrument panel.

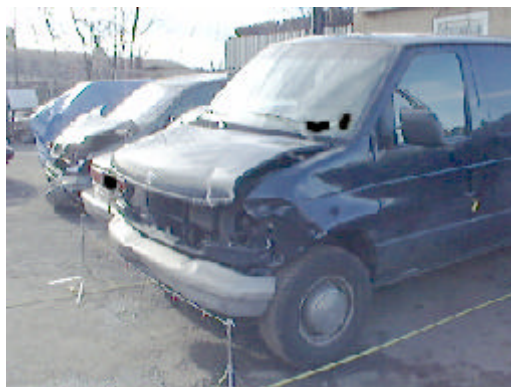
The 1994 Ford Econoline E350 cargo van which was used as a commercial vehicle struck the left side of the 2000 Cadillac as the driver of the Cadillac was attempting to make a U-turn from a parking lane. Direct damage to the front bumper measured 177.8 cm (70.0") across the entire frontal plane. The maximum crush of 9.5 cm (3.75") was located 20.3 cm (8.0") right of the vehicle centerline (**Figure 14**). The vehicle was towed from the scene as the result of damage to the transmission. The van was empty of cargo at the time of the crash. Crush values are listed in the following table:

Figure 14 Left corner view of the impact damage to the frontal plane of the 1994 Ford Econoline cargo van

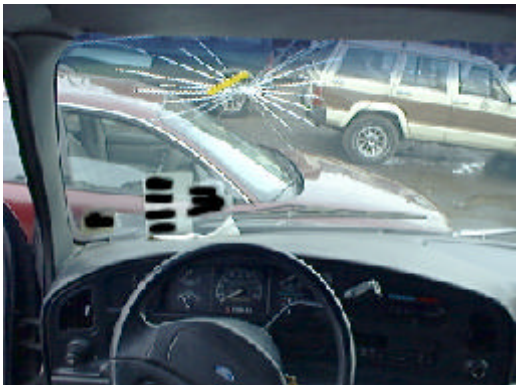
The windshield exhibited a spider web pattern crack with a tissue oil transfer surrounding the fracture site. The crack was located 47.0 cm (18.5") left of the vehicle centerline and 17.8 cm (7.0") below the windshield header (**Figure 15**). This artifact was directly in front of the driver seat and was attributed to contact by the driver's facial area. There was a 7.6 cm (3.0") diameter fabric transfer along the lower

Figure 15 View of the contact pattern to the windshield of the 1994 Ford Econoline cargo van

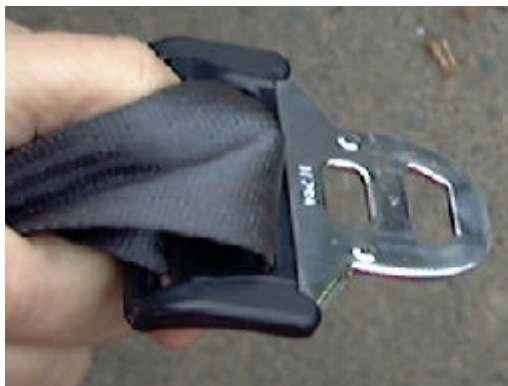
instrument panel located 38.1 cm (15.0") left of the vehicle centerline which was attributed to contact by the driver's right knee. The manual lap and torso restraint belt indicated wear marks on the latch plate, but the wear indicator did not appear to represent a frequent usage pattern with respect to the vehicle mileage [228,078 km (141,725 miles) on the odometer] (**Figure 16**). Although the driver indicated he was wearing the restraint belt at the time of the crash, the contact pattern to the windshield and the lower instrument panel along with a laceration of the face was indicative that he was not using the restraint system.

Figure 16 View of the latch plate for the front left 3 point manual lap and torso restraint belt

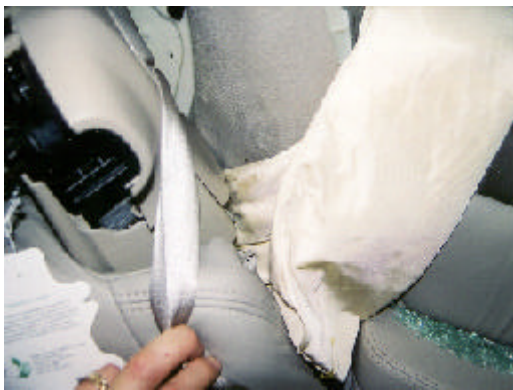
The driver's side air bag was mounted in a restraint tower which also housed the seat back head restraint, the manual three point lap and torso belt, and the restraint belt pretensioner. As the air bag began to expand, the leading edge of the tower wall adjacent to the seat back support separated to allow the excursion of the air bag (**Figure 17**).

Figure 17 View of the top outboard aspect of the front left seat back support partially showing the air bag deployment area

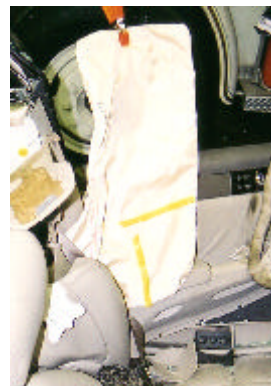
The side impact air bag was designed in a "J" configuration where the bottom portion of the air bag measured a static travel distance of 38.1 cm (15.0") in a forward direction from the restraint tower (**Figure 18**). The air bag then extended in a vertical direction which had a static measured distance of 58.4 cm (23.0"). The vertical segment of the air bag had a longitudinal measurement of 30.5 cm (12.0") near the base which tapered slightly to a longitudinal dimension of 27.8 cm (11.0") at the top of the air bag.

Figure 18 View of the left front side impact air bag

The side impact air bag was not tethered and there were no visible vent ports. The material of the air bag appeared to be a medium denier density with a fine mesh weave. The air bag identification number ink printed on the surface of the air bag was recorded as follows: 312267 630d. There was no visible driver related contact evidence detected on the surface of the air bag. There was a fabric transfer noted along the bottom inboard surface of the air bag which was attributed to contact with the lower B-pillar during the deployment sequence. This area measured 17.8 cm (7.0") vertically and 15.2 cm (6.0") longitudinally.
