# INDIANA UNIVERSITY

## TRANSPORTATION RESEARCH CENTER

## ON-SITE AIR BAG INVESTIGATION

CASE NUMBER - IN99-076  
LOCATION - ILLINOIS  
VEHICLE - 1991 CHEVROLET CORSICA LT  
CRASH DATE - June, 1999

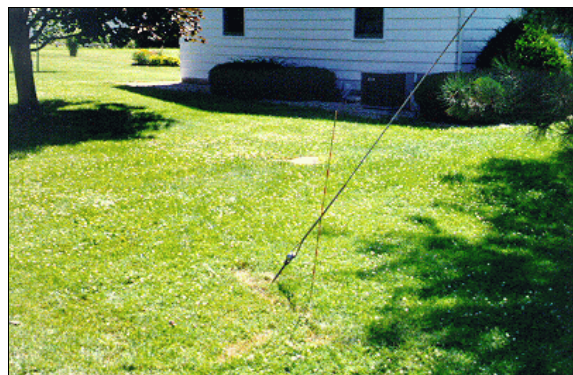
**Figure 3:** Guy wire impacted by case vehicle which was located off the west (right) side of the road (case photo #05)

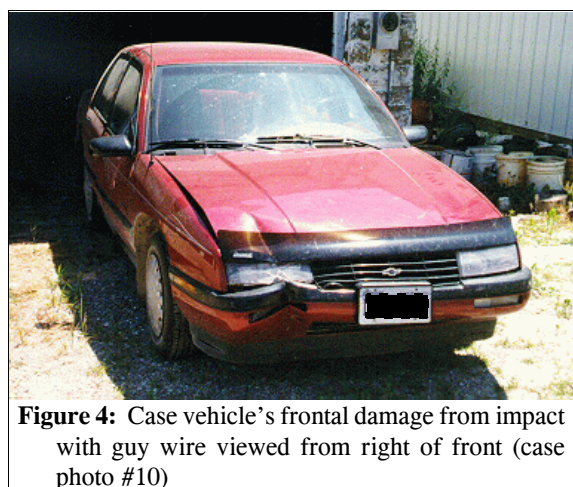
The case vehicle's front right bumper (**Figures 4 and 5**) impacted a guy wire used to support a utility pole (**Figures 6 and 7** below) and momentarily continued forward prior to reaching maximum engagement which caused the case vehicle's driver (only) supplemental restraint (air bag) to deploy. At maximum engagement, the case vehicle's front right snagged on the guy wire, and the case vehicle rotated approximately 35 degrees clockwise coming to rest primarily off the west side of the road on the grass heading southwest. The case vehicle was towed from the scene but not due to damage.

**Figure 4:** Case vehicle's frontal damage from impact with guy wire viewed from right of front (case photo #10)

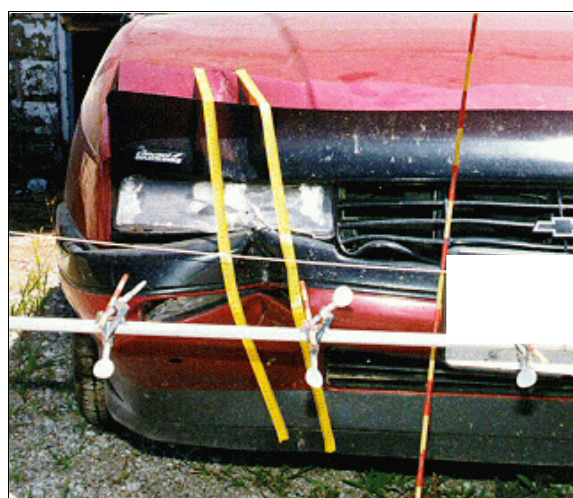
**Figure 5:** Close-up of case vehicle's front right deformation from impact with guy wire; Note: yellow tape highlights guy wire's vertical interaction (case photo #15)

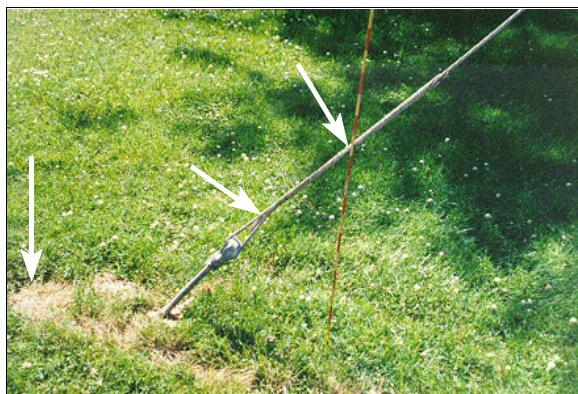
**Figure 6:** Close-up of guy wire impacted by case vehicle; Notes: left arrow highlights location of guy wire post-impact; guy wire was partially up-rooted from ground by impact and was subsequently reburied; center arrows show width of damage on guy wire from impact with case vehicle (case photo #06)

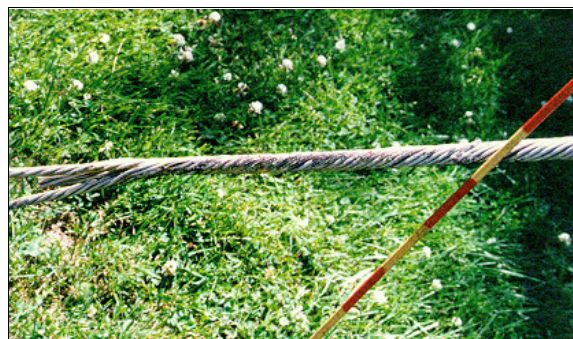
**Figure 7:** Close-up of guy wire section damaged by impact with case vehicle (case photo #07)

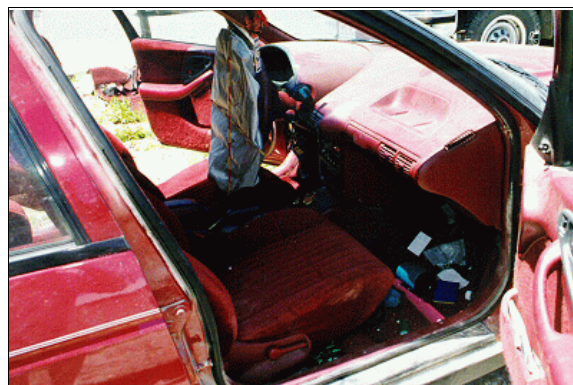
**Figure 8:** Case vehicle's front seating area, view from right front door, showing deployed driver (only) air bag (case photo #33)

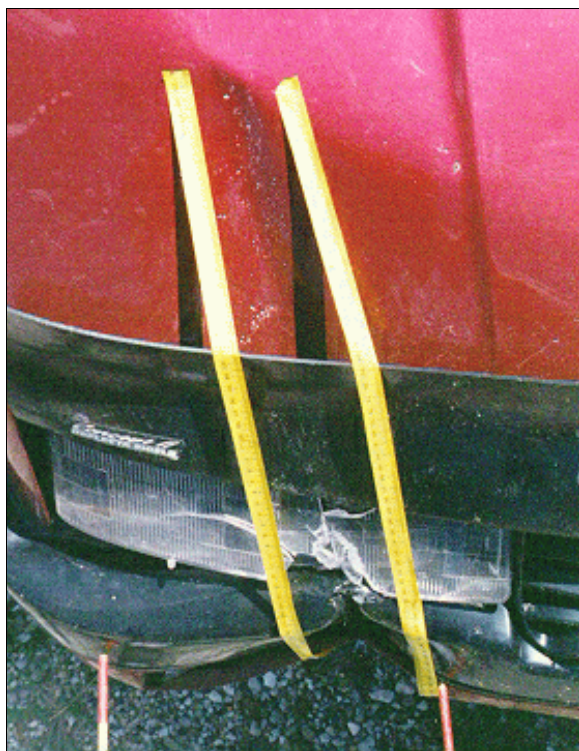
The case vehicle's impact with the guy wire resulted in a narrow vertical direct damage pattern that wrapped around the front end from the undercarriage to the hood of the vehicle (**Figure 9** below). The measured width of direct damage was a distance of 5 centimeters (2.0 inches). Field L was a measured distance of 127 centimeters (50.0 inches), extending from bumper corner to bumper corner. Direct damage on the hood extended 24 centimeters (9.5 inches) rearward from the leading edge. The right half of the front bumper was noticeably

deformed with the hood and grille also being deformed rearward. The case vehicle's wheelbase remained unchanged from the crash.

**Figure 9:** Overhead close-up of deformation to case vehicle's front right bumper, bug deflector, and hood from impact with guy wire (case photo #16)

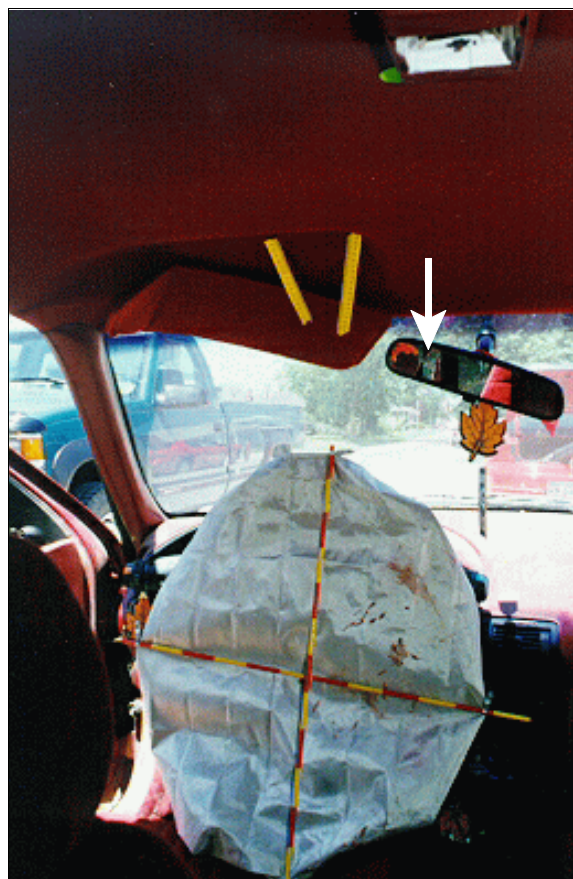
An examination of the case vehicle's interior revealed that the rearview mirror was askew (**Figure 10**), most likely from contact by the driver's hand as her hand was propelled upwards during the air bag's inflation. In addition, the energy absorbing steering column showed significant evidence of compression; although, the steering wheel rim showed no apparent deformation. The shear capsules were separated a measured distance of 5.5 centimeters (2.2 inches). The driver's sun visor and roof above the sun visor showed evidence of skin transfers (**Figure 10**). The top of the instrument panel, just above and to the right of the steering wheel rim, had what appeared to be four finger imprints from the case vehicle's driver (**Figure 11**). Further, the left side of the driver's knee bolster was scuffed and indented from contact with the driver's left knee. And finally, the driver air bag module's

**Figure 10:** Vertical view of case vehicle's driver seating area showing cracked (arrow) rearview mirror, probable occupant contact to sun visor, and blood evidence on driver air bag (case photo #28)

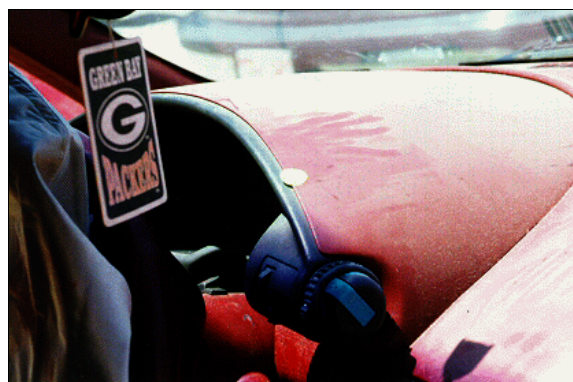
**Figure 11:** Right hand print deposited on dash by case vehicle's driver when she loaded the steering column during the crash sequence (case photo #31)

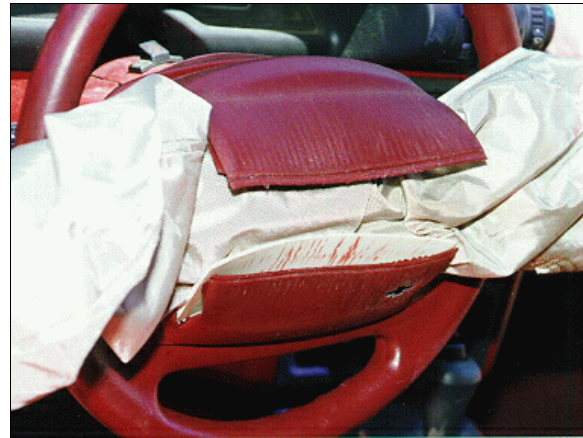
cover flaps had cloth transfers on them (**Figure 12**).

**Figure 12:** Close-up of cloth transfers deposited on case vehicle driver air bag module's cover flaps; Note: edge of top cover flap struck driver in upper right anterior neck (case photo #22)

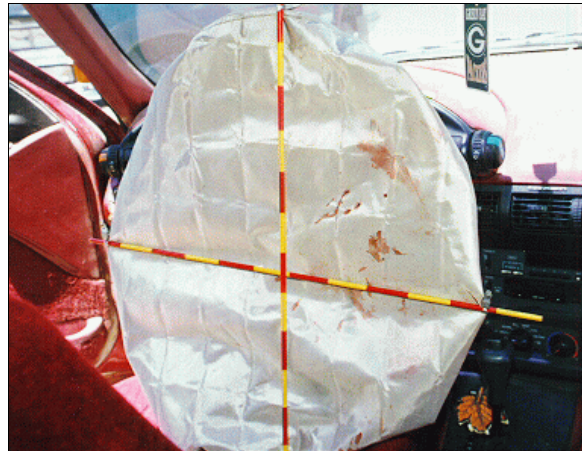
An inspection of the case vehicle's driver air bag revealed a significant area of blood smears on the front bottom half of the air bag (**Figure 13**). Also present were purple striations from the back side of the cover flaps as the driver was restricting the air bag's deployment. The vast majority of the striations were on the back right half of the air bag, but some striations were also found between the 6 and 7 o'clock areas on the bottom lower portion of the front of the air bag. In addition, there was contact evidence readily apparent [i.e., a 3 x 9 centimeter (1.2 x 3.5 inch) area of skin transfer] on the backside of the driver's air bag near the 3 o'clock position (**Figure 14**).

**Figure 13:** Case vehicle's driver air bag with blood evidence to bottom half; Note: steering wheel turned 90 degrees counterclockwise (case photo #25)

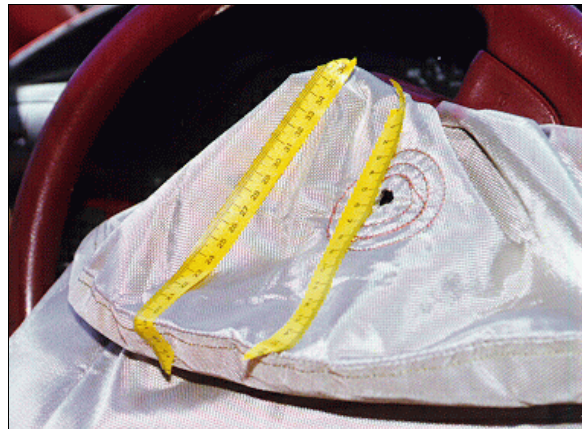
**Figure 14:** Close-up of skin transfer to backside of case vehicle's driver air bag (case photo #27)
