## REMOTE AIR BAG DEPLOYMENT REPORT

CASE NUMBER - IN99-093

VEHICLE - 1998 CHEVROLET CORVETTE

CRASH DATE - October 1998

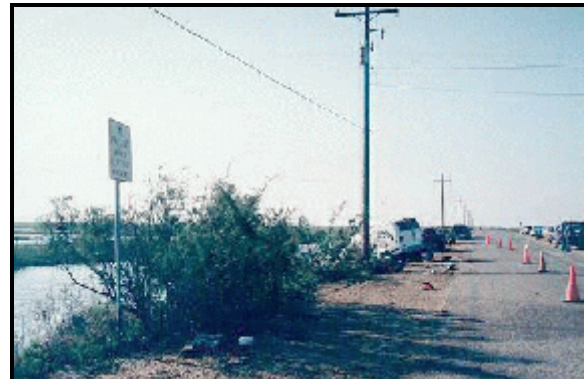
**Figure 1:** Southbound approach for Corvette along east shoulder; Note: Corvette's final rest position just beyond white van (case photo #01)

The crash occurred on the east shoulder (**Figure 1**). The front of the Corvette impacted the back of an empty boat trailer attached to a not in-transport cargo van. The front left of the Corvette then struck the back right of the van, causing the Corvette's driver and front right passenger air bags to deploy. The front of the Corvette also collided with a second empty boat trailer attached to a not in-transport pickup truck. The left side of the Corvette struck the right front wheel area of the not in-transport van and then descended an embankment into a canal. It is not known how much of the Corvette was in the canal water at final rest (**Figure 2**).

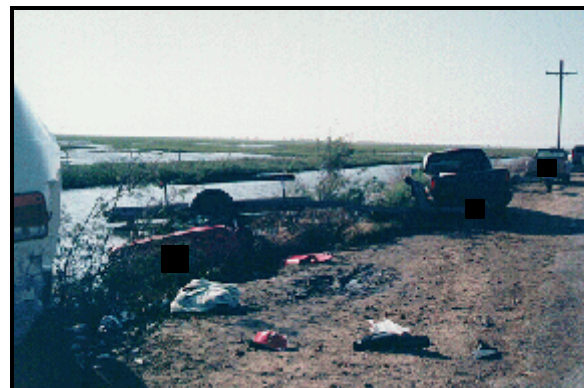
**Figure 2:** Southeast view of Corvette's final rest position; Note: second boat trailer atop Corvette's hood (case photo #03)

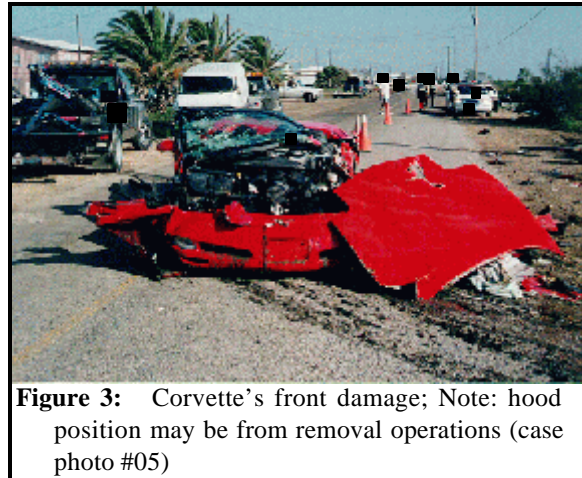
The Corvette sustained five impacts and several of the fiberglass body panels shattered and flew apart. Because of the hood's position in police on-scene photographs, much of the front left damage is hidden (**Figure 3**); note that the Corvette had been hauled up out of the canal to the position where it is seen in these photos. The front bumper fascia was pushed rearward and downward. The hood had scrapes, a long gouge, and a hole (probably from the second trailer overriding the front of the Corvette). The bottom left corner of the windshield frame was separated from the cowl's top and moved rearward and inward; the left front fender disintegrated; the left front tire and wheel was knocked askew (top in, bottom out); the left front door is missing; and the front portion of the left rear quarterpanel was holed (**Figure 4**). The right front fender was disintegrated; the right front door was ajar (unknown if crash-induced or due to extrication) and the door panel showed a streak of rubber transfer; the right upper A-pillar was bent rearward and the lower right corner of the windshield was holed; there was a horizontal crease indentation approximately a third of the way up the windshield that extended from the right upper A-pillar to just short of the left upper A-pillar (**Figure 5**). Induced damage included the left lower A-pillar rearward movement and the dangling/separated interior rearview mirror.

The Corvette sustained major intrusion into the passenger compartment, including the left lower and upper A-pillar, the left side of the instrument panel, the steering wheel and column, and the right upper A-pillar. Floorboard and toe pan intrusion seem likely but cannot be verified.

**Figure 3:** Corvette's front damage; Note: hood position may be from removal operations (case photo #05)

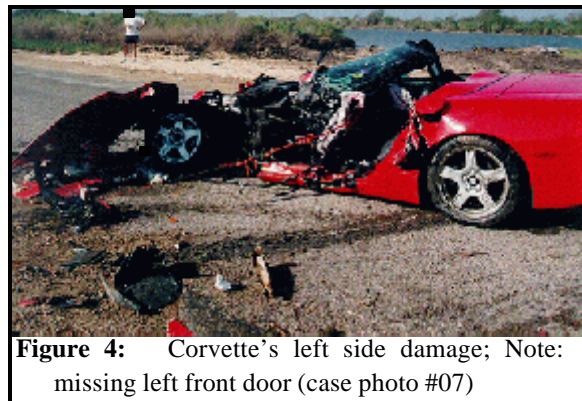
**Figure 4:** Corvette's left side damage; Note: missing left front door (case photo #07)

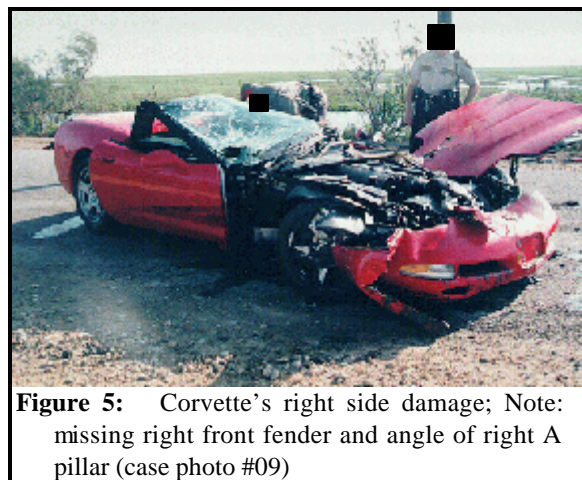
**Figure 5:** Corvette's right side damage; Note: missing right front fender and angle of right A pillar (case photo #09)

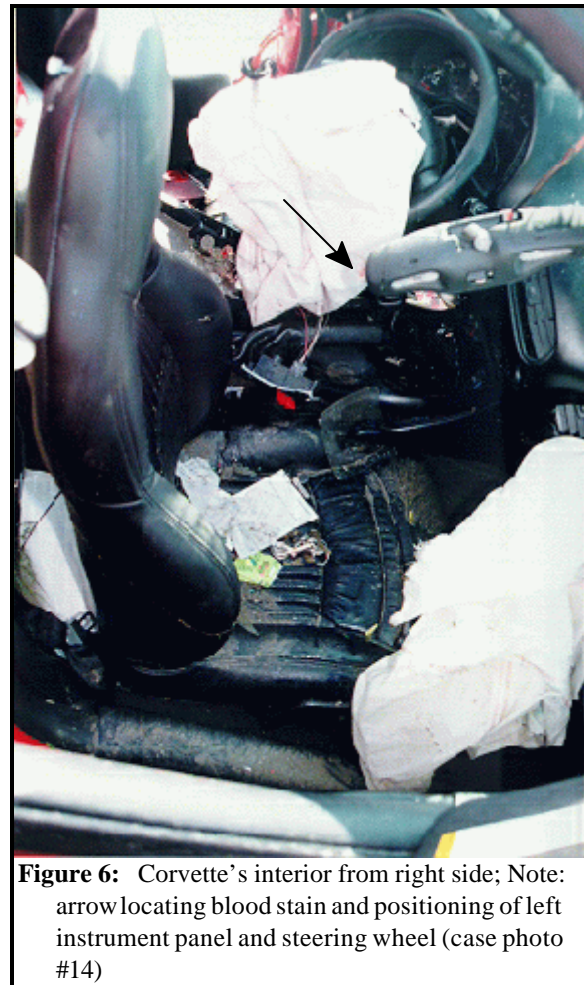
The available photographs do not permit a thorough evaluation of the Corvette's automatic restraint system, but they do verify that both driver and front right passenger air bags deployed (**Figure 6**). The driver's air bag module was located in the steering wheel hub. It is not known if the driver air bag was equipped with tethers or vent ports. The shape of the driver's air bag is also unknown. One small blood stain was detected on the air bag fabric but the deflated fabric positioning is such that the stain's location cannot be described (**Figure 6**). The front right passenger air bag module was located in the top of the instrument panel's right side. Its cover flap configuration is unknown, as is its shape. No vent ports are discernible but the air bag fabric stitching indicates the likelihood of at least one tether strap being present. No definitive occupant contact marks were identified on the passenger's air bag fabric.

**Figure 6:** Corvette's interior from right side; Note: arrow locating blood stain and positioning of left instrument panel and steering wheel (case photo #14)

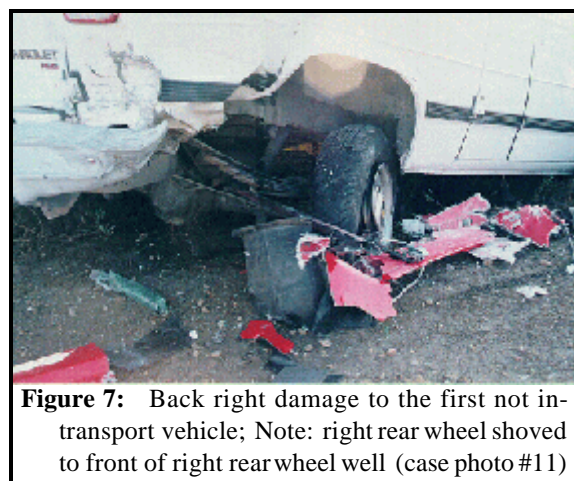
The Corvette's most severe impact (which caused the air bags to deploy) was event #2. The front of the Corvette underrode the back of the parked van (Corvette front underride, van back override; see **Figure 7**, below). Because of the multiple overlapping impacts, it was not possible to estimate any CDCs for the Corvette and no WinSMASH reconstruction run was attempted. The crash severity for the Corvette's most severe impact was moderate (24 to 40 km.p.h. [15 to 25 m.p.h.]).

**Figure 7:** Back right damage to the first not in-transport vehicle; Note: right rear wheel shoved to front of right rear wheel well (case photo #11)

and the back right wheel and suspension. The rear axle and right rear wheel were displaced forward (Figure 7). A CDC for the van's first impact with the Corvette was estimated from photographs as **06-BREE-4 (180)**. The van also sustained a second, relatively minor impact with the Corvette, at the right front corner area. The right front fender was creased, trim pieces around right headlight assembly were broken, the right turn signal lens was shattered and the right corner of the front bumper was displaced
