ON-SITE SIDE IMPACT INFLATABLE OCCUPANT PROTECTION INVESTIGATION

CASE NUMBER - IN99-114
LOCATION - IOWA
VEHICLE - 1999 PONTIAC MONTANA
CRASH DATE - December, 1999

March 7, 2003

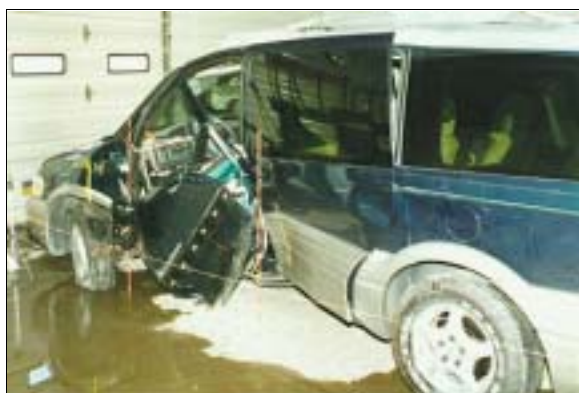
Figure 1: Case vehicle's left side deformation viewed from left of back (case photo #03)

The left side of the case vehicle (**Figures 1, 2 and 3**) was impacted by the front of the Honda (**Figure 4** below), causing the case vehicle's driver, seat back-mounted, side impact air bag to deploy. The case vehicle's dual front air bags did not deploy. The case vehicle was redirected in a southeasterly direction and came to rest on the south leg of the intersection with its front left tire

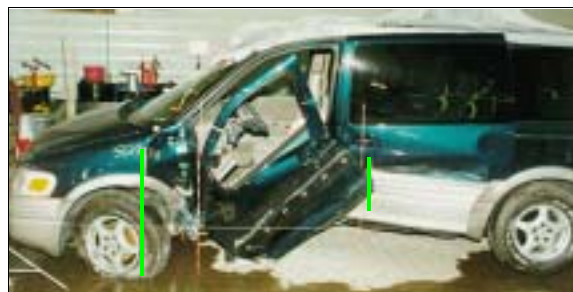
Figure 2: Case vehicle's left side deformation; Note: green lines indicates width of direct damage (case photo #02)

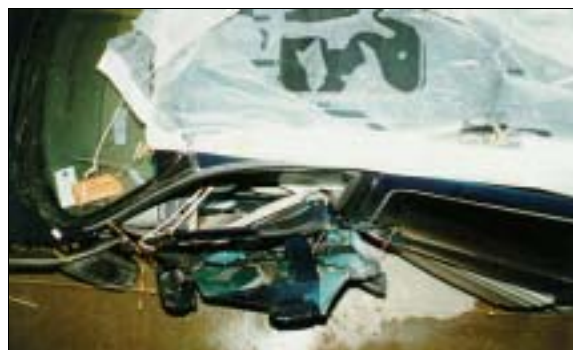
Figure 3: Overhead view of case vehicle's left side deformation showing crush relative to string line (case photo #06)

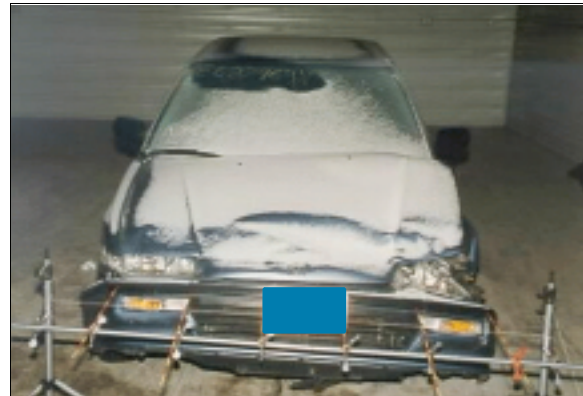
Figure 4: Honda's frontal damage viewed at eye level with contour gauge placed at bumper level (case photo #40)

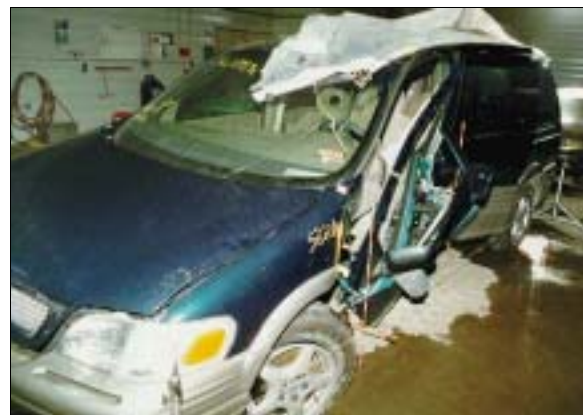
The case vehicle's contact with the Honda involved the left side and extended from the front axle rearwards to the rear axle (**Figure 5** and **Figure 6** below). Direct damage began 120 centimeters (47.2 inches) forward of the left rear axle (i.e., just behind the left "B"-pillar) and extended, a measured distance of 153 centimeters (60.2 inches), along the left side to just behind the left front axle (**Figure 2** above). Residual maximum crush was measured as 39 centimeters

Figure 5: Deformation to case vehicle's left side, viewed from left of front, as a result of impact by front of Honda (case photo #01)

(15.4 inches) at C₄. The wheelbase on the case vehicle's left side was shortened 13 centimeters (5.1 inches) while the right side was extended approximately 2 centimeters (0.8 inches). The case vehicle's damage was concentrated at the sill area and extended upwards from the ground approximately 65 centimeters (25.6 inches). The case vehicle's left fender, left front door, and left rear sliding door were directly damaged and crushed inward. The left front door was torn off its hinge. The case vehicle's left front tire was deflated. The case vehicle's hood, left fender, left quarter panel, and left "A" and "B"-pillars sustained induced damage. The left front window glazing was disintegrated, and there was remote buckling to the right quarter panel.

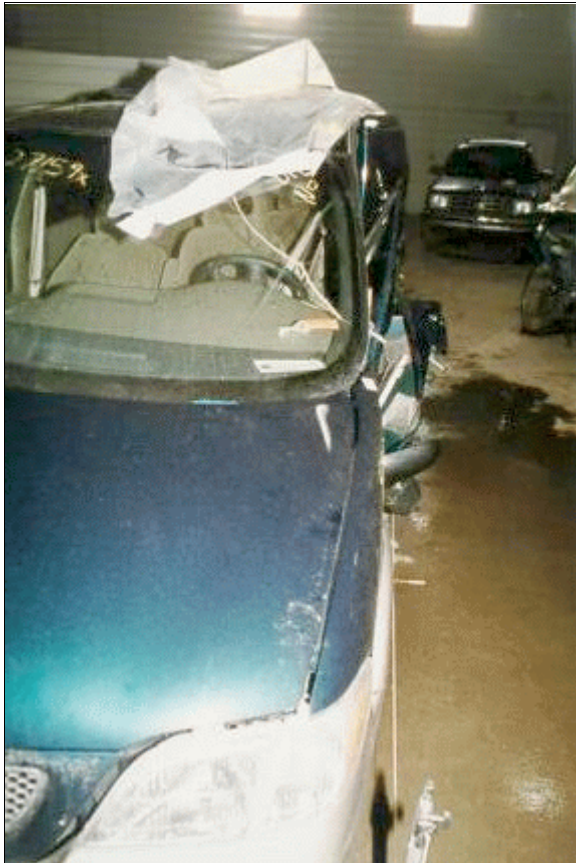
Figure 6: Vertical elevated view along case vehicle's damaged left side showing stringline placement (case photo #12)

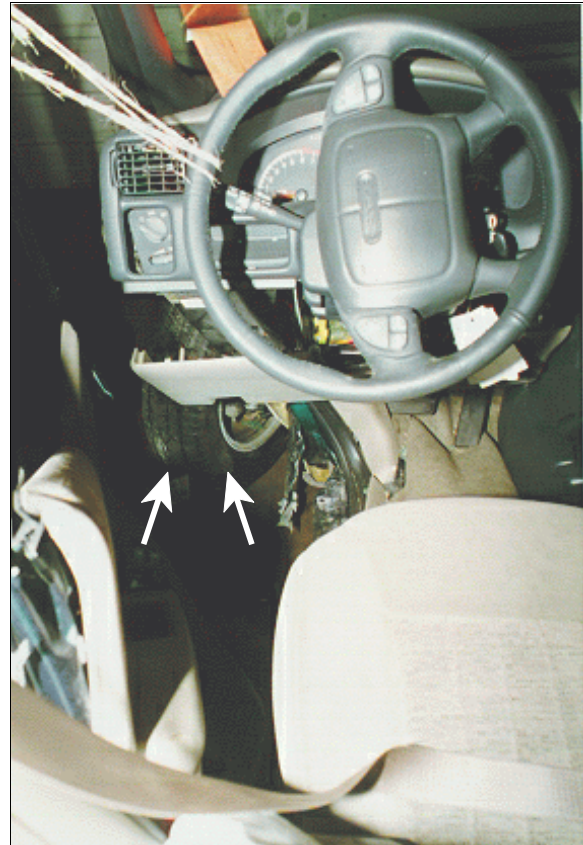
Figure 7: Vertical overhead view of case vehicle's driver seating area from in front of second seat left showing sill intrusion into driver's seating area and displacement of driver's seat toward vehicle's center; Note: arrows mark outline of left front tire (case photo #23)

case vehicle’s driver, at final rest she was seated, leaning towards the right half of her seat because of the intrusion at the sill level (**Figure 7** above).

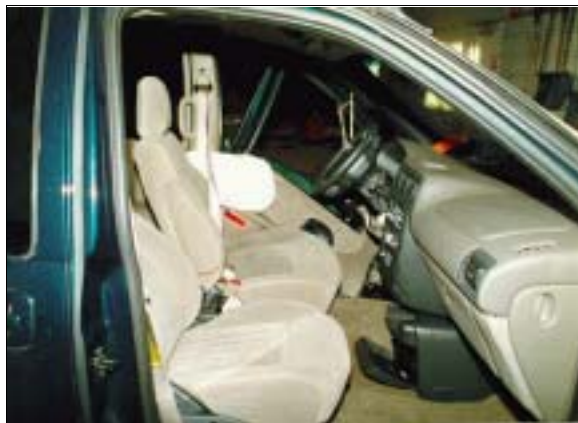
Figure 8: Case vehicle's front seating area showing driver's deployed side impact air bag and non-deployed frontal air bags (case photo #19)

The case vehicle's driver, side impact air bag was mounted in the outside portion of the driver's seat back (**Figure 8**). An inspection of the air bag module's cover flap and air bag fabric revealed that the cover flap opened at the designated tear points, and there was no evidence of damage during the deployment to the air bag or the cover flap. The driver's side air bag was designed without any tethers. The driver's side air bag had one vent port approximately 5 centimeters (2.0 inches) in diameter, located on the exterior surface of the air bag's fabric, beginning 8 centimeters (3.1 inches) forward of the cover flap and 2 centimeters (0.8 inches) down from the top seam (**Figure 9**). The deployed driver's side impact air bag was rectangular with a height of approximately 26 centimeters (10.2 inches), and it extended outward from the seat back a distance of approximately 42 centimeters (16.5 inches). There was no contact evidence readily

The case vehicle's driver and front right passenger supplemental restraints (air bags) did not deploy as a result of the case vehicle's left side impact (**Figure 8** above). The driver air bag was located in the steering wheel hub. The front right passenger air bag was located in the top of the instrument panel. In addition, the front right passenger's seat back-mounted, side impact air bag also did not deploy.

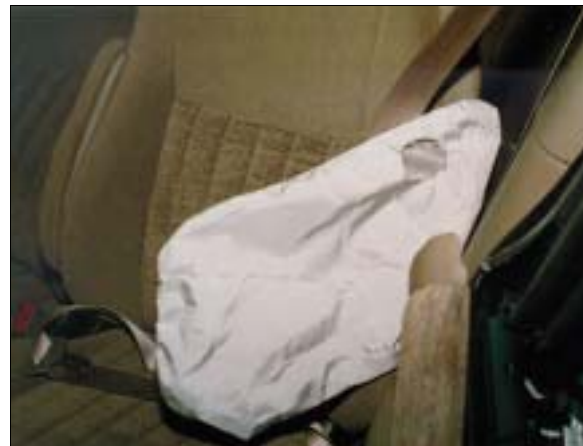
Figure 9: Exterior surface of case vehicle's deployed, driver, seat back-mounted, side impact air bag; Note: vent port was located near top back of air bag's fabric (case photo #37)

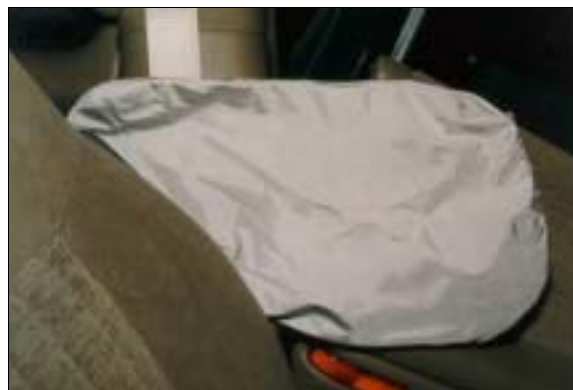
apparent on the interior surface of the driver's, seat back-mounted, side impact air bag (**Figure 10**).

Figure 10: Interior side of case vehicle's deployed, driver, seat back-mounted, side impact air bag showing no apparent evidence of contact (case photo #36)

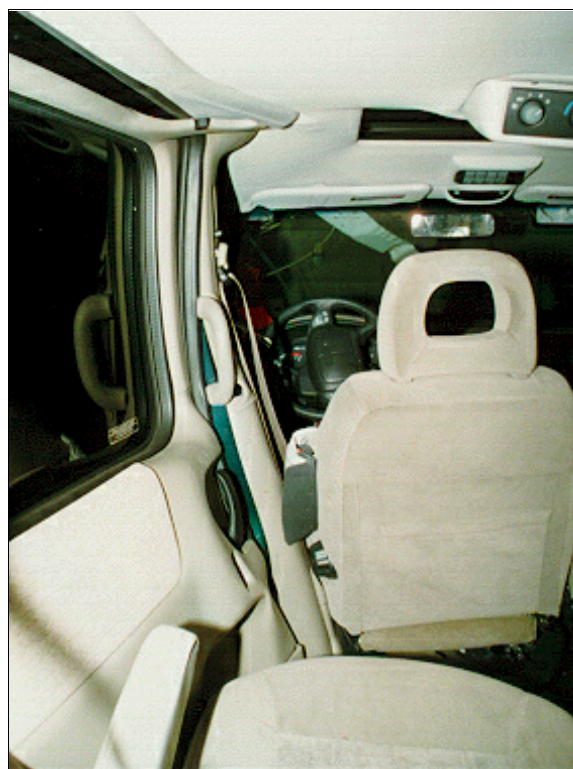
Figure 11: Vertical view from back left seat showing displacement of driver's seat inward and intrusion into left second seating area from left door panel and left "B"-pillar (case photo #32)

which limited her leftward movement and most likely prevented the child from possible injury by the intruding left “B”-pillar and side interior surface⁵ (**Figure 11** below). Post-crash, the case vehicle was redirected southeastward. The case vehicle’s redirection in conjunction with the intrusion into this occupant’s seating area caused the second seat left passenger to rebound rightward and forward. Once again, the second seat left passenger loaded her child seat restraints and the vehicle’s safety belts, which helped keep her in her child seat. The case vehicle’s driver was unaware of this child’s final rest position, but based on her lack of injuries, she was most likely near her original pre-crash position in the child seat.

The second seat left passenger was transported by ambulance to the hospital for a precautionary examination. According to the case vehicle's driver (i.e., Mother) and her medical records, she did not sustain any injuries as a result of this crash, despite the intrusion into her seating position (**Figure 11** above).

⁵ In Figure 11 (above) the left armrest for the left second seating position is shown. It is unknown if this armrest was positioned as shown (i.e., up or down) at the time of the crash. In addition, there was no evidence of contact to either side of the depicted armrest.

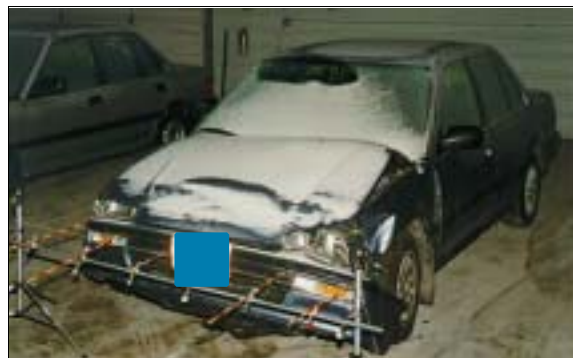
Figure 12: Honda's frontal damage from impact with case vehicle's left side-viewed from left of front (case photo #44)

Based on the vehicle inspection (**Figure 12** above and **Figure 13**), the CDC for the Honda was determined to be: **12-FDEW-1 (10)** [maximum crush was 19 centimeters (7.5 inches)]. The Honda was towed due to damage.

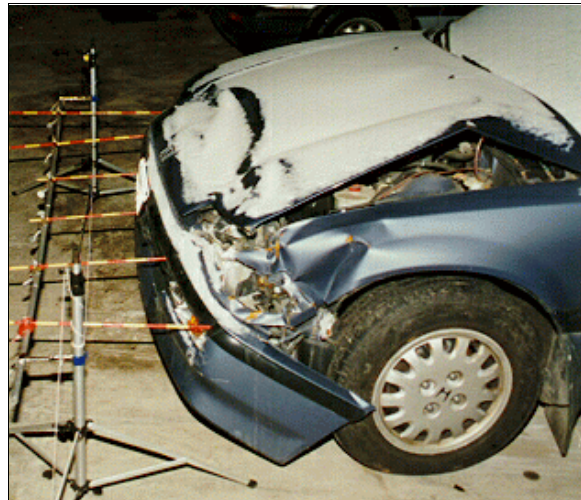
Figure 13: Honda's frontal damage viewed from left along front reference line, with contour gauge present showing deformation (case photo #42)
