Case 373 : Narrative

Case Vehicle (A): 2000 Nissan	Vehicle (B): 2000 Ford
Type: Xterra SE, 4 x 4, 4-door SUV	Type: Ranger, 4 x 2, 2-door pickup
Driver: 31-year-old female	Driver: 23-year-old female
CDC: 12-FDEW-3	CDC: 03-RDEW-5

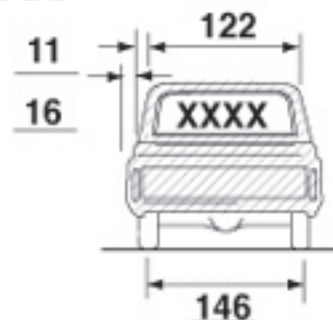
Width of direct damage to right side

194

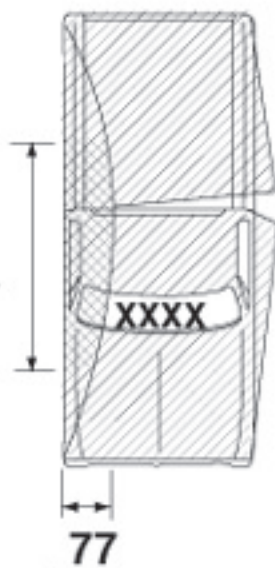
Max. crush to right side at the right A-pillar

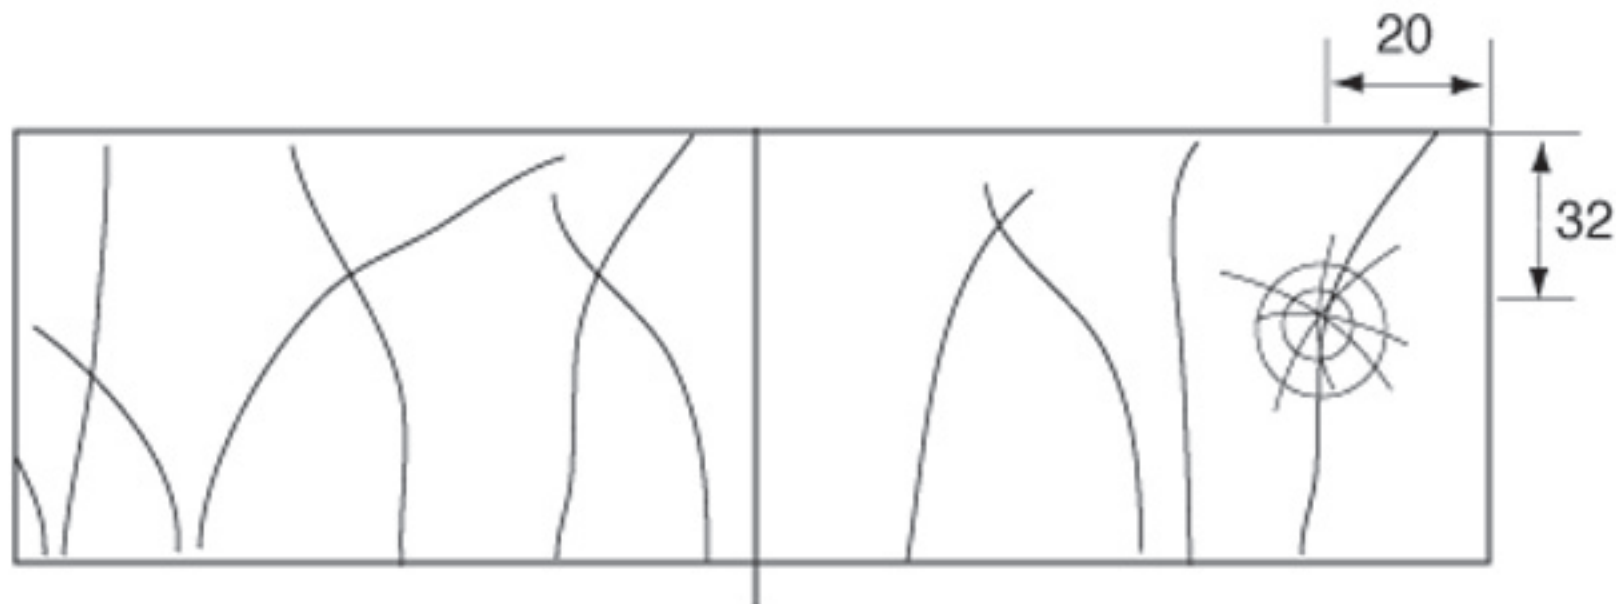
**Windshield cracked on right by rear edge of hood
and along the bottom due to cowl contact**
