## Case 391 : Narrative

Case Vehicle (A): 1999 Chevrolet	Vehicle (B): 2002 Dodge
Type: Metro, 2-door hatchback	Type: Stratus ES, 4-door sedan
Driver: 20-year-old male	Driver: 76-year-old female
CDC: 01-FDEW-3	CDC: 11-FLEW-1

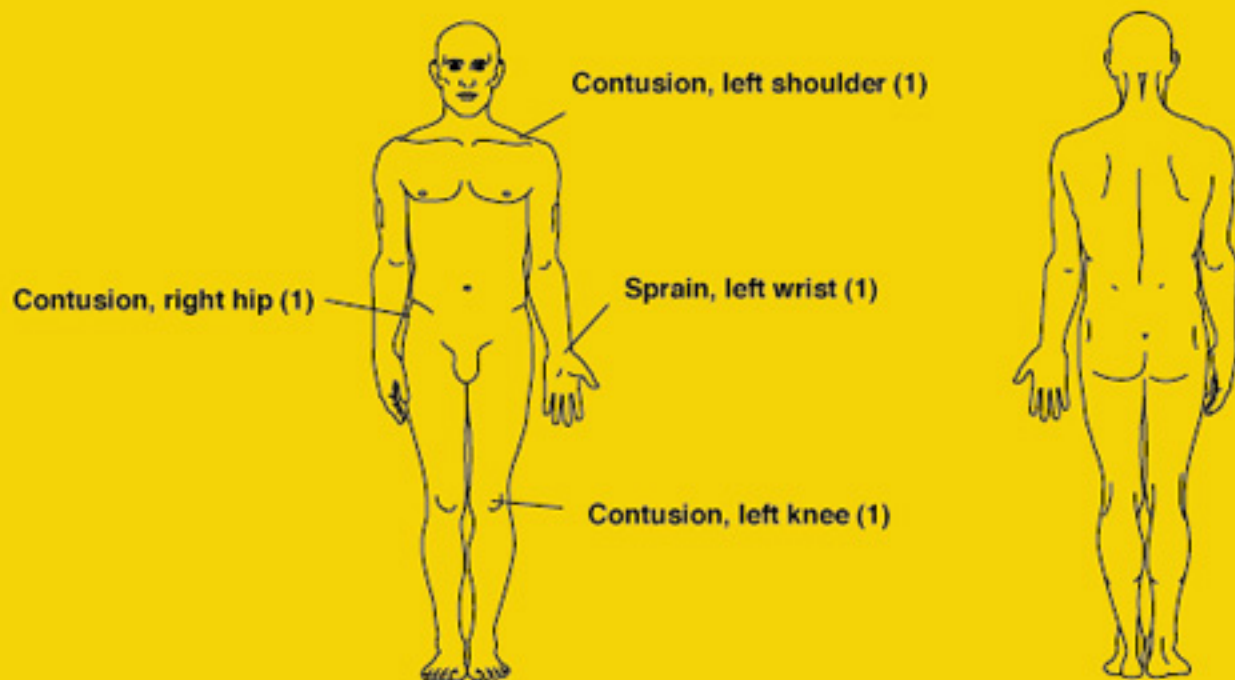
Occupant: Driver	Age: 20 years	Gender: Male		
Restraints: 3-point belt; steering-wheel airbag	Stature: 173 cm (5 ft, 8 in)	Mass: 54 kg (120 lb)		
Injury Description	A.I.S.	Injury Source		
		Definite	Probable	Possible
—	—	—	—	—
Contusion, left shoulder	1	Shoulder belt	—	—
Sprain, left wrist	1	—	—	Steering wheel
Contusion, right hip	1	Lap belt	—	—
Contusion, left knee	1	Knee bolster	—	—
Maximum A.I.S. Level	1	—	—	—
Injury Severity Score	2	—	—	—

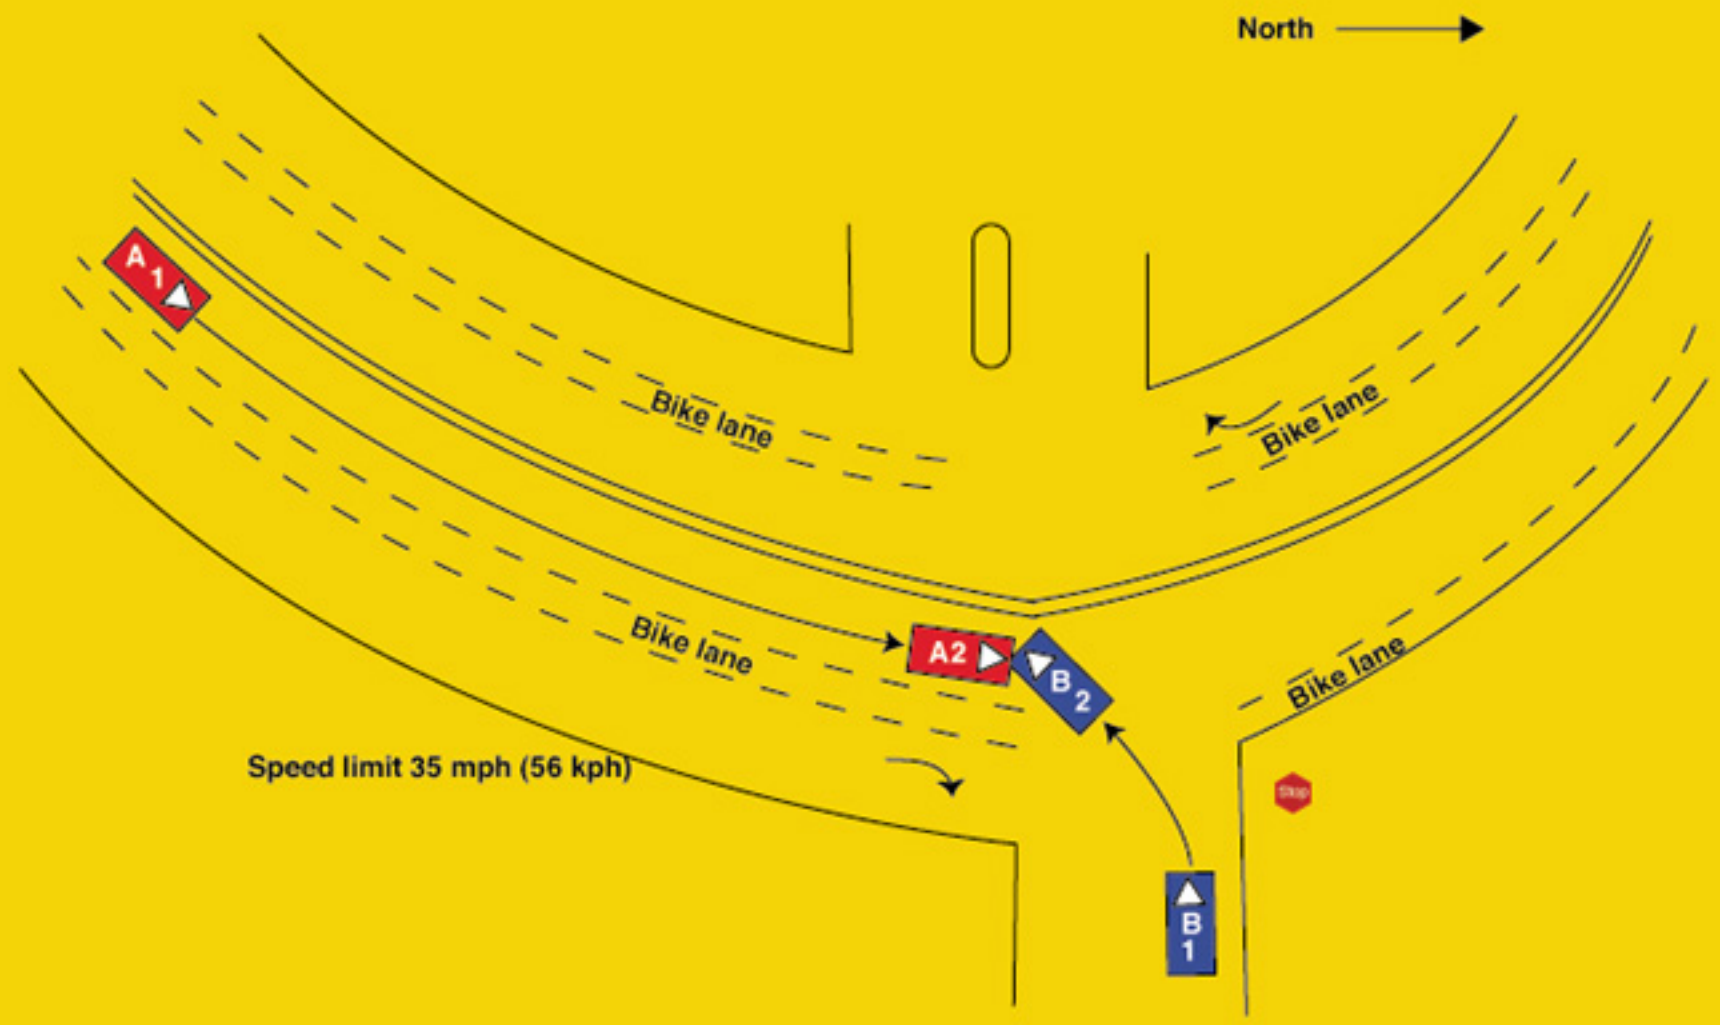
[1](#) It was daylight and clear and the road surfaces were dry and in good condition. [2](#) Case vehicle (A) was traveling north at an unknown speed in the left northbound lane of the curved section of a four-lane asphalt road and [3](#) and vehicle (B) was stopped facing west in the westbound lane of the intersecting east-west road. [4](#) The driver of vehicle (B) did not see case vehicle (A) approaching the intersection and [5](#) accelerated into the intersection to make a left turn onto the north-south road. The driver of case vehicle (A) was unable to take any evasive action and the front of case vehicle (A) struck the left front of vehicle (B). Both vehicles were towed due to damage.

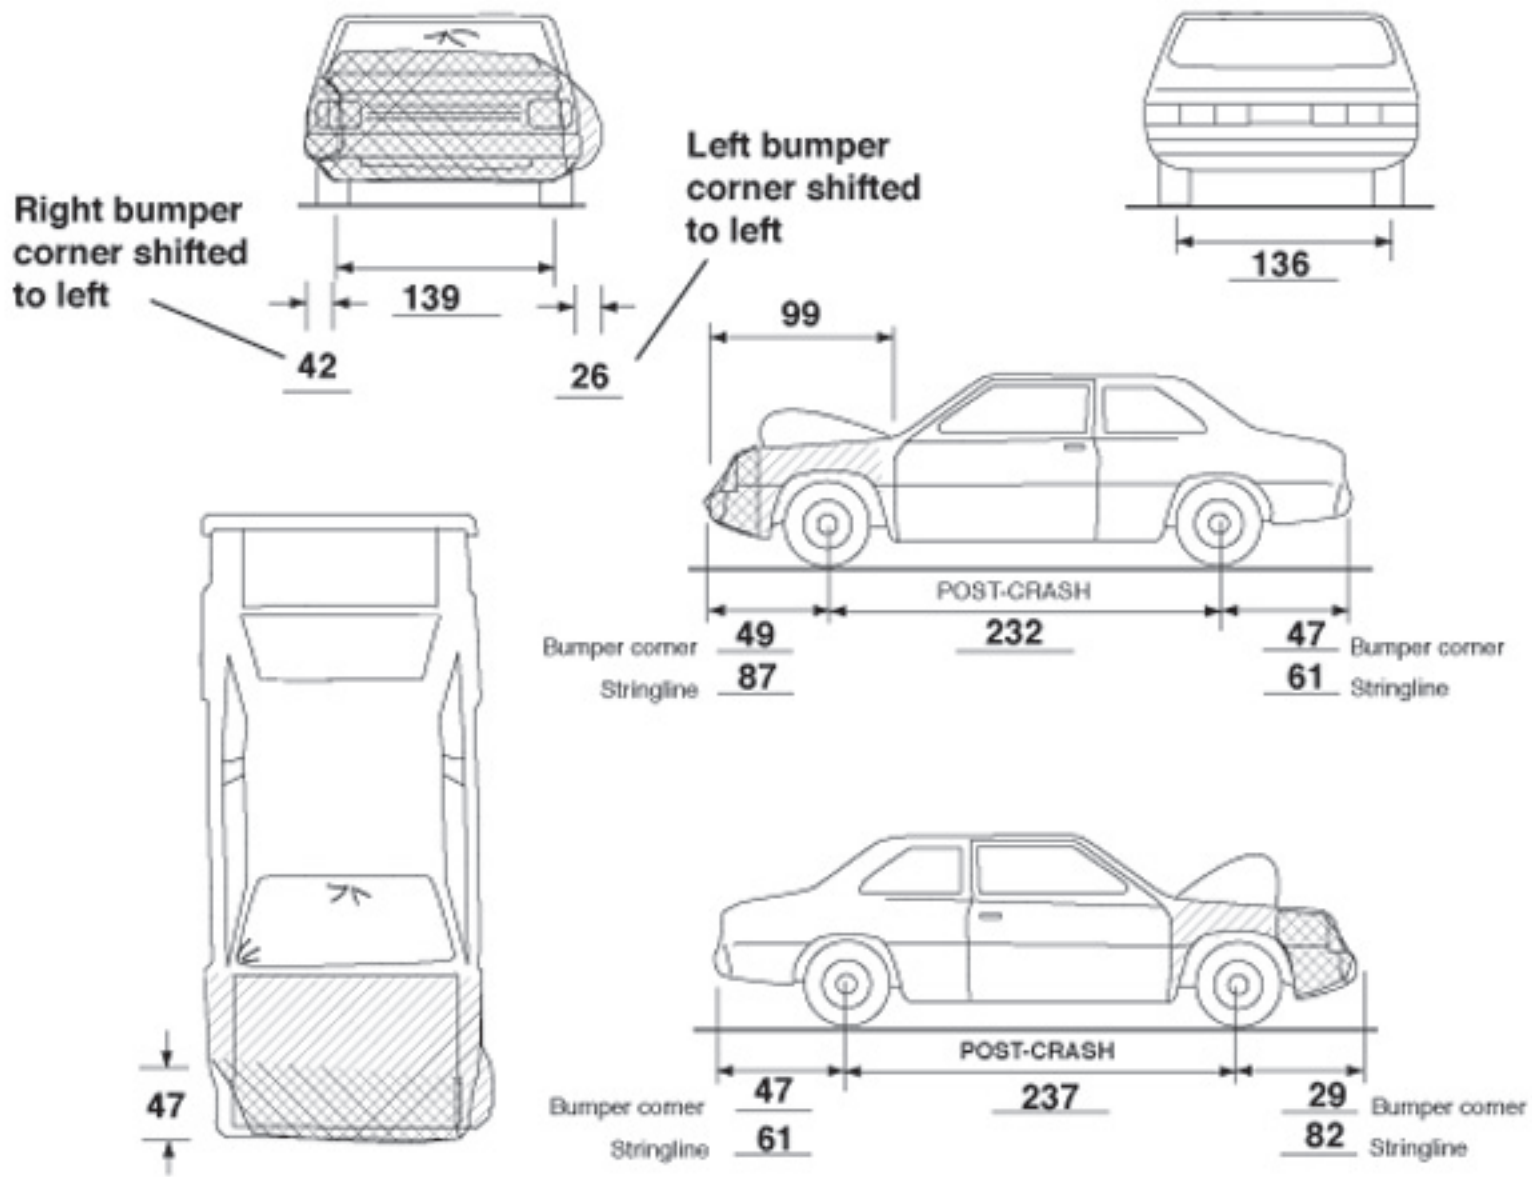
Max. crush to center front of the center bumper

Using the WinSMASH crash-reconstruction program and crush profiles measured for [12](#) [13](#) [14](#) case vehicle (A) and [15](#) [16](#) [17](#) vehicle (B), the following impact severities were estimated:

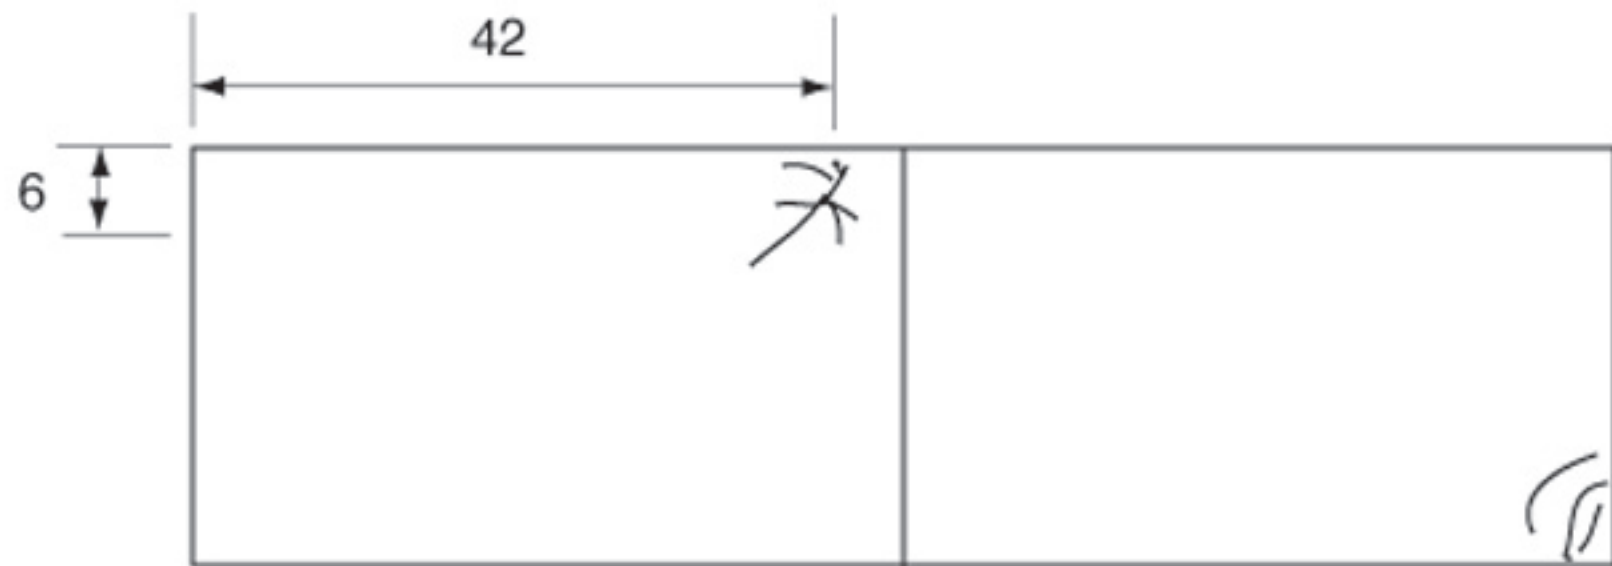
WINDSHIELD MARK ON CASE VEHICLE:

Windshield cracked in upper center from rear-view mirror contact, and on lower right corner due to cowl contact

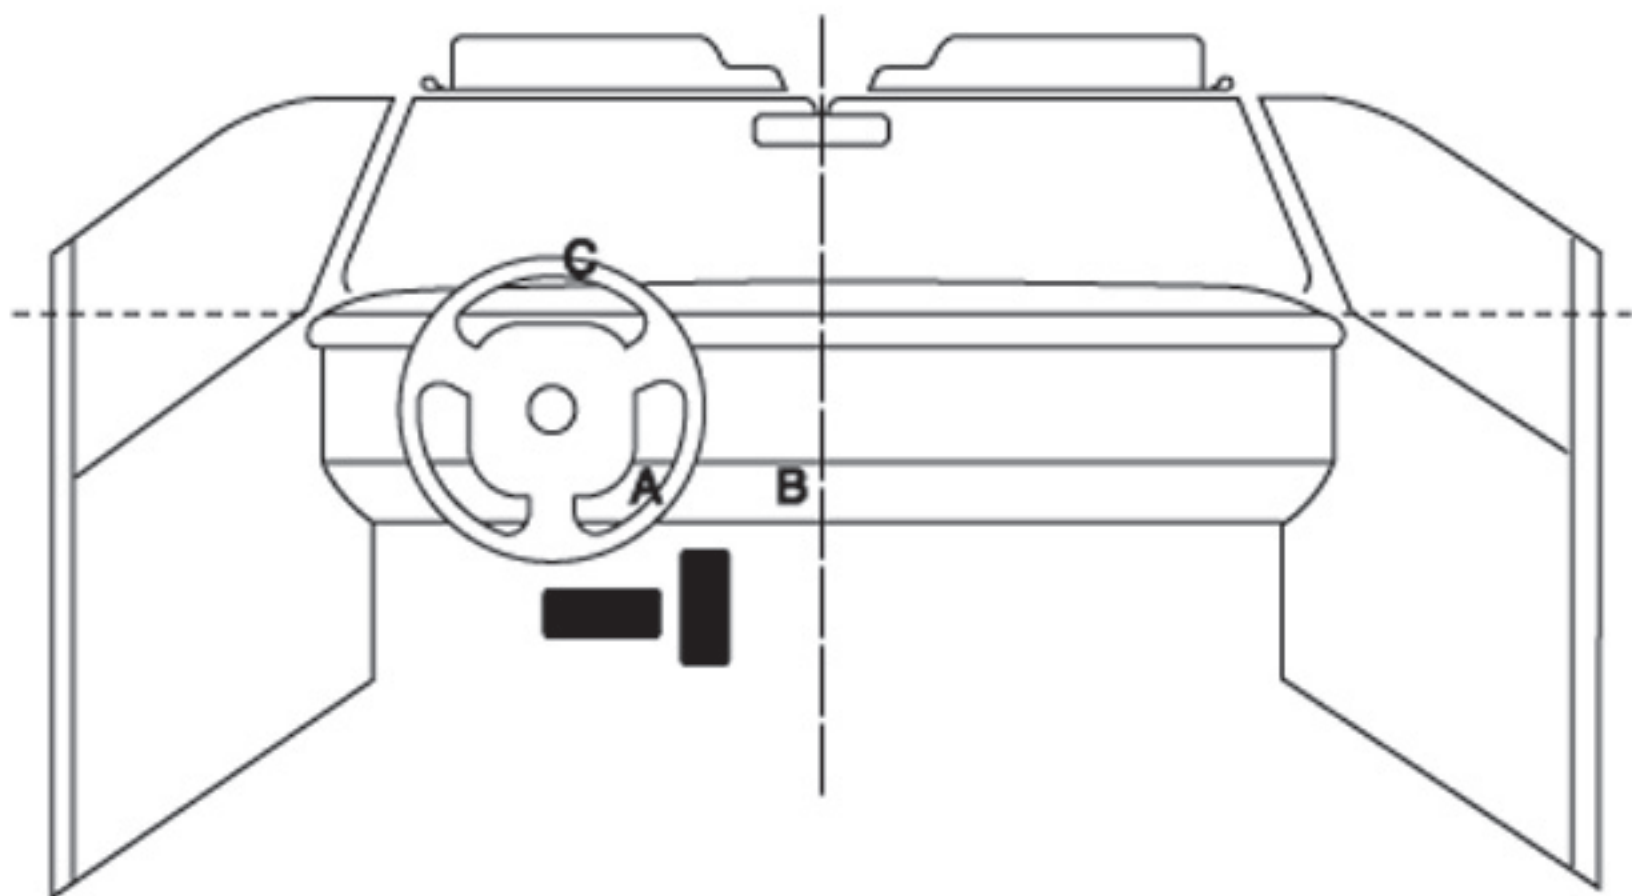
OCCUPANT CONTACT WORKSHEET

- A = Knee bolster, scuffmark
- B = Vertical console, indented
- C = Steering wheel rim and spokes,  
rim forward, spokes bent

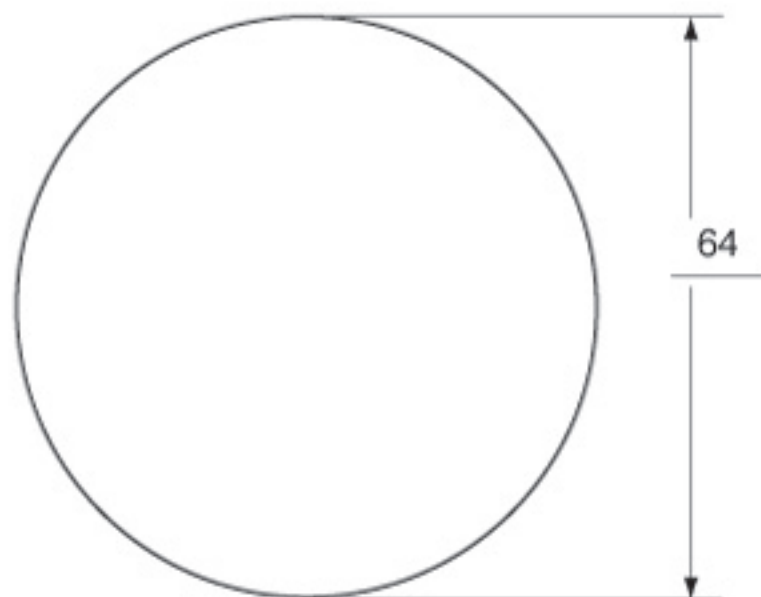
Driver Airbag

vents at 11 and 1 o'clock
