Case 400 : Narrative

Case Vehicle (A): 1999 Chevrolet
Type: S10 LS, 3-door cab pickup, 4x4
Driver: 28-year-old male
CDC: 12-FREN-1, 11-LDAW-3, 12-LBMS-2

This is a fatal crash. The driver of the case vehicle sustained fatal head and brain injuries due to head contact with a tree during a left-side impact.

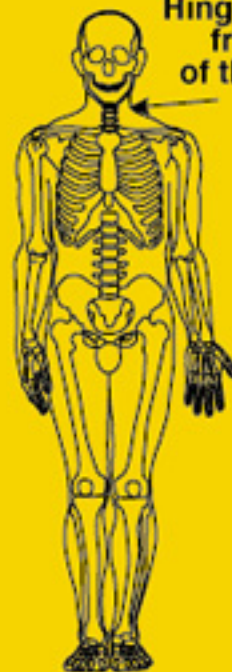
Laceration with partial disruption and intraparenchymal hemorrhage and hematoma at the basilar pons (6)

Bilateral lung contusions with hemothorax (4)

Subarachnoid hemorrhage, left frontal lobe (3)

Hemorrhage, anterior and posterior aspects of left scalp (2)

Contusion of the pole and orbital aspects of the left frontal lobe with diffuse convexinal injury (white matter shearing) (5)

8x3-cm full-thickness laceration to the left temporal-parietal scalp (2)

Multiple lacerations, left arm and left elbow (1)

Multiple abrasions and lacerations, left side of chest and left flank (1)

Hinge and ring fractures of the basilar skull (4)

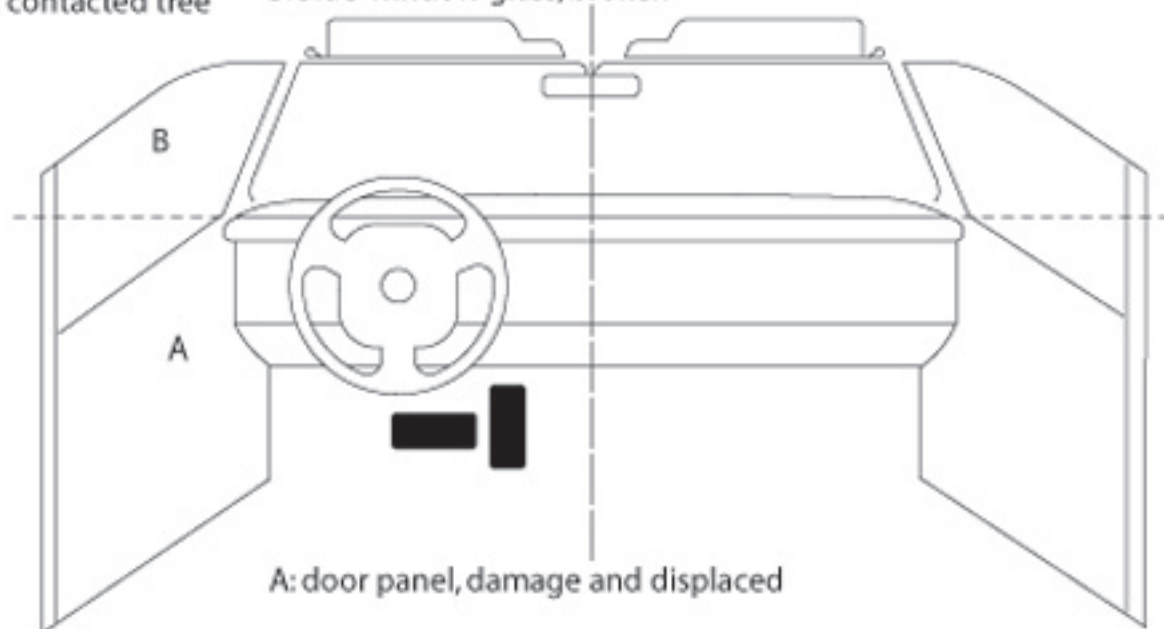
INTRUSION IT-1

Driver's head
outside of window
and contacted tree

B: Side-window glass, broken

A: door panel, damage and displaced

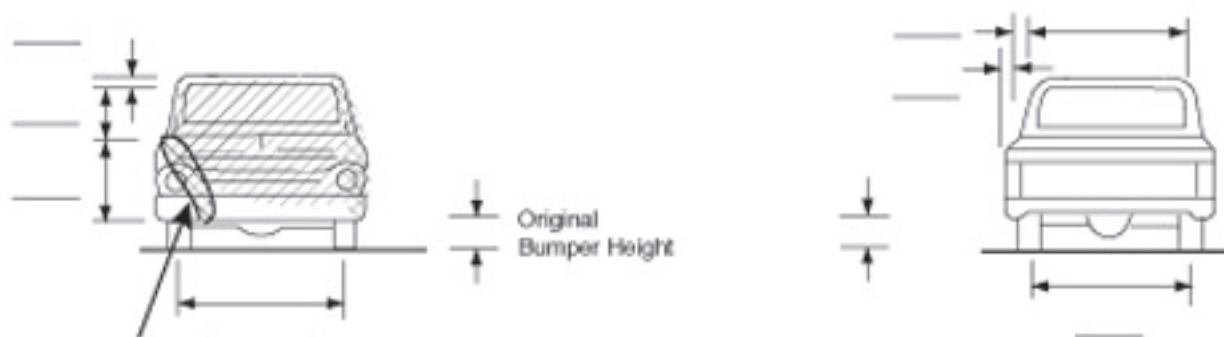
impact #1 with sign
10-cm direct damage
2-cm max crush

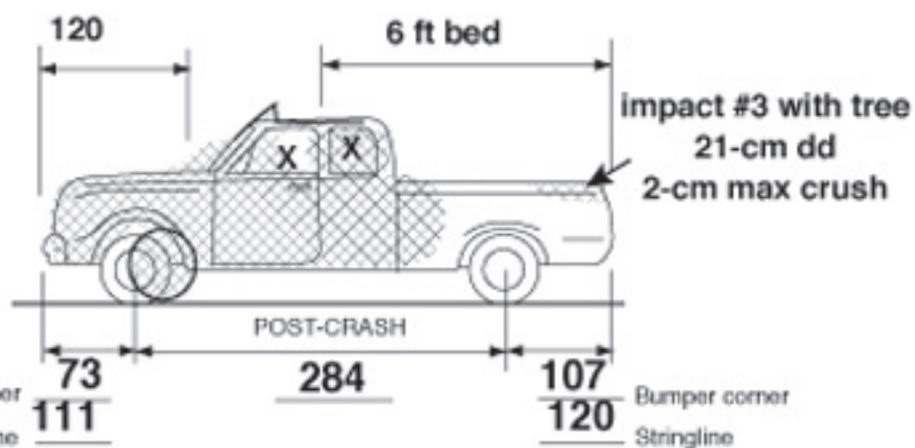
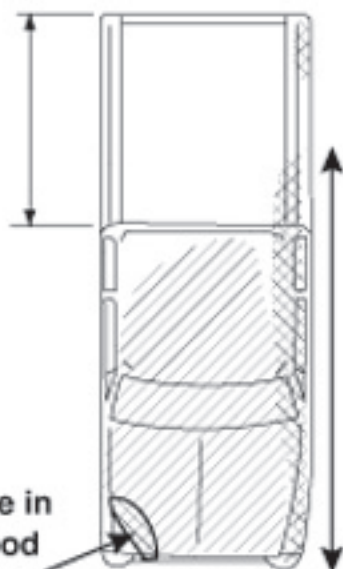
impact #2 with tree
317 cm along left side
33-cm max crush
at fender

hole in hood
