Case 407 : Narrative

Case Vehicle (A): 2003 Chrysler
Type: Sebring LX, 4-door sedan
Driver: 65-year-old female
CDC: 12-FDEW-3

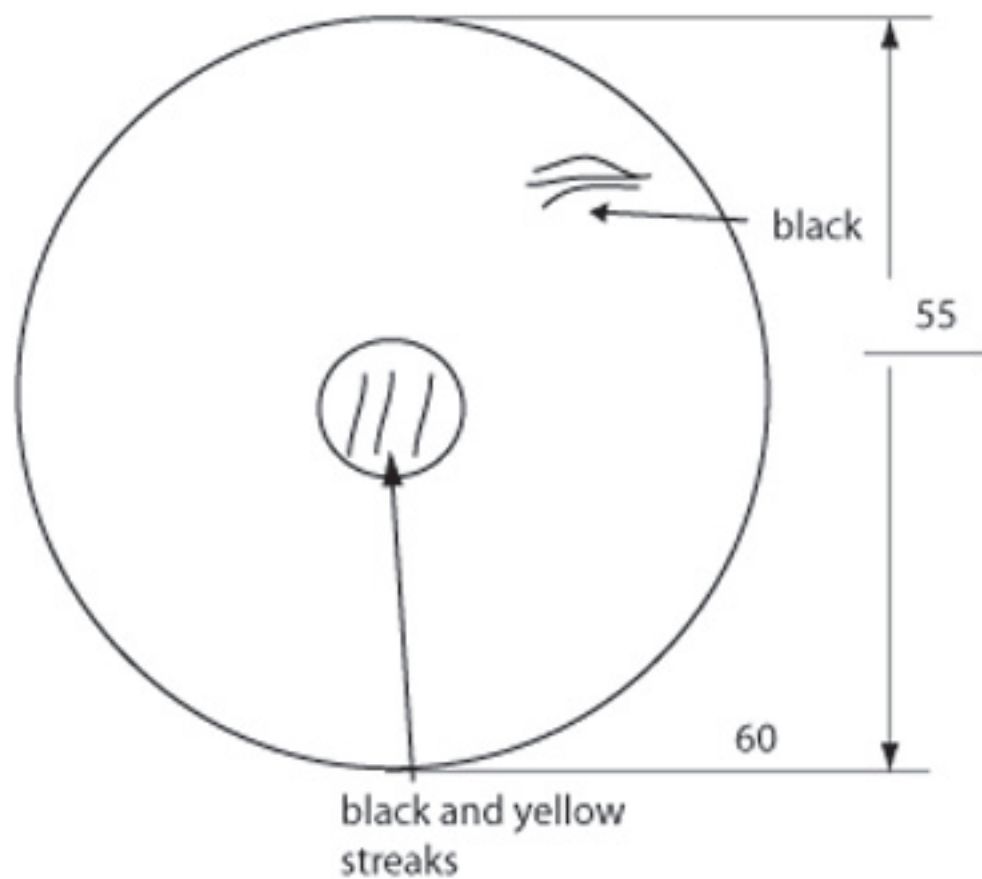
Driver Airbag

Vents: Y N
if yes, how many: 1
1 vent at 11 o'clock

Tethers: Y N
if yes, how many: 2

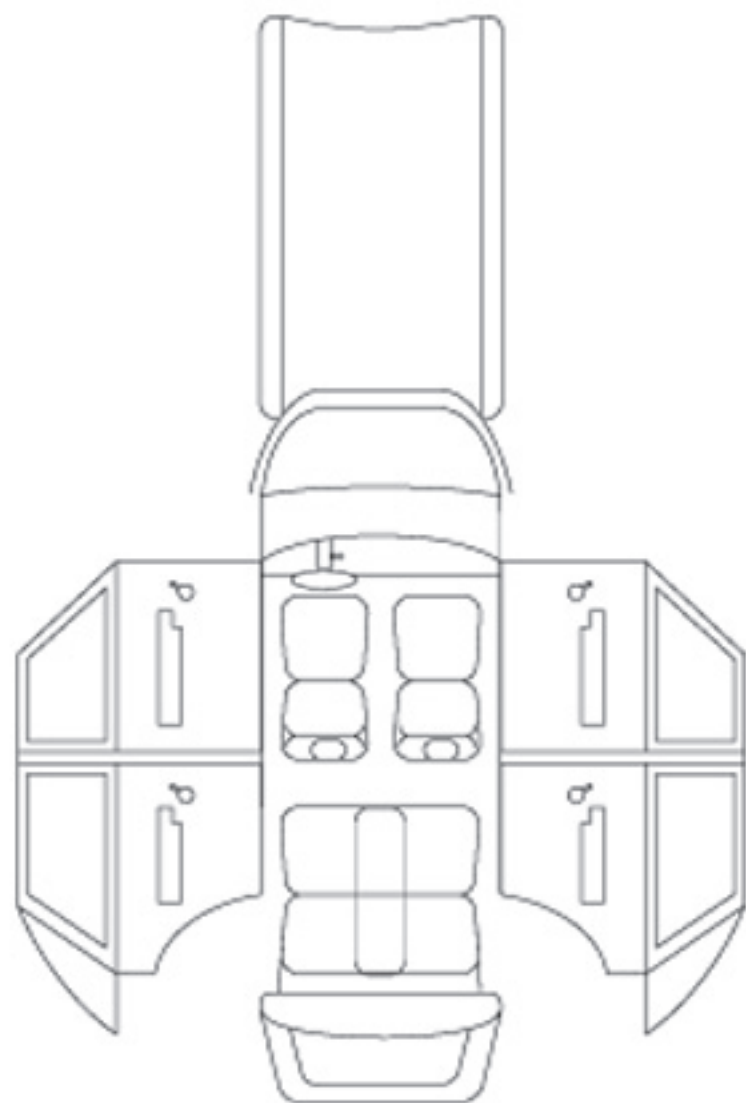
DR Belt: Yes
 Pretensioner activated and locked in an extended position
 Mark on webbing from D-ring
 Continuous loop is abraded

RF Belt: Yes
 Pretensioner activated and locked in an extended position
 Mark on webbing from D-ring
 Scratches on D-ring

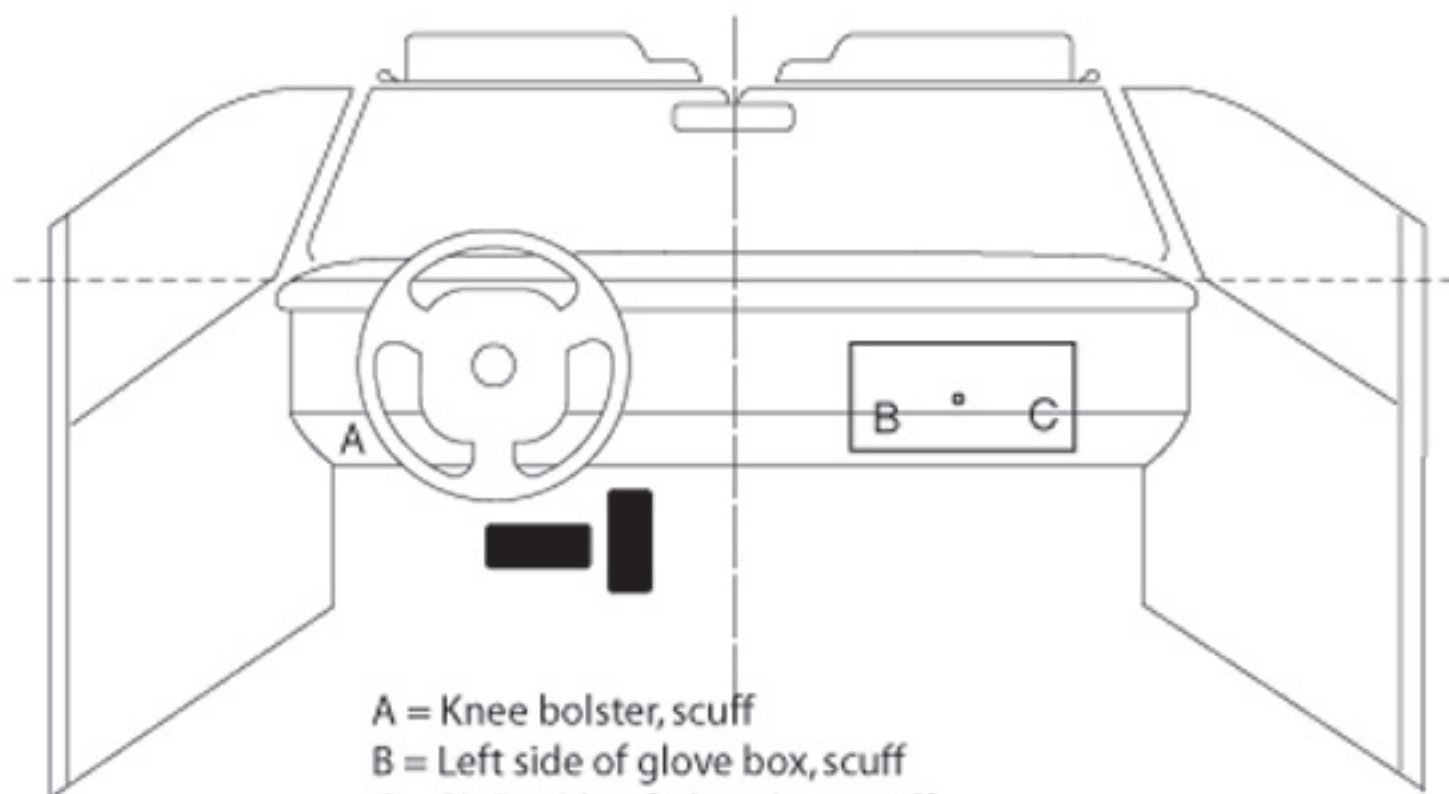
A = Knee bolster, scuff
 B = Left side of glove box, scuff
 C = Right side of glove box, scuff

Contact	Interior Component Contacted	Occupant No. if Known	Body Region if Known	Supporting Physical Evidence	Confidence Level of Contact Point
A	Left knee bolster	1	Knee	Scuff	1
B	Left side glove box	2	Knee	Scuff	1
C	Right side glove box	2	Knee	Scuff	1
D					
E					
F					
G					
H					
I

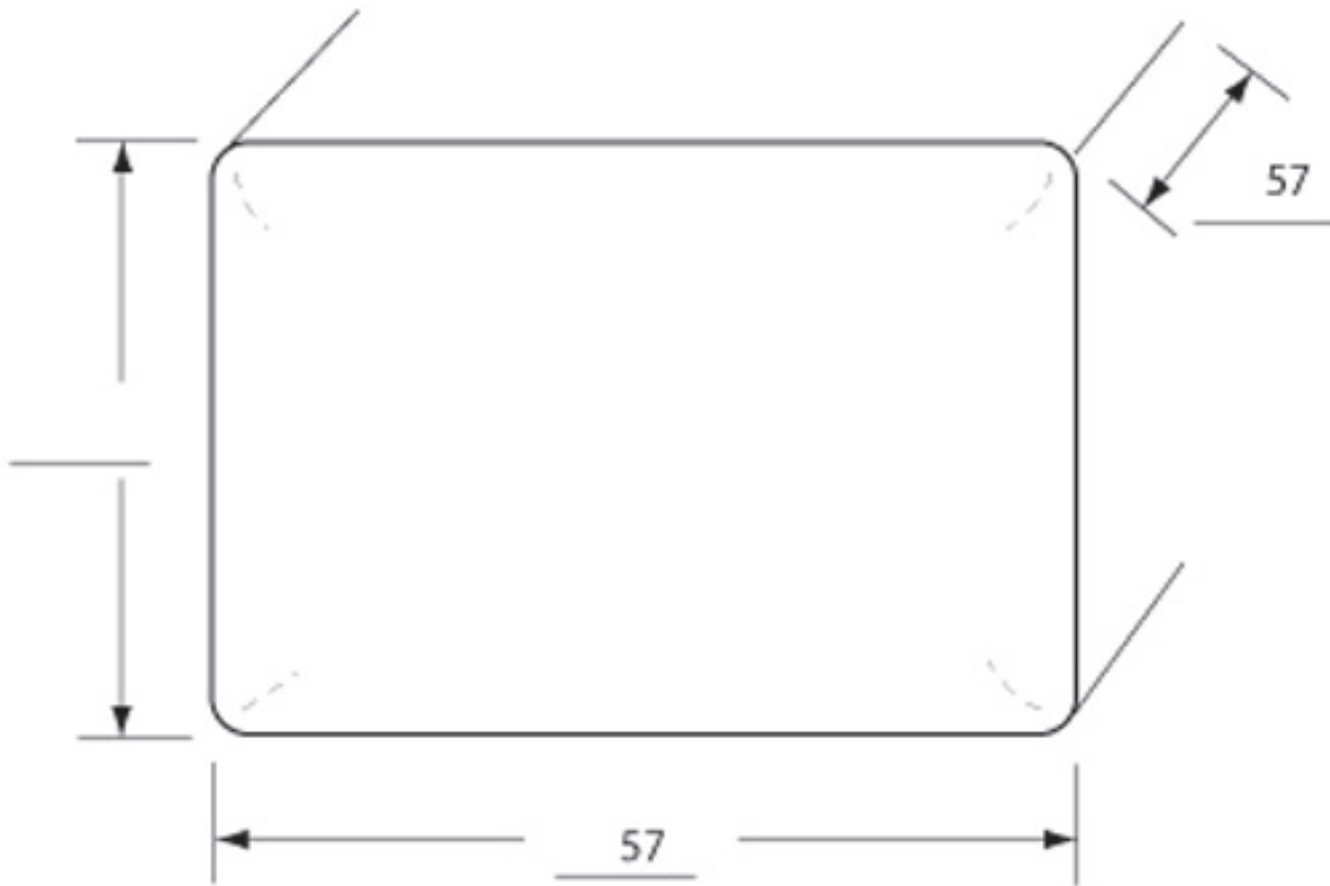
Passenger Airbag

Vents: Y N
if yes, how many: 1
vent at 9 o'clock
