Case 415 : Narrative

Case Vehicle (A): 1999 Ford	Vehicle (B): 1996 Nissan
Type: Escort, 2-door coupe	Type: Sentra, 4-door sedan
Driver: 76-year-old female	Driver: 23-year-old male
CDC: 11-FYEW-2	CDC: 02-RFEW-3

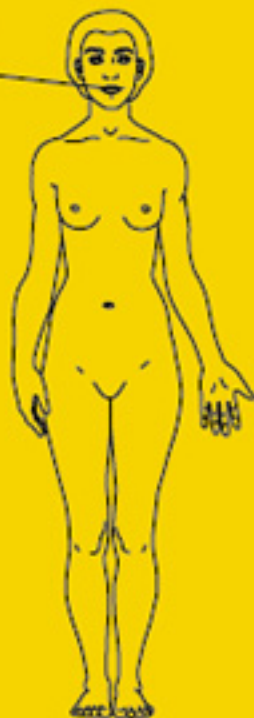
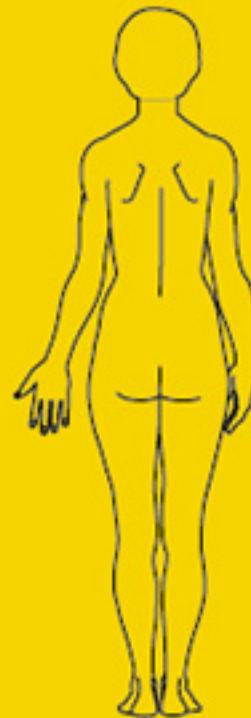
Loose front tooth
(1)

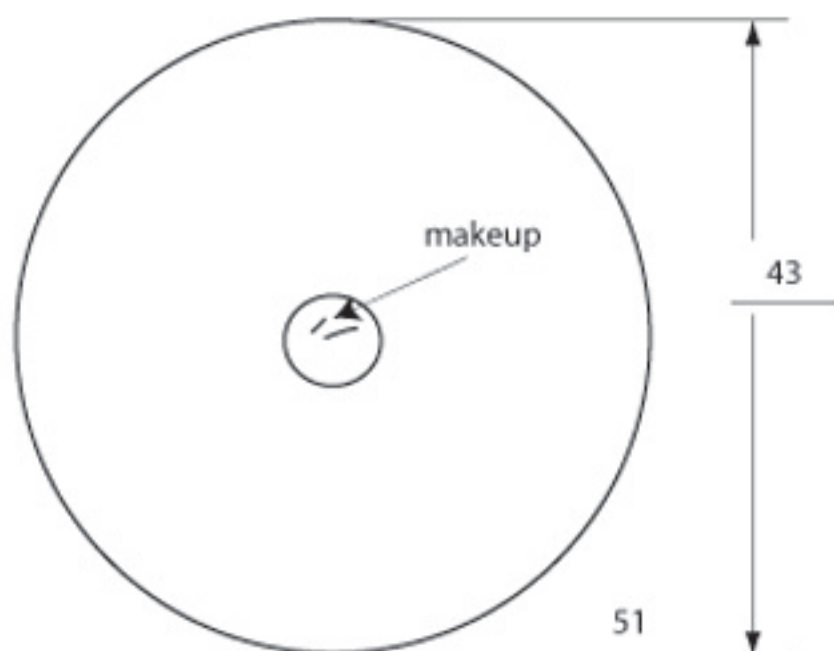
Driver Airbag

Vents: Y N
if yes, how many: 2

Tethers: Y N
if yes, how many: 2

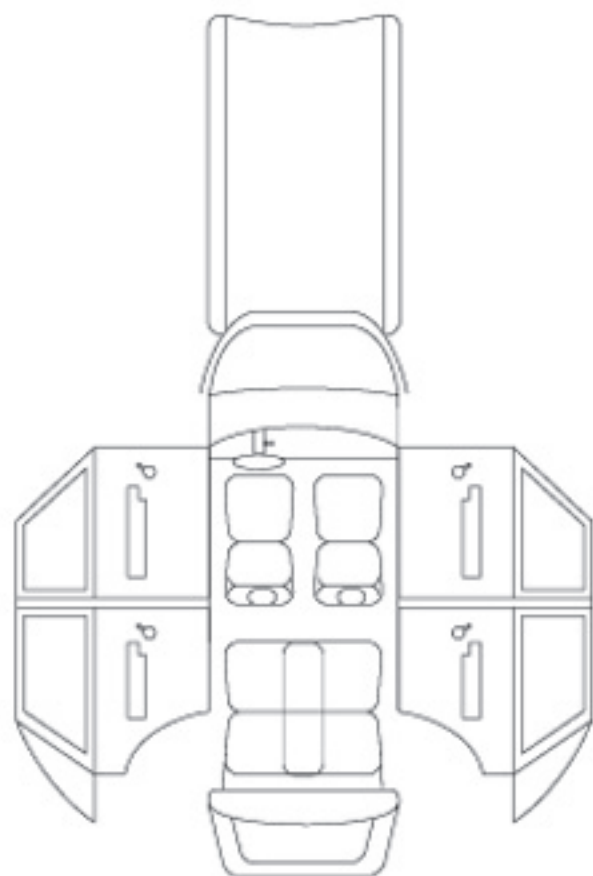
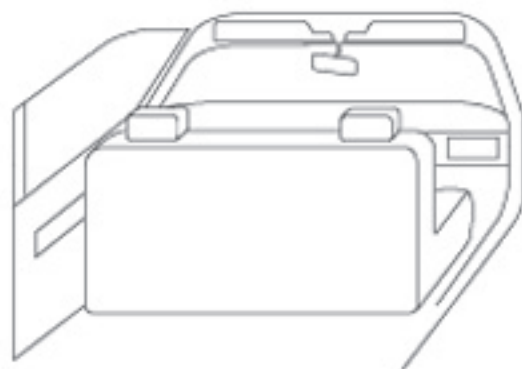
Dr belt: loading mark on webbing,
loading mark on d-ring,
replacement tab pulled out

RF belt: replacement tab pulled out

- A: steering-wheel airbag, facial makeup on fabric
- B: steering-wheel airbag flap, scuff
- C: dimmer light switch on knee bolster, scuff
- D: knee bolster - scuff on left
- E: IP above glove box, scuff
- F: dash-mounted airbag, facial makeup

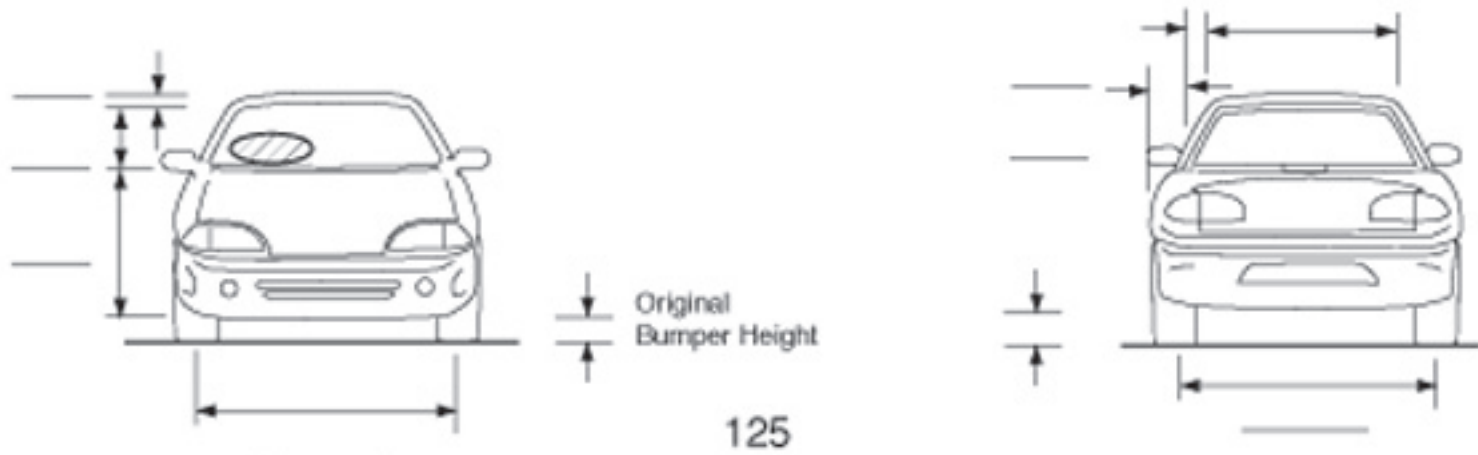
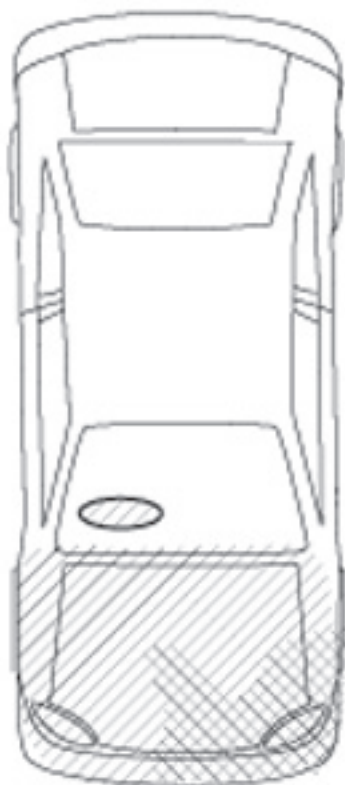
DW-1300

79 cm direct damage
29 cm max crush
