## Case 420 : Narrative

Case Vehicle (A): 2000 Mercury	Vehicle (B): 2002 Volvo	Vehicle (C): 1997 Honda
Type: Grand Marquis LS, 4-door sedan	Type: V70 XC, 4-door station wagon	Type: Civic EX, 4-door sedan
Driver: 29-year-old male	Driver: 46-year-old female	Driver: 32-year-old female
CDC: 12-FYEW-3, 06-RDES-1	CDC: 12-FYEW-3	CDC: 99-0000-0

CASE NO.: 420

CASE VEHICLE: 2000 Mercury

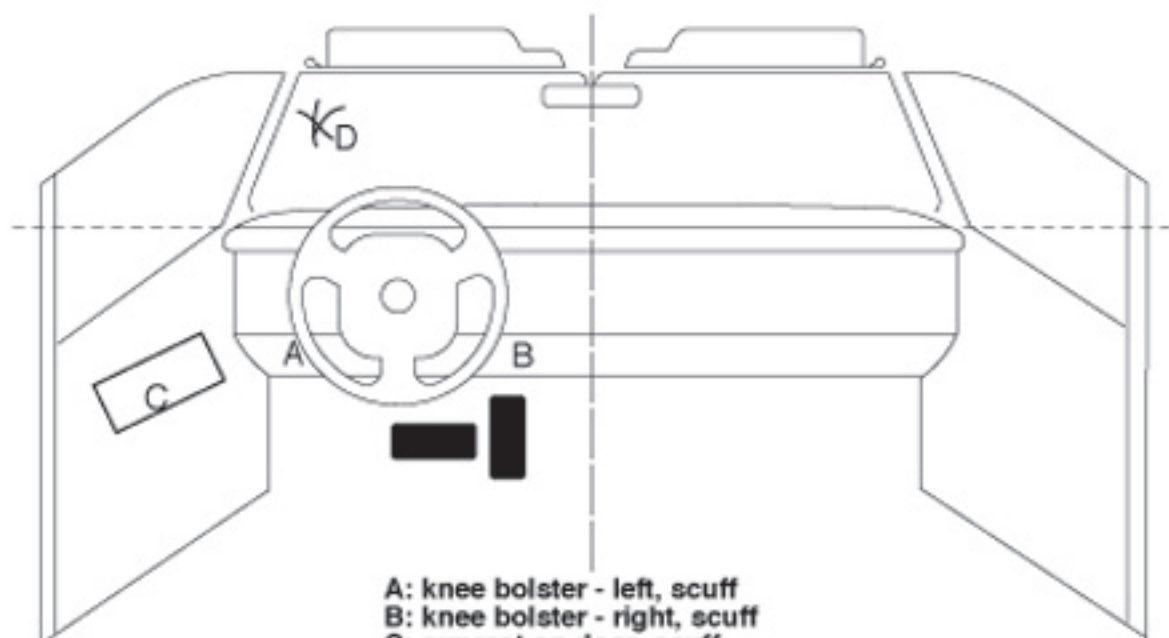
OCCUPANT CONTACT WORKSHEET

**no evidence of belt use**

**A: knee bolster - left, scuff**  
**B: knee bolster - right, scuff**  
**C: armrest on door, scuff**  
**D: windshield, cracked and pushed out**

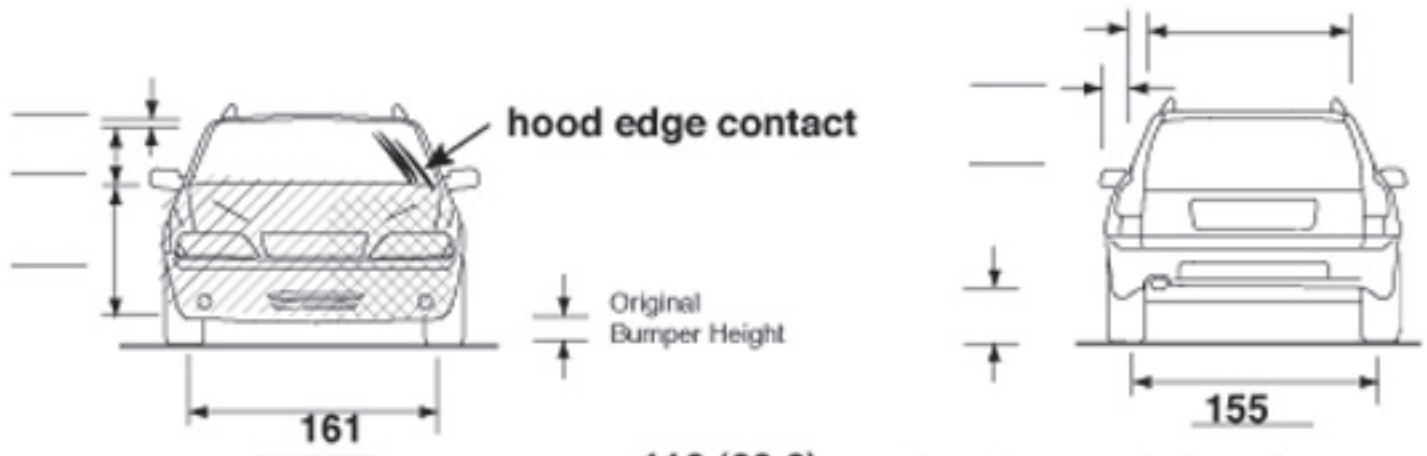
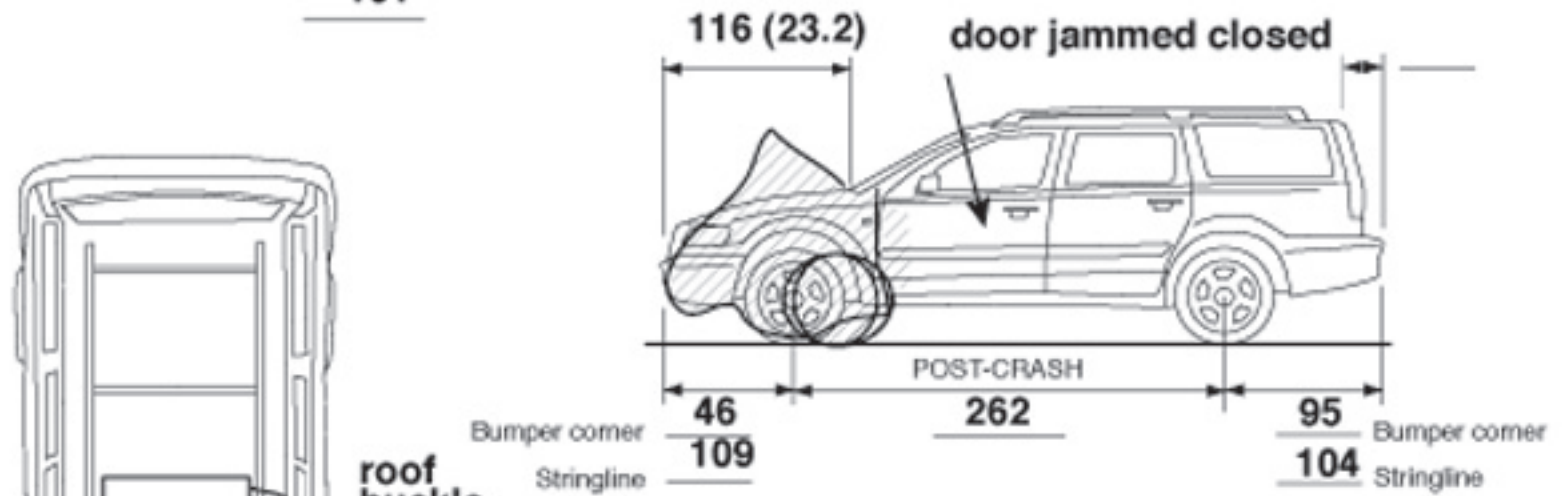
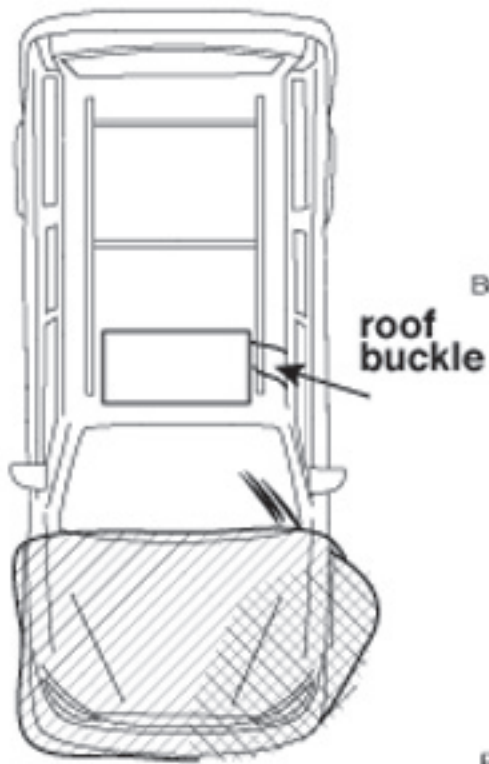
77 cm direct damage  
58 cm max crush at  
left-front bumper corner
