Case 428 : Narrative

Case Vehicle (A): 2002 Chevrolet
Type: Monte Carlo LS, 2-door coupe
Driver: 17-year-old male
CDC: 12-FREE-4

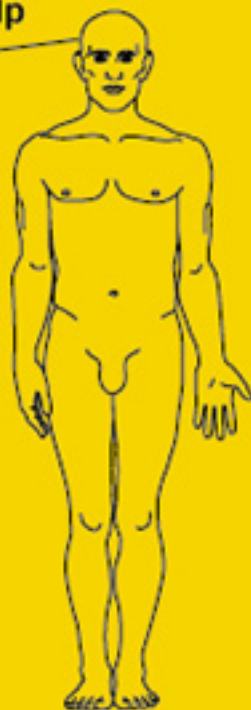
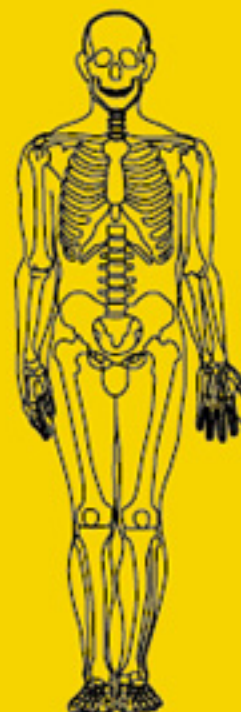
Laceration, upper-right
aspect of the scalp
(1)

Spiral fracture,
left-middle
metacarpal
(2)

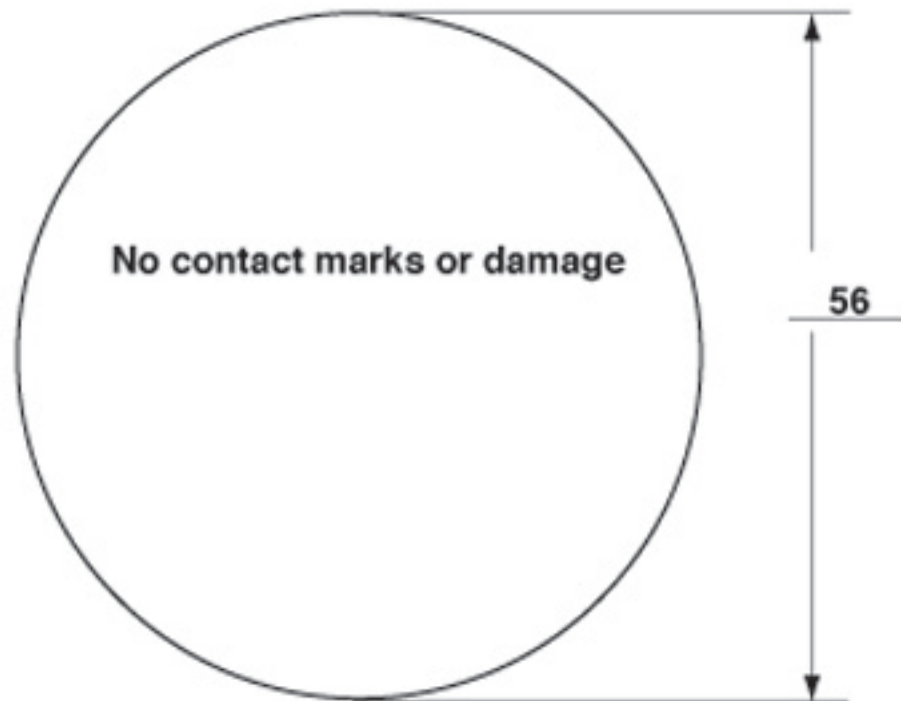
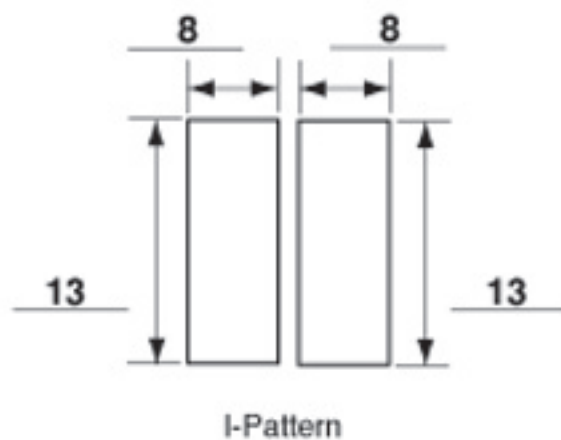
Driver Airbag

[33](#) This vehicle was equipped with steering-wheel and dash-mounted frontal-impact airbags and both deployed in the narrow-frontal impact with the concrete bridge rail. [34 35 36](#) In the driver area, there was no damage to the steering-wheel airbag or to the module cover. The top of the steering-wheel rim was slightly deformed but there was no damage to the spokes or to the hub, and there was no rotation of the steering column. The plastic cover to the upper section of the instrument panel in the driver area was displaced up due to deployment of the steering-wheel airbag and [37 38](#) there was a spider-web crack with hair in the cracks in the upper section of the windshield to the right of the steering wheel. [39 40 41 42](#) There was no other damage in the driver area.

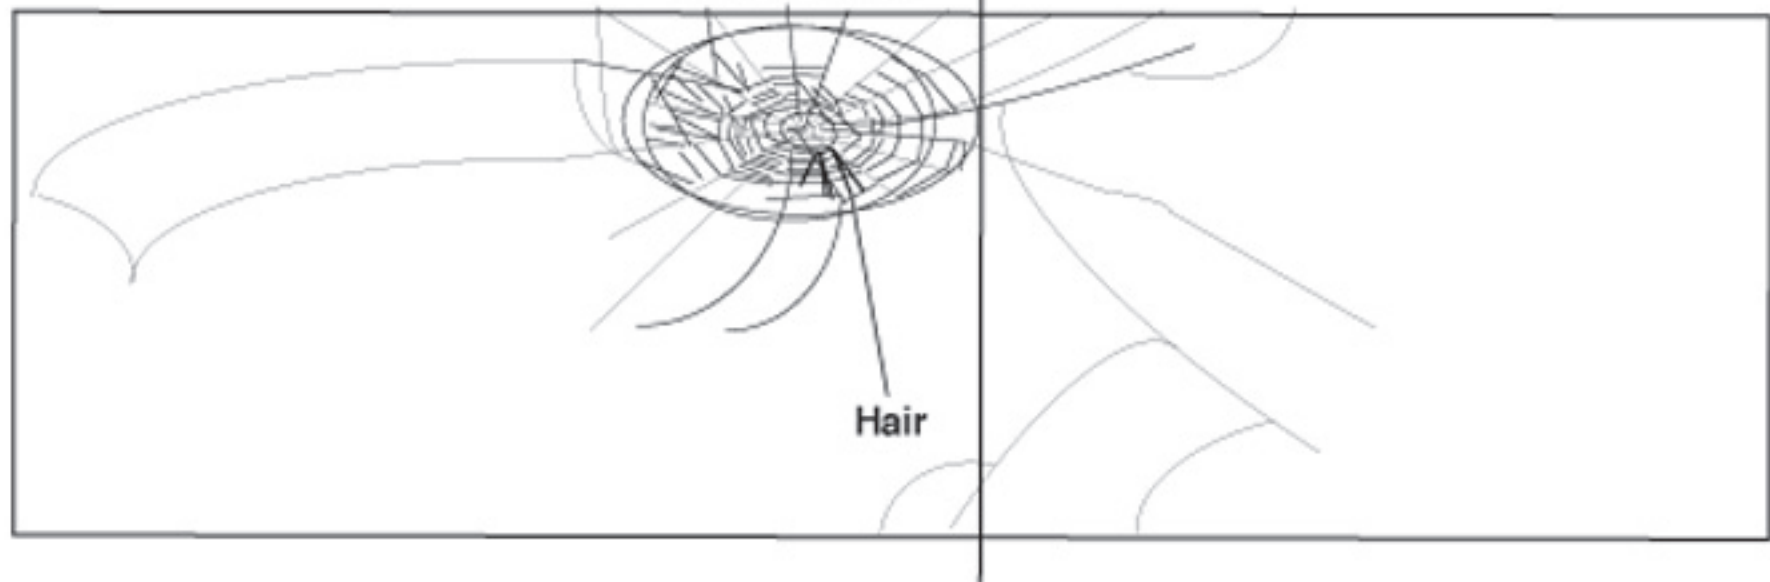
A = Spider-web crack with hair

B = Steering wheel deformed

Driver contact
