Case 443 : Narrative

Case Vehicle (A): 2002 Buick	Vehicle (B): 2003 Pontiac
Type: Century Custom, 4-door sedan	Type: Grand Am SE, 4-door sedan
Driver: 34-year-old male	Driver: 82-year-old female
CDC: 11-FYEW-2	CDC: 01-FDEW-2

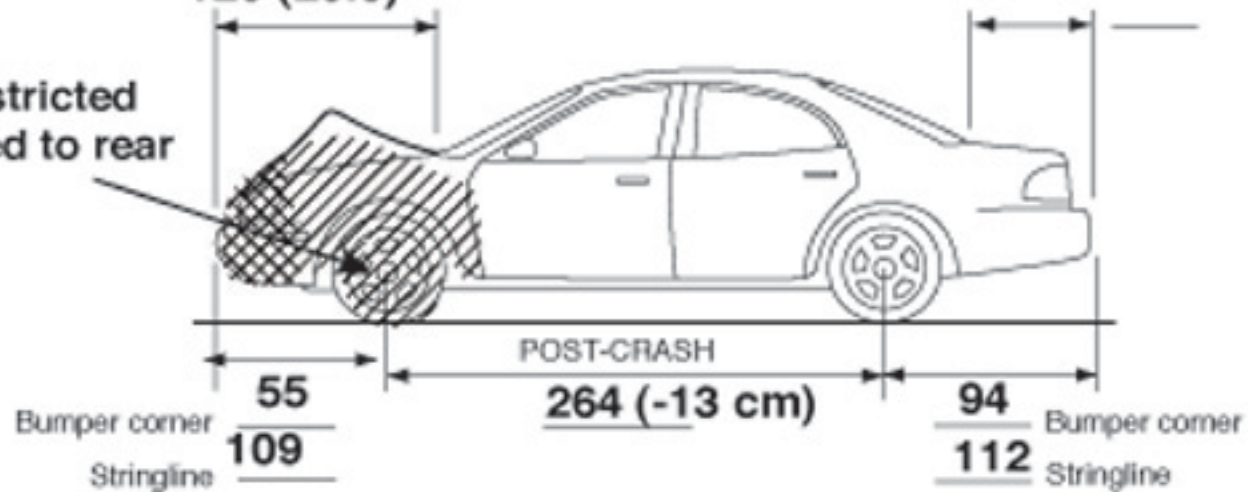
wheel restricted
and pushed to rear

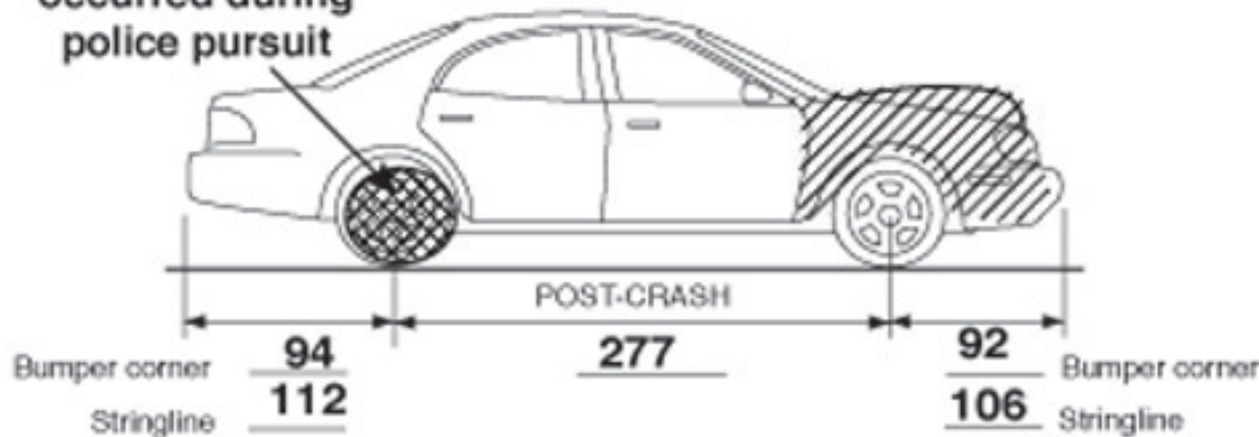
airbag
cover
contact

tire damage may have
occurred during
police pursuit

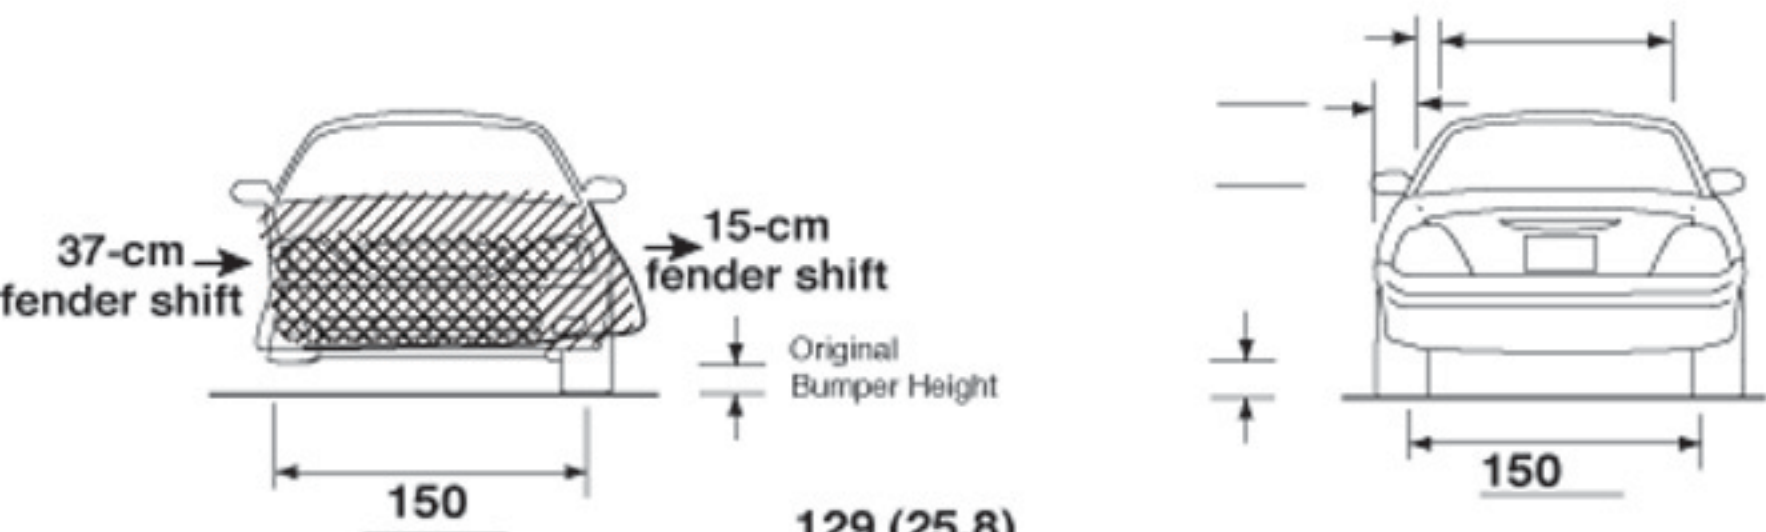
72-cm direct damage
38-cm max crush

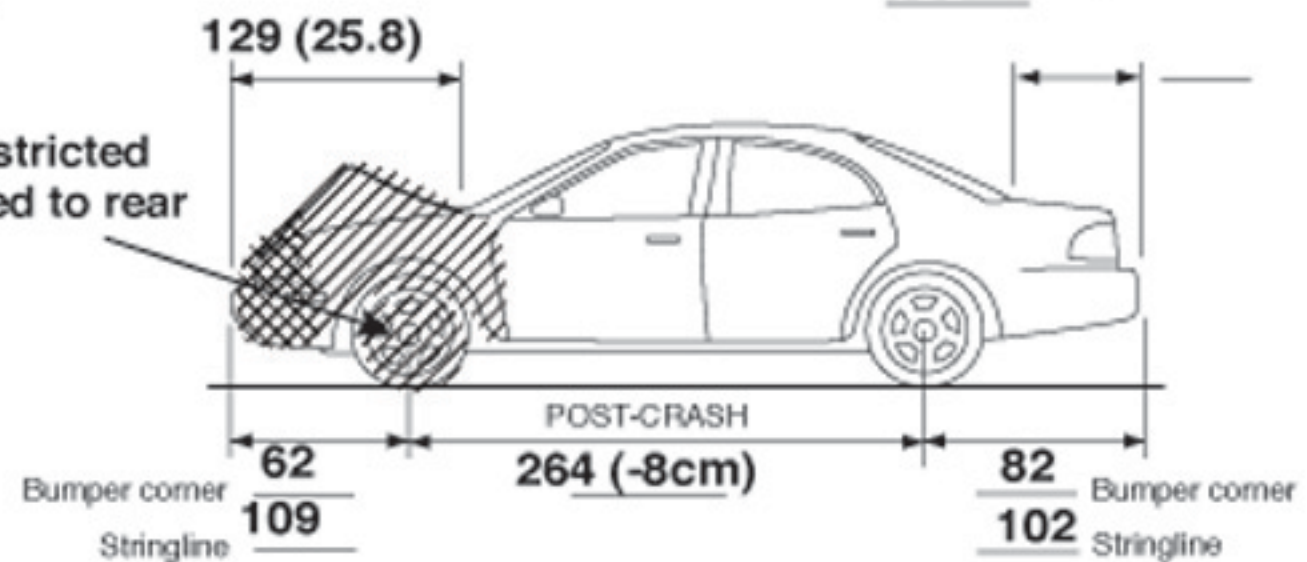
120-cm direct damage
51-cm max crush
