Case 444 : Narrative

Case Vehicle (A): 2000 Mazda	Vehicle (B): 2002 Ford
Type: Miata MX-5, 2-door convertible	Type: Econoline E150, 4 x 2, van
Driver: 21-year-old male	Driver: 36-year-old male
CDC: 02-FDEW-2	CDC: 10-LYEW-3, 12-FCEN-1

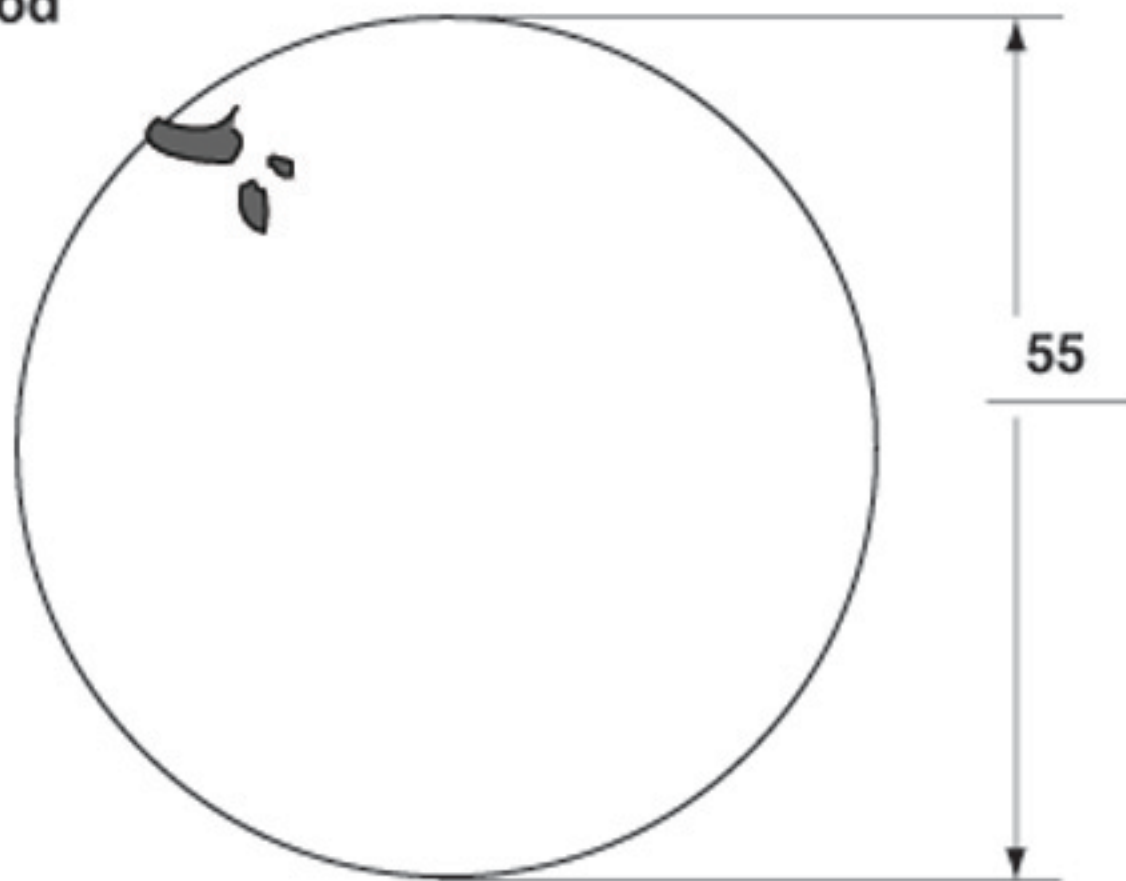
Driver Airbag

Blood

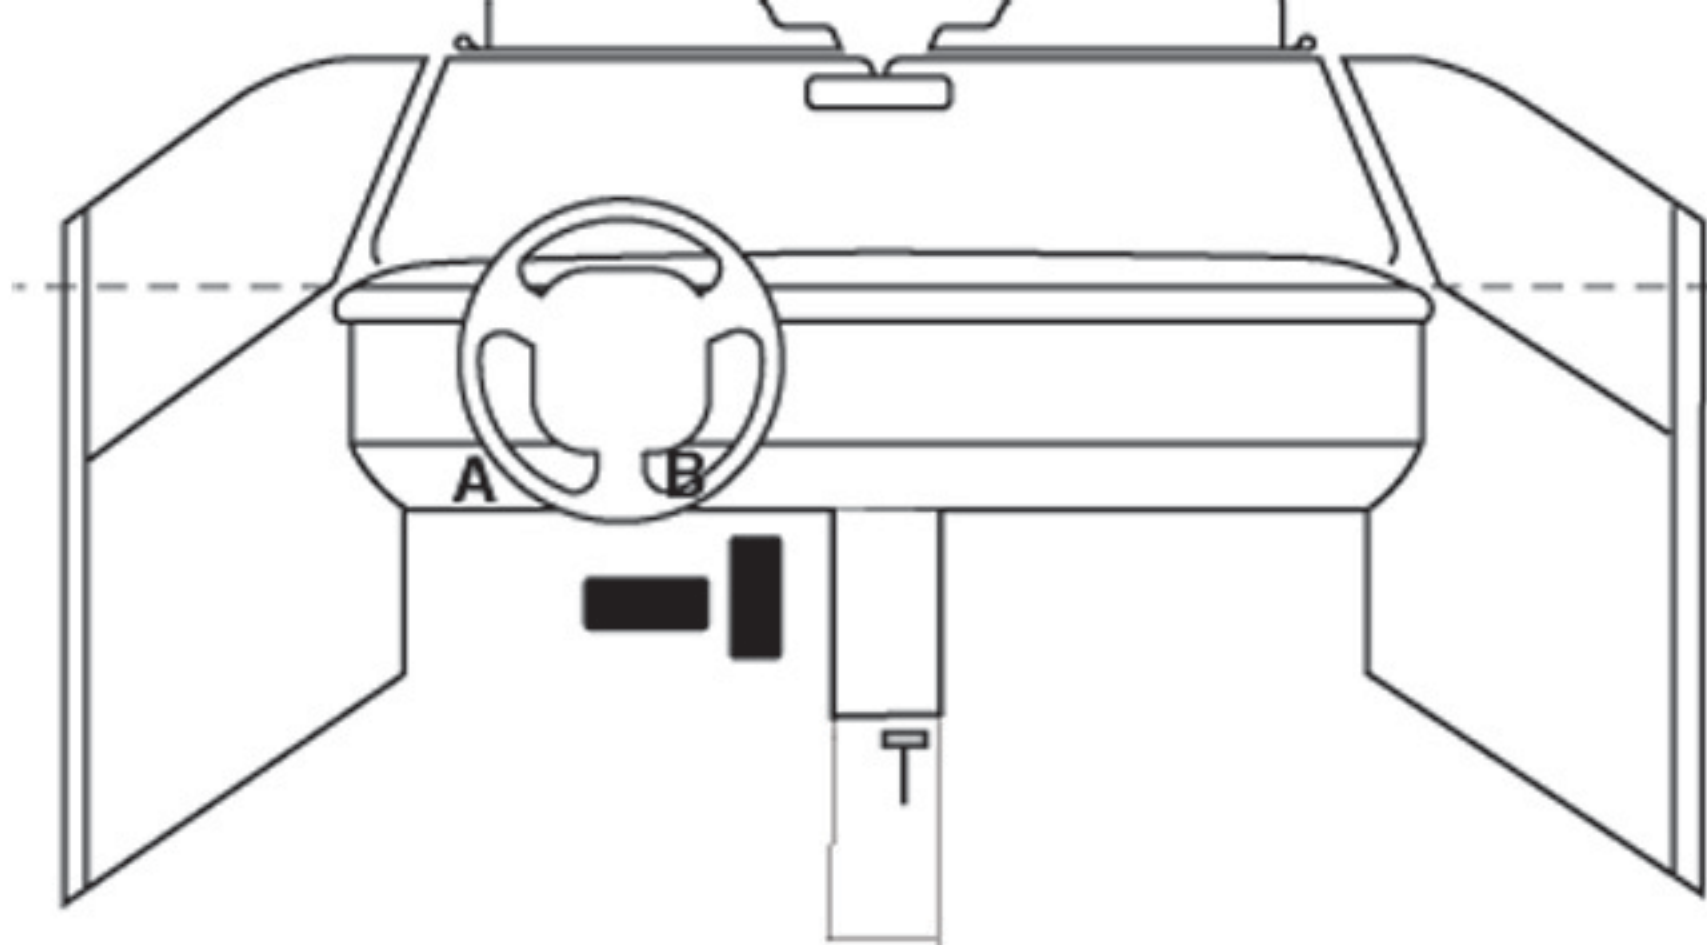
A = knee bolster, scuffmark

B = knee bolster, scuffmark

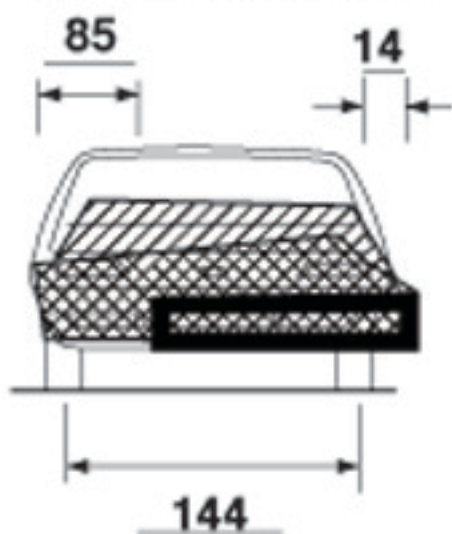
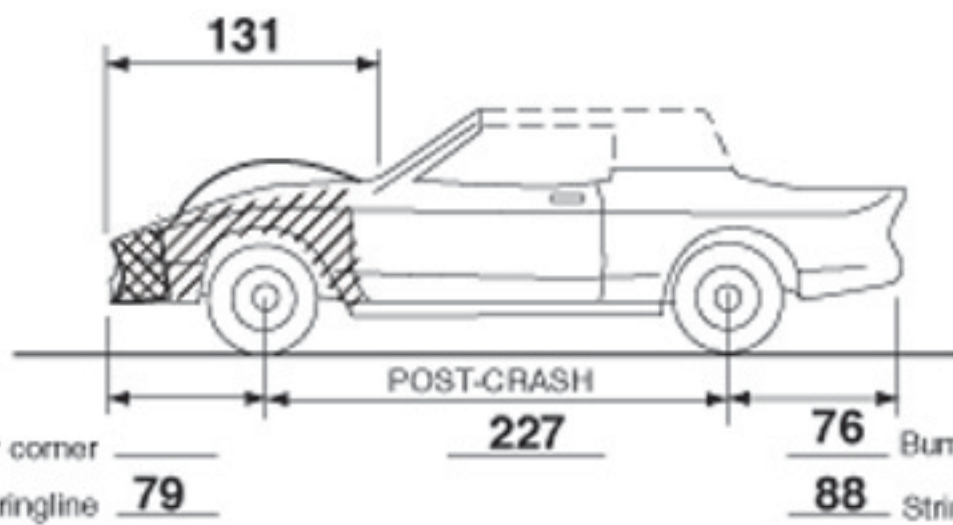
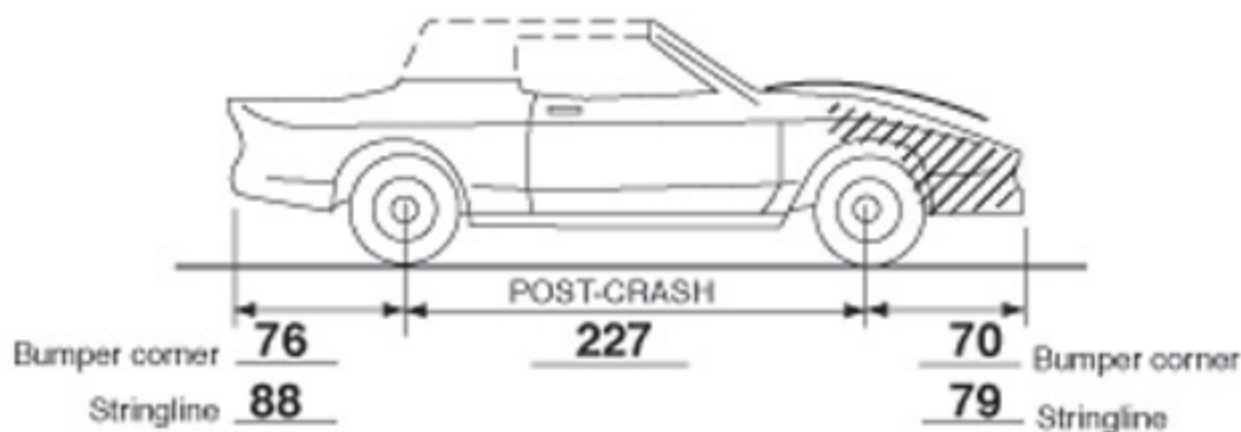
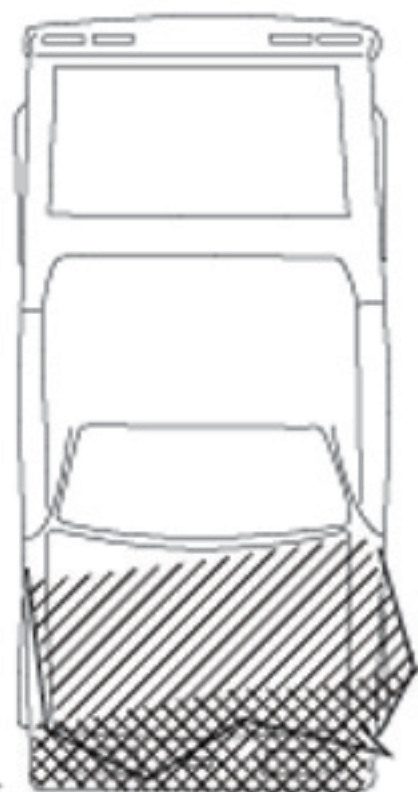
Bumper shift to left

Max. crush to center front bumper
