Case 447 : Narrative

Case Vehicle (A): 2001 Honda	Vehicle (B): 1992 Mercury
Type: Civic EX, 4-door sedan	Type: Cougar LS, 2-door sedan
Driver: 56-year-old female	Driver: 22-year-old male
CDC: 12-FYEW-2	CDC: 99-0000-

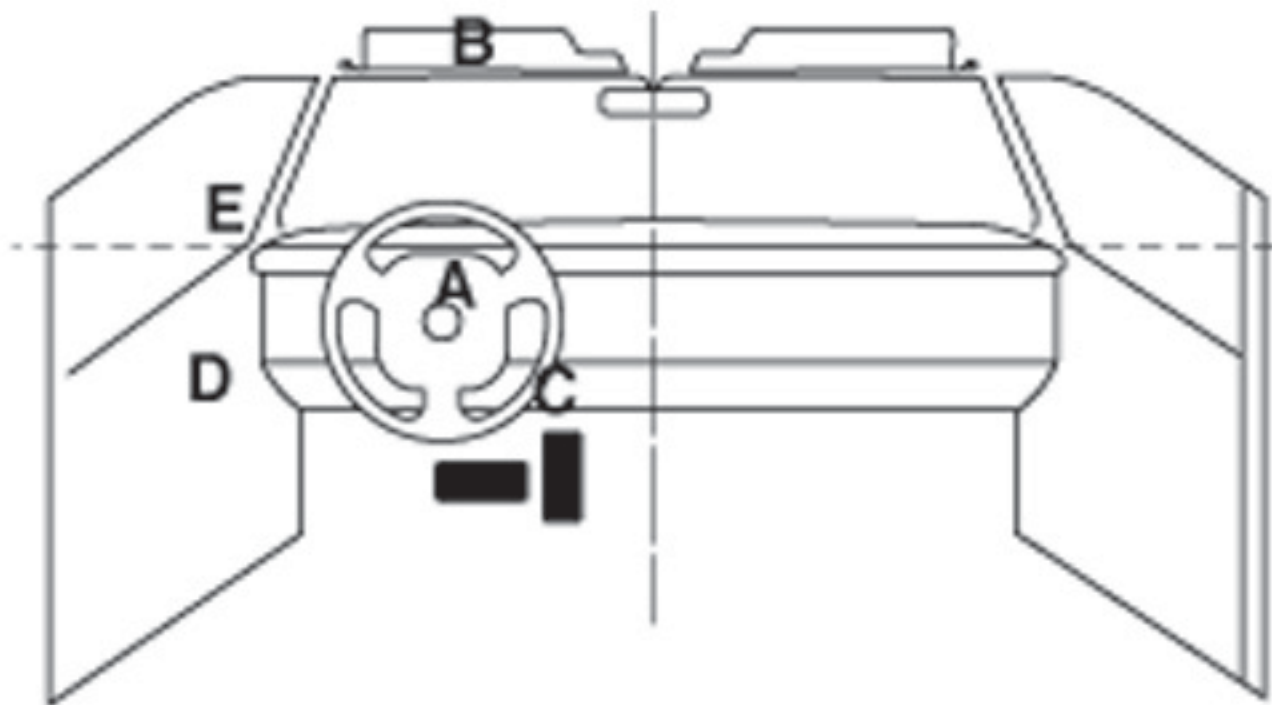
- A = upper SW rim, 2-cm deflection - no marks on AB**
- B = driver sunvisor, scuff**
- C = knee bolster, damaged**
- D = door hardware, detached, cloth transfer**
- E = side window trim, damaged & scuffed**

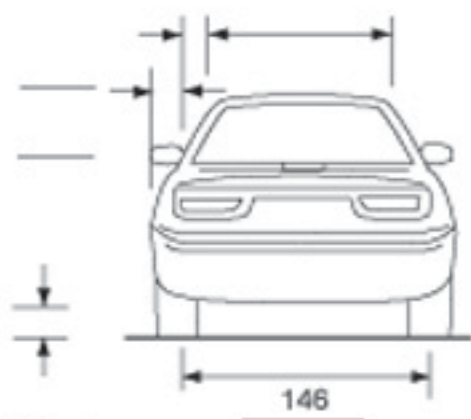
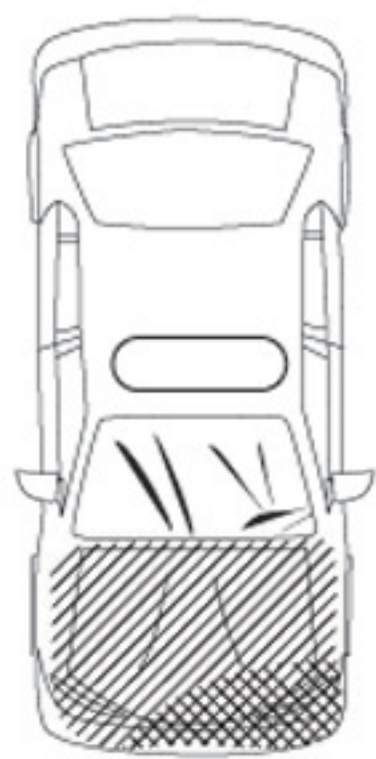
90 cm direct damage
max crush is 37 cm
