Case 451 : Narrative

Case Vehicle (A): 2003 Chevrolet	Vehicle (B): 1998 Ford
Type: Impala LS, 4-door sedan	Type: F350, snowplow truck
Driver: 35-year-old female	Driver: 23-year-old male
CDC: 12-FDEW-3	CDC: 99-0000-0

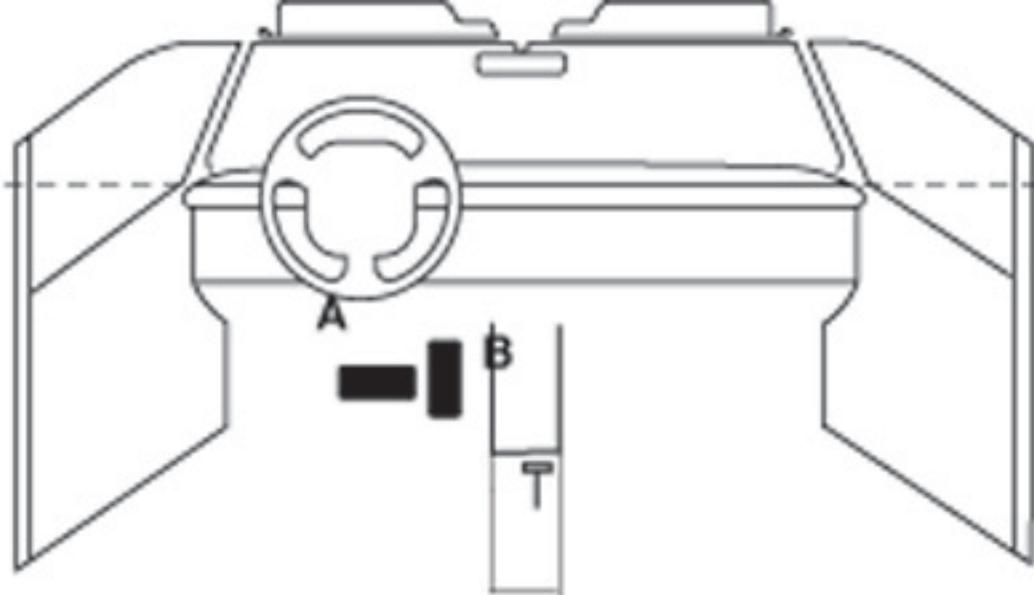
OCCUPANT CONTACT WORKSHEET

A= Knee bolster, scuffmark

B= Center floor storage compartment, crack

Contact	Interior Component Contacted	Occupant No. if Known	Body Region if Known	Supporting Physical Evidence	Confidence Level of Contact Point
A	Knee bolster	1	Knee	Scuffmark	1
B	Center floor console	1	Foot	Crack	3
C					
D					
E					
F					
G					
H					
I					
J					
K					
L

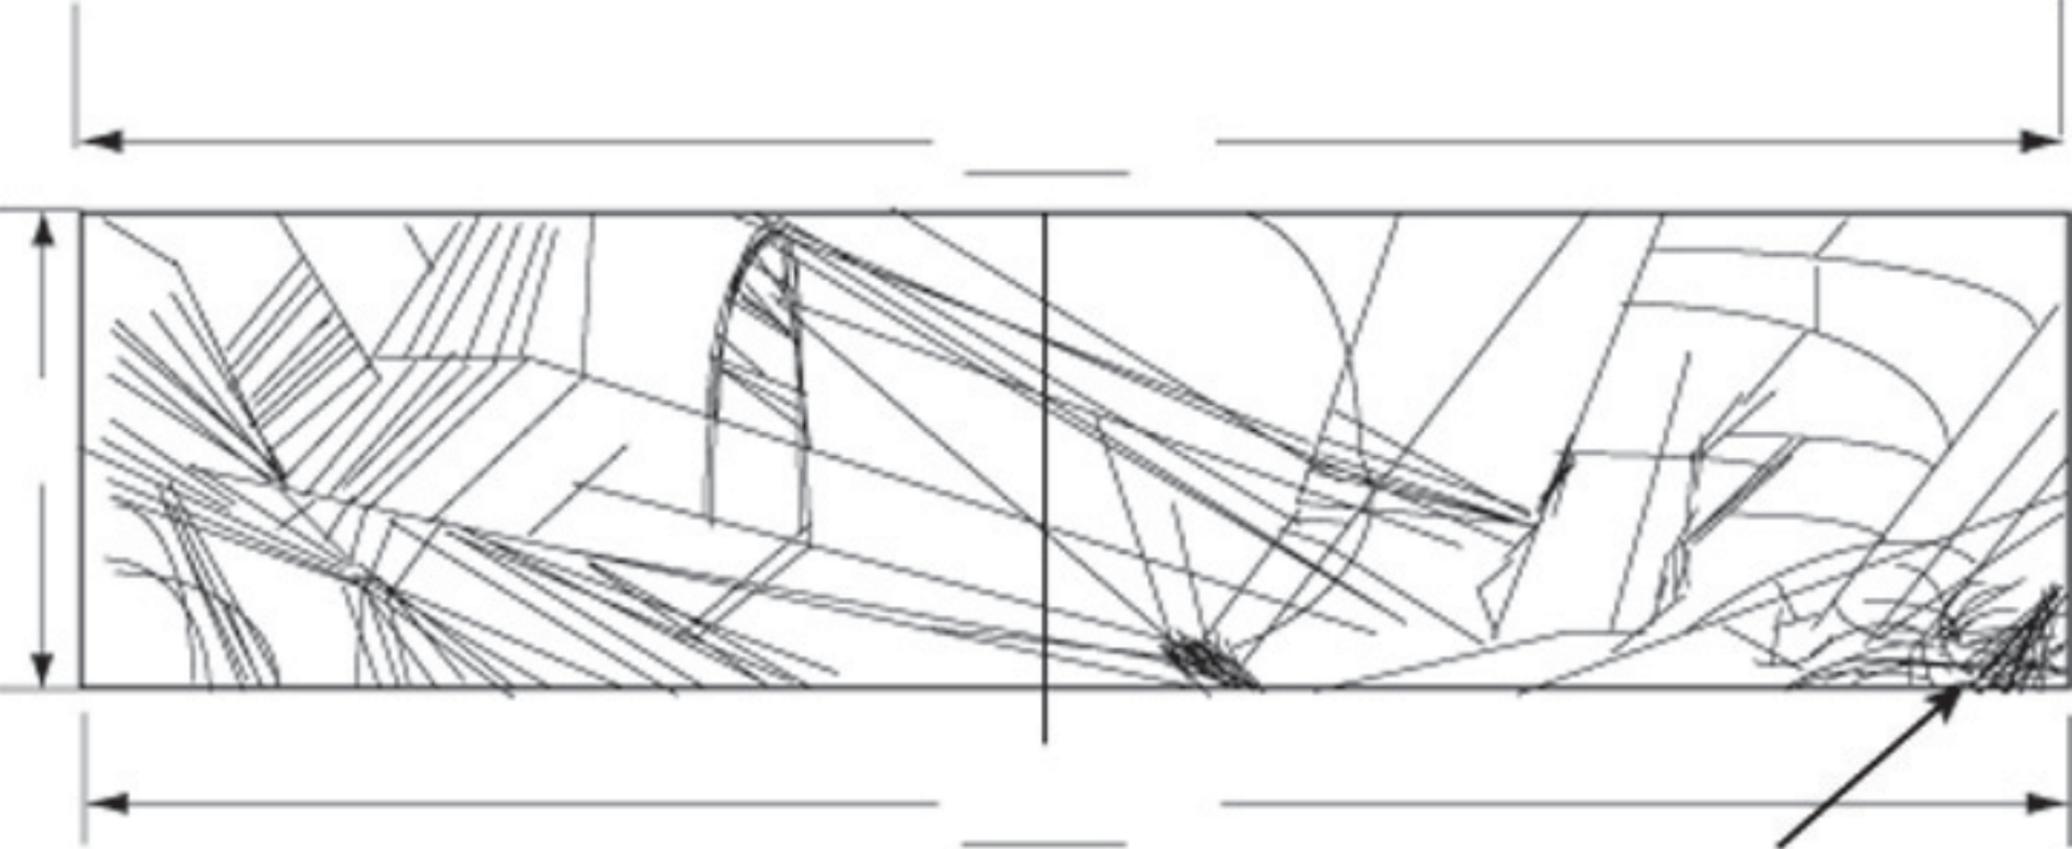
WINDSHIELD MARK ON CASE VEHICLE:

**contact and hole by
rear edge of hood**
