Case 455 : Narrative

Case Vehicle (A): 1999 Chevrolet	Vehicle (B): 1983 Ford
Type: Suburban LS, 4x4, 4-door SUV	Type: E150 Club wagon, 4x2
Driver: 38-year-old male	Driver: 37-year-old male
CDC: 12-FYEW-3	CDC: 99-0000-0

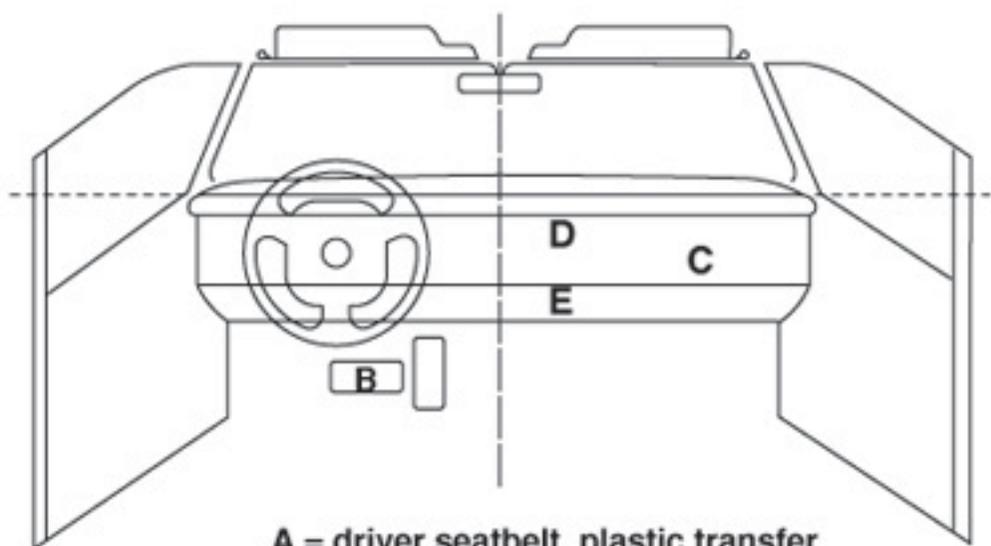
- A = driver seatbelt, plastic transfer**
- B = brake pedal, bent**
- C = glove box, scuff mark**
- D = vent outlet, flow control knob broken off and blood deposit**
- E = ashtray, displaced to left**
- F = driver seatback, deflected to left**
