Case 464 : Narrative

Case Vehicle (A): 2004 Saturn	Vehicle (B): 1998 Pontiac
Type: Ion, 4-door sedan	Type: Trans Sport, 4x2, 4-door minivan
Driver: 35-year-old male	Driver: 18-year-old female
CDC: 12-FDEW-3	CDC: 06-BDEW-3

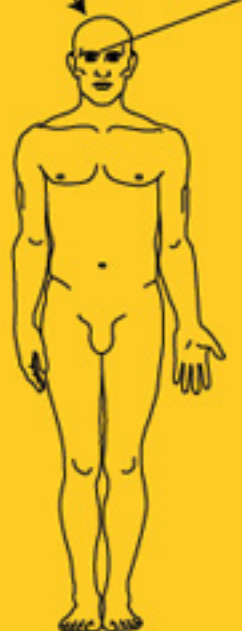
Closed head injury, awake on admission,
but no recollection of crash (2)

Laceration, center forehead (1)

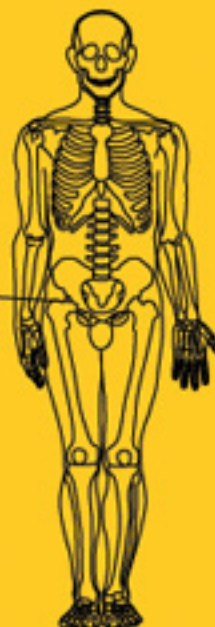
Fractures, posterior wall and
posterior column of right
acetabulum with right hip
dislocation (2)

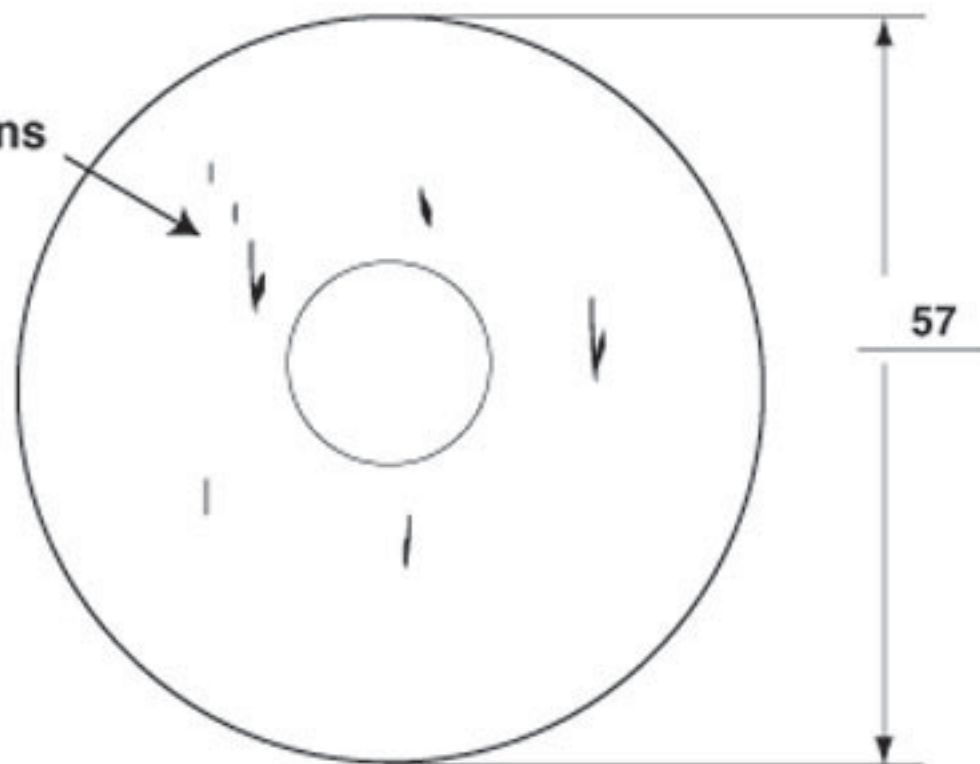
Driver Airbag

Blood stains

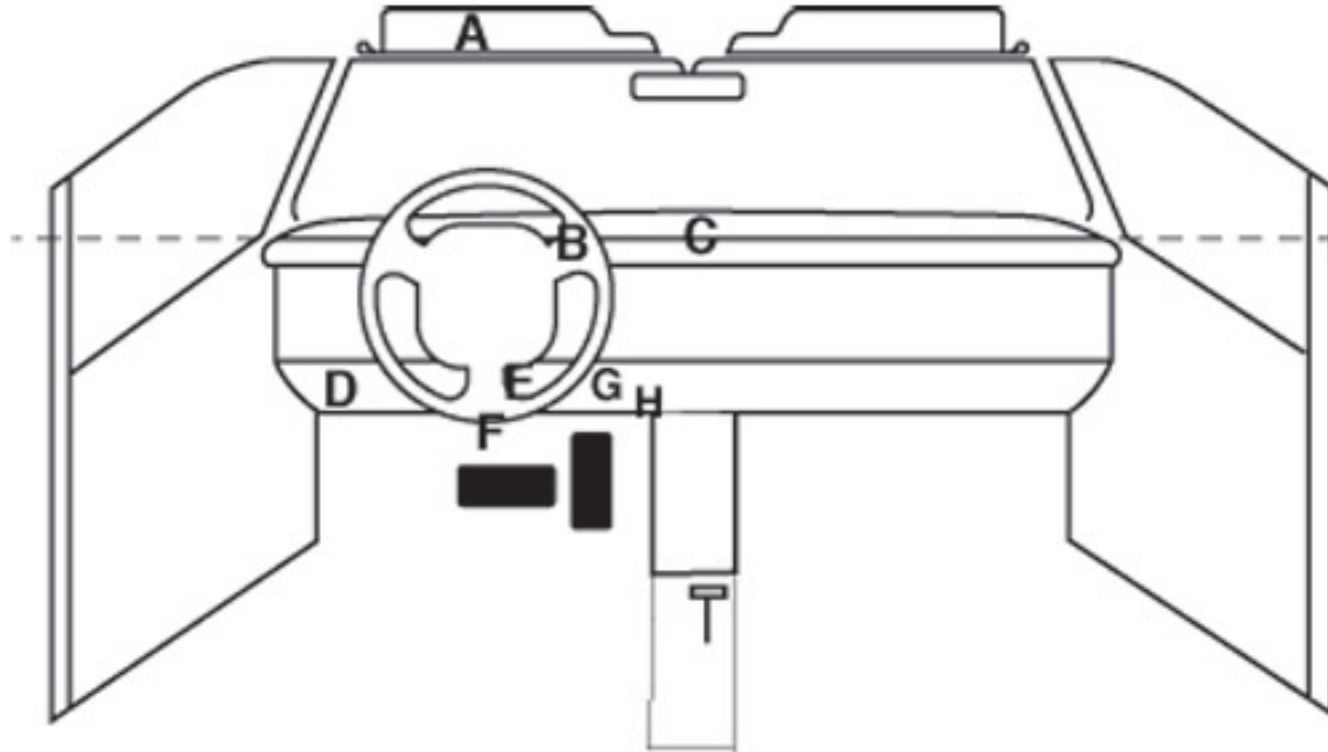
A = left sunvisor - scuffed, skin deposit and vanity mirror broken

B = steering wheel - top and right rim and right spoke bent forward

C = upper instrument panel - instrument cluster broken

D = knee bolster - scuffed and cracked

E = steering column cover - plastic broken and cloth deposit

G = knee bolster - scuffed

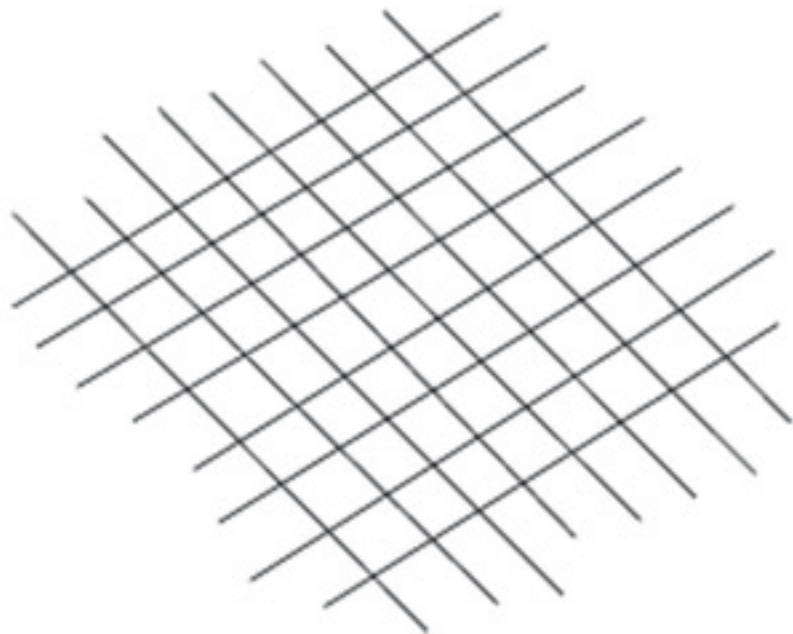
WINDSHIELD MARK ON CASE VEHICLE:

**Windshield cracked on lower right due to contact by
the rear edge of the hood**

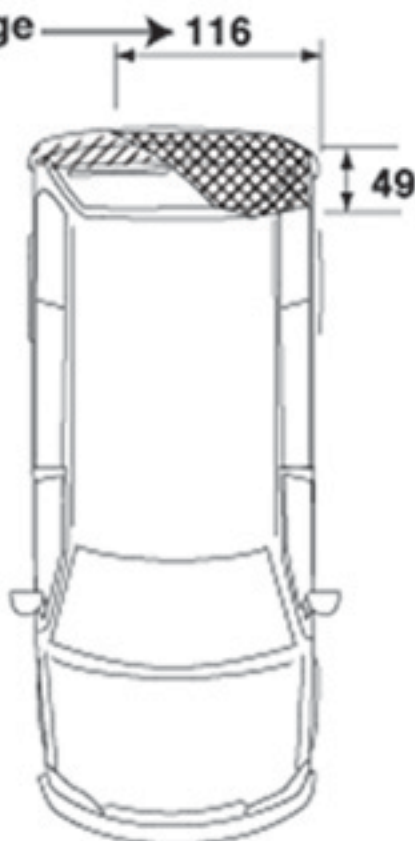
Width of direct damage to rear

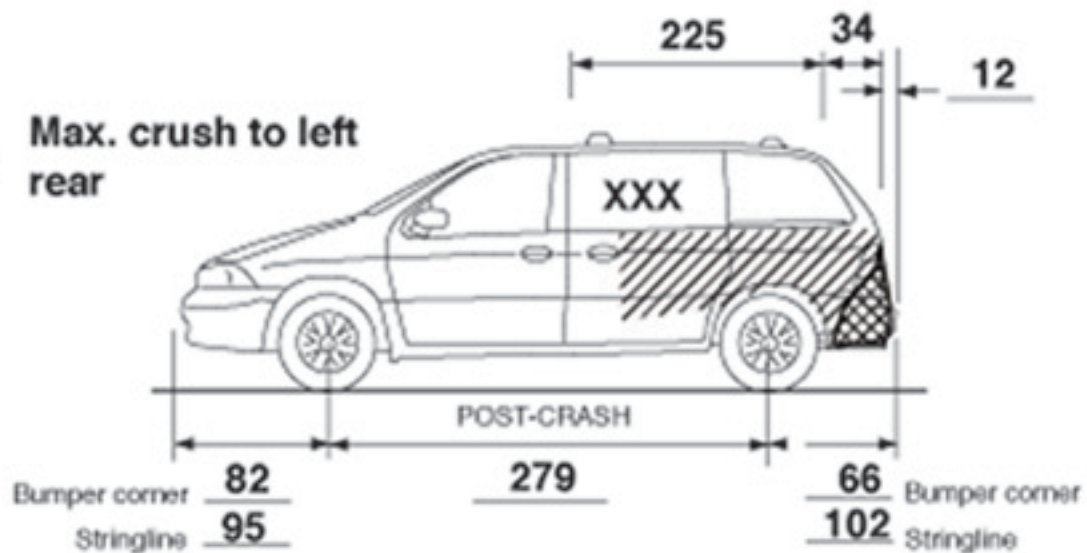
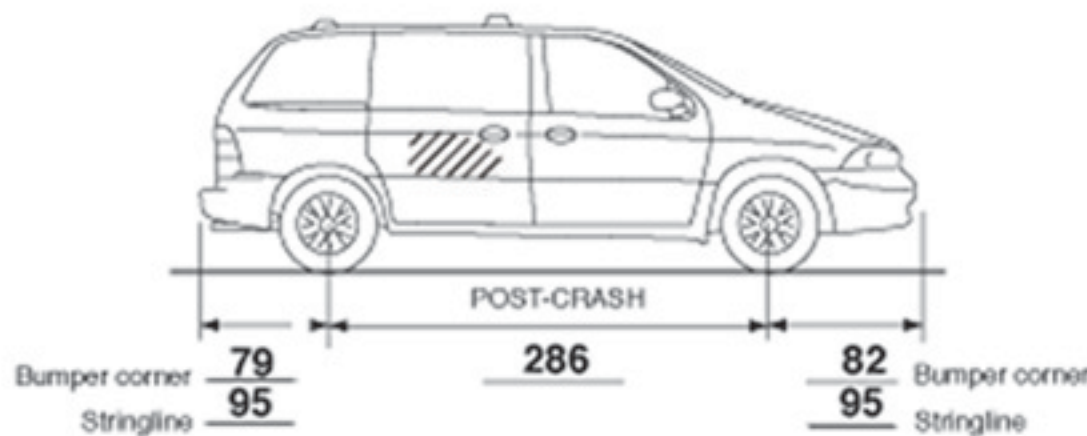
Max. crush to left rear

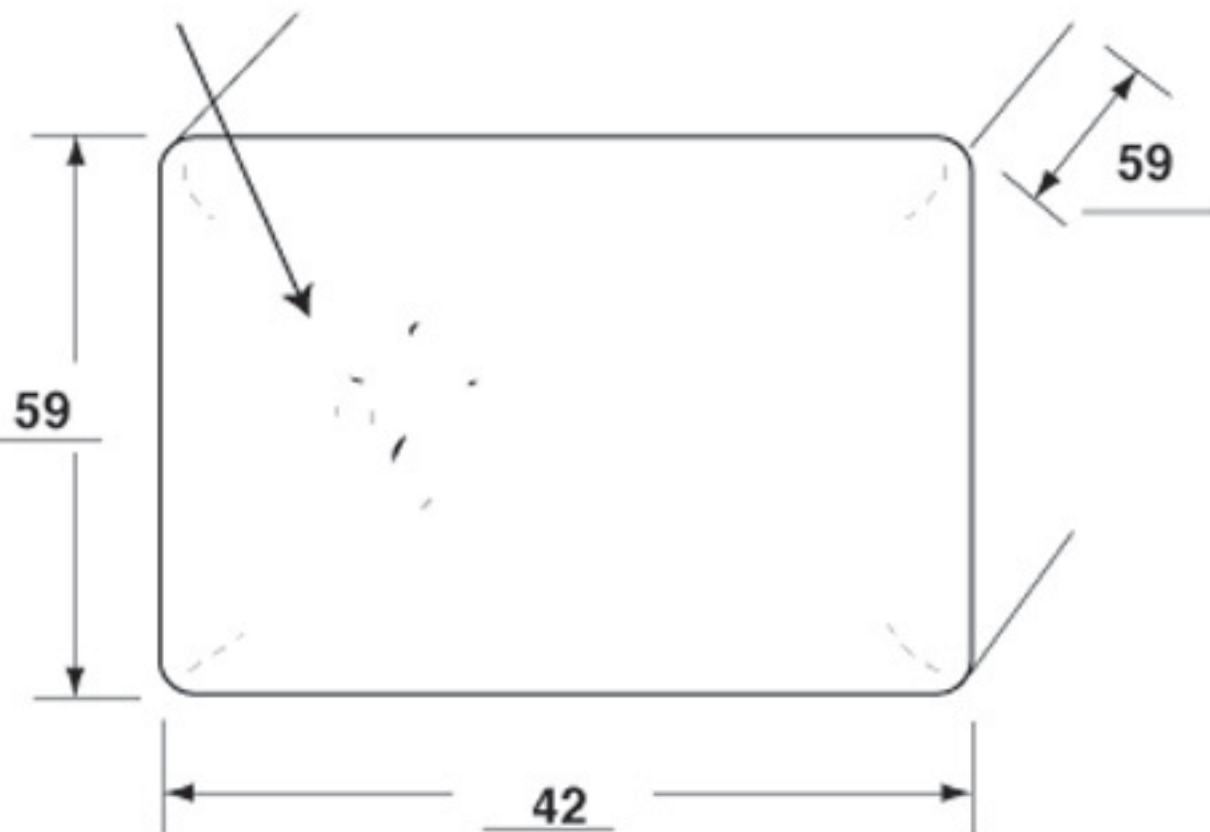
Passenger Airbag

Blood stains
