Case 466 : Narrative

Case Vehicle (A): 2004 Jeep	Vehicle (B): 1996 Ford
Type: Grand Cherokee, 4-door SUV	Type: Contour, 4-door sedan
Driver: 65-year-old male	Driver: Unknown
CDC: 12-FYEW-4	CDC: 12-FYAW-4

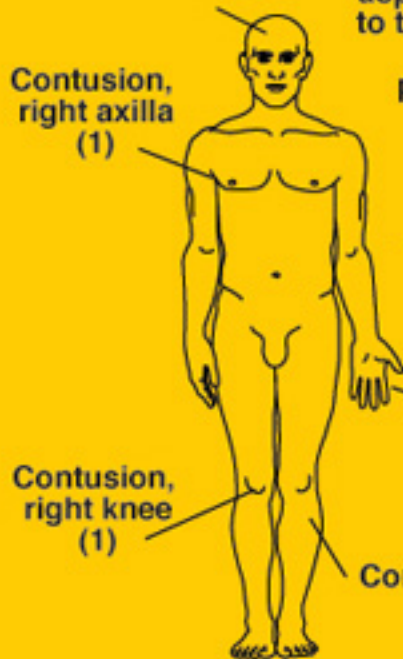
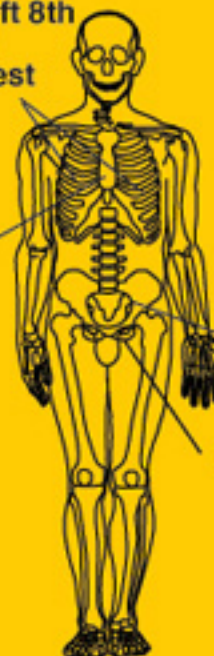
Loss of consciousness,
less than 30 minutes

Bilateral fractures to the anterior
aspects of the ribs 2 through 7 and
to the anterior aspect of the left 8th
rib, with bilateral hemo/
pneumothorax with flail chest

Contusion,
right axilla

Displaced fracture,
sternum with retrosternal
hematoma

Comminuted fractures to left
acetabulum including lateral,
superior and posterior walls,
with hip dislocation

Abrasion, left hand

Fracture, left ischium

Contusion,
right knee

Contusion, left shin

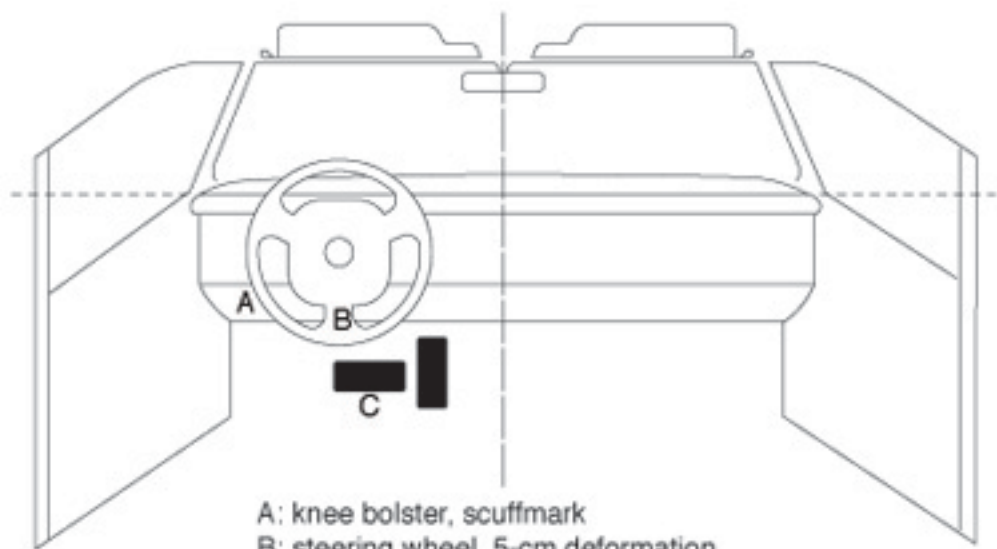
A: knee bolster, scuffmark
B: steering wheel, 5-cm deformation
C: brake pedal, bent to right

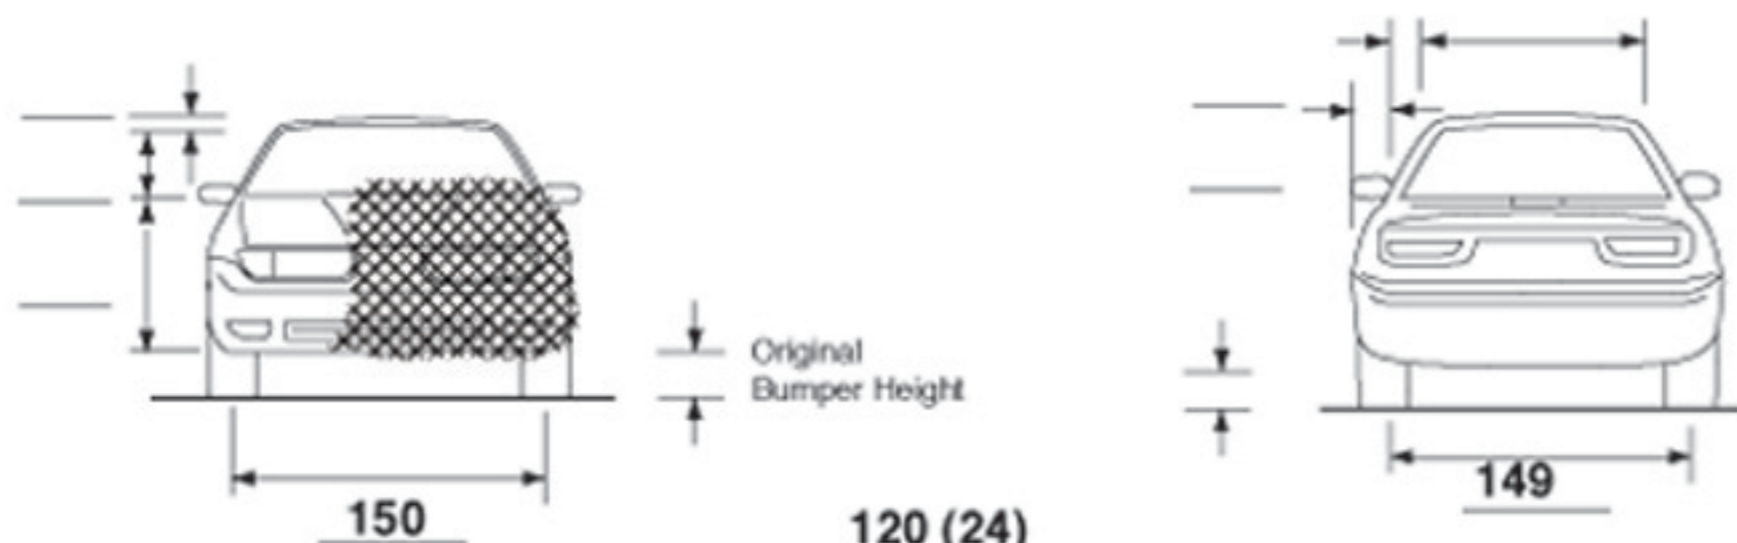
all window glass broken
unknown if damage or extrication

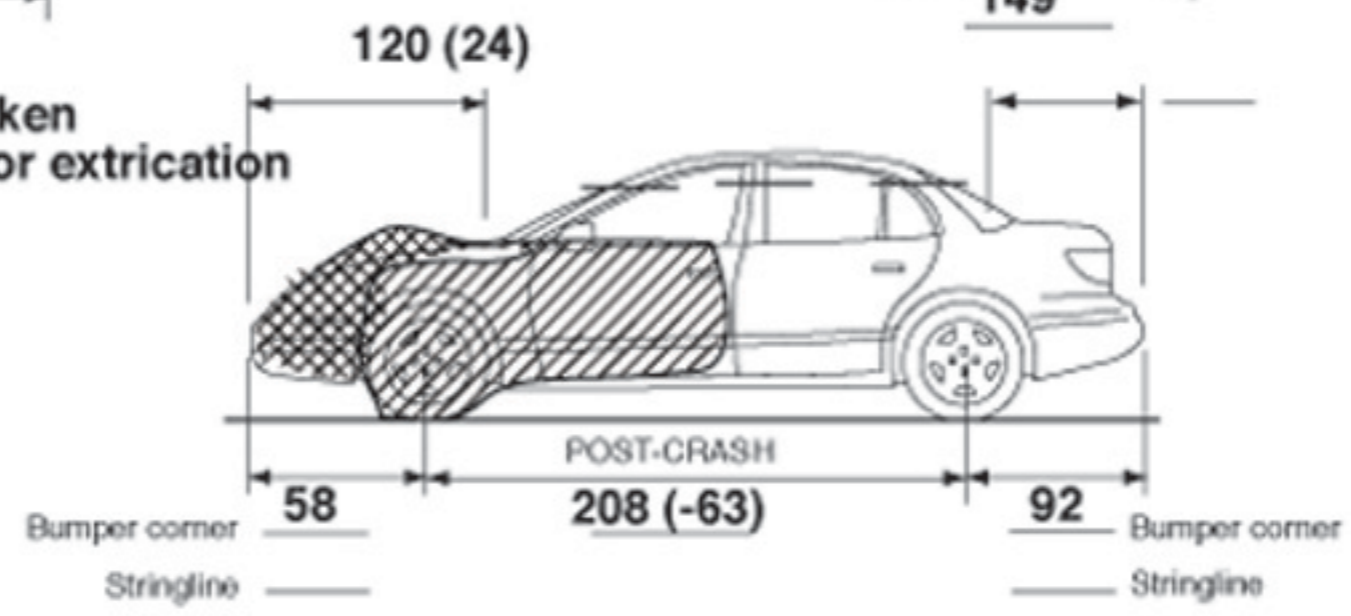
pillars cut and roof removed
for extrication
