# Case 470 : Narrative

Case Vehicle (A): 2003 Saturn
Type: Vue, 4-door SUV
Driver: 56-year-old female
CDC: 12-FDEW-3

# 470: Vehicle Report

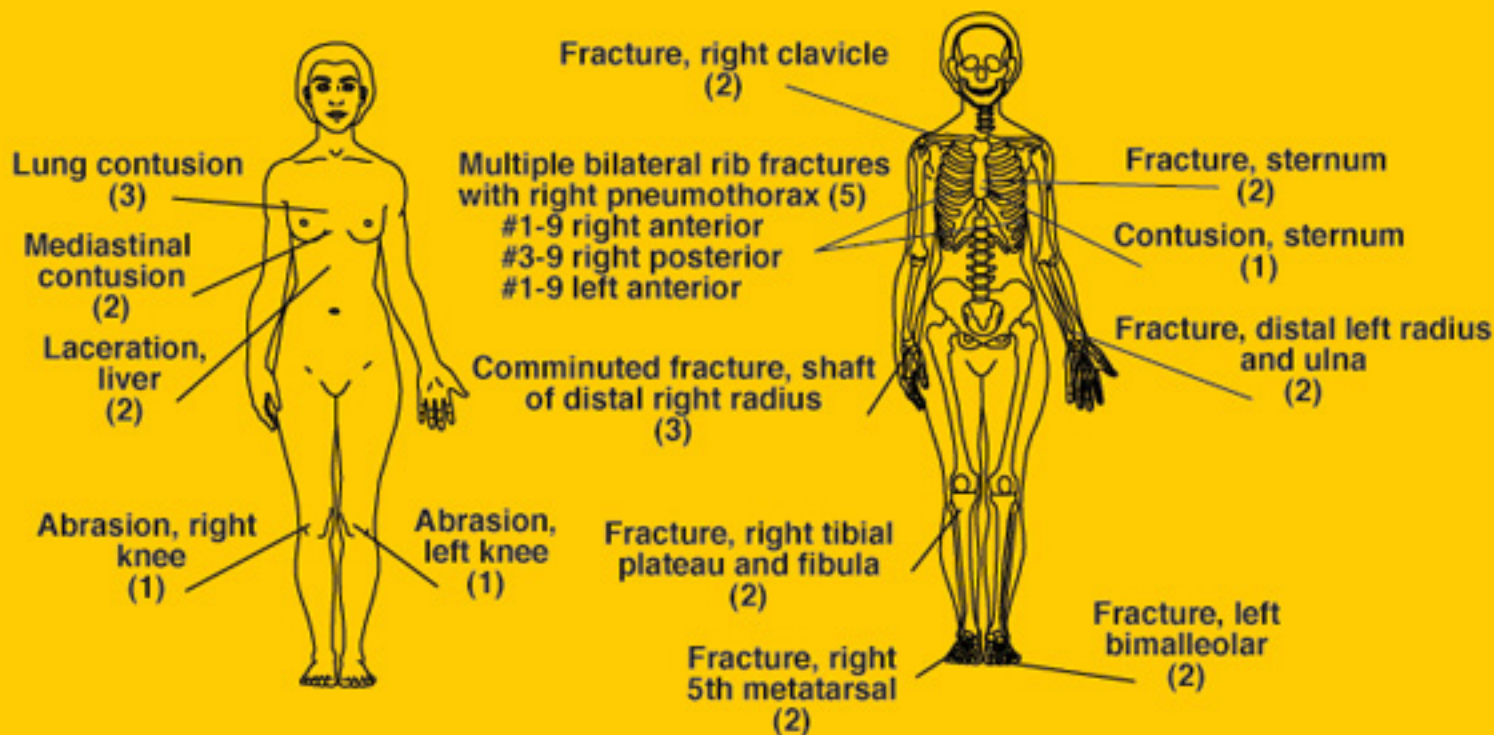
The following table [70](#) and attached drawing summarize the injuries for the belt-plus-airbag restrained driver.

Occupant: Driver	Age: 56 years	Gender: Female		
Restraints: 3-point belt with after-market belt extender; steering-wheel airbag	Stature: 173 cm (5 ft, 8 in)	Mass: 120 kg (265 lb)		
Injury Description	A.I.S.	Injury Source		
		Definite	Probable	Possible
—	—	—	—	—
Fracture, right clavicle	2	Unknown	—	—
Multiple bilateral rib fractures with right pneumothorax #1-9 right anterior, #3-9 right posterior, #1-9 left anterior	5	—	Shoulder belt	—
Lung contusion (unknown aspect)	3	—	Shoulder belt	—
Fracture sternum	2	—	Shoulder belt	—
Contusion sternum	1	—	Shoulder belt	—
Laceration, liver	2	—	Shoulder belt	Steering-wheel rim
Mediastinal contusion	2	—	Shoulder belt	—
Comminuted fracture, shaft of distal right radius	3	—	Vertical console	—
Fracture distal left radius and ulna	2	—	—	Upper instrument panel
Abrasion, left and right knees	1	—	Knee bolster	—
Fracture, right tibial plateau and proximal fibula	2	—	Knee bolster	—

Fracture, left bimalleolar	2	—	Toepan	—
Fracture, right 5th metatarsal	2	—	Toepan; foot controls	—
Maximum A.I.S. Level	5	—	—	—
Injury Severity Score	38	—	—	—

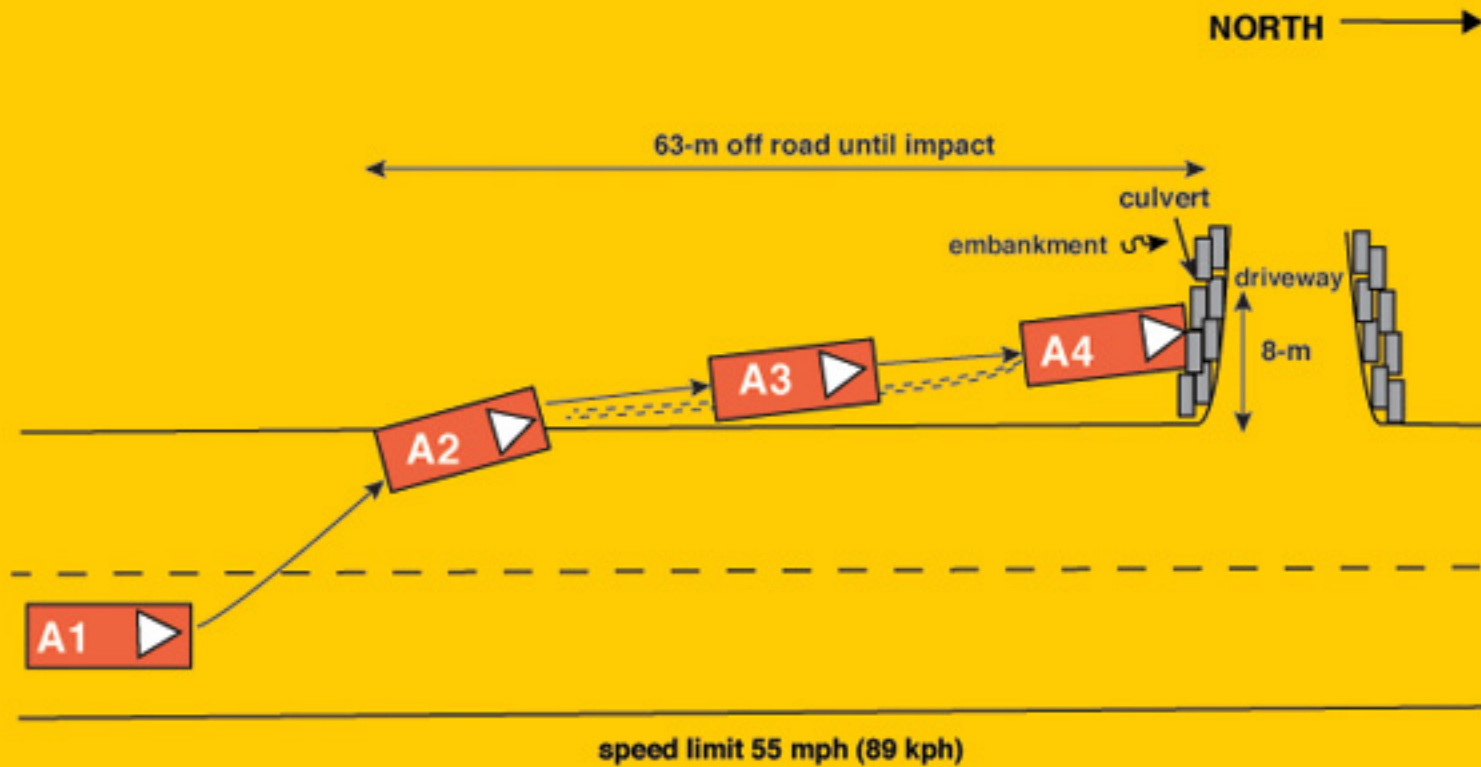
[1](#) [2](#) It was daylight and foggy, and the asphalt surface of the north-south road with a posted speed of 55 mph (89 kph) was wet. Case vehicle (A) was traveling north in the northbound lane at a driver-estimated speed of 45 mph (72 kph) when [3](#) it crossed the centerline and the southbound lane for an unknown reason and [4](#) exited the west edge of the road. [5](#) The case vehicle entered a grassy ditch located about 8 meters west of the road edge and continued to travel north for approximately 63 meters [6](#) [7](#) until the front end struck a brick and concrete residential driveway embankment. The vehicle came to rest and was towed from the scene due to damage.

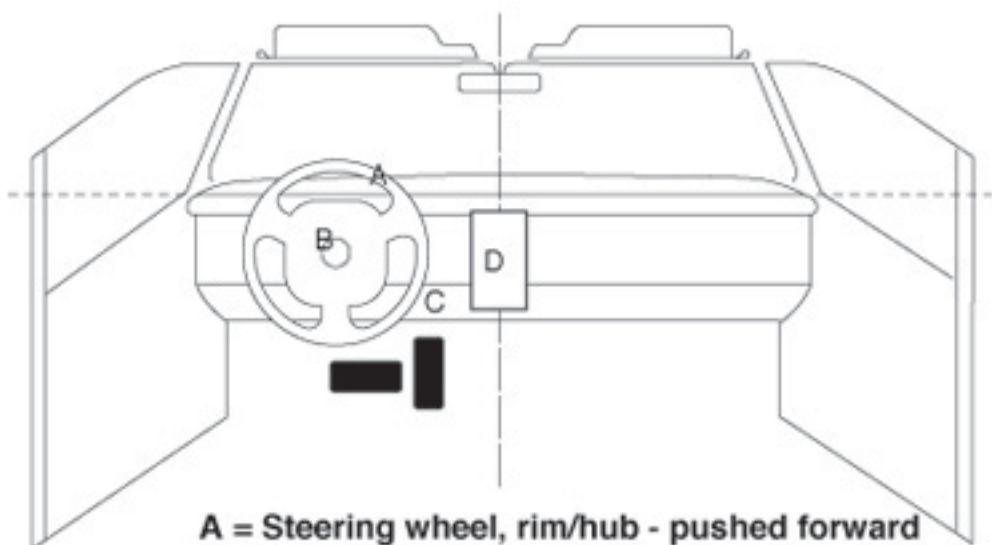
OCCUPANT CONTACT WORKSHEET

- A = Steering wheel, rim/hub - pushed forward**
- B = Airbag - blood**
- C = Knee bolster - cracked**
- D = Vertical console, scuff**

Contact	Interior Component Contacted	Occupant No. if Known	Body Region if Known	Supporting Physical Evidence	Confidence Level of Contact Point
A	Steering wheel	1	Chest	Rim/Hub pushed forward	1
B	Driver airbag	1	Chest	Blood	1
C	Knee bolster	1	Knees	Cracked	1
D	Vertical console	1	Right hand	Scuff	1
E					
F					
G					
H					
I
