Case 471 : Narrative

Case Vehicle (A): 1999 Hyundai	Vehicle (B): 2003 Lincoln
Type: Accent GL, 4-door sedan	Type: Navigator SUV, 4x4 4-door
Driver: 20-year-old male	Driver: 46-year-old female
CDC: 11-FDEW-2, 09-LZAW-2	CDC: 99-0000-0, 99-0000-0

CASE NO.: 471

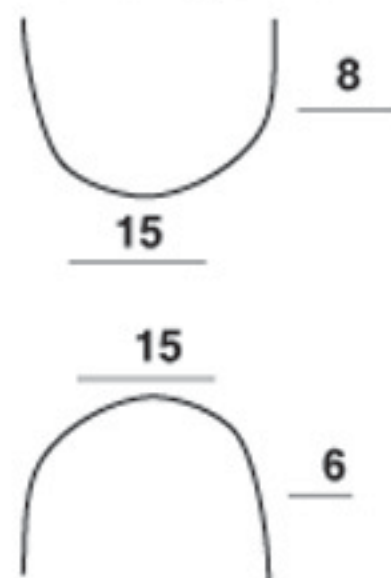
vents located at 10 and 2 o'clock

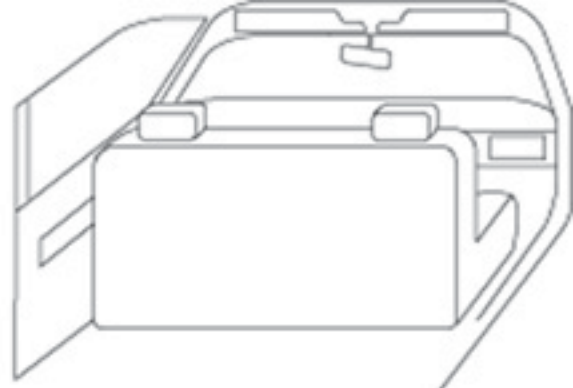
no evidence of belt use

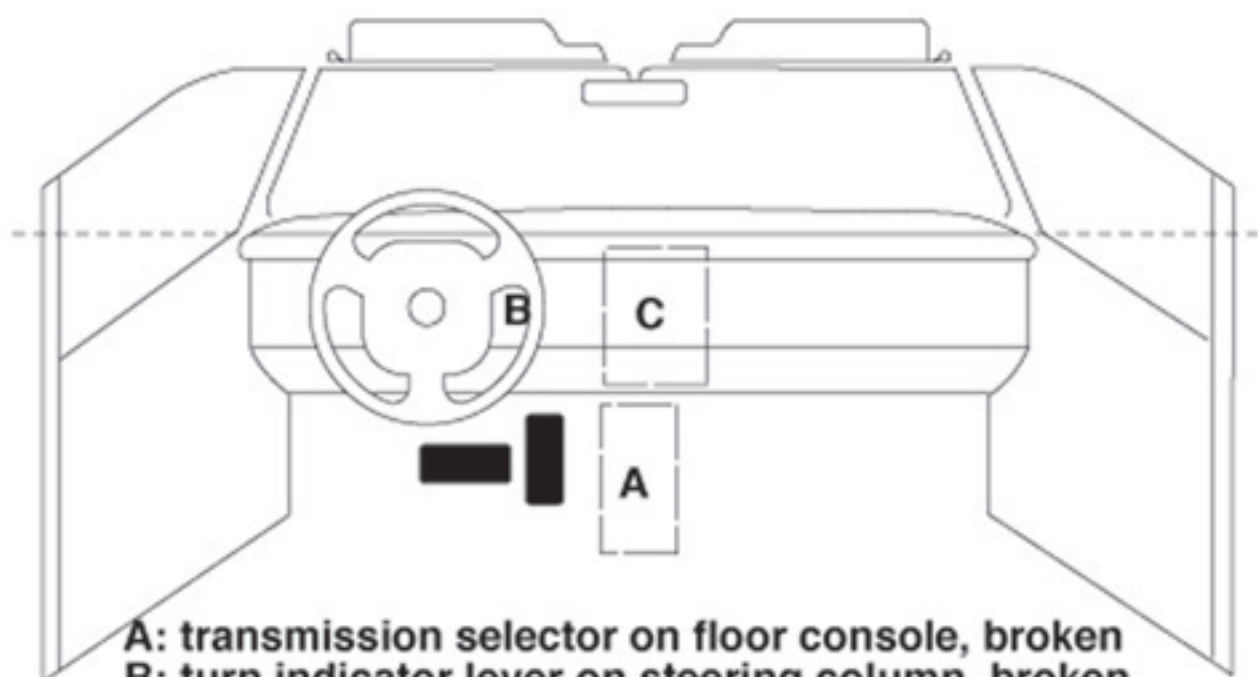
A: transmission selector on floor console, broken
B: turn indicator lever on steering column, broken
C: vertical console, pushed in
