Case 472 : Narrative

Case Vehicle (A): 2000 Mercury	Vehicle (B): 1998 Nissan
Type: Grand Marquis GS, 4-door sedan	Type: Pathfinder, 4x4, 4-door SUV
Driver: 67-year-old male	Driver: 17-year-old female
CDC: 12-FDEW-1	CDC: 99-0000-0

GENERAL VEHICLE DAMAGE AND ESTIMATED CRASH SEVERITIES

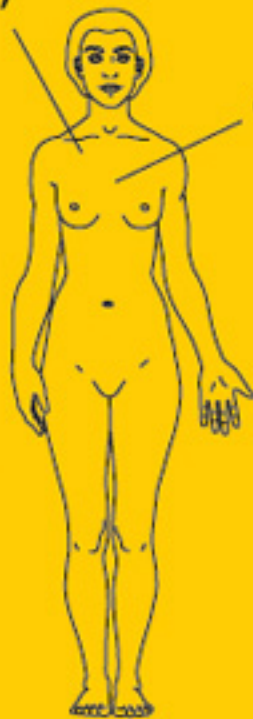
Contusion, across right
upper chest (1)

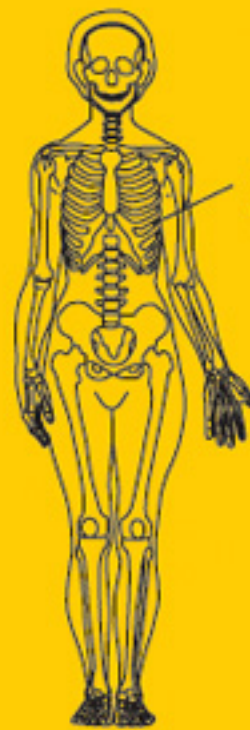
Cardiac contusion (1)

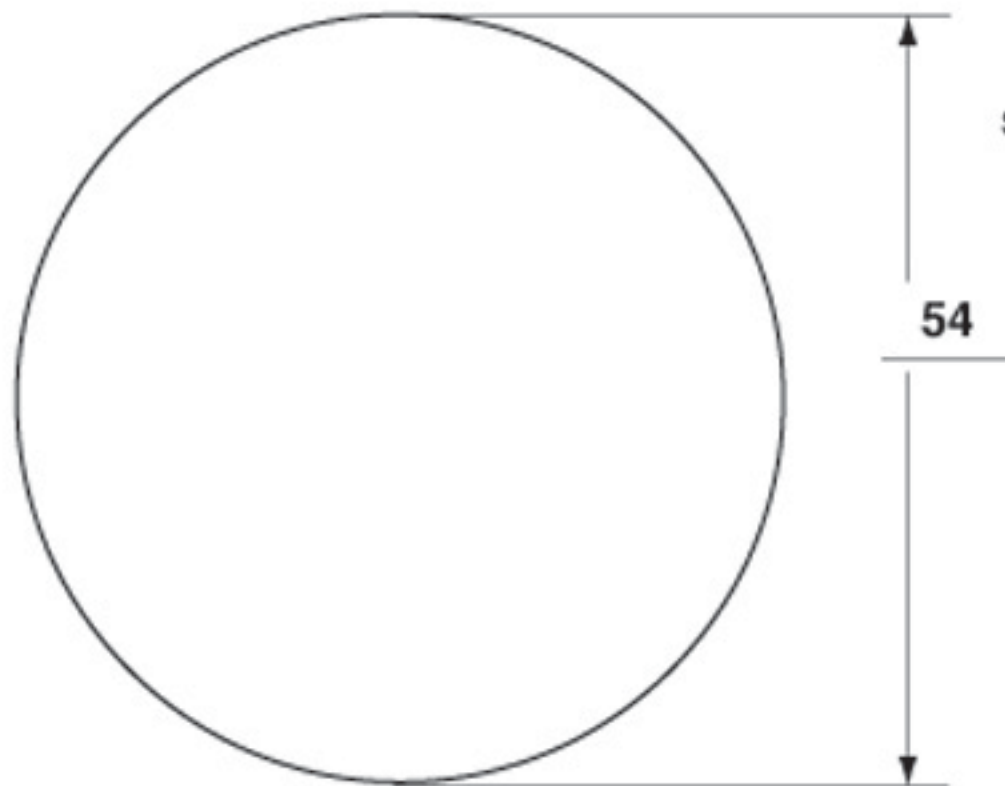
Driver Airbag

scuffmark

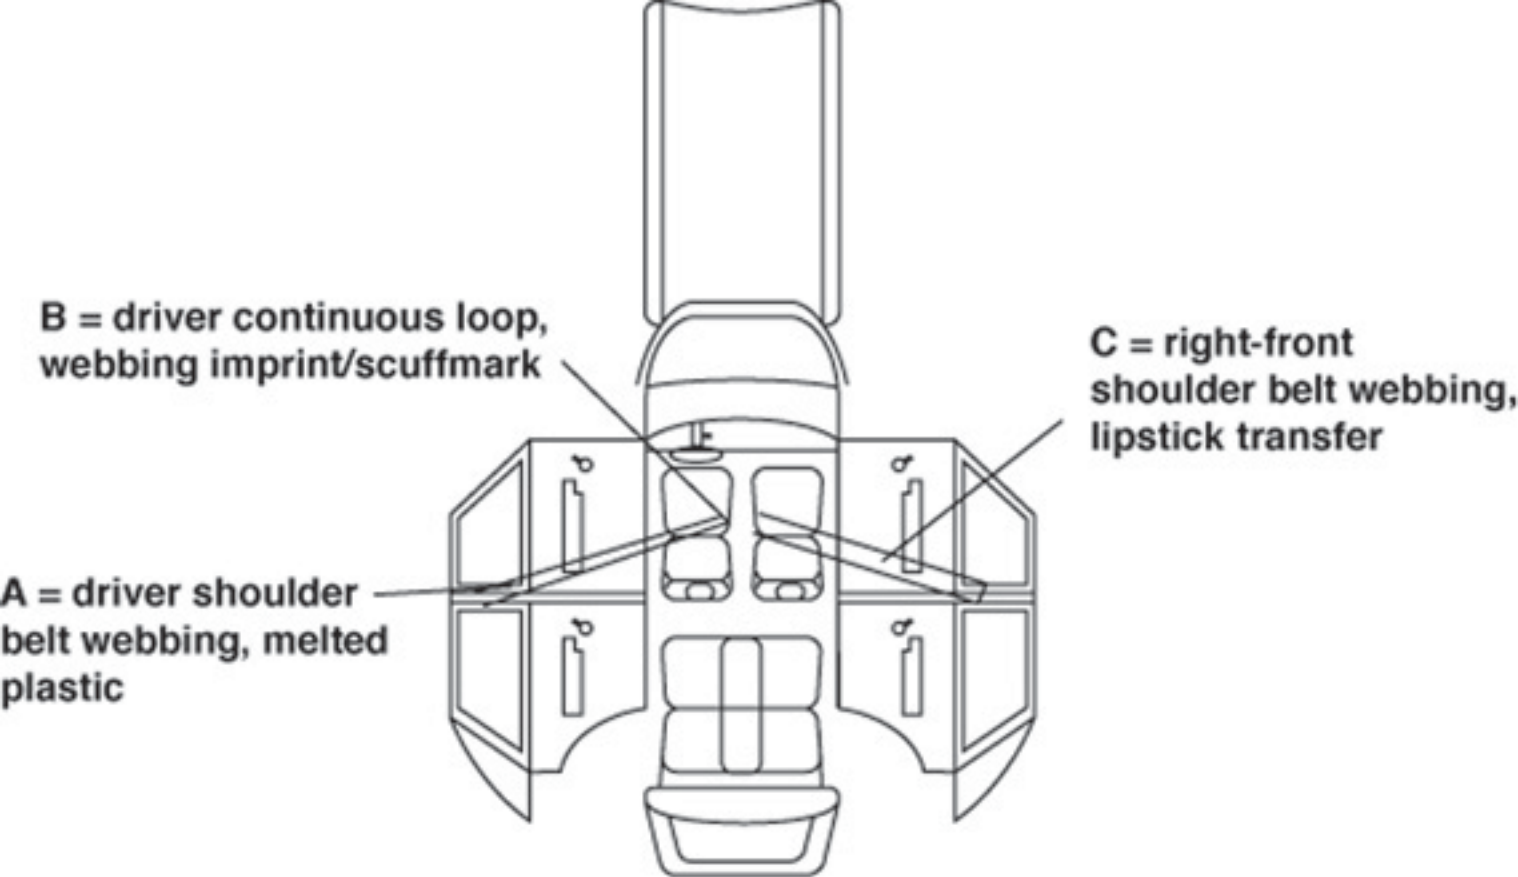
D = steering wheel hub (airbag cover/flap), scuffmark

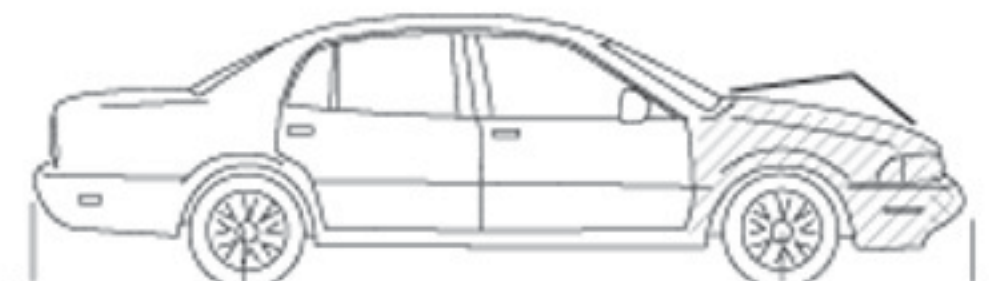
Max. crush to left
front bumper corner
