Case 473 : Narrative

Case Vehicle (A): 2003 Pontiac
Type: Sunfire SL, 2-door coupe
Driver: 47-year-old male
CDC: 12-RYES-1, 12-FYAW-3, 00-TZLN-1

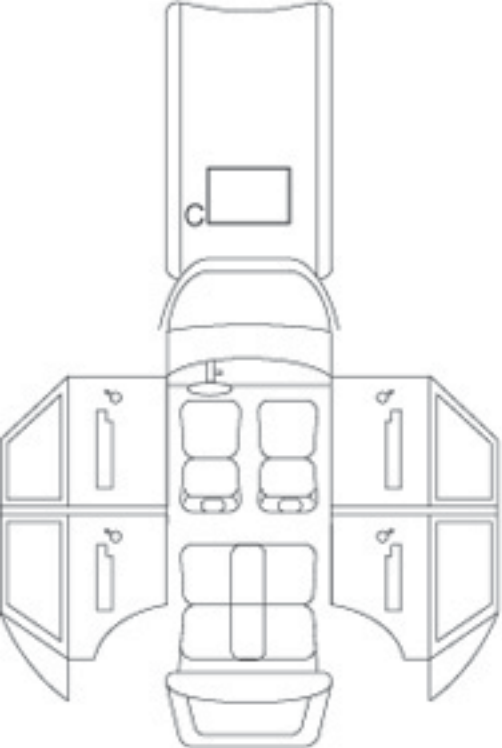
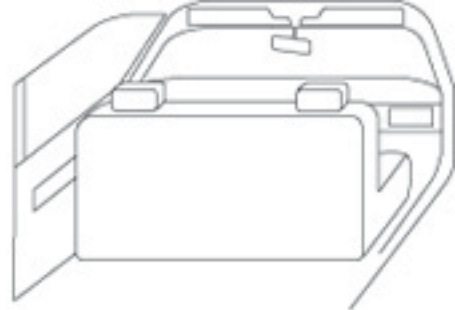
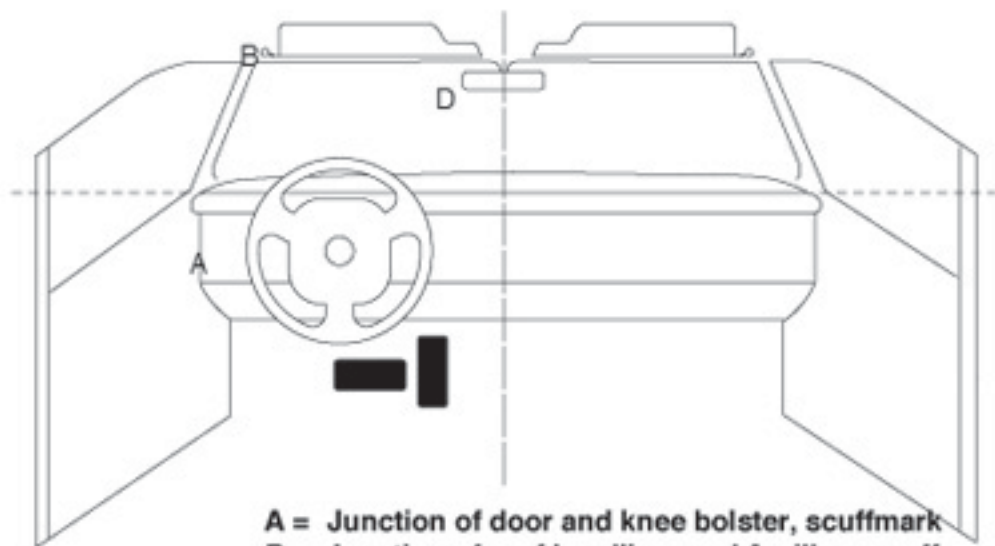
- A = Junction of door and knee bolster, scuffmark**
- B = Junction of roof headliner and A-pillar - scuff**
- C = Roof - hair deposit**
- D = Windshield - starred crack**

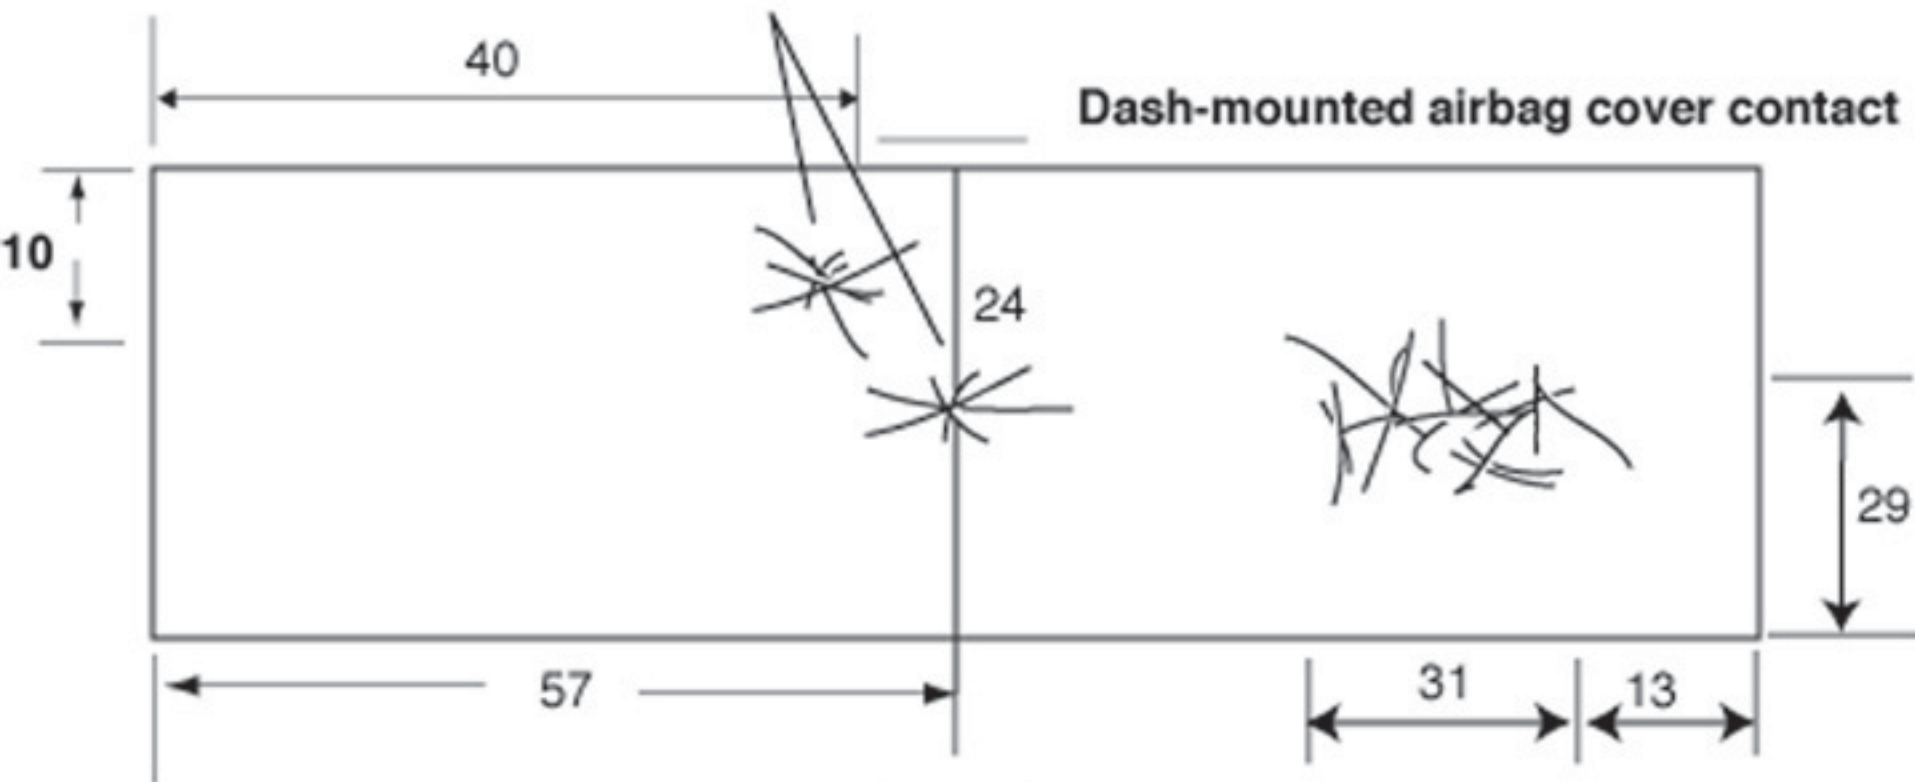
WINDSHIELD MARK ON CASE VEHICLE:

Rear-view mirror or driver contact

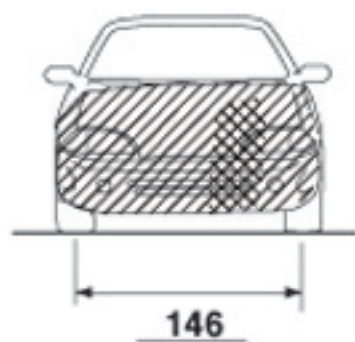
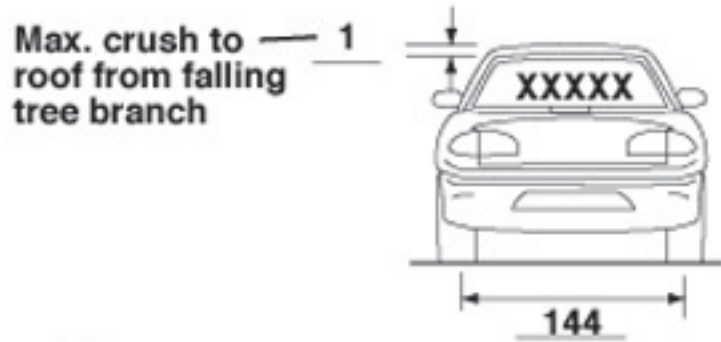
Length of damage to roof from falling tree branch

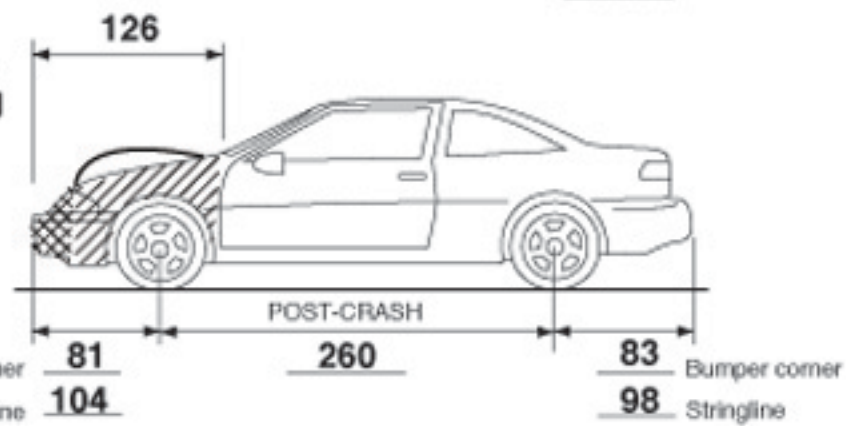
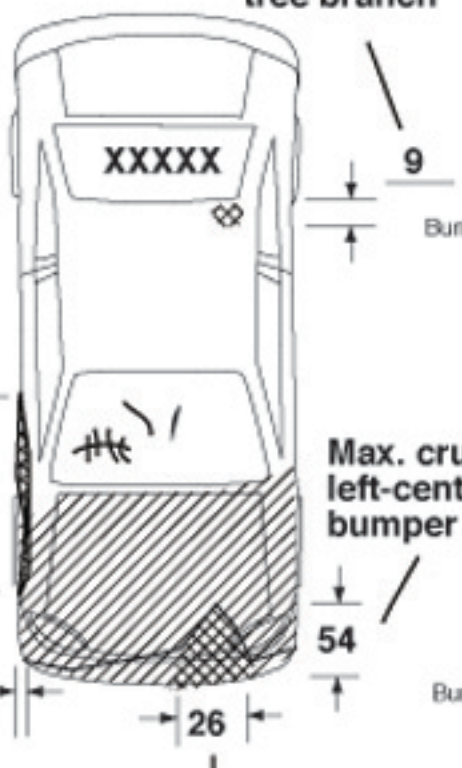
Length of sideswipe damage to right side 52

Max. crush to right side from sideswipe 1

Max. crush to left-center front bumper 54

Width of direct damage to front from the tree impact 26
