Case 475 : Narrative

Case Vehicle (A): 2000 Mazda	Vehicle (B): 1994 Ford
Type: 626, 4-door sedan	Type: E-150 Econoline van, 4x2
Driver: 34-year-old male	Driver: 16-year-old male
CDC: 12-FZEW-2	CDC: 99-0000-0

475: Vehicle Report

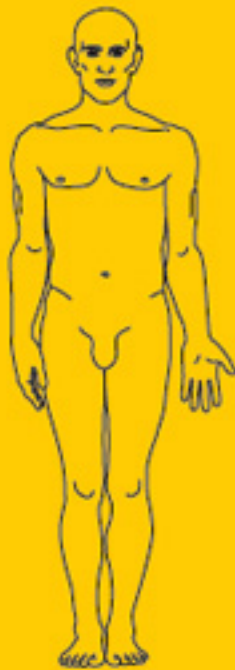
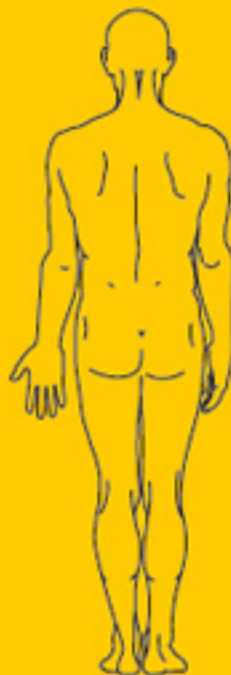
No Injury

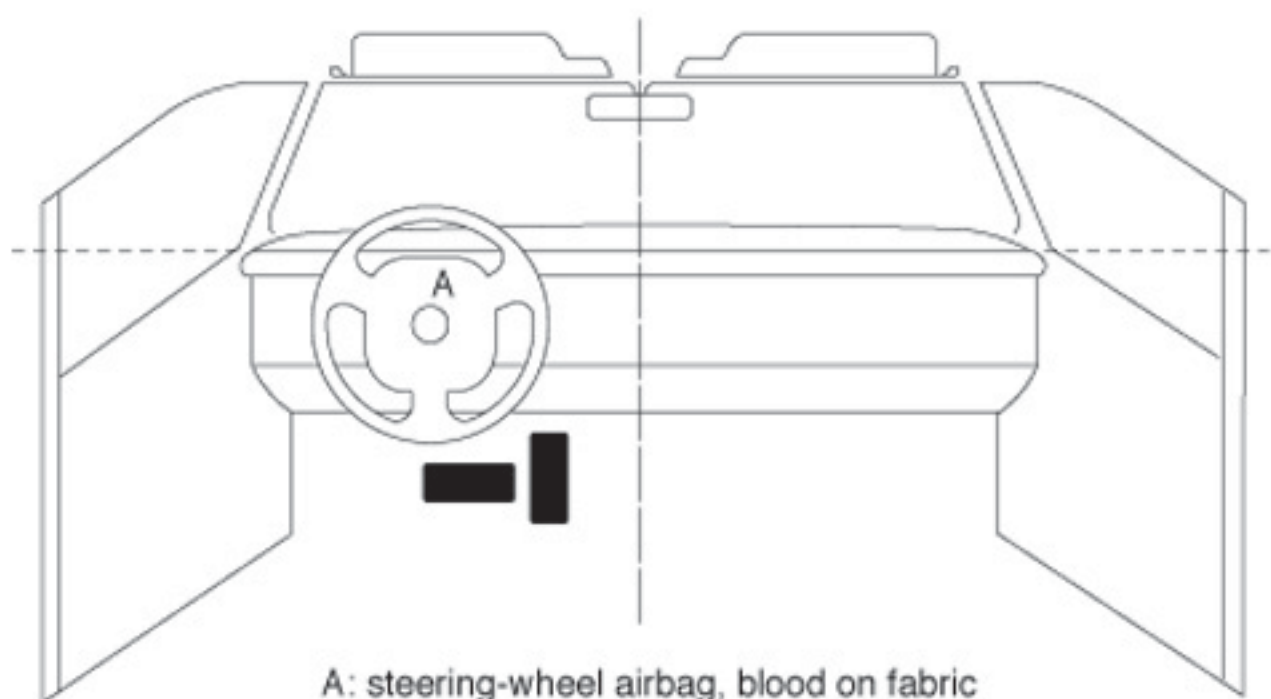
A: steering-wheel airbag, blood on fabric
B: B-pillar, blood

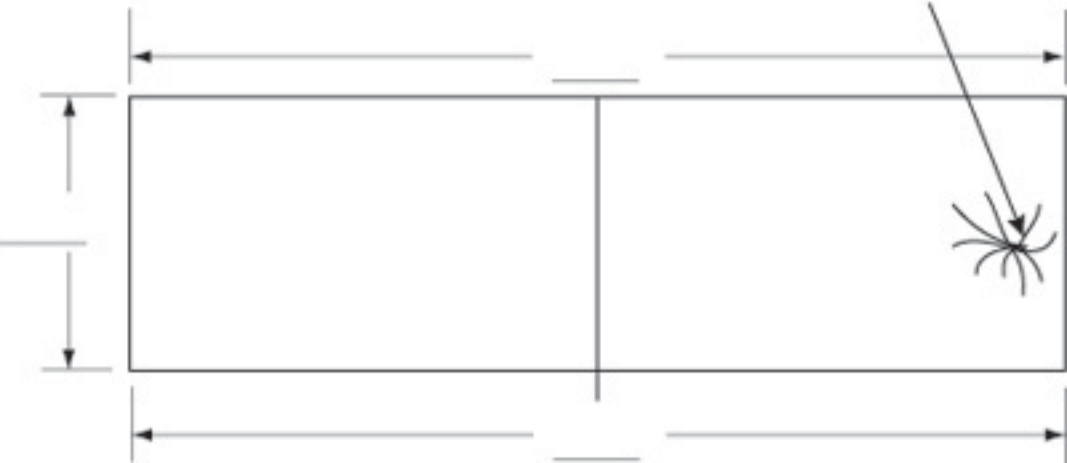
WINDSHIELD MARK ON CASE VEHICLE:

Unknown

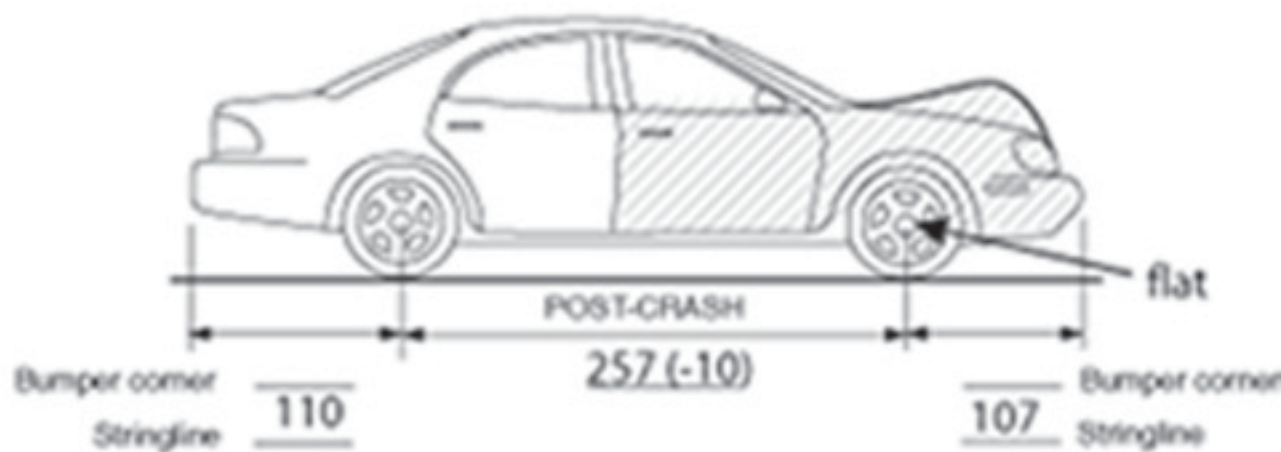
75-cm direct damage
44-cm max crush at C6
