# Case 477 : Narrative

Case Vehicle (A): 2004 Pontiac
Type: Grand Prix GTP, 4-door sedan
Driver: 29-year-old female
CDC: 12-FZEW-3

# 477: Vehicle Report

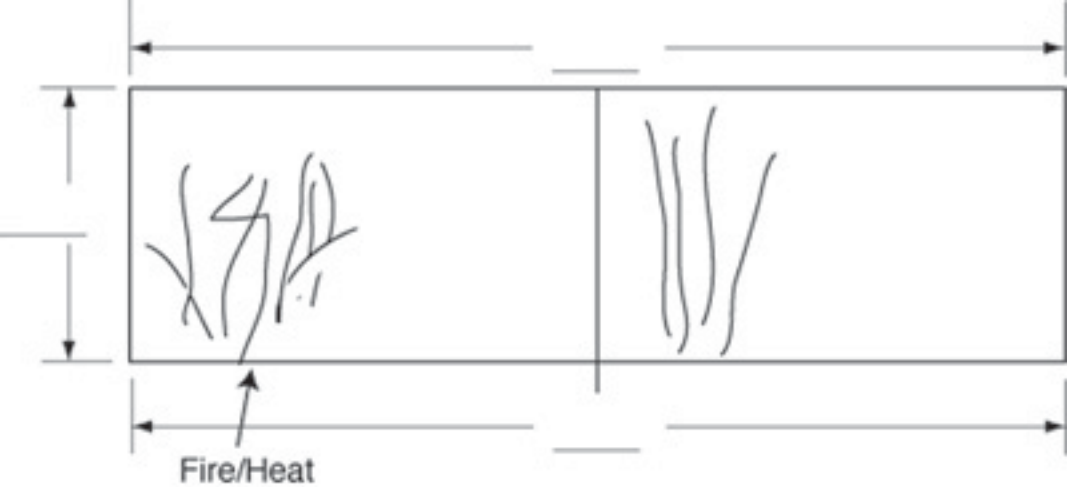
WINDSHIELD MARK ON CASE VEHICLE:

rearward, and the center of the hood was buckled up. [16](#) [17](#) A small fire in the left-rear area of the engine compartment damaged the left half of the hood and forward portion of the windshield. The hood latch was damaged and had released [18](#) [19](#) but there was no damage to the hood hinges. [20](#) The rear edge of the hood was slightly elevated but it did not contact the windshield. [21](#) [22](#) The lower-left portion of the windshield was cracked from heat caused by the fire and the windshield was cracked in the center from impact forces.

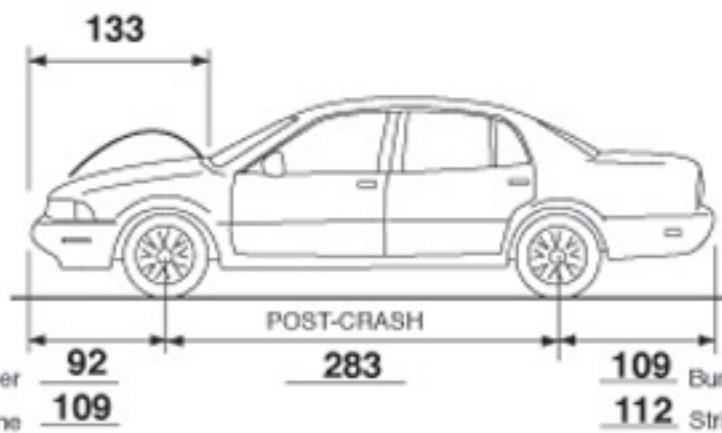
Fire damage
