# Case 489 : Narrative

Case Vehicle (A): 2000 Dodge
Type: Caravan, 4-door minivan
Driver: 36-year-old male
CDC: 12-FRWN-3, 12-FZEN-3

# 489: Vehicle Report

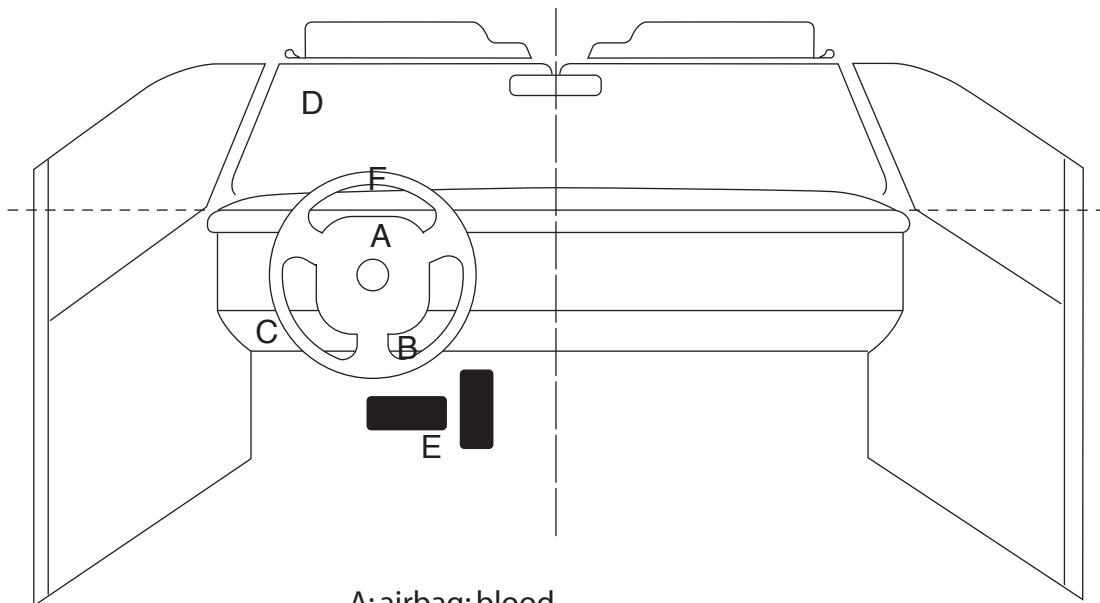
- A: airbag; blood
- B: knee bolster below steering column; dent
- C: knee bolster; scuff
- D: windshield; crack
- E: brake pedal, deformed
- F: steering-wheel rim; upper half deformed

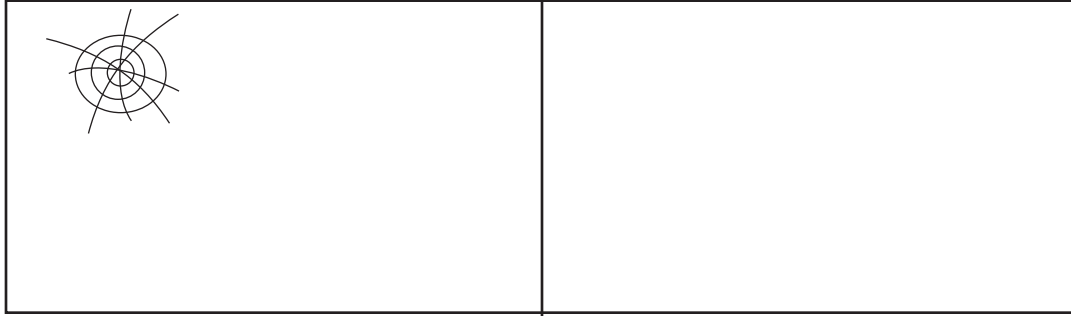
WINDSHIELD MARK ON CASE VEHICLE:

**Windshield cracked on upper left, possibly  
due to contact by the driver**

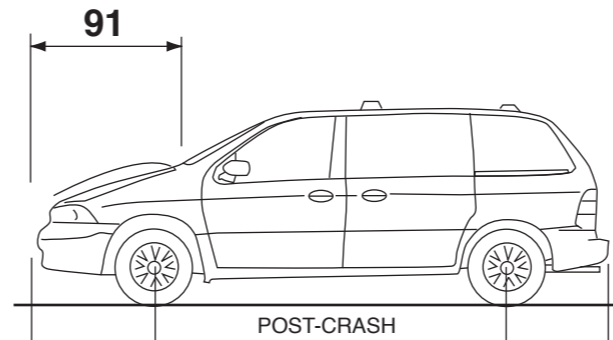
impact #2  
Width of direct damage to front

Bumper corner 81 Stringline 96

Stands were set too long subtract 3 cm from string line and c-values

82 Bumper corner Stringline 93

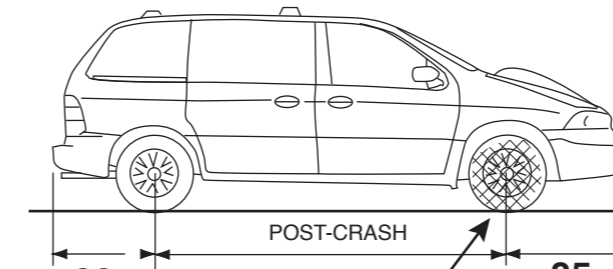
Bumper corner 82 Stringline 93

85 Bumper corner Stringline 96
