# Case 491 : Narrative

Case Vehicle (A): 1999 Chevrolet	Vehicle (B): Unknown International
Type: S-10 LS, 4x2, 2-door pickup	Type: Tractor-trailer
Driver: 18-year-old male	Driver: Unknown
CDC: 12-FYEW-4	CDC: 99-0000-0

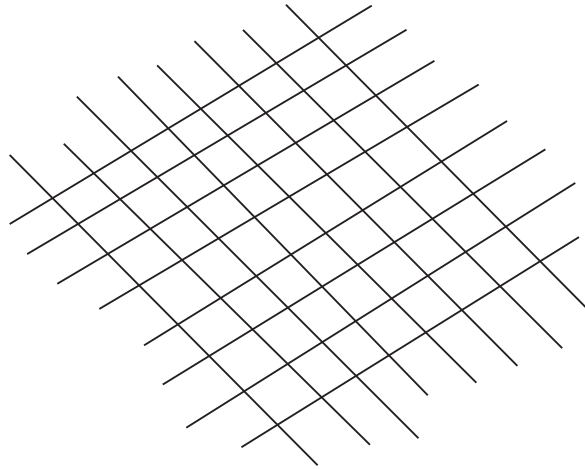
WINDSHIELD MARK ON CASE VEHICLE:

**Cut out by rescue personnel.**

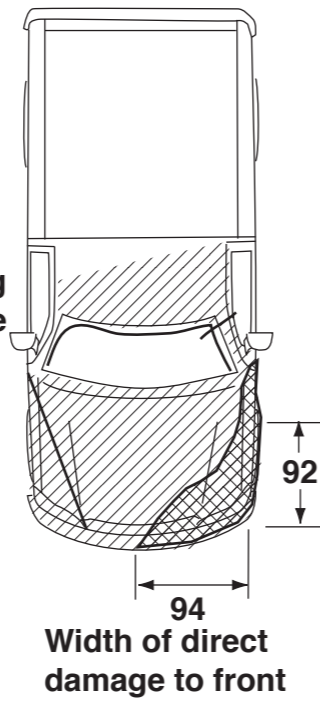
Windshield cut on both sides and along the header by rescue

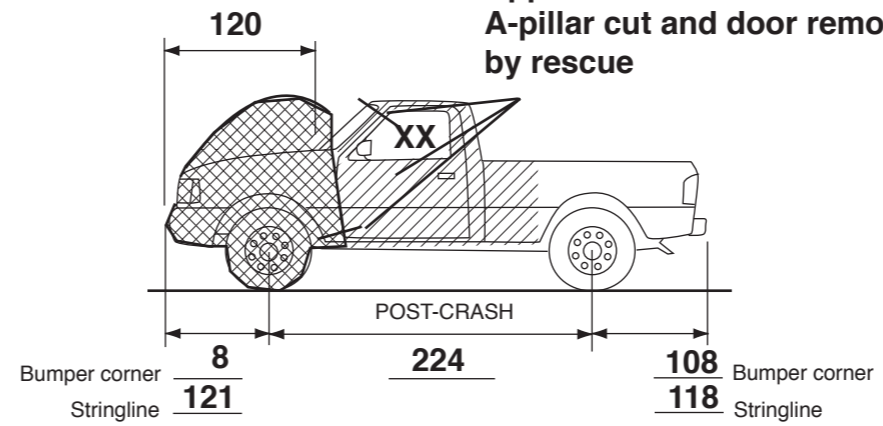
Upper and lower sections of A-pillar cut and door removed by rescue

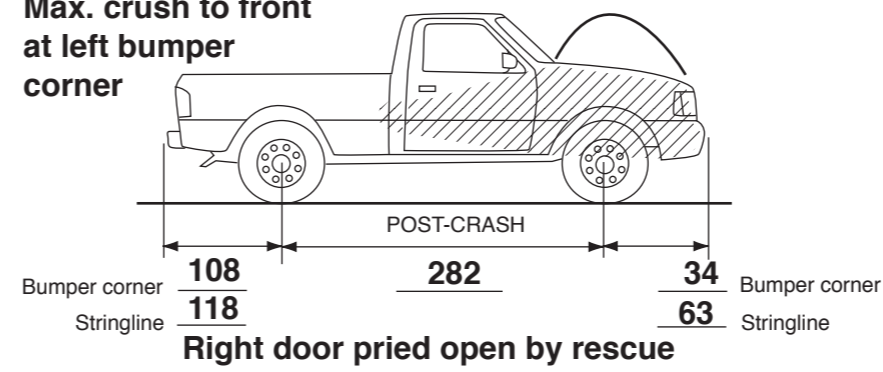
Max. crush to front at left bumper corner
