## Case 492 : Narrative

Case vehicle (A): 2002 Mercury	Vehicle (B): 1995 Plymouth
Type: Cougar, 2-door hatchback	Type: Grand Voyager SE, minivan
Driver: 19-year-old female	Driver: 44-year-old male
CDC: 12-FYEW-1	CDC: 99-0000-0

# 492: Vehicle Report

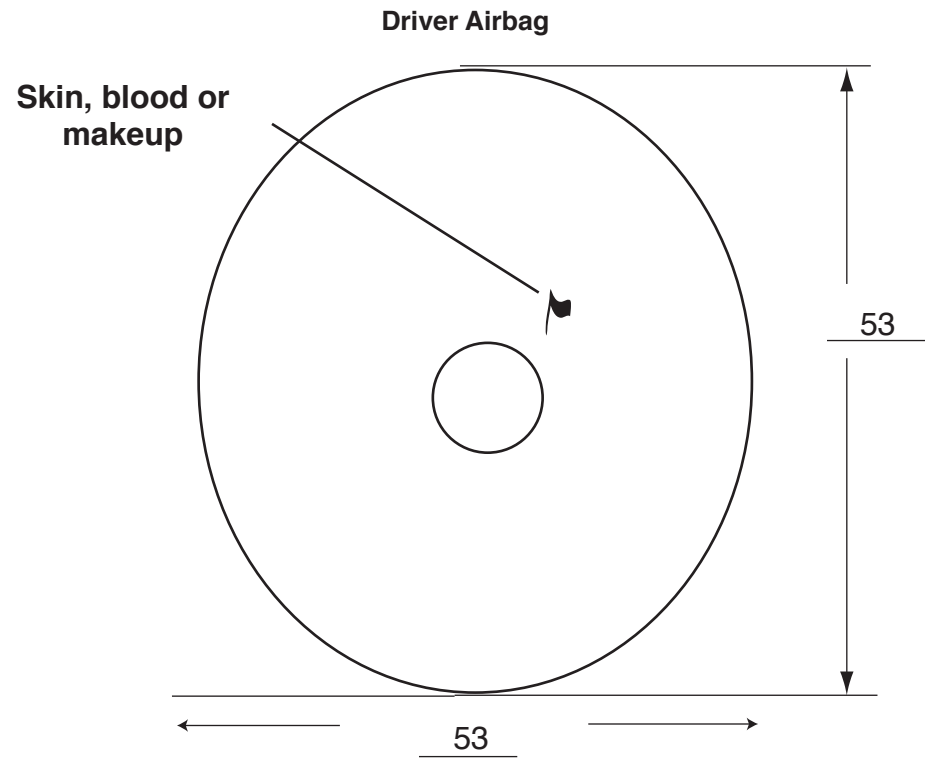
**Driver Airbag Doors**

Vents:  Y  N  
 if yes, how many: 2  
 vents @ 11 and 1 o'clock

Tethers:  Y  N  
 if yes, how many: 4

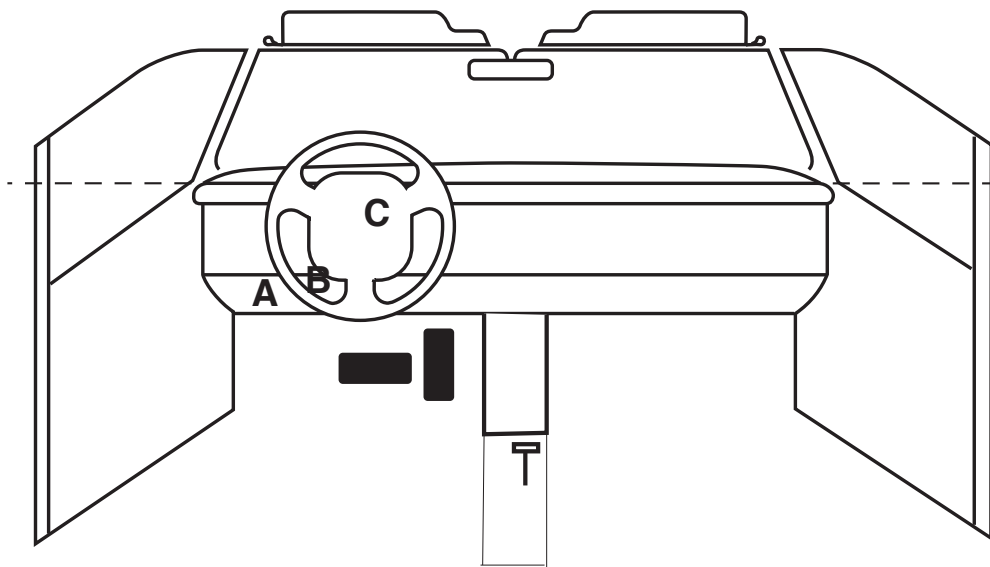
**A = knee bolster, scuffs**

**B = tilt steering-wheel adjustment lever, skin deposit**

**C = airbag, skin, blood or makeup deposit**

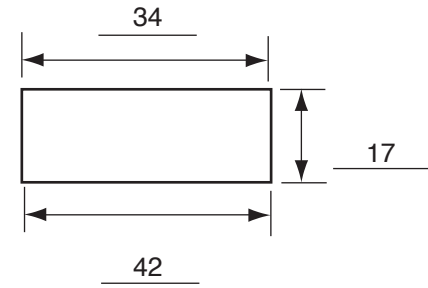
**Passenger Airbag Door**  
Single Door

Vents:  Y N  
if yes, how many: 1  
Vent @ 10 o'clock

Tethers:  Y N  
if yes, how many: 2
