Case 496 : Narrative

Case Vehicle (A): 2002 Mitsubishi	Vehicle (B): 1995 Ford
Type: Lancer ES, 4-door sedan	Type: F-250 HD, 4x4, 4-door pickup
Driver: 39-year-old female	Driver: 71-year-old male
CDC: 12-FDMW-5	CDC: 06-BLDW-2

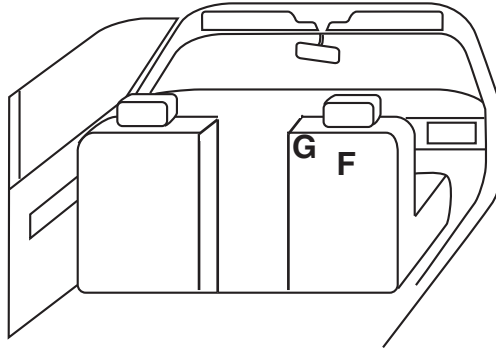
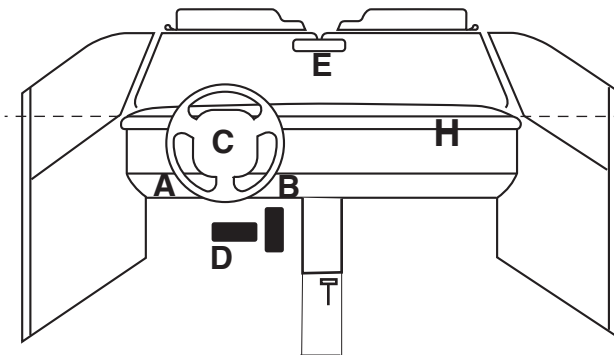
- A = knee bolster left of steering column, bent and crazed**
- B = knee bolster right of steering column, bent and crazed**
- C = steering wheel airbag, blood stain**
- D = brake pedal, deflected to left**
- E = rear-view mirror, knocked off mount, cracked and blood deposit**
- F = rear of right front seat backrest, two holes**
- G = right front seat backrest, left half deflected forward**
- H = dash-mounted airbag, blood stain**
