Case 506 : Narrative

Case Vehicle (A): 2005 Jaguar
Type: X-Type, 4-door sedan
Driver: 25-year-old male
CDC: 12-FCEN-2

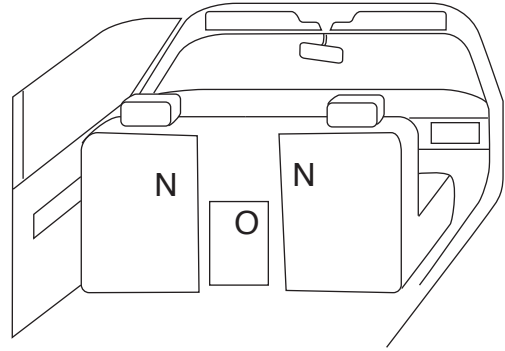
- A: windshield - crack, skin
- B: steering wheel - forward deflection
- C: steering-wheel rim - scuff to lower rim
- D: upper IP - scuffs to lt and rt of wheel
- E: light knob - broken
- F: steering column - scuff
- G: knee bolster - dent
- H: armrest between seats - skin
- I: transmission selector - broken
- J: ashtray - broken, bent
- K: glove box - dent
- L: vertical console - broke, dent
- M: mid IP - dent
- N: rear of front seatbacks - scuffs
- O: rear of center armrest - plastic scraped off

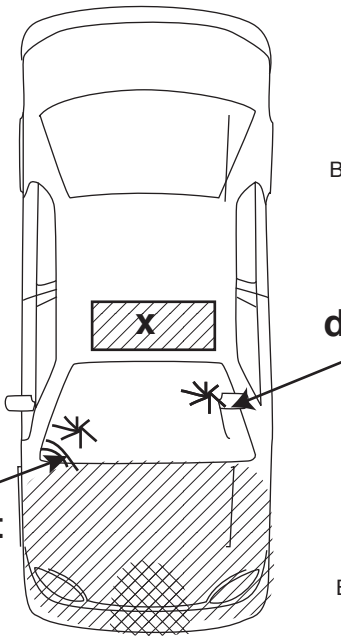
24-cm direct damage
49-cm max crush

stringline was set at 461 oal
should have been 467, so
add 6-cm to all c's
