CALSPAN ON-SITE AIR BAG DEPLOYMENT/ PEDESTRIAN CRASH
INVESTIGATION

CALSPAN CASE NO. 94-17

VEHICLE #1 - 1993 SATURN SR2 (AIR BAG-EQUIPPED)

CRASH DATE - [REDACTED], 1993

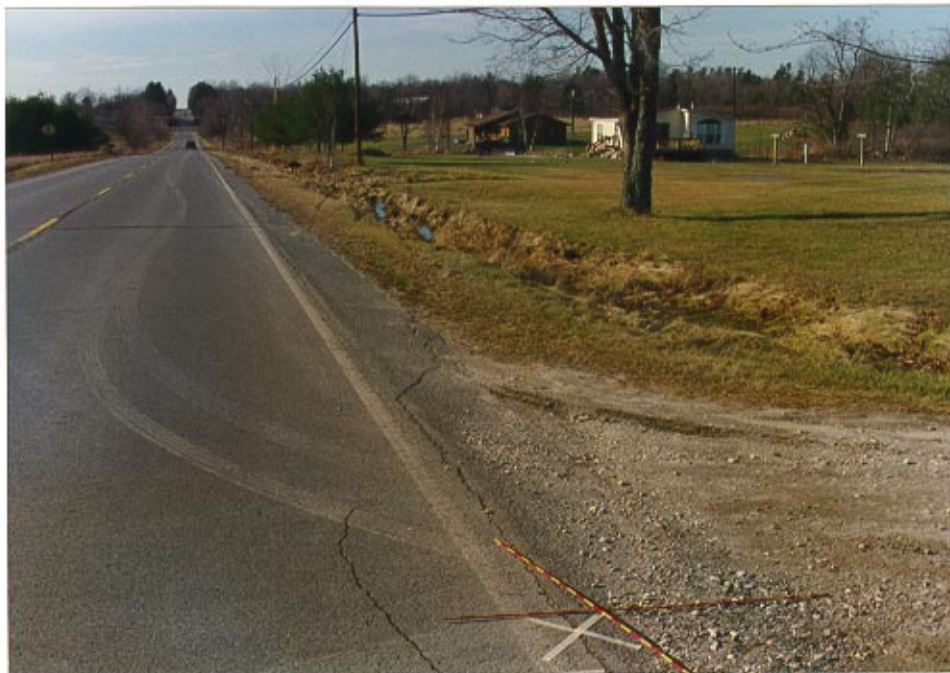
8. Location of the POI.

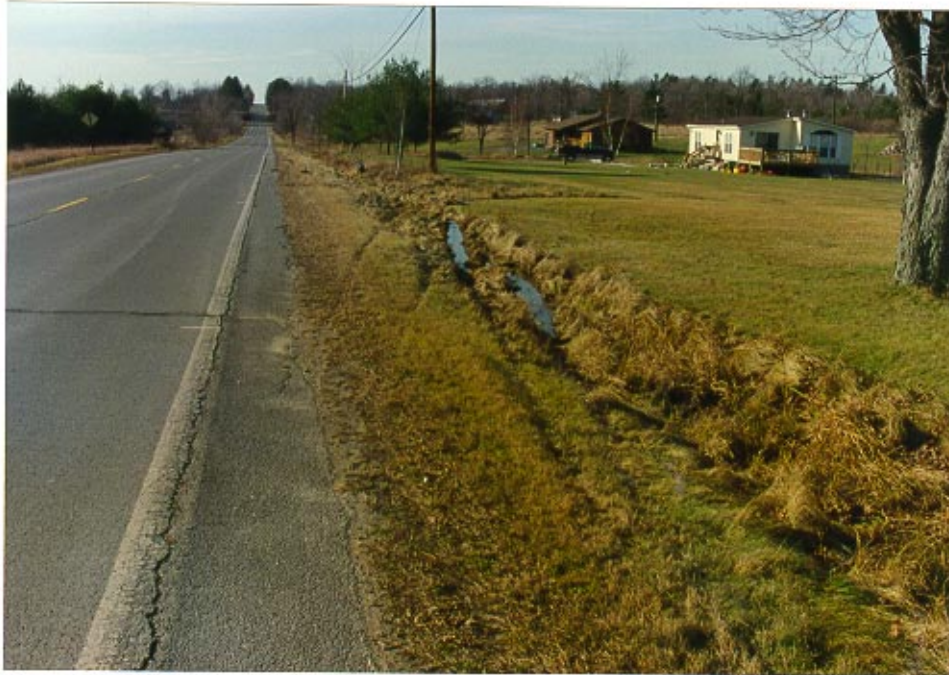
9. Post pedestrian impact trajectory of Vehicle #1, highlighting CCW rotational tire marks

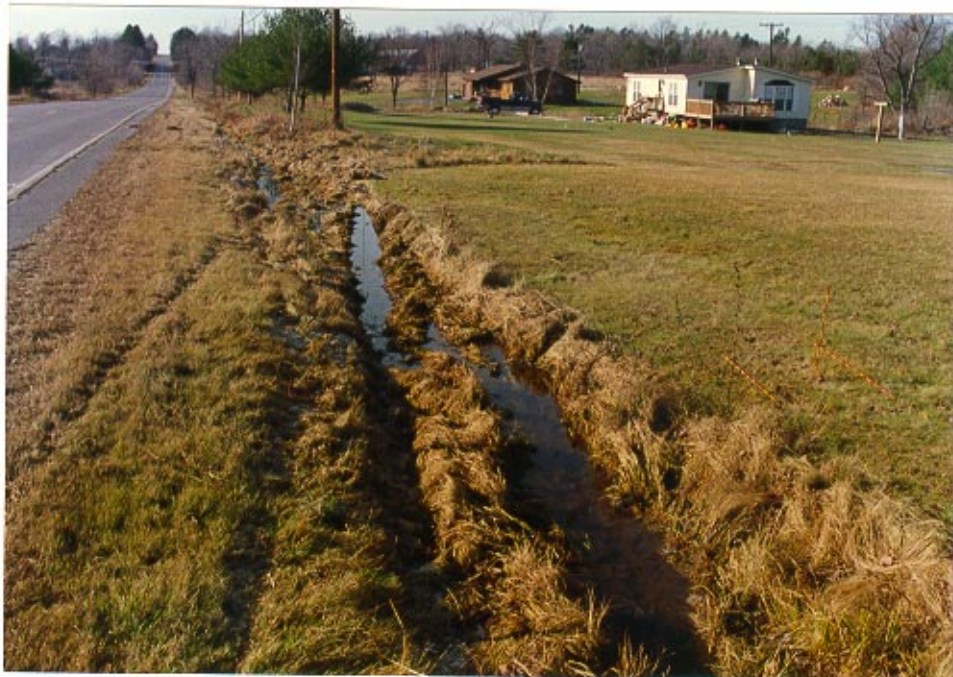
10. Impact with north side of ditch by right side of Vehicle #1.

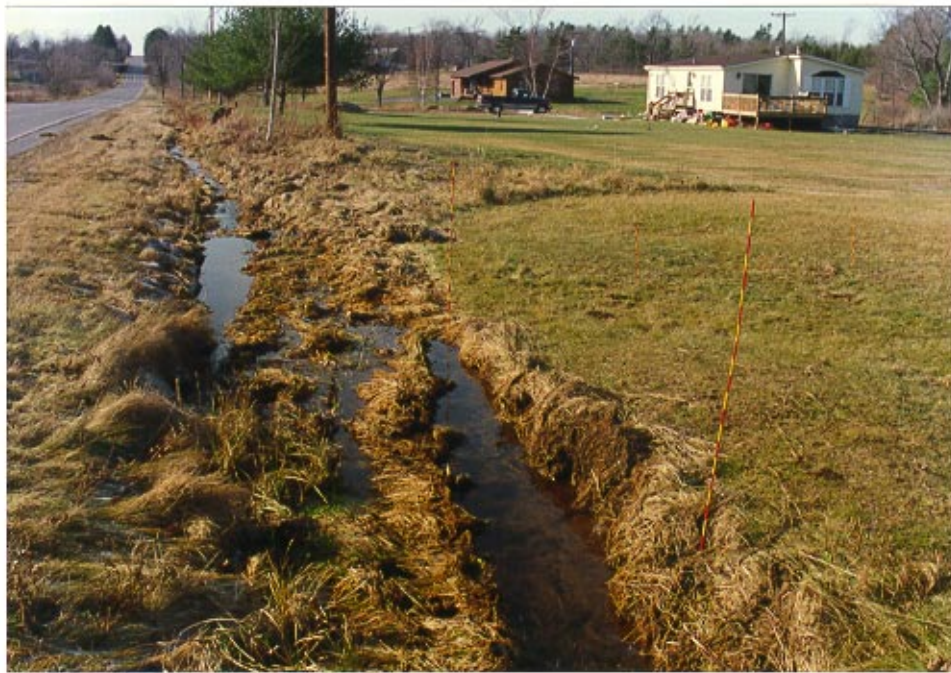
16. Close-up view of the vehicle's right front tire impact with the ditch. This impact reversed the vehicle's CCW rotation.

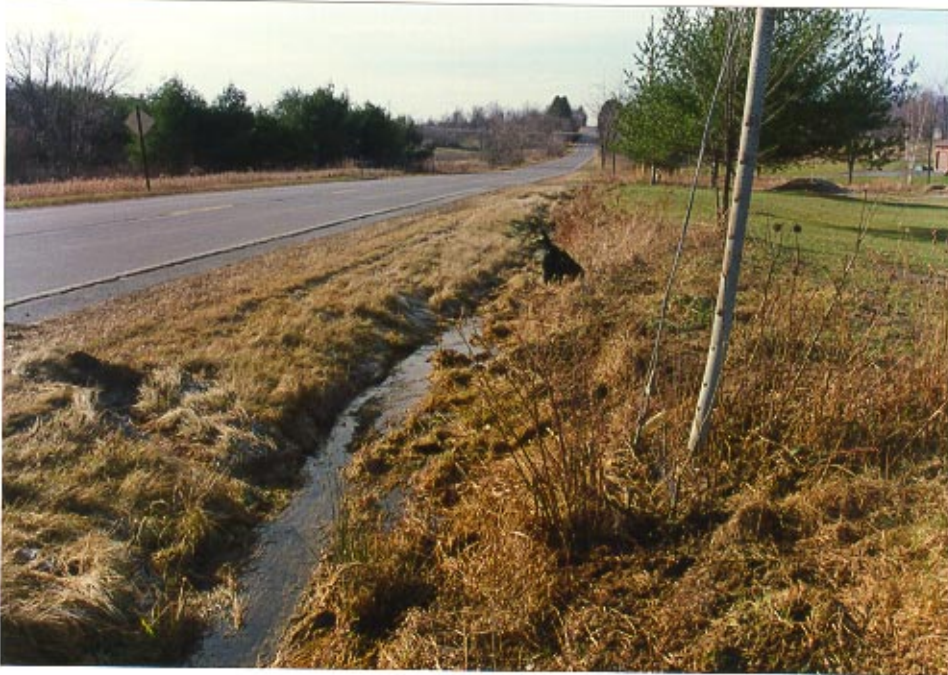
The lower valence panel/air dam, right side plane, all tires/wheels and undercarriage contained grass and dirt residue from contact with the roadside ditch. There was no recordable damage noted. An impact with the utility pole guy wire resulted in fracture/separation of the polymer right side door panels and a 3.8 cm (1.5") rearward displacement of the lower hinge of the right rear door.

17. View of the utility pole guy wire struck by the right side of Vehicle #1.

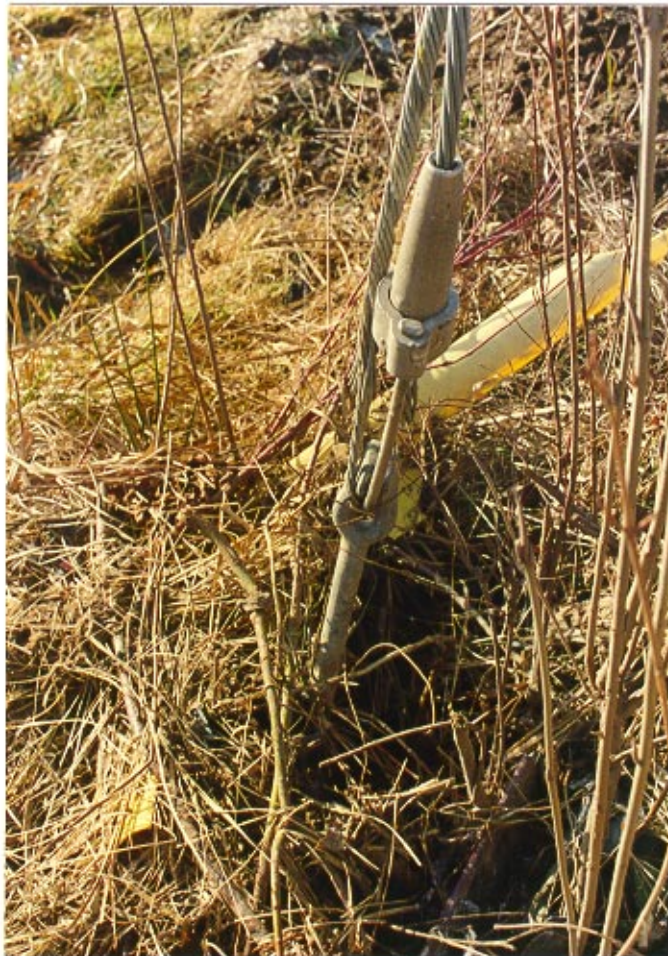
18. Close-up view of contact on the guy wire.

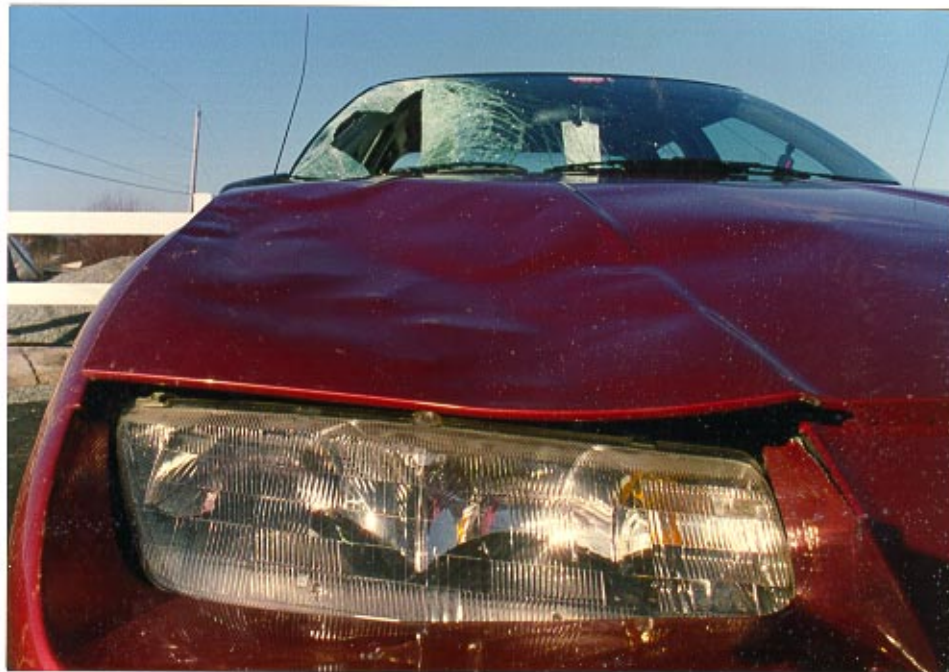
The right headlight assembly was displaced downward as the result of the pedestrian contact on the hood surface. The right side of the hood surface was indented over a general area which measured 53.3 cm (21.0") along the hood edge, 76.2 cm (30.0") along the centerline, 61 cm (24") along the right fender, and 35.6 cm (14.0") from the right fender toward the centerline. The maximum vertical crush of 3.18 cm (1.25") was located 24.1 cm (9.5") rearward of the hood edge and 35.6 cm (14.0") right of the centerline. Within this area, there were three distinct pedestrian contact areas observed.

26. Close-up view along hood edge line providing more definition on contact points and vertical crush.

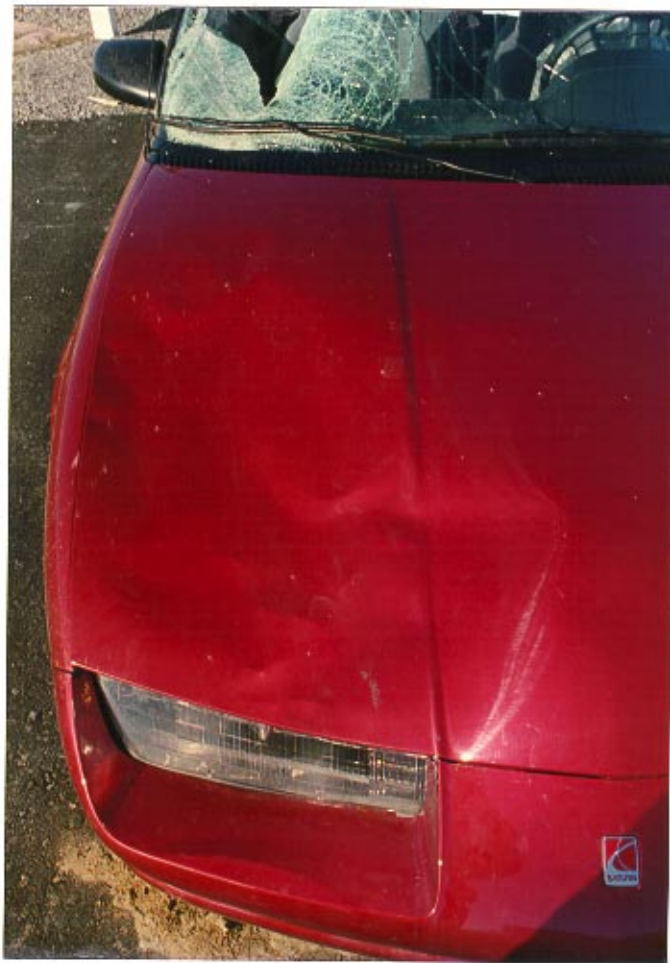
27. Overhead view of contact pattern on hood prior to highlighting with calibrated tape.

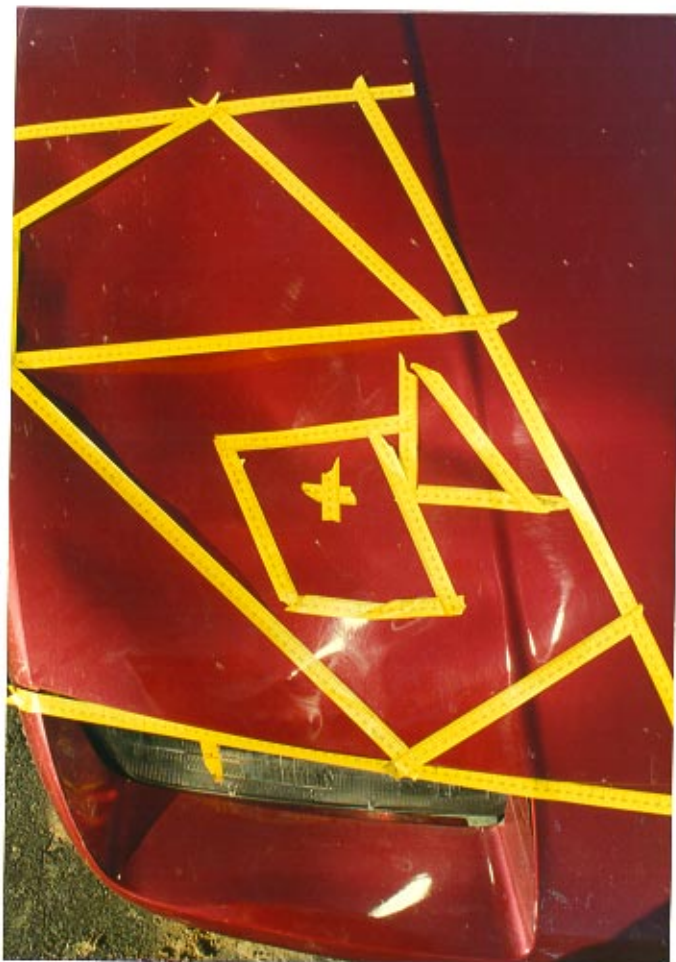
28. Same overhead view as the previous photo, with calibrated tape applied.

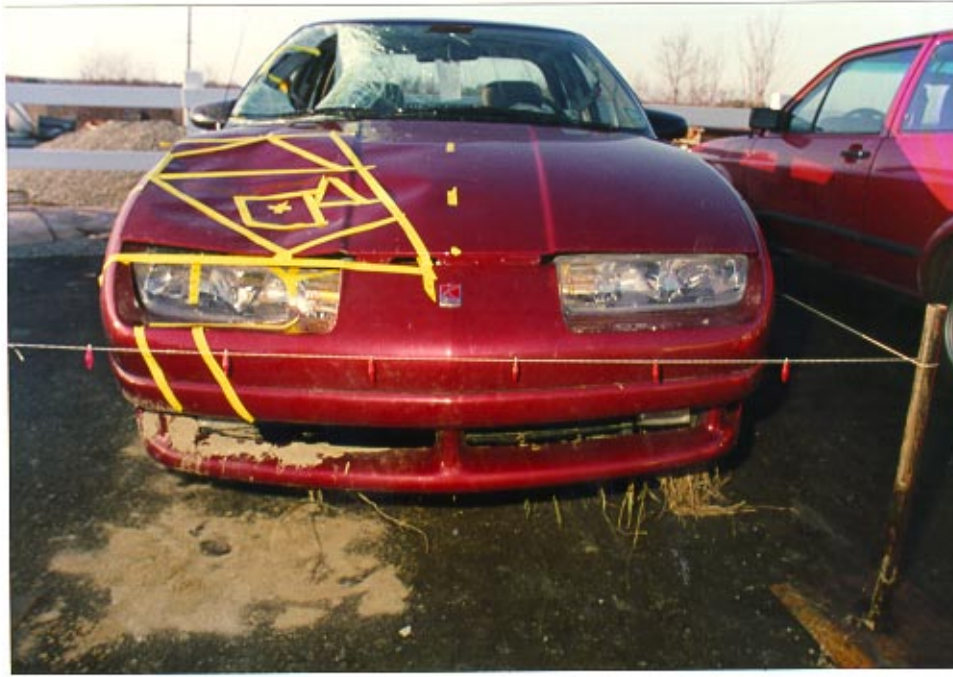
29. Frontal view with calibrated tape applied. The box with the "X" indicates a focal point from hip contact while the triangular area highlights the contact point by the pedestrian's right elbow.

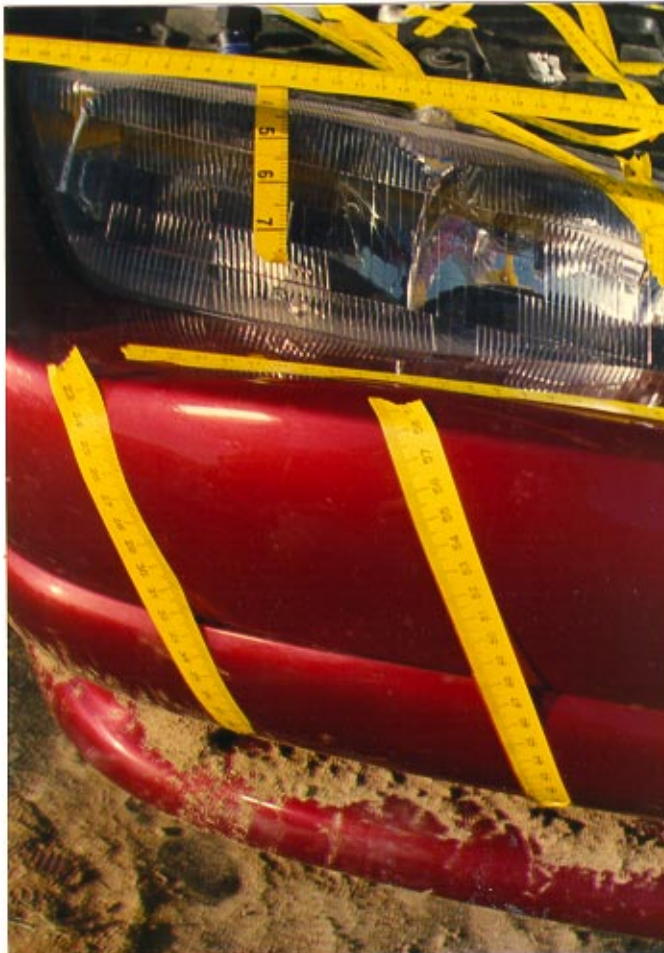
The right frontal plane of the 1993 Saturn SL2 impacted an 82 year old, 162.5 cm (64.0"), 93 kg (205 lbs.), female pedestrian who was crossing the roadway in a northern direction. A 10.2 cm (4.0") wide and 17.8 cm (7.0") high light gray fabric transfer mark was noted to the red bumper cover. The transfer was tilted toward the right with the top portion of the transfer beginning 43.8 cm (17.3") right of the vehicle centerline and the bottom portion beginning 39.4 cm (15.5") right of the vehicle centerline (refer to photographs #29, #30 and slide #34). This transfer mark was associated with the pedestrian's left leg and was consistent with the pedestrian's gray sweat pants. The bumper cover directly forward of the right headlight was deformed rearward 1.3 cm (0.5") in an area measuring 19.1 cm (7.5") laterally and beginning 31.1 cm (12.3") right of the vehicle centerline.

30. Close-up view of the right front bumper face highlighting the left leg contact pattern.

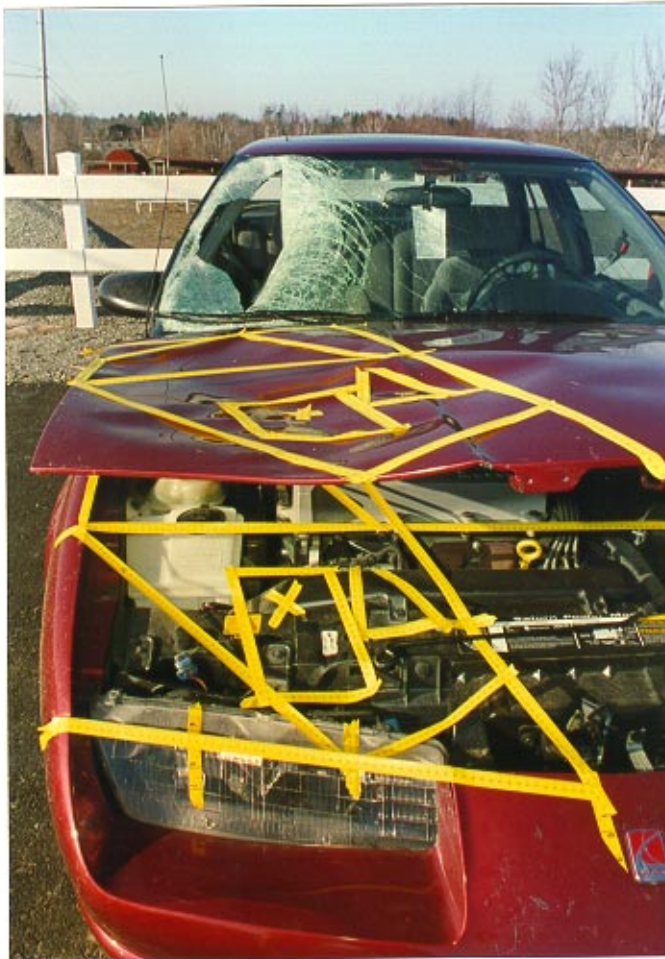
32. Bi-level view of the hood contact pattern and corresponding underhood components.

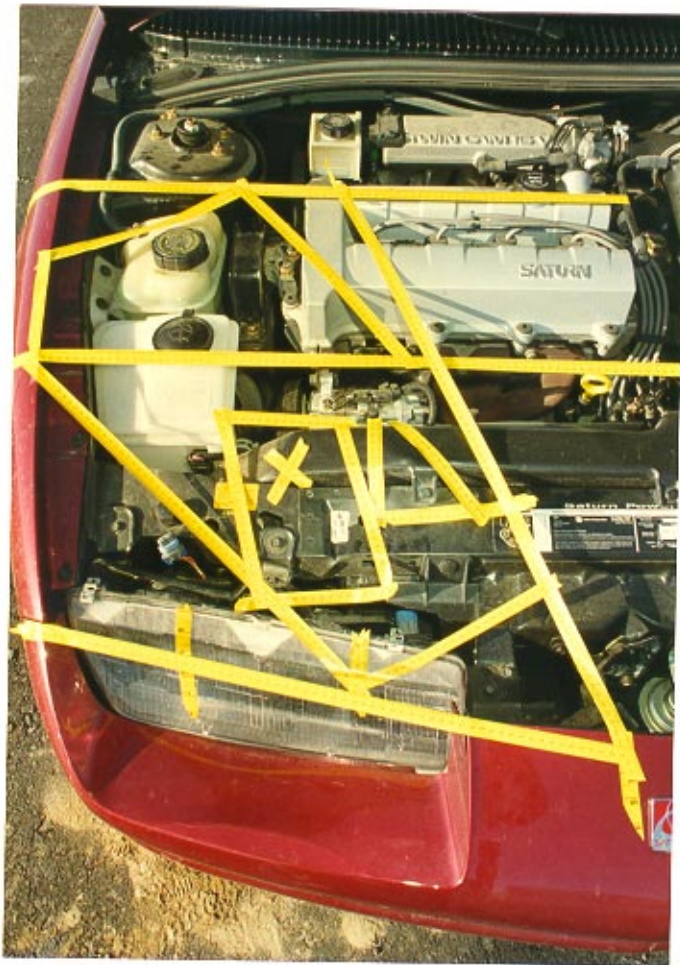
33. Overhead view of engine compartment components with an overlay mapping of pedestrian contact points.

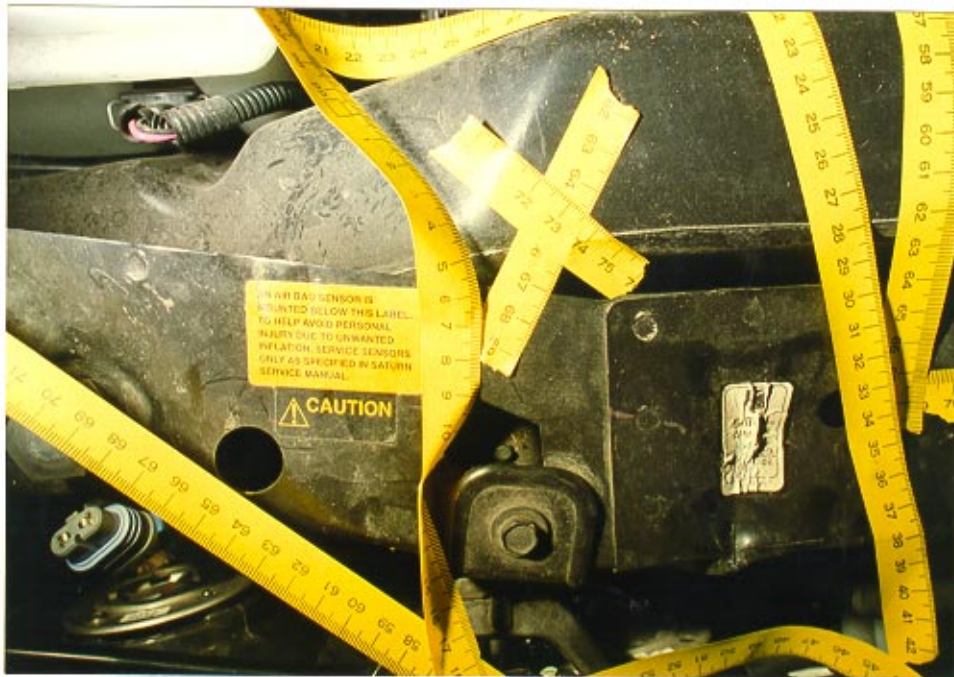
34. Close-up view of air bag discriminating sensor and radiator support damage.

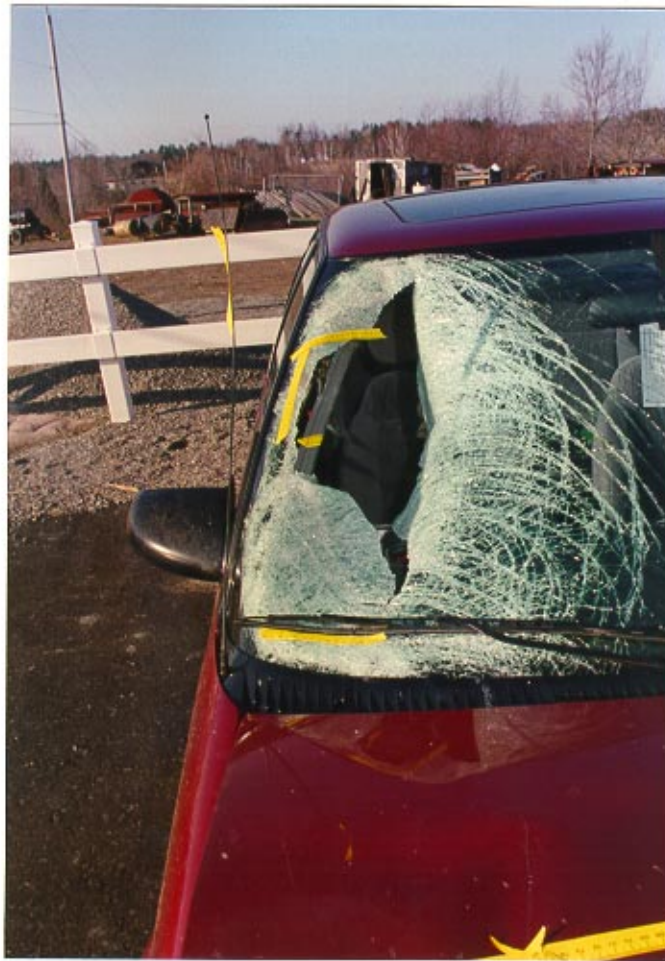
The pedestrian continued rearward along the hood and contacted the right windshield wiper blade with the right shoulder resulting in the rearward displacement of the wiper blade. The right side of her head then struck the windshield glazing which resulted in an abrasion of the right cheek. Her head penetrated the glazing and simultaneously struck the leading edge of the A-pillar. This contact resulted in a gaping laceration of the forehead, fracture of the frontoparietal bone, and laceration and hemorrhage of the brain. As the head continued into the interior of the vehicle, the nose contacted the glazing and A-pillar resulting in a laceration and comminuted fracture of the nasal bones. Simultaneous with the windshield contact, the pedestrian's left shoulder and chest contacted the radio antenna mounted on the top surface of the right front fender, bending it rearward.

35. View of windshield showing pedestrian contact points.

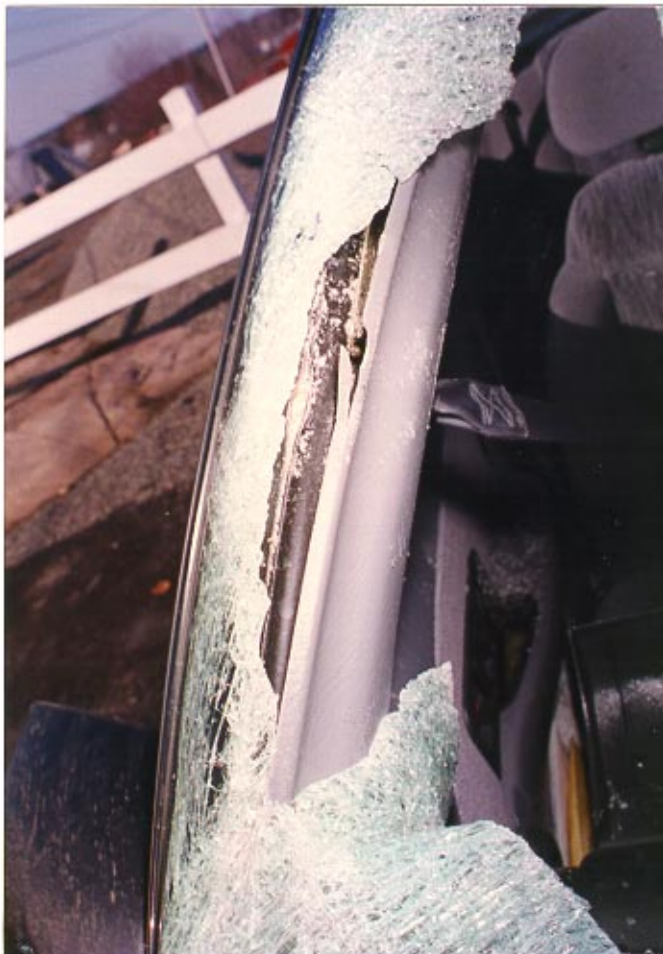
36. Close-up view of right A-pillar showing skull fragments from the pedestrian.

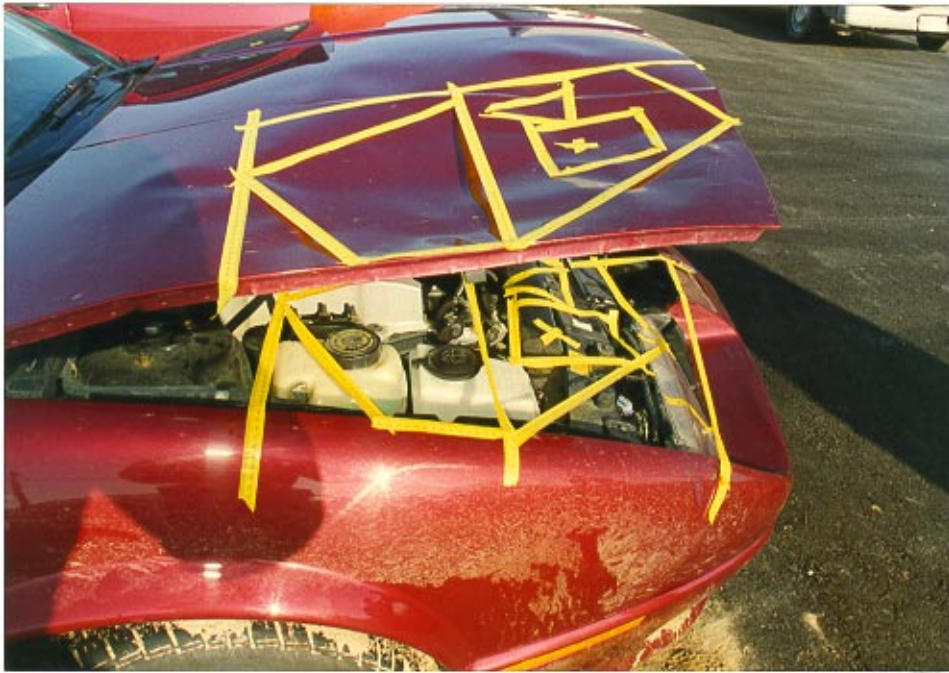
The third distinct pedestrian contact was a continuation of the first contact. This indentation measured 26.7 cm (10.5") in diameter with the center located 47.0 cm (18.5") rearward from the hood edge and 50.8 cm (20.0") right of the centerline. It measured 2.2 cm (0.9") deep and was attributed to contact by the pedestrian's upper torso. Numerous internal injuries were attributed to this contact including: fracture dislocation of the thoracic vertebra with complete severance of the spinal cord; laceration of the mesentery; avulsion of

37. Lateral view of hood contact evidence showing an overlay mapping of pedestrian contact points with underlying engine compartment components.

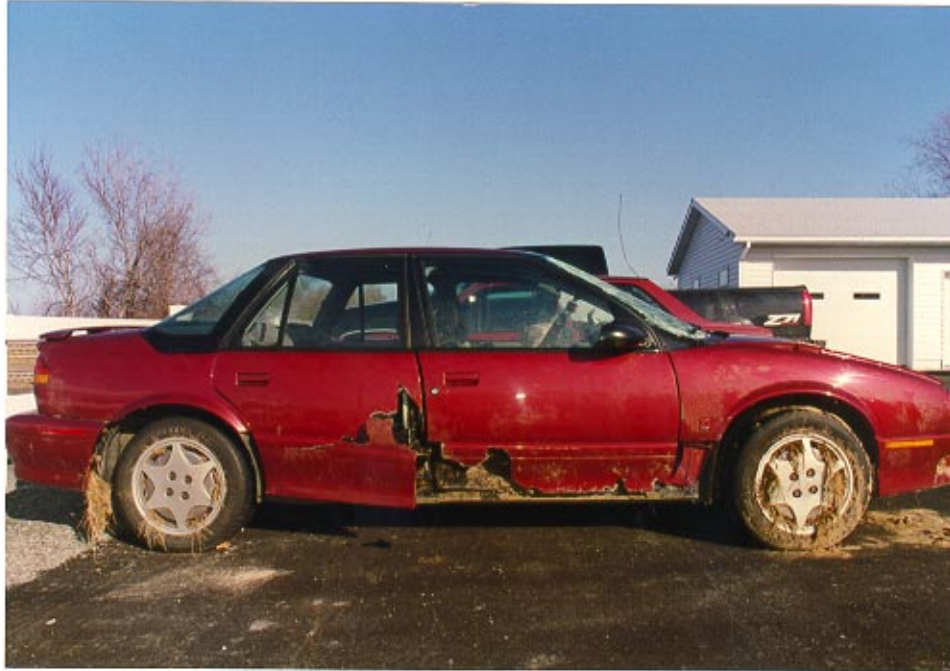
41. View of right side plane showing contact damage from utility pole guy wire and ditch.

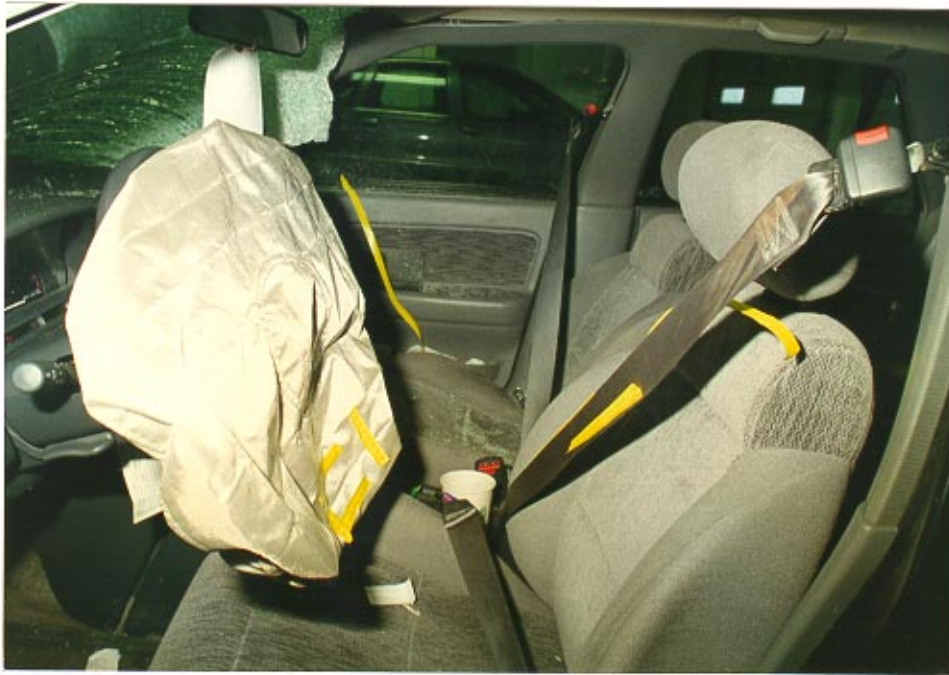
Tissue and bodily fluid deposits from the pedestrian were observed on the right front door surface and arm rest. These deposits were broadcasted diagonally over an area 7.6 cm (3.0") wide that began 27.9 cm (11.0") rearward from the instrument panel and extended 26.7 cm (10.5") from the belt line down to the armrest (refer to photographs #43, #44).

43. Lateral view of front seating area taken from the left side of the vehicle showing contact evidence on the shoulder belt and right front door surface.

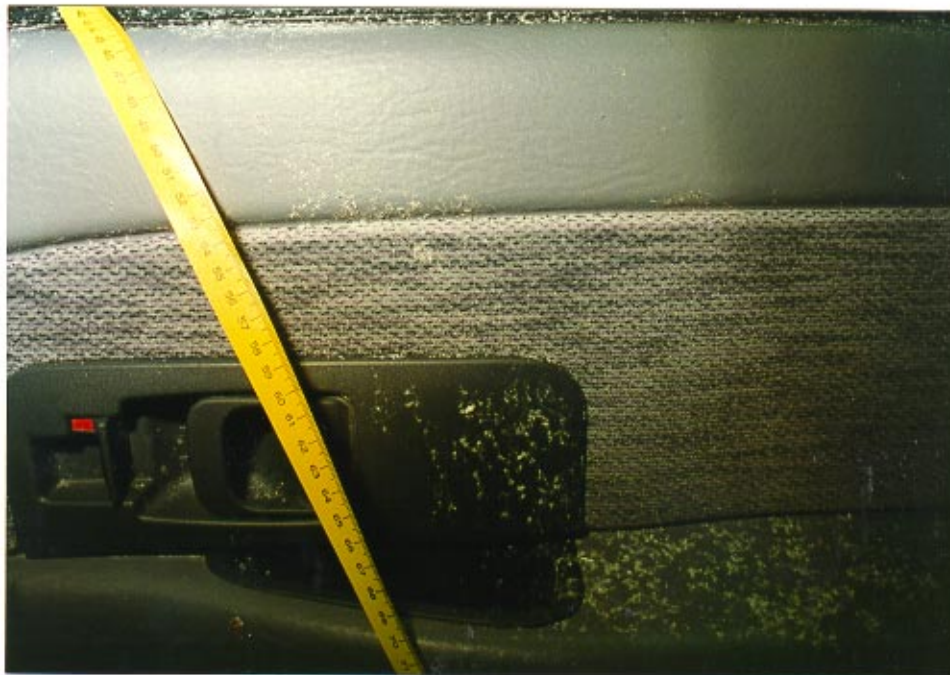
44. Close-up view of pedestrian's brain matter along the right front door surface.

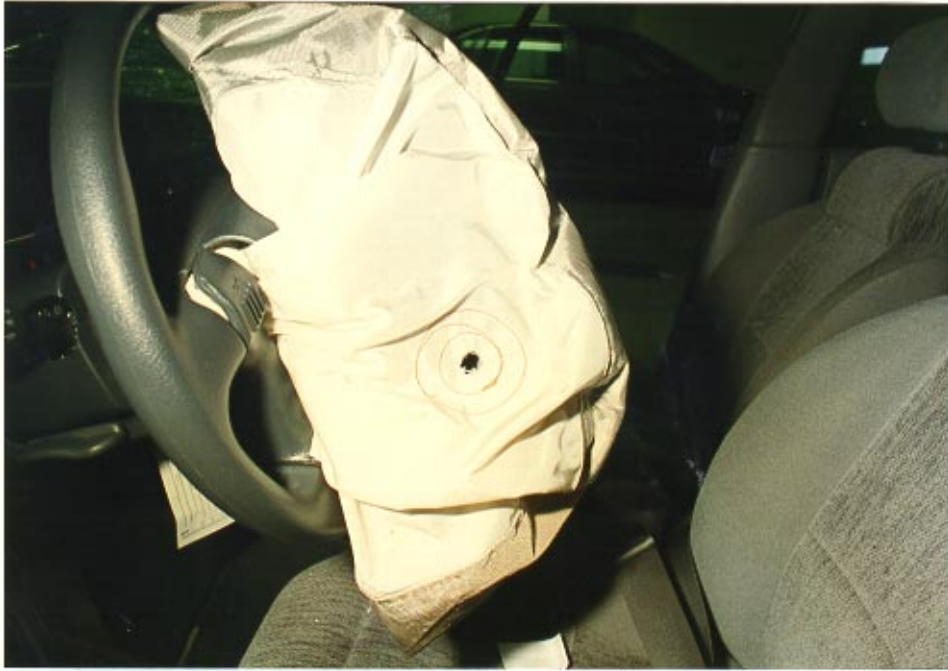
Vertical black striation marks were observed on the lower portion of the air bag which may have resulted from the interaction of the air bag fabric with the pliable fluted structure of the air bag module cover during the deployment sequence. This area measure 10.2 cm (4.0") wide and 4.4 cm (1.8") high and was located 15.9 cm (6.3") below the air bag center (refer to photograph #47 and slide #54).

47. View of the air bag left vent port.

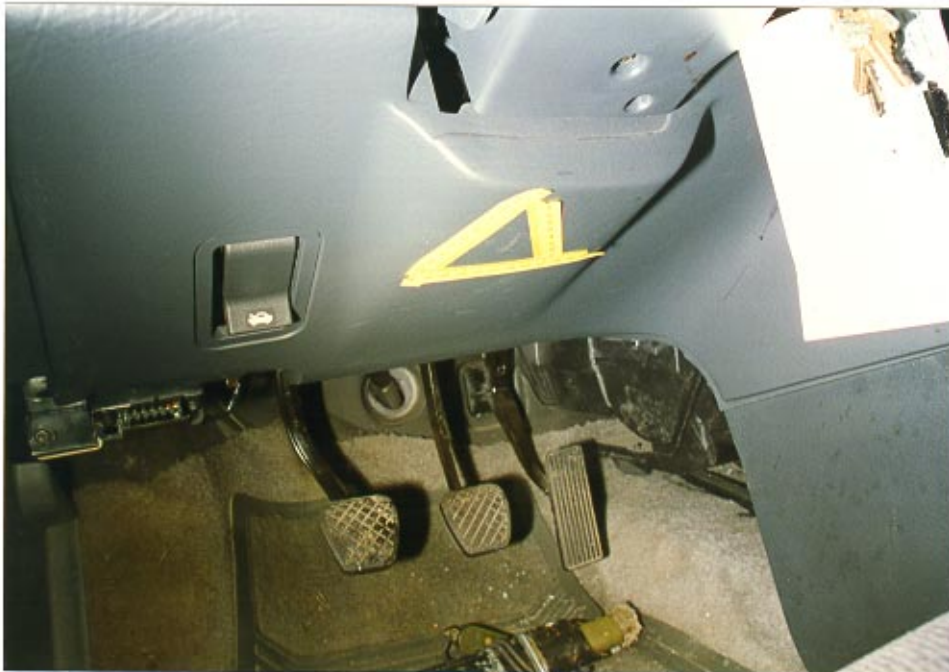
50. Scuff mark on the knee bolster by the driver's left knee.

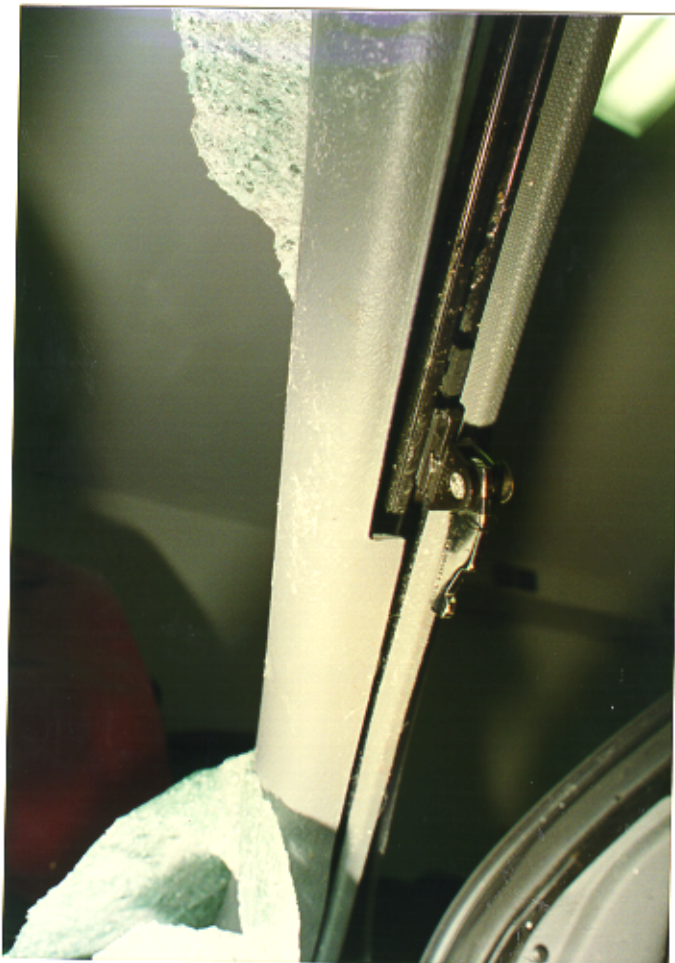
52. Close-up view of contact by the pedestrian's head on the right A-pillar cover.

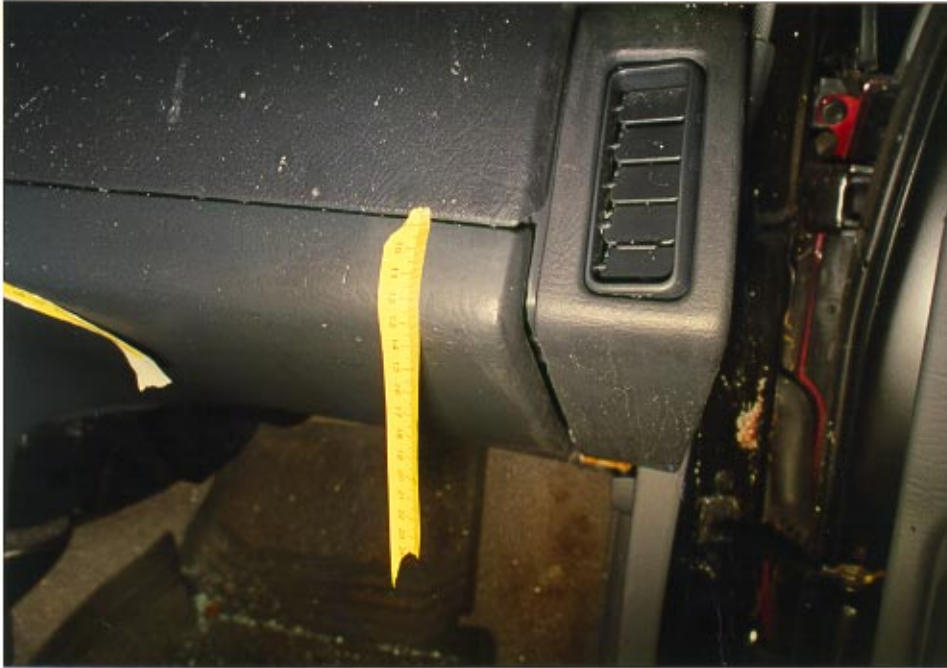
53. Close-up view of a right knee contact by the right front passenger along the lower edge of the instrument panel

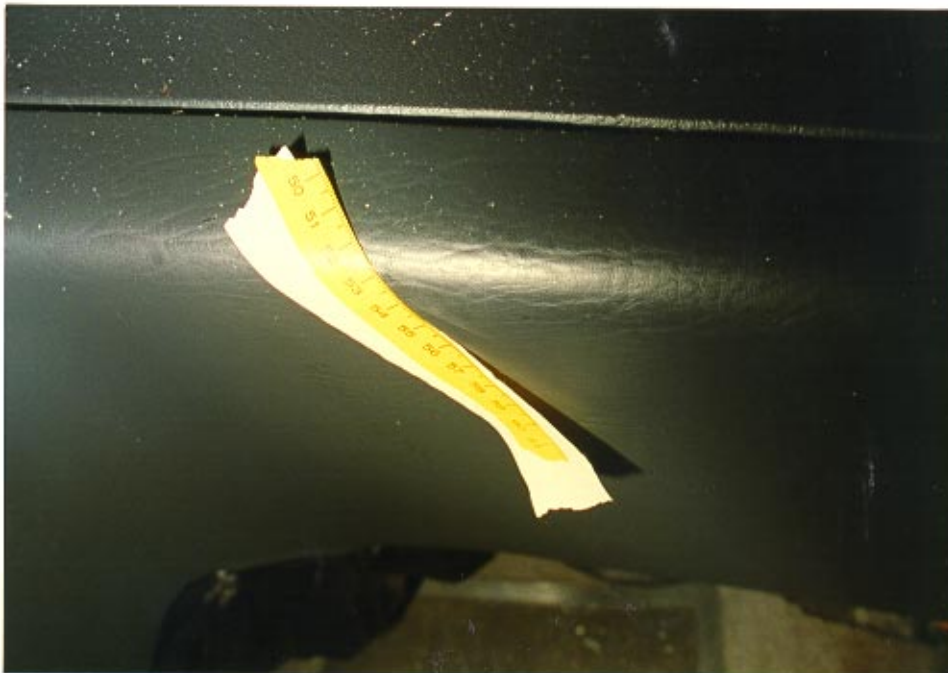
54. Scuff mark from the passenger's left knee.

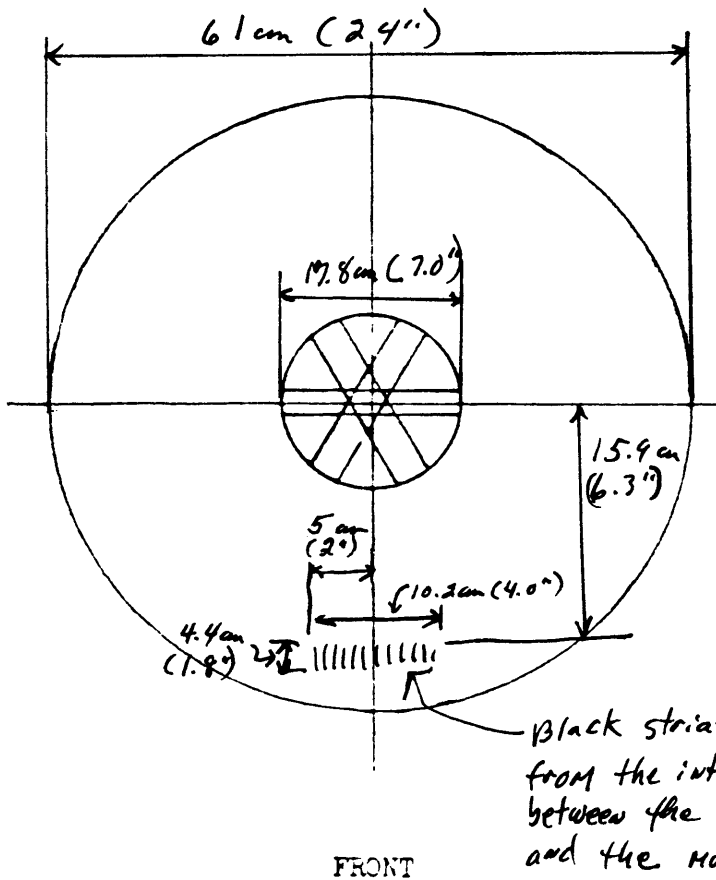
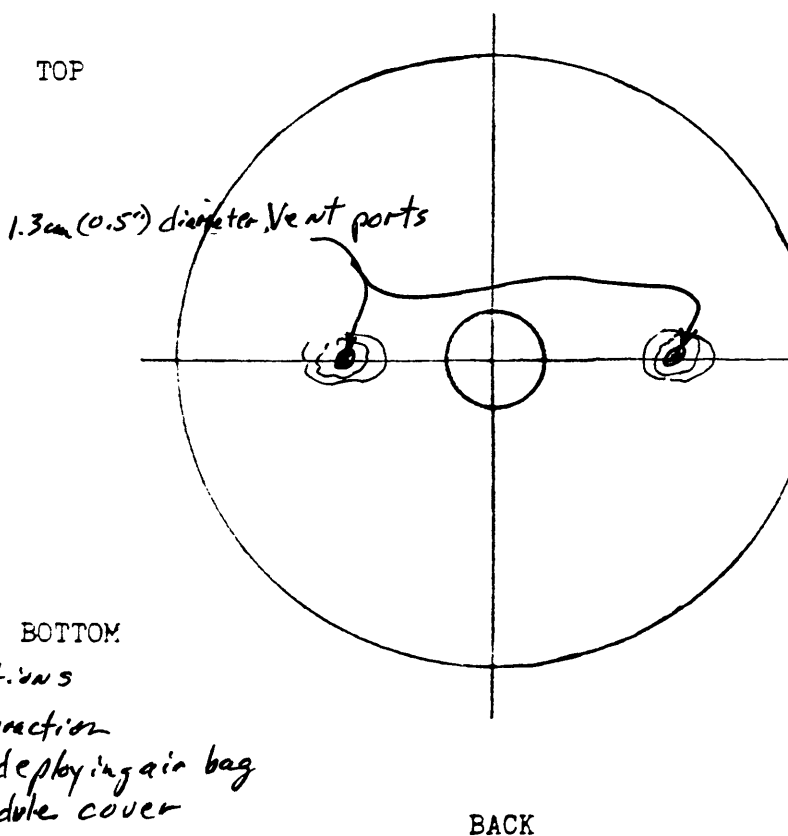
Black striations from the interaction between the deploying air bag and the module cover

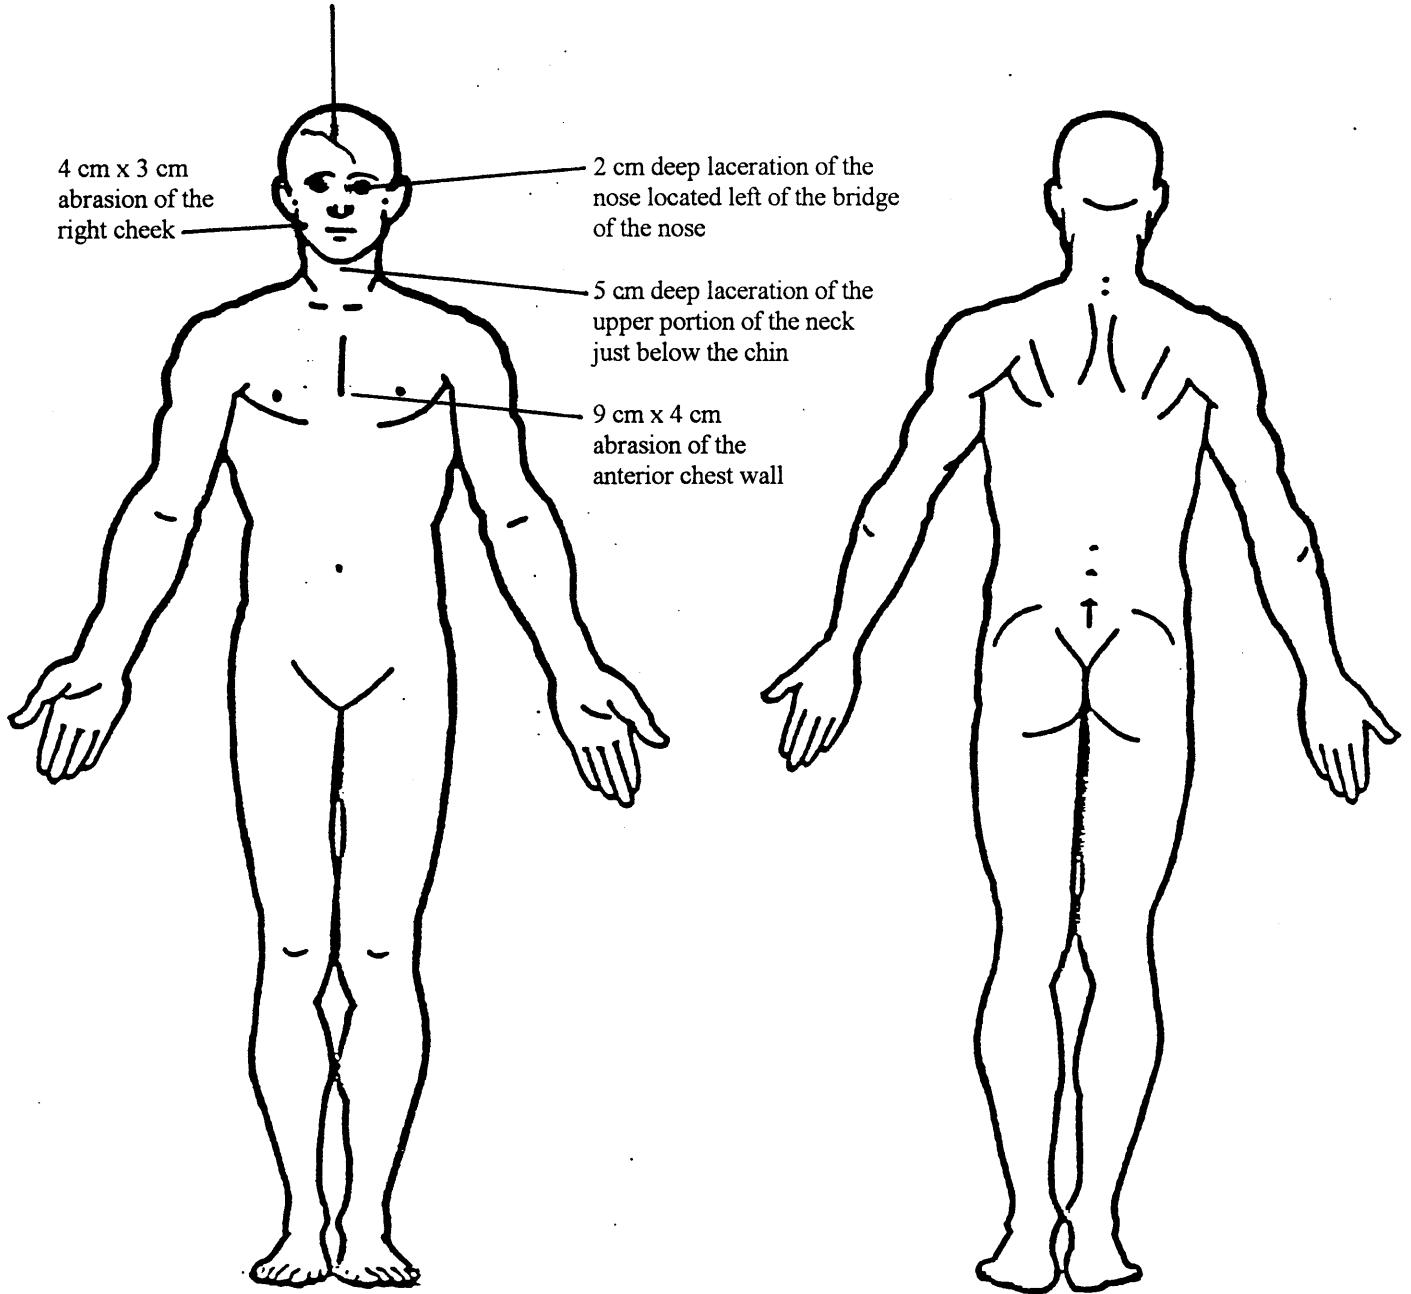
Case 94-17, [REDACTED], New York
Pedestrian Soft Tissue Injuries

Gaping laceration of the forehead which
extended in an upward arching pattern
from 2 cm left of the midline to 1 cm
lateral to the outer corner of the right eye
