**TRANSPORTATION SCIENCES CENTER  
ACCIDENT RESEARCH GROUP**

**CALSPAN ON-SITE AIR BAG DEPLOYMENT INVESTIGATION  
CALSPAN CASE NO. 94-25  
VEHICLE: 1990 MERCURY SABLE  
LOCATION: [REDACTED] MD  
CRASH DATE: [REDACTED] 1994**

U.S. Department of Transportation  
National Highway Traffic Safety Administration  
Washington, D.C. 20590

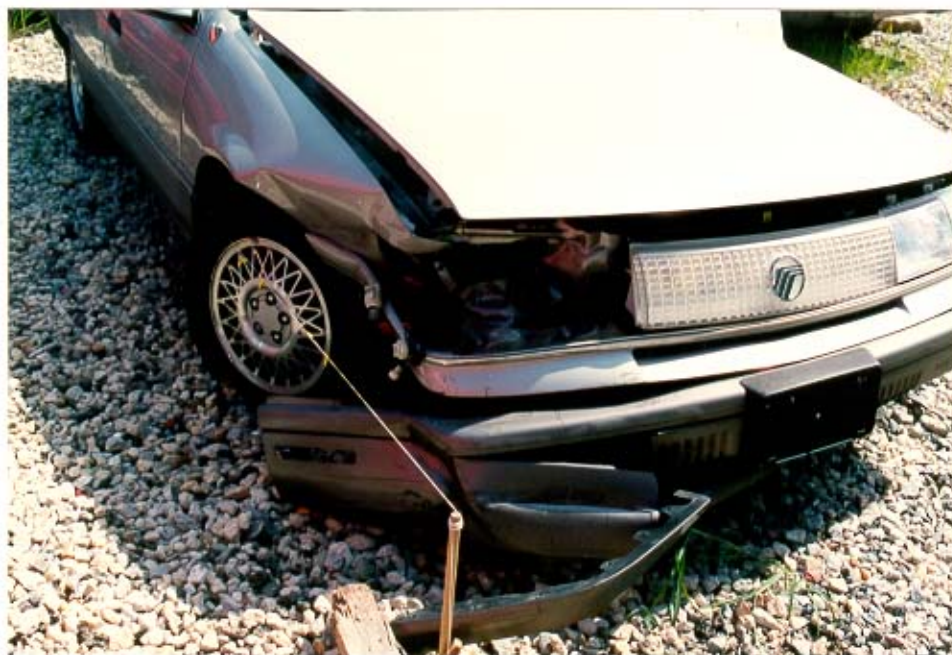
The 1990 Mercury Sable sustained moderate right side damage from the intersection related crash with vehicle #2. Maximum crush was 35.3 cm (13.9") located at the leading edge of the right front fender. Direct contact damage began 26.7 cm (10.5") forward of the right front axle and extended 49.5 cm (19.5") forward to the corner of the front bumper. The combined induced and direct contact damage was 64.8" (25.5") which began 14.0 cm (5.5") forward of the reference axle. Crush values at bumper level along the damaged right side of the vehicle were as follows: C<sub>1</sub> = 0 cm , C<sub>2</sub> = 15.2 cm (6.0"), C<sub>3</sub> = 21.8 cm (8.6"), C<sub>4</sub> = 30.2 cm (11.9"), C<sub>5</sub> = 35.3 cm (13.9"), C<sub>6</sub> = 30.2 cm (11.9").

11. Impact damage to the right front side area.

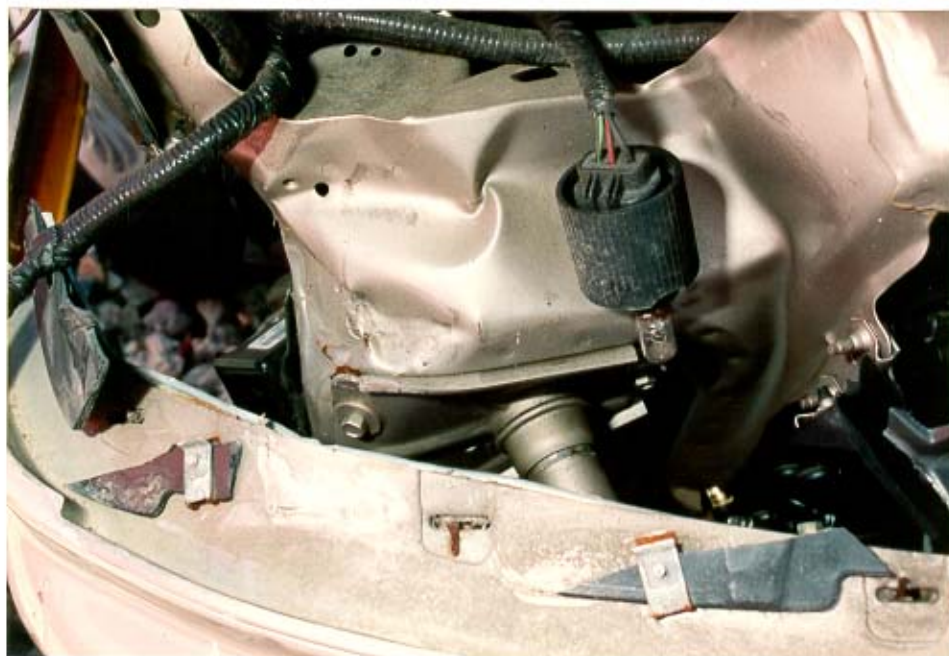
The 2 o'clock impact force displaced the right front fender and its related components laterally to the left and compressed the right bumper energy absorbing device 0.6 cm (0.25"). Components damaged by the crash included the right front fender, right headlamp assembly, front bumper fascia, bumper valance, and the header panel.

12. Lateral displacement of the bumper and bumper isolator.

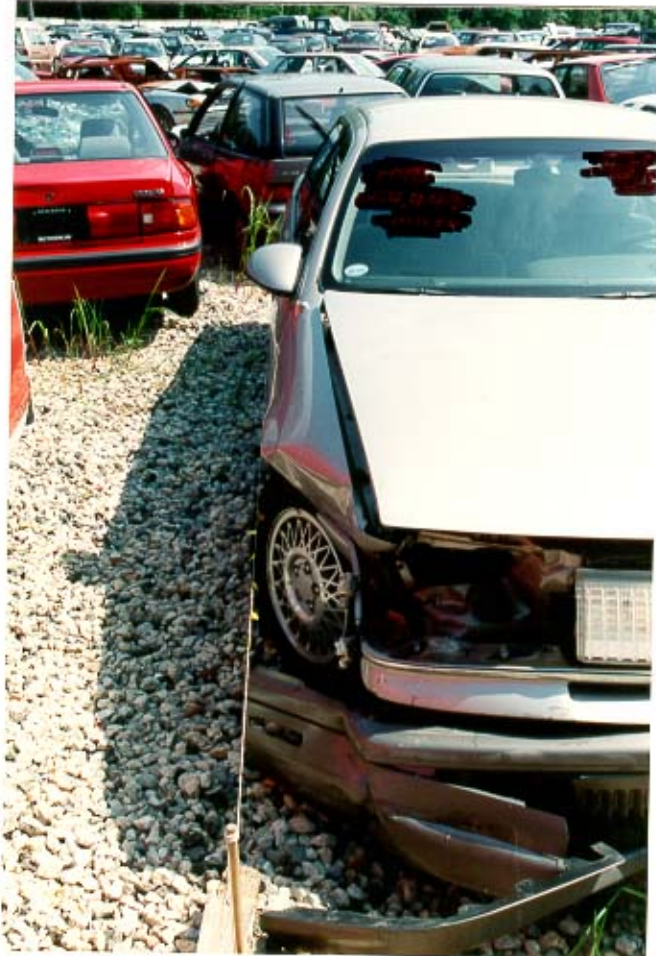
13. Lateral displacement of the impact area.

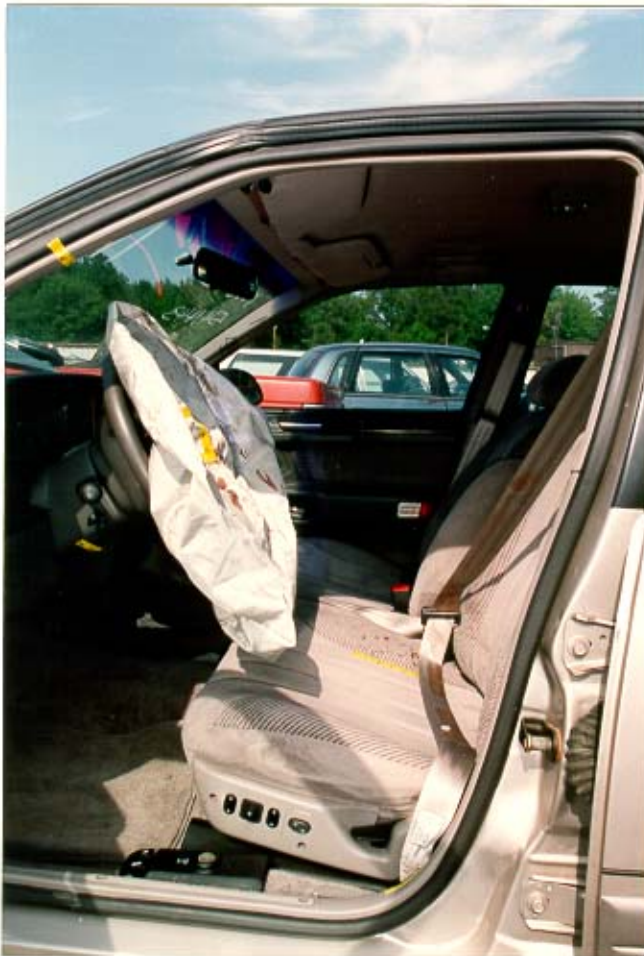
17. Overall view of the driver's compartment and the deployed air bag.

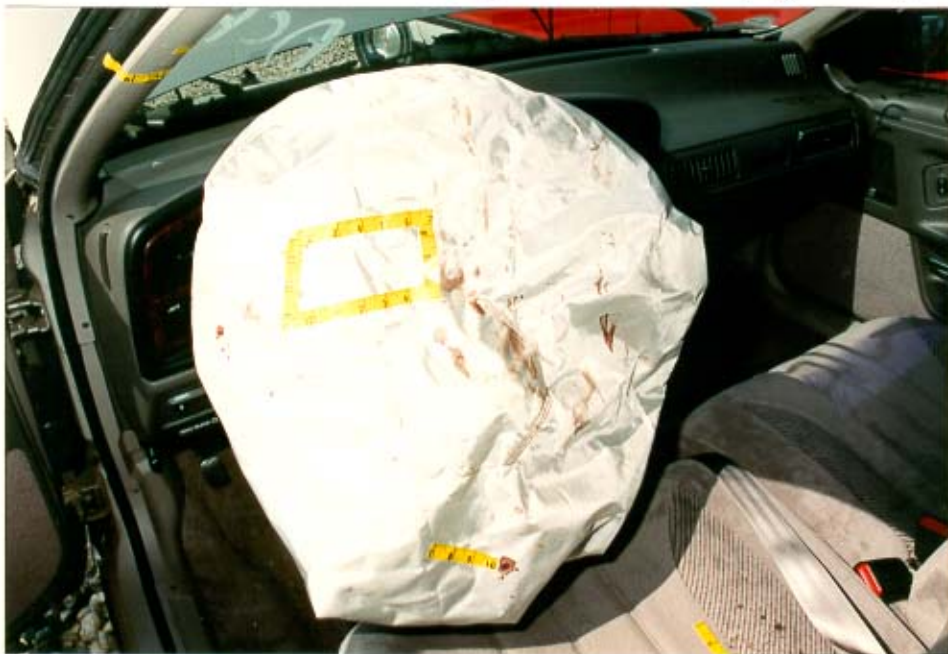
The deploying air bag contacted and expanded across the driver's face. The bag compressed the driver's metal framed eyeglasses against her face which fractured the nasal and septal bones. In addition, the plastic eyeglass lenses shattered as a result of air bag contact. The air bag and eyeglass contact resulted in numerous injuries to the eyes which included multiple small conjunctival lacerations with hemorrhage, right corneal abrasions, bilateral hyphema, right pupil distortion, and bilateral iris injuries.

18. Driver contact points on the deployed air bag.

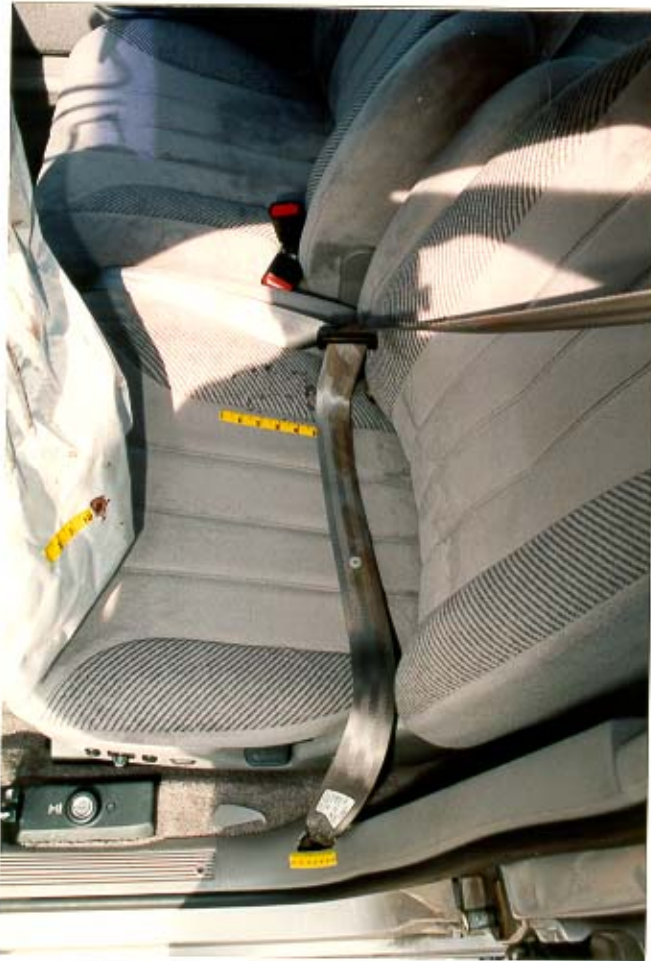
The blood stains on the belt webbing began 16.5 cm (6.5") below the latchplate stop button and extended 90.2 cm (35.5") above the stop on both the outside and inside surfaces of the webbing. These stains, in combination with the fractured trim panel verified belt usage at the time of the crash. With the belt in the retracted position, the majority of the stains were concealed by the B-pillar trim panel.

20. Blood transfers on the seatbelt webbing.

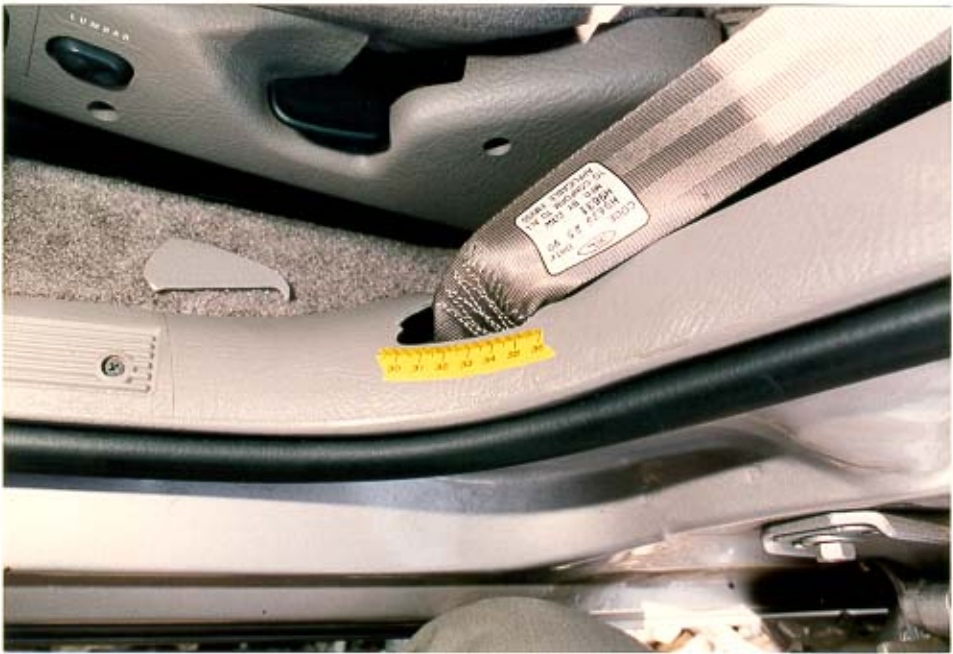
The driver initially loaded the manual 3-point lap and shoulder belt system as she responded to the right side impact force. Her loading force against the belt webbing fractured the plastic sill trim panel at the inboard edge of the lap belt anchorage point. The driver's subsequent contact with the deploying air bag produced two areas of abrasion to the face of the bag at the upper right and lower right quadrants. She subsequently bled profusely from facial injuries onto the deployed air bag, seat belt webbing, and left front seat cushion.

21. Belt loading fracture to the plastic sill trim.

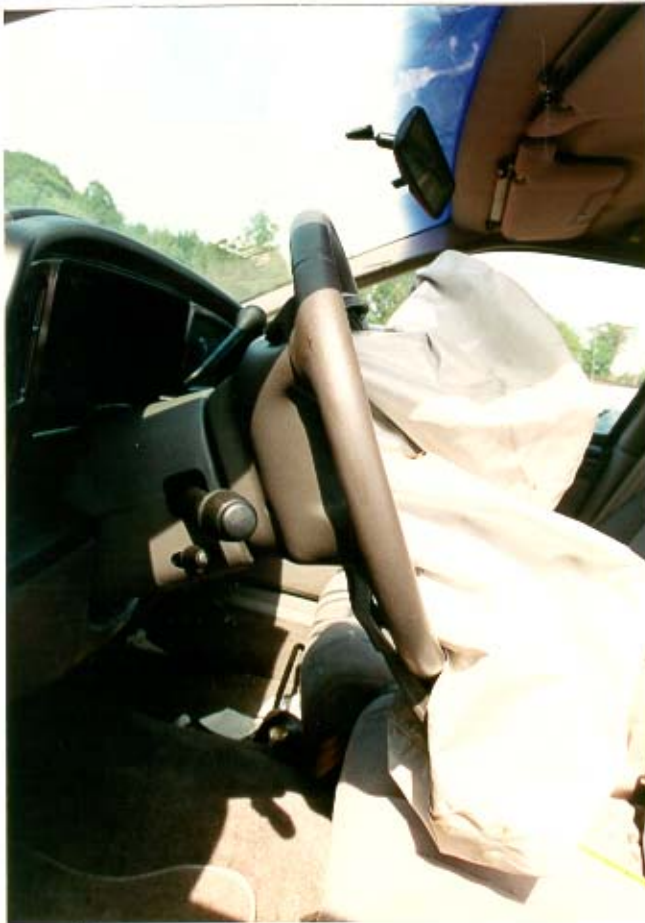
22. Profile view of the steering wheel; no deformation.

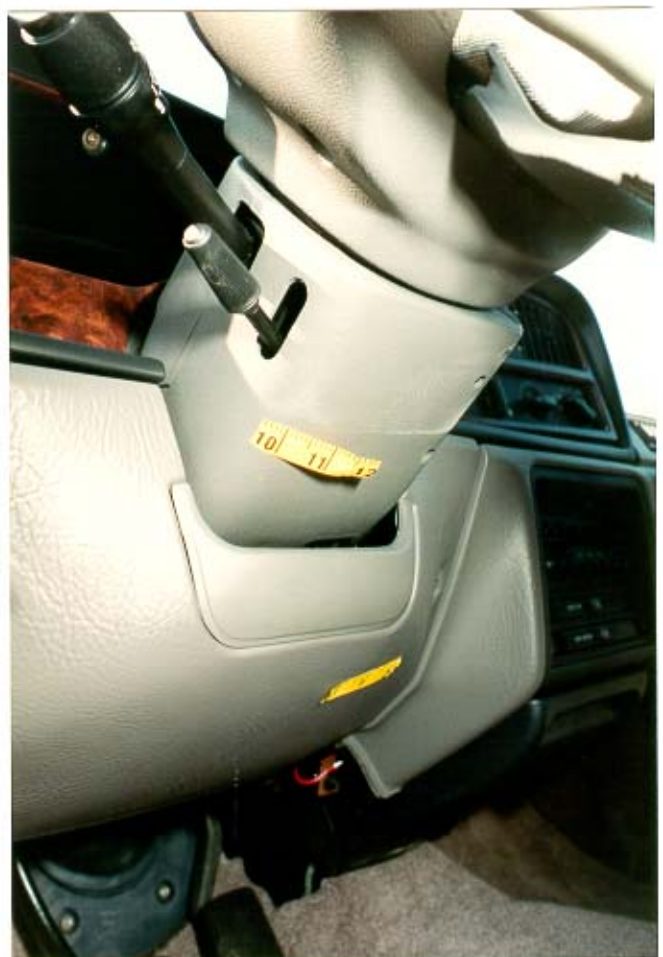
Due to the driver's forward position, her knees contacted the steel knee bolster and the plastic steering column cover. Two small areas of scuff marks were noted to these components which produced a hematoma to her right knee. The driver also complained of pain over both heels from probable contact with the floor pan.

24. Driver knee loading to the steering column cover and bolster.

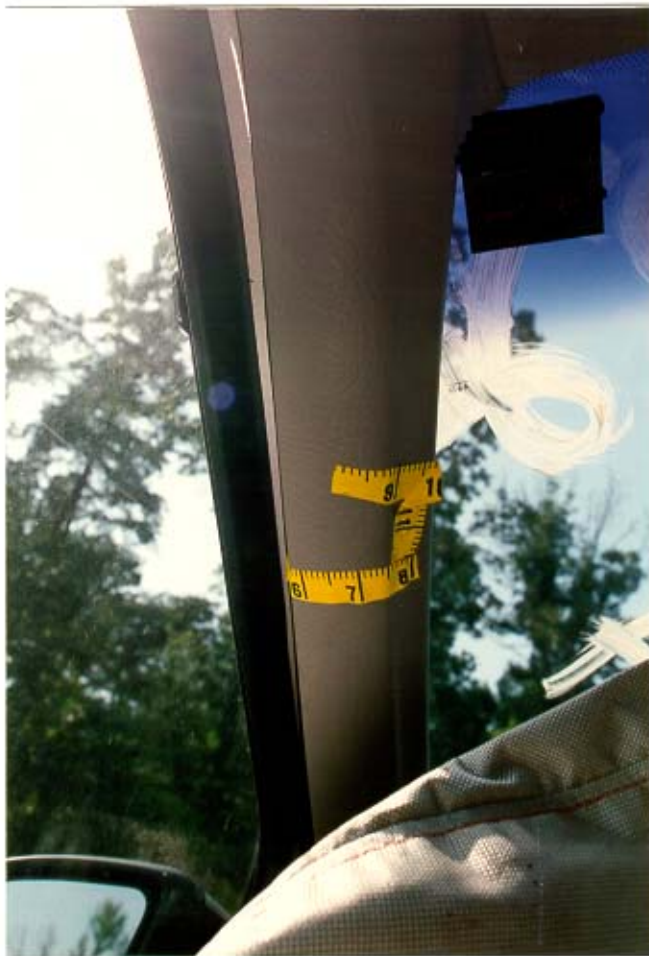
25. Driver left hand contact to left A-pillar.

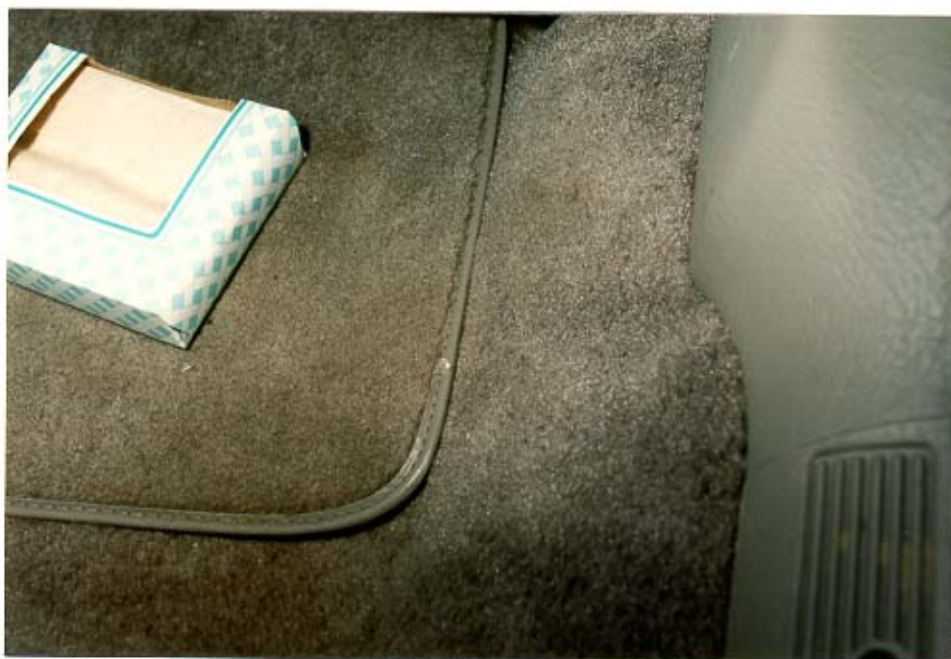
27. Eyeglass plastic lens fragment on the right rear floor mat.

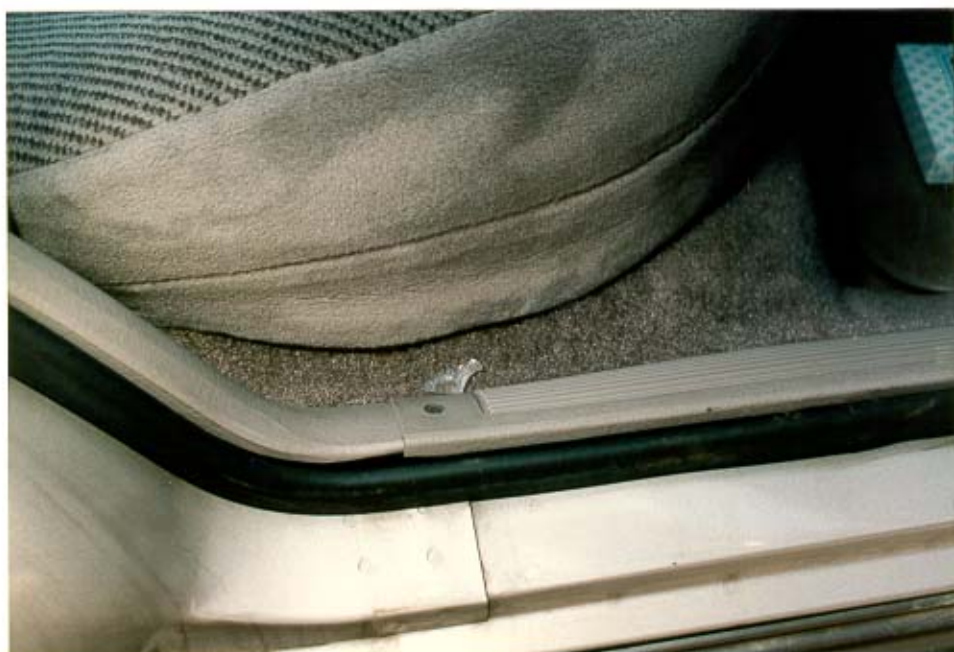
28. Large eyeglass lens fragment adjacent to base of left C-pillar.

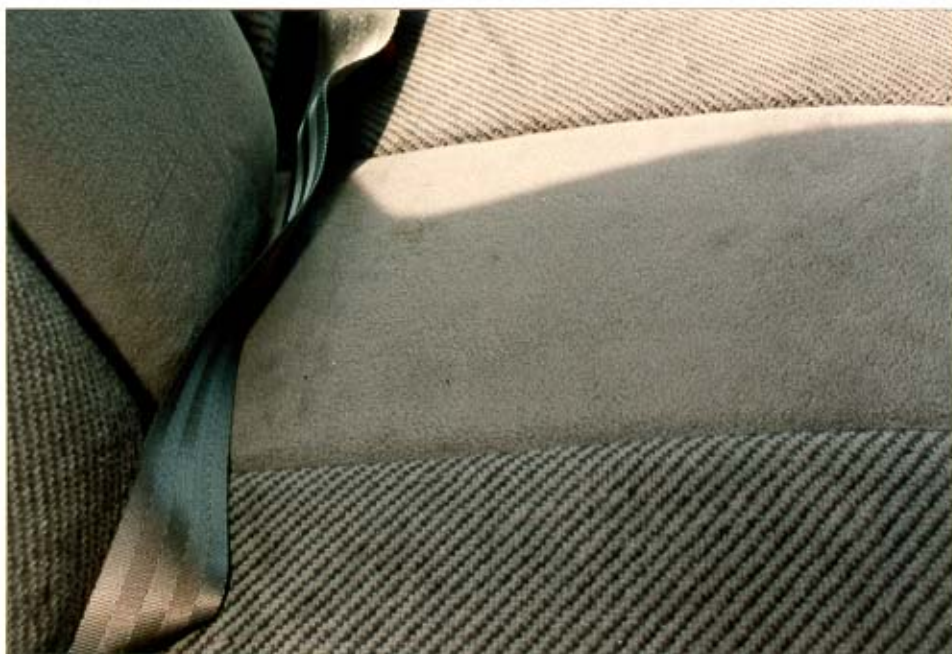
29. Addition lens fragment on center rear seat cushion.

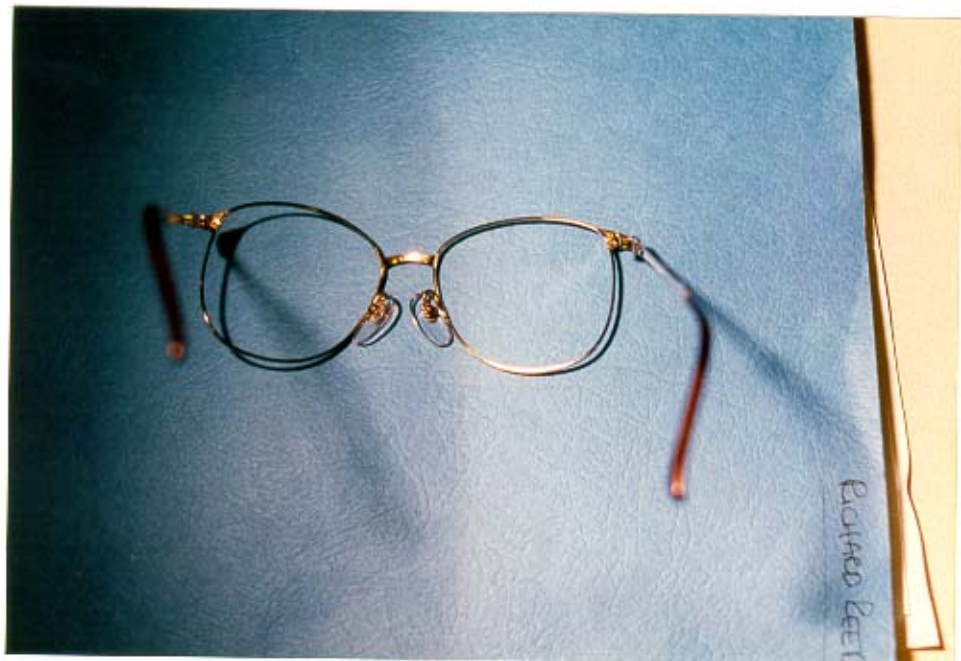
30. Deformed eyeglass frames from air bag involvement.

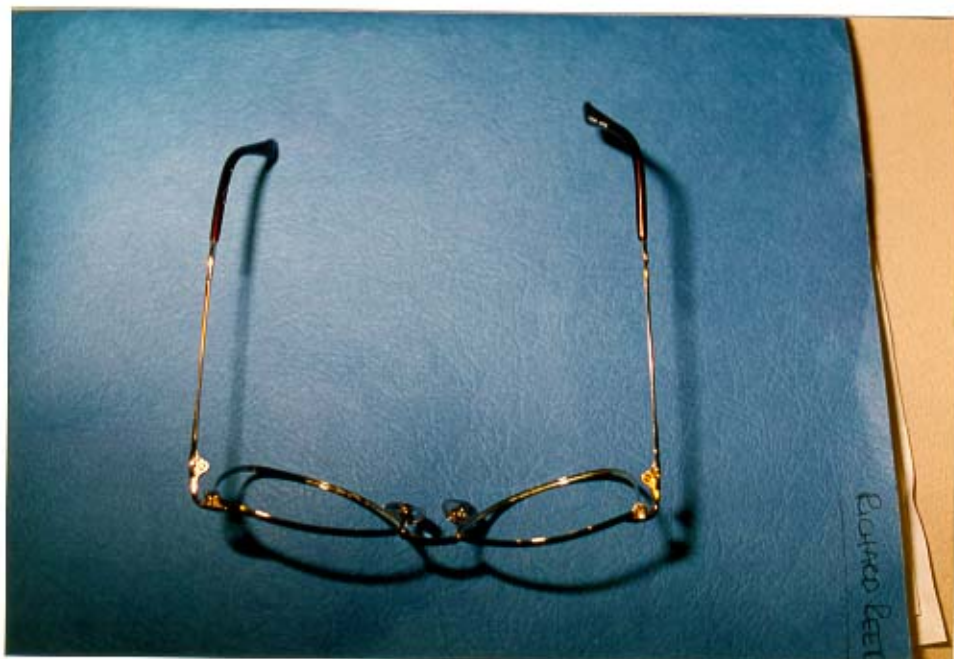
31. Additional view of the deformed metal eyeglass frames.

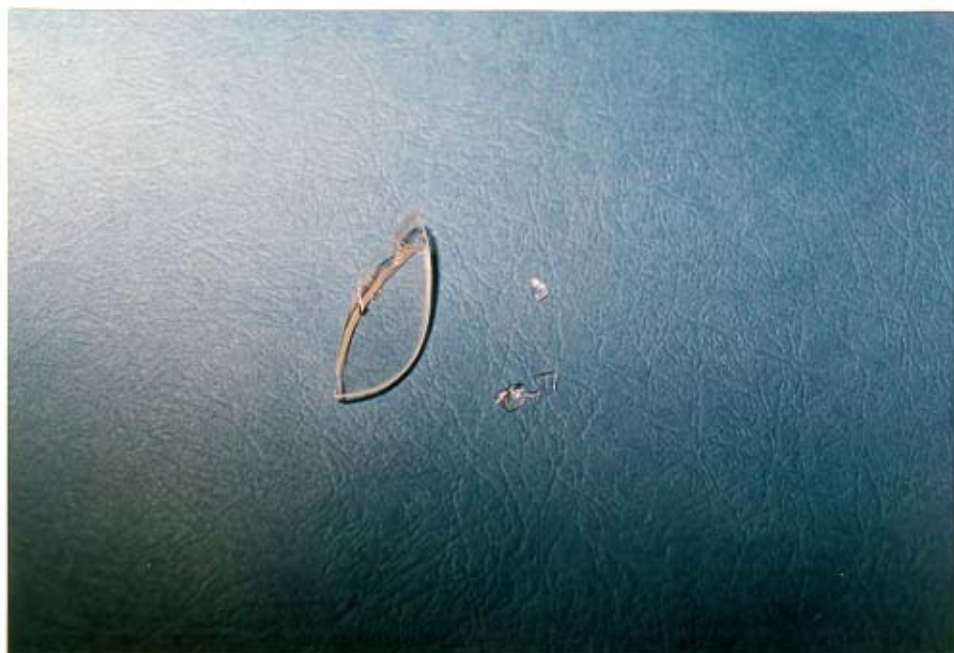
32. Shattered plastic lens fragments recovered from vehicle by family members.

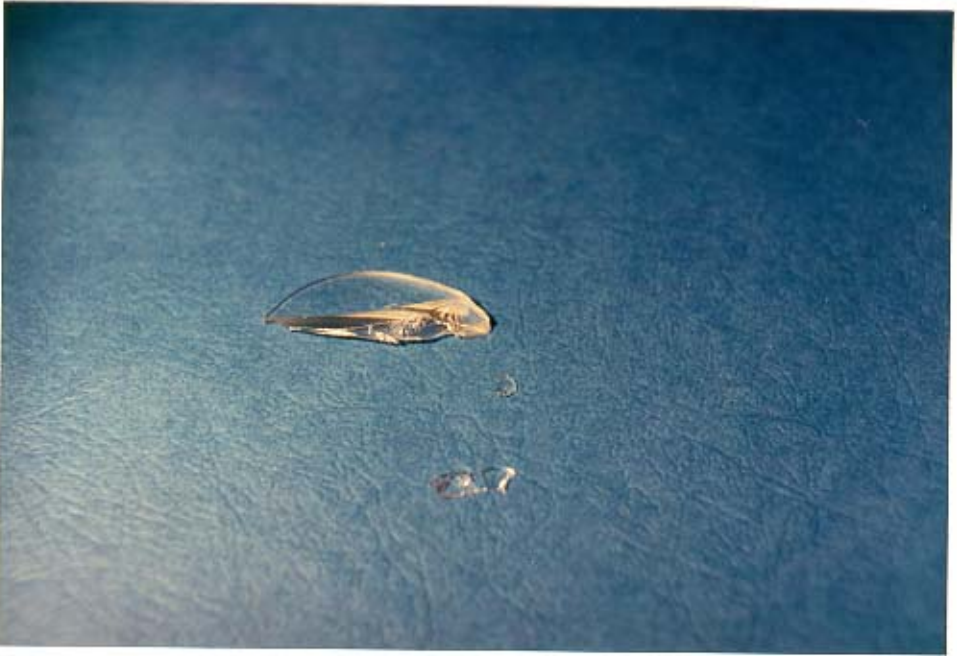
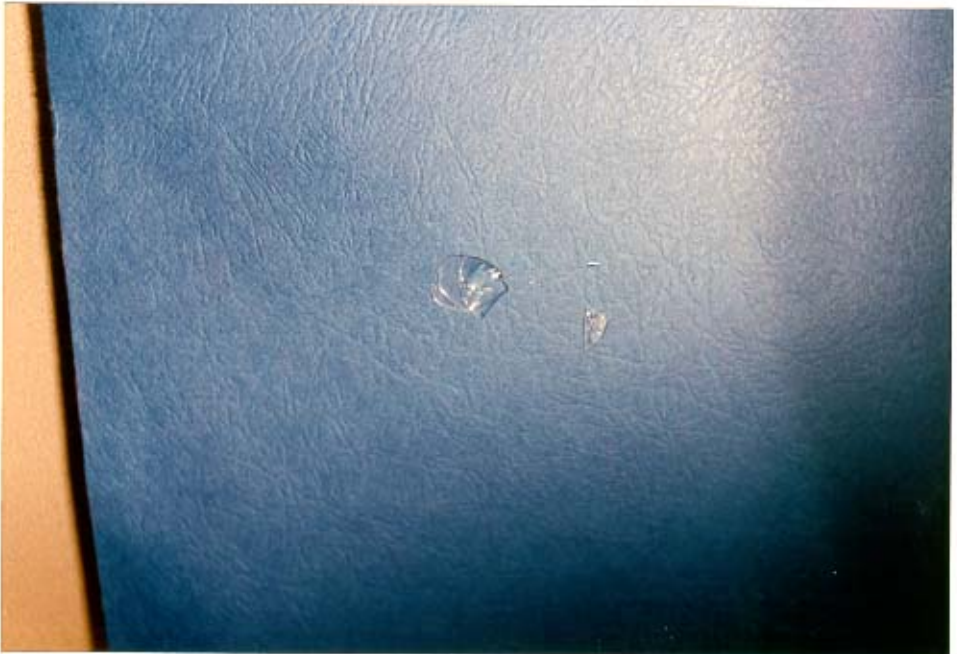
33. & 34. Additional views of the plastic eyeglass lens fragments.
