**CALSPAN ON-SITE AIR BAG DEPLOYMENT INVESTIGATION  
CALSPAN CASE NO. 94-30  
VEHICLE: 1991 MERCURY GRAND MARQUIS  
LOCATION: [REDACTED], FL  
DATE: [REDACTED] 1994**

14. <i>Sponsoring Agency Code</i>	
15. <i>Supplementary Notes</i> On-site investigation of an air bag deployment crash that resulted in a fracture and dislocation of the driver's right forearm.

**SELECTED PRINTS**  
**CASE NO. 94-30**  
**[REDACTED], FL**

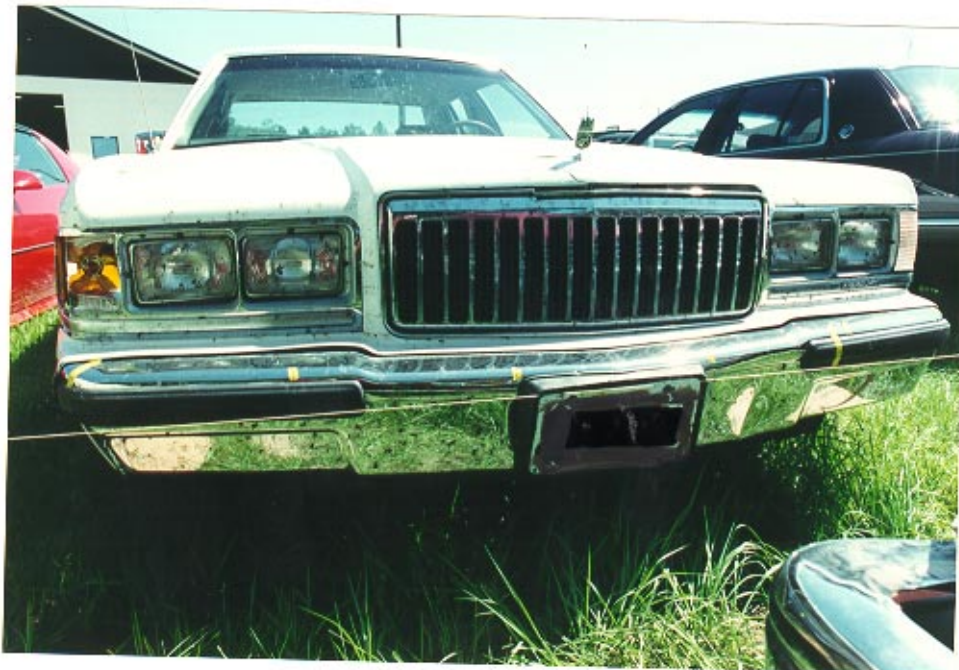
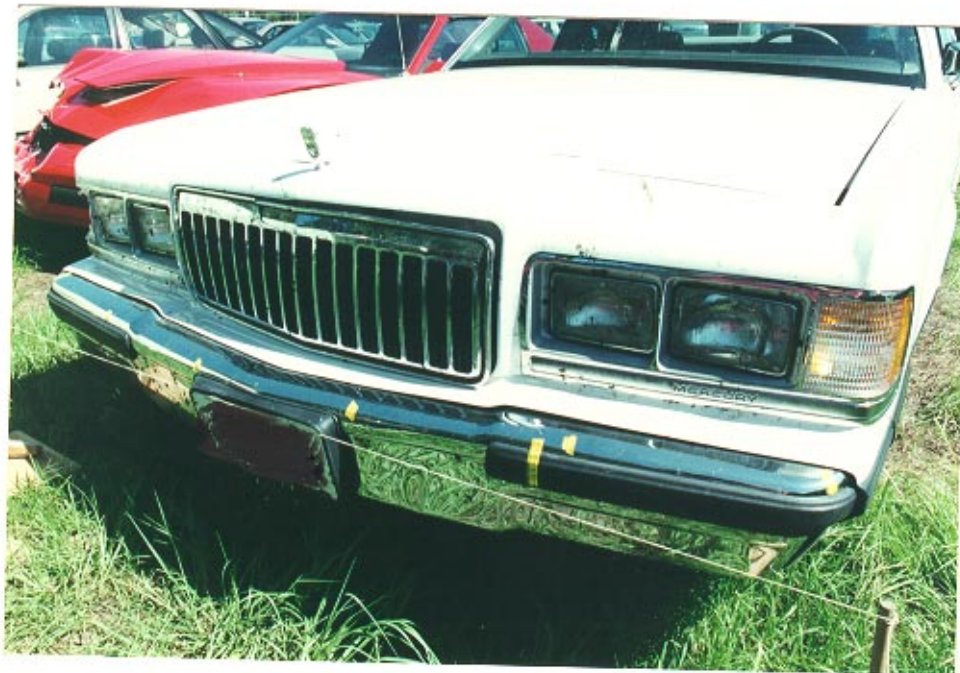
Damaged components included a dented bumper, an abraded bumper rub strip, deformed license plate, cracked plastic grille, fractured header panel, fractured right parking light lens, and a small diameter dent on top of the right front fender at the leading edge. There was no door or glazing damage.

9. & 10. Minor impact damage to the frontal area of the Grand Marquis.

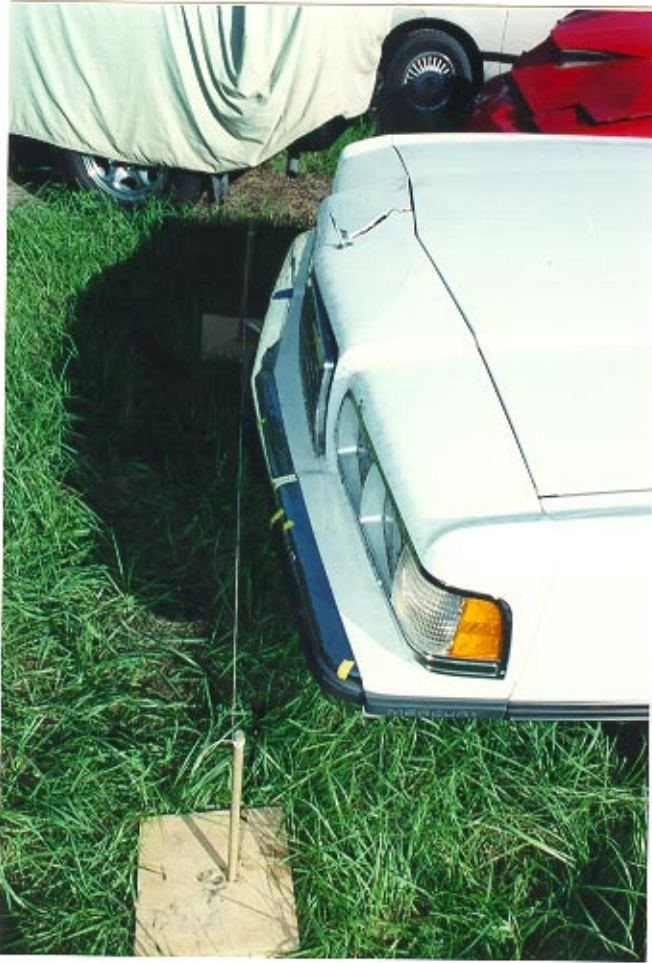
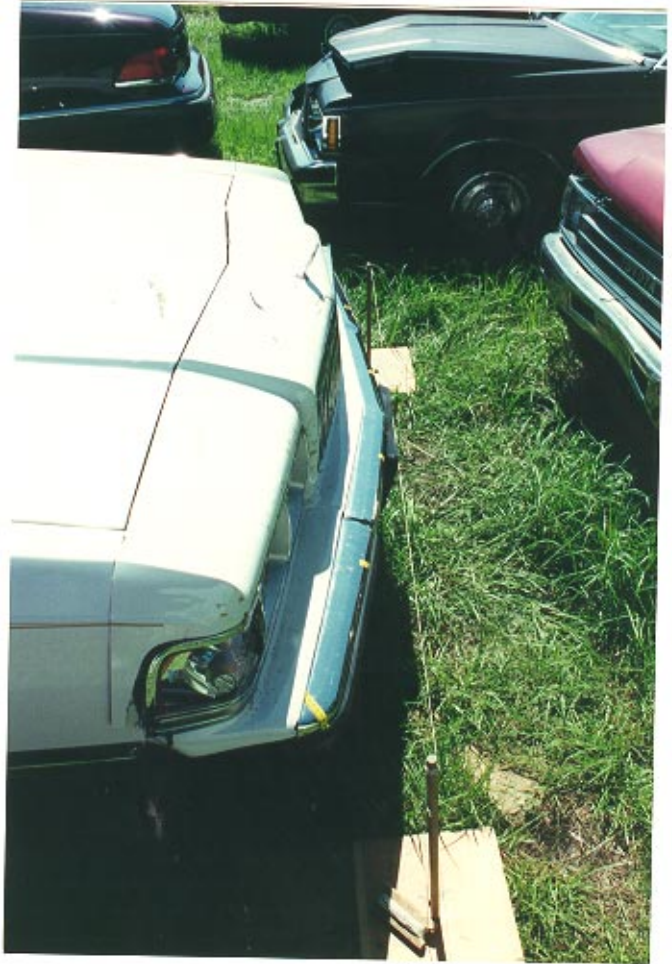
The 1991 Mercury Grand Marquis sustained minor frontal damage from its impact sequence with Honda Accord. Direct contact damage began 48.90 cm (19.25") left of center on the rub strip and extended 136.53 cm (53.75") to the right front corner. There was minimal residual crush at bumper level, however, the energy absorbing devices compressed 5.3 cm (2.1") and returned to the original pre-crash length of 6.6 cm (2.6"). Maximum residual bumper crush was 1.5 cm (0.6") located at the right corner. The crush profile at bumper level was as follows:  $C_1 = 0.3$  cm (0.1"),  $C_2 = 0.3$  cm (0.1"),  $C_3 = 0.3$  cm (0.1"),  $C_4 = 0.3$  cm (0.1"),  $C_5 = 0.6$  cm (0.25"),  $C_6 = 1.5$  cm (0.6").

13. & 14. Profile views of the frontal area showing the minor severity impact damage.

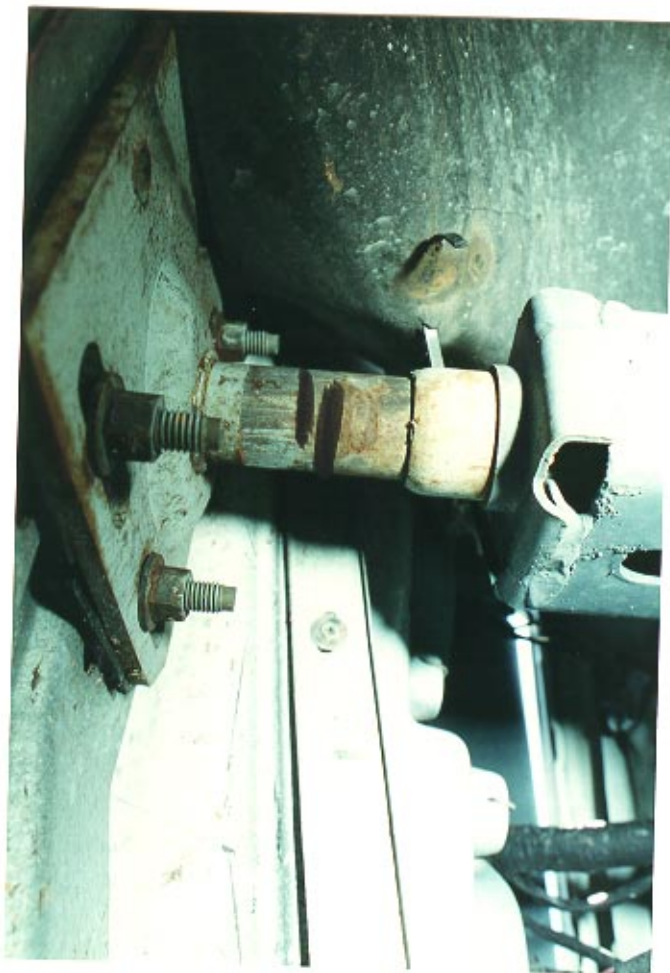
1.5 cm (0.6") at the right corner of the front bumper. Both front bumper energy absorbers compressed 5.4 cm (2.1") and returned to the original pre-crash length of 6.6 cm (2.6"). Damaged components included the front bumper, the license plate and frame assembly, grille, header panel, and the right front fender. There was no damage to the glazing or to the interior components, and no passenger compartment intrusion.

15. Compression of the left front bumper energy absorbing device.

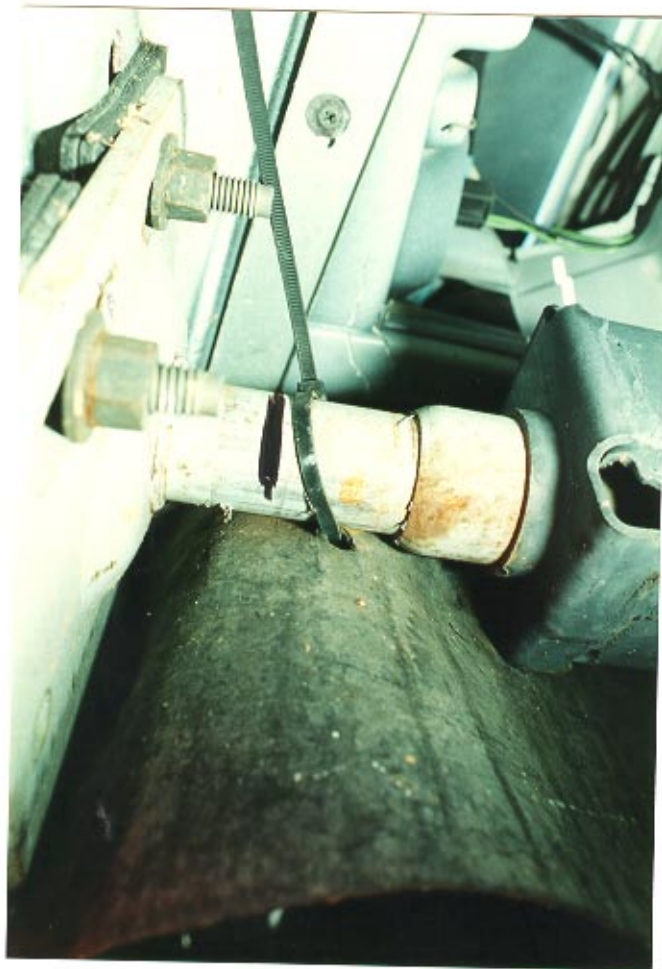
16. Compression of the right front bumper energy absorbing device.

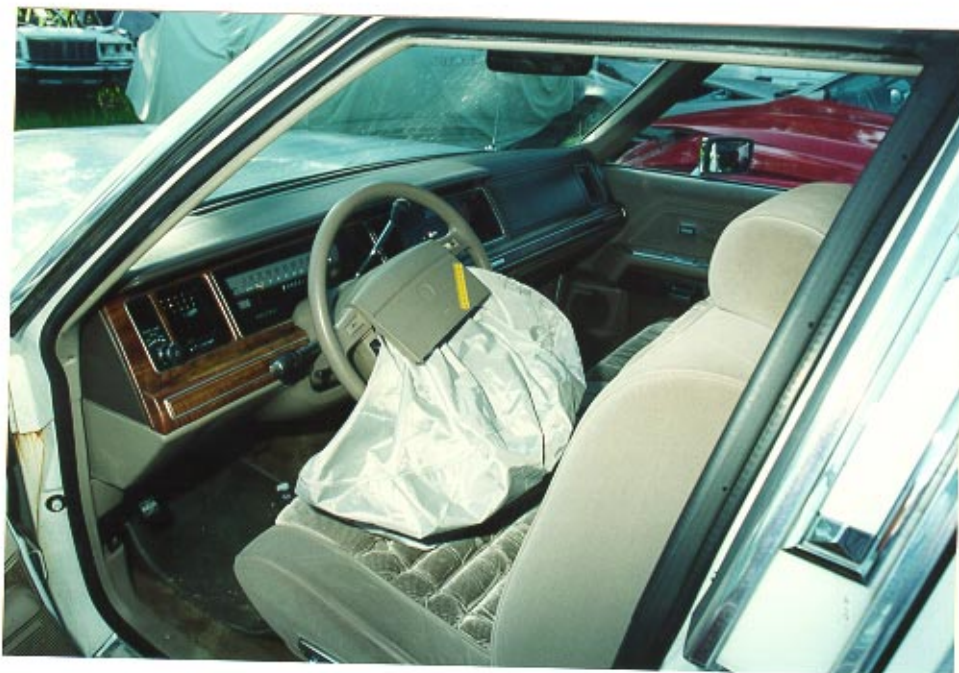
20. Overall interior view and the deployed driver's side air bag.

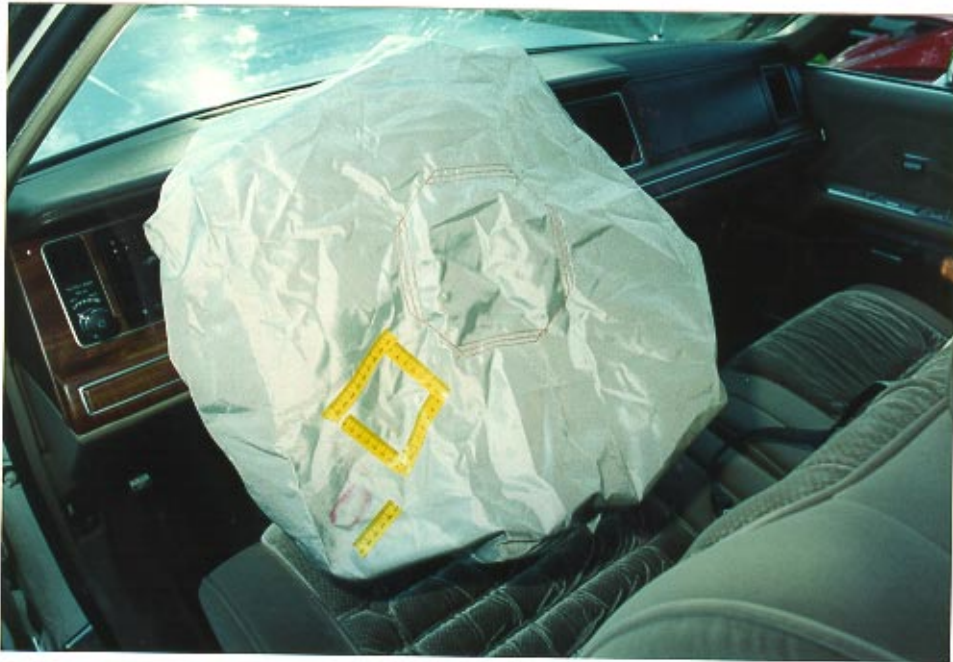
The steering wheel mounted air bag module trim cover opened at the designated tear points in an asymmetrical H-configuration. The cover flaps were hinged at the 12 and 6 o'clock positions. The large upper module cover flap measured 20.3 cm (8.0") in width, 12.4 cm (4.875") in height, and 7.9 mm (5/16") in thickness. The lower cover flap had respective measurements of 20.3 cm (8.0") and 3.5 cm (1.375"). There was no damage or occupant contact evidence to the module cover flaps.

23. Overall view of the deployed driver's side air bag.

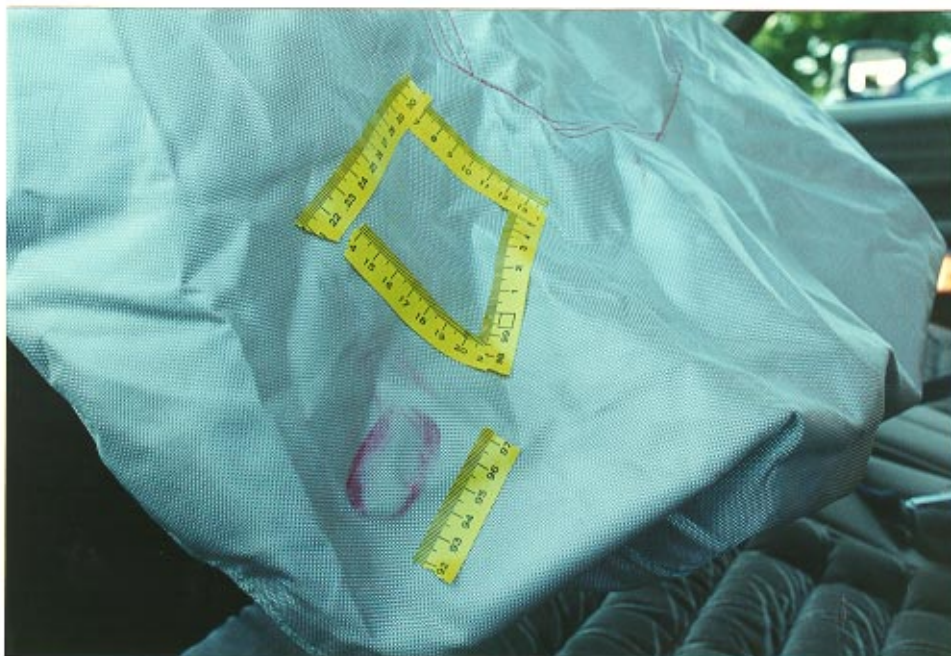
The air bag module cover opened at the designated tear points in an asymmetrical H-configuration. The large upper flap measured 20.3 cm (8.0") horizontally and 12.4 cm (4.875") vertically while the lower flap had respective measurements of 20.3 cm (8.0") X 3.5 cm (1.375"). The right lower corner area of the upper air bag module cover flap contacted the lateral-anterior aspect of the driver's right forearm which resulted in a *Monteggia* fracture. This fracture type involved a comminuted and displaced fracture of the proximal ulna (AIS-3) and a dislocation of the right radial head (AIS-1) at the elbow. In addition to the skeletal injuries, the driver sustained right radial nerve palsy (AIS-1) which affected the range of motion of her right fingers. There was no soft tissue injury overlying the fracture site. The driver was wearing a long-sleeved light weight blouse with the sleeves folded up to the elbows. Due to her forward driving position and subsequent forward trajectory in response to the impact, the driver's face contacted the deploying air bag. Her facial contact was evidenced by lipstick and makeup transfers. The lipstick transfer was located 24.3-29.0 cm (9.6-11.4") left of the centerline of the bag and 0-2.9 cm (0-1.1") below the horizontal centerline. No injury resulted from the facial contacts.

24. Driver lipstick transfer to the lower left quadrant of the air bag.

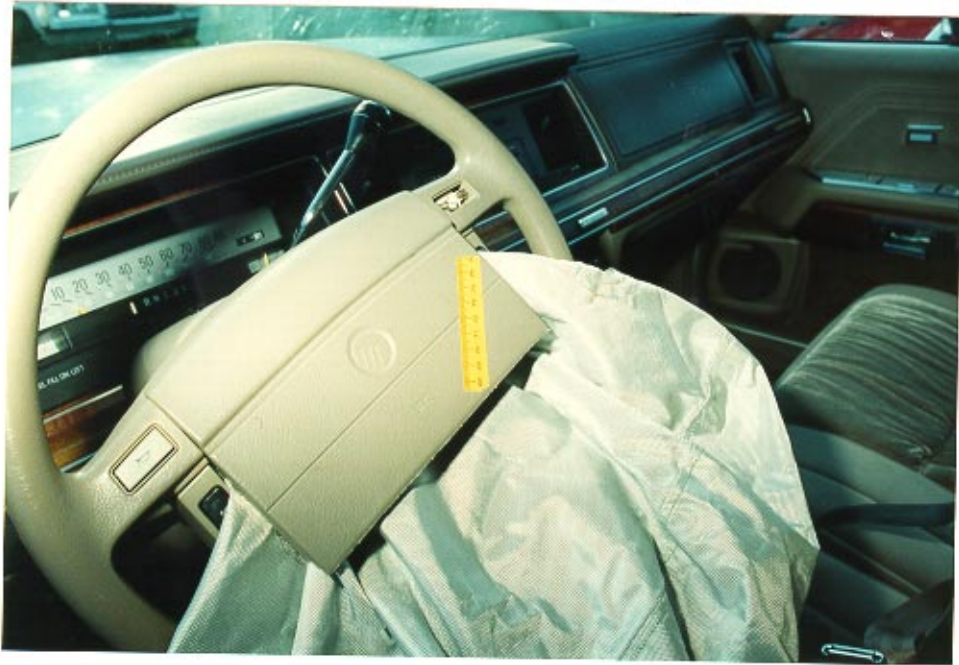
25. Asymmetrical upper air bag module cover flap.

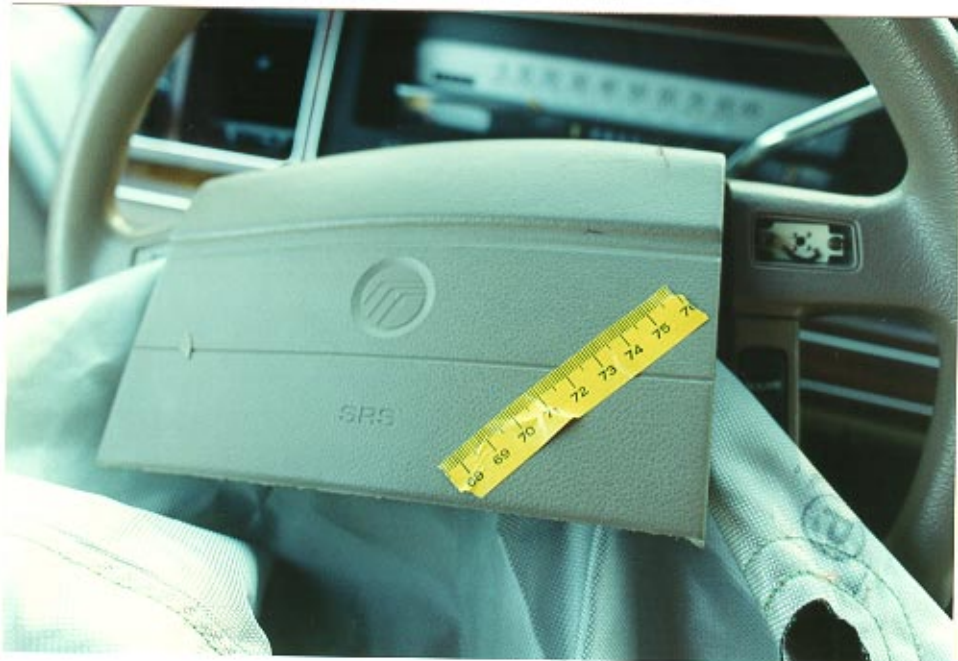
At impact the driver's side air bag deployed. The driver reported hearing a "bang" within the vehicle and felt an impact to the right forearm. Although unconfirmed by contact evidence, the right corner of the upper asymmetrical module cover flap contacted the anterior aspect of the driver's right forearm which resulted in a comminuted, displaced *Monteggia* fracture of the right ulna and a dislocation of the radial head. In addition, the driver sustained a right radial nerve injury. She stated that there no contusion or abrasion to the tissue on the right forearm. Her face subsequently contacted the deployed air bag left of center, depositing a makeup and lipstick transfer which evidenced the contact area. There was no facial injury from the latter contact sequence.

26. Probable area of contact with the driver's right forearm.

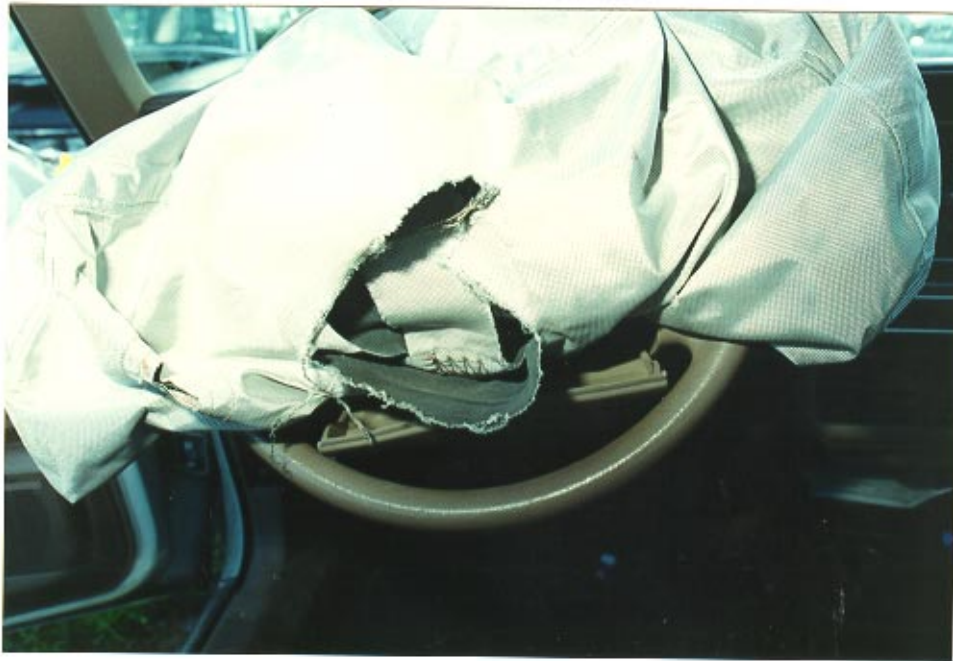
30. Tear of the air bag membrane at the 6 o'clock position of the air bag.

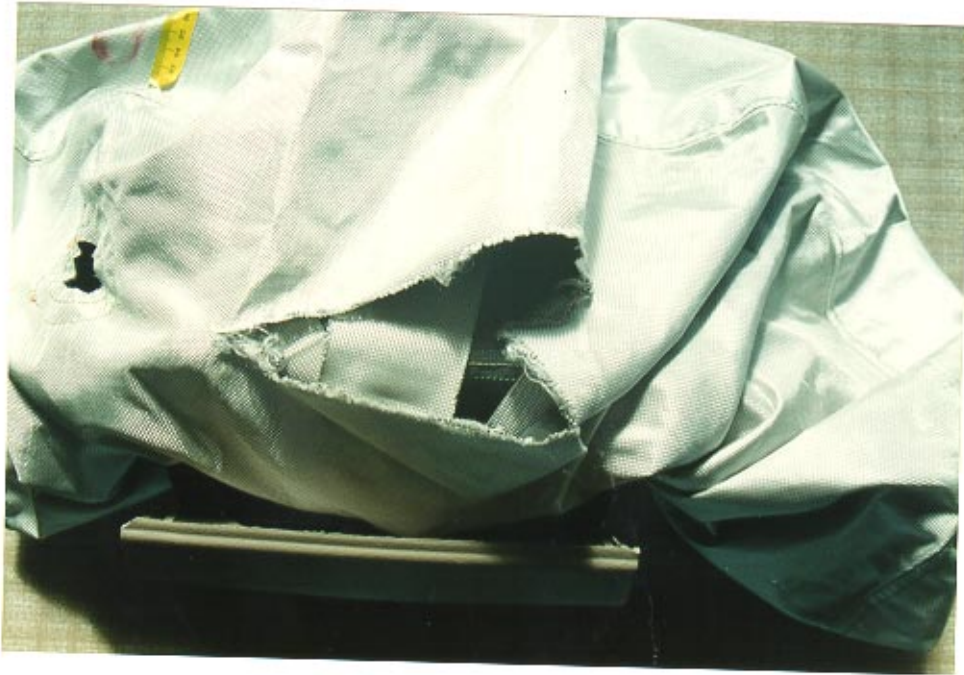
31. Close-up view of the membrane tear.

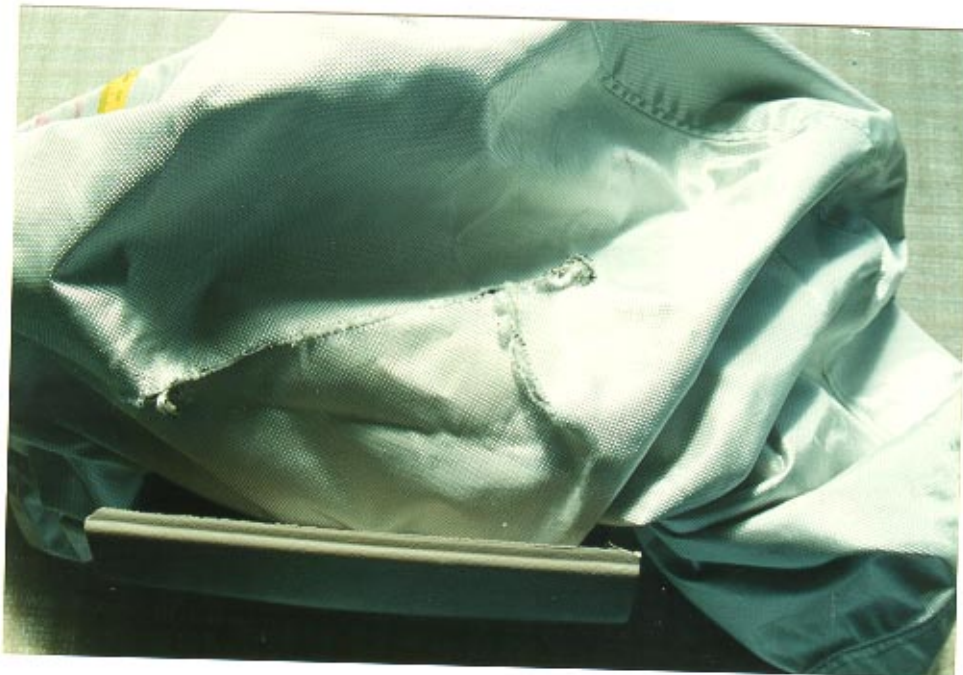
32. T-shaped tear pattern.

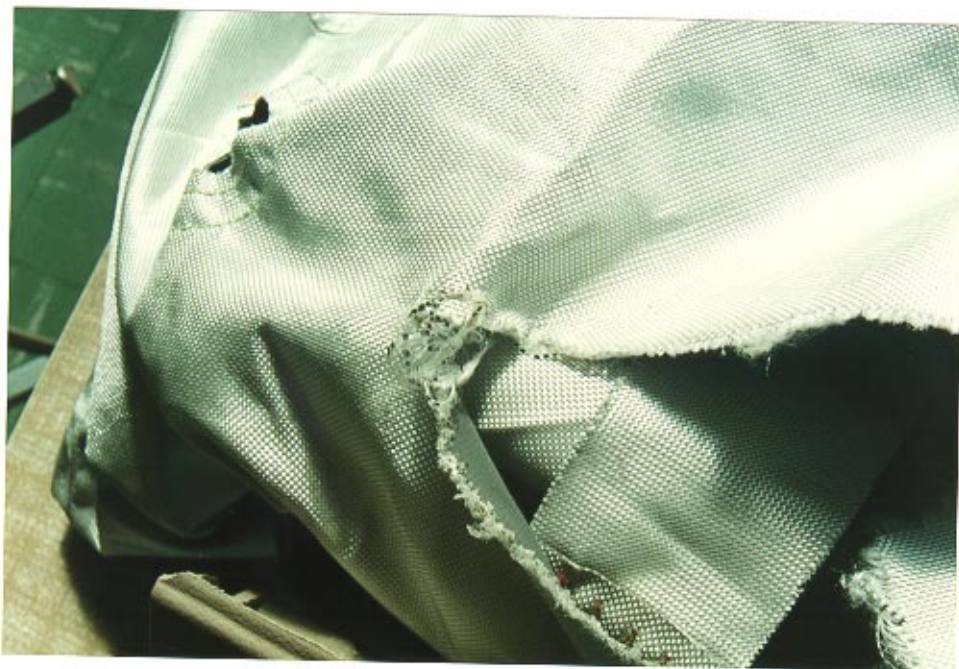
33. Close-up view of the tear at the left edge.

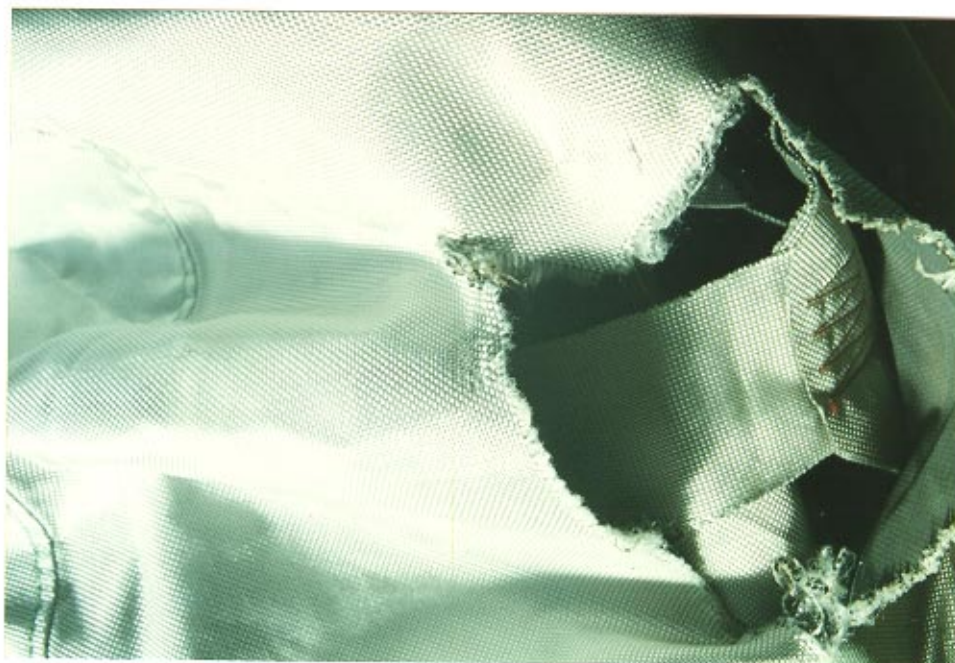
34. Close-up view of the tear at the right edge.

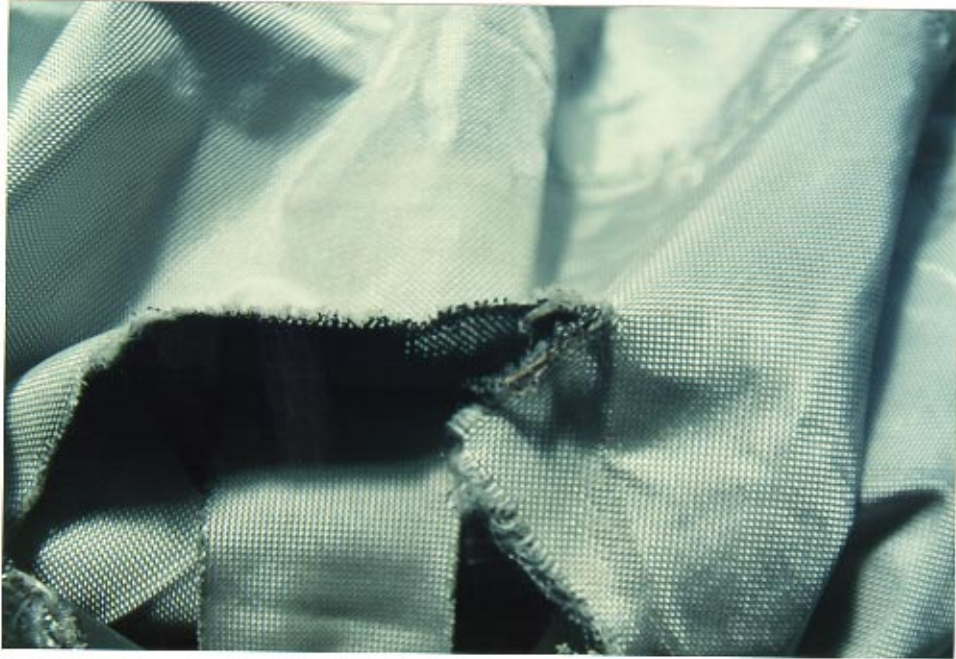
35. Close-up view of the edges of the tear.

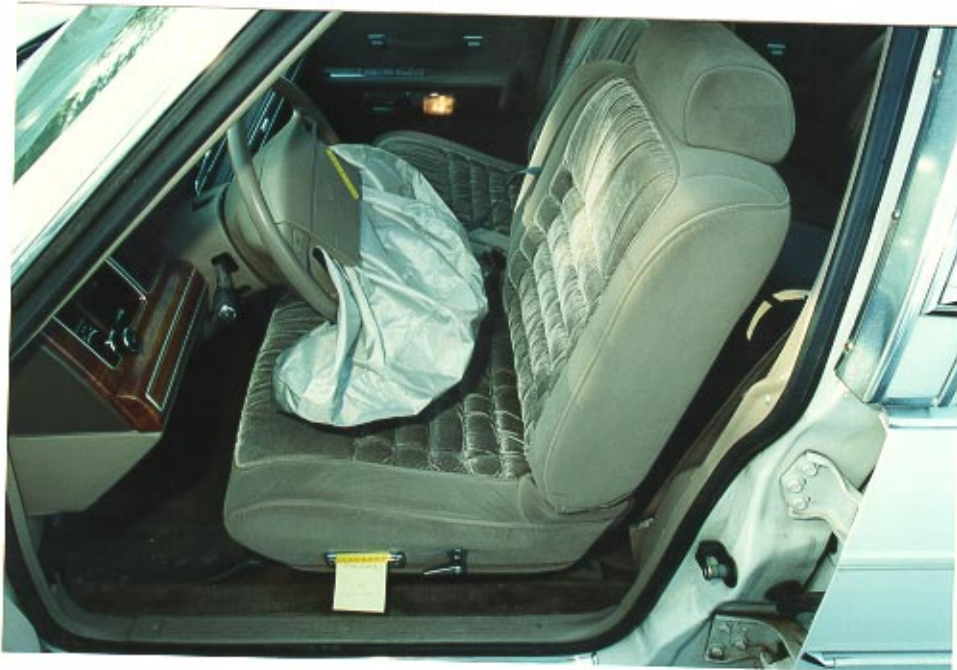
The driver of 1991 Mercury Grand Marquis was in a normal driving posture at impact with the six-way power seat adjusted to a forward track position. She stated that she was properly wearing the manual 3-point lap and shoulder belt system. There were faint abrasive type routine wear marks on the latchplate, however, there was no evidence of belt loading due to the driver's forward position, air bag deployment and subsequent loading, and the low-speed decelerative pulse that the vehicle sustained from the crash. The driver was wearing a long sleeve blouse with the sleeves folded up to the elbows and had her reading eyeglasses hanging from a strap around her neck with the glasses resting on her chest. She was not wearing jewelry such as a watch, bracelet, or necklace.

40. Longitudinal distance between the seat back and the steering wheel/air bag module with the driver's seat adjusted to a forward track position.

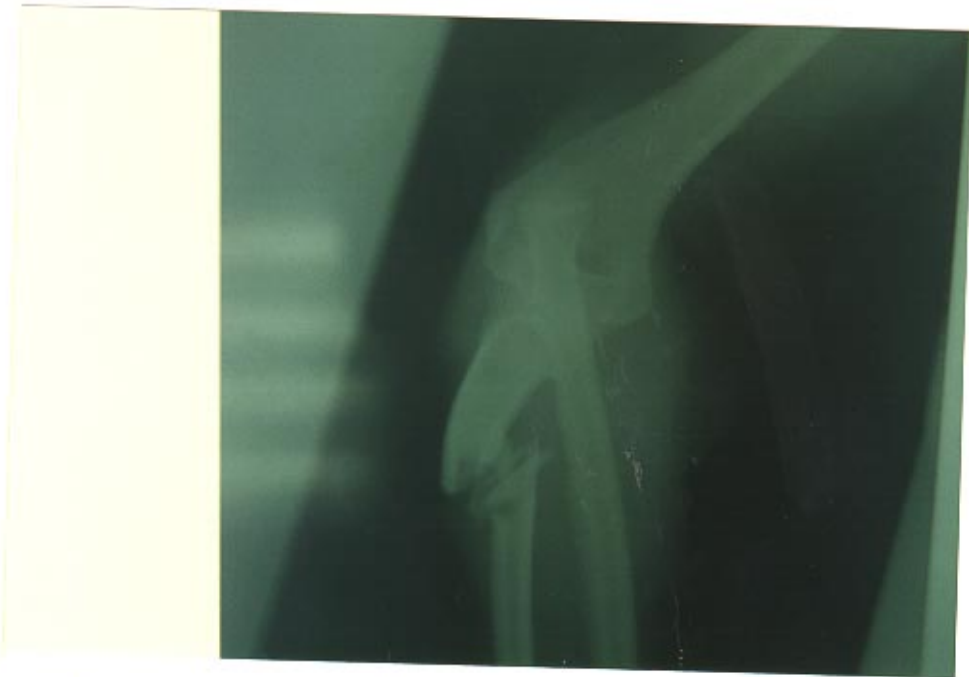
This on-site investigation focused on a 53 year-old female driver who sustained a comminuted and displaced fracture of the right proximal ulna with a dislocation of the radial head (*Monteggia* fracture) from her involvement with the deploying air bag upper module cover flap in a 1991 Mercury Grand Marquis. Air bag deployment resulted from a moderate severity front-to-side impact sequence with a stopped 1986 Honda Accord at a three-leg intersection. The driver of the Mercury was admitted to a local hospital for surgical repair of the fractures. In addition to the skeletal injuries, she sustained a right radial nerve injury which affected the movement of her fingers and hand.

41. X-ray of the driver's Monteggia fracture of the right forearm.

titanium DCP plate was applied to the fracture site with six 3.5 cortical screws above and below the fracture. The physician applied a Coralline hydroxyapatite bone filler over the comminuted fracture.

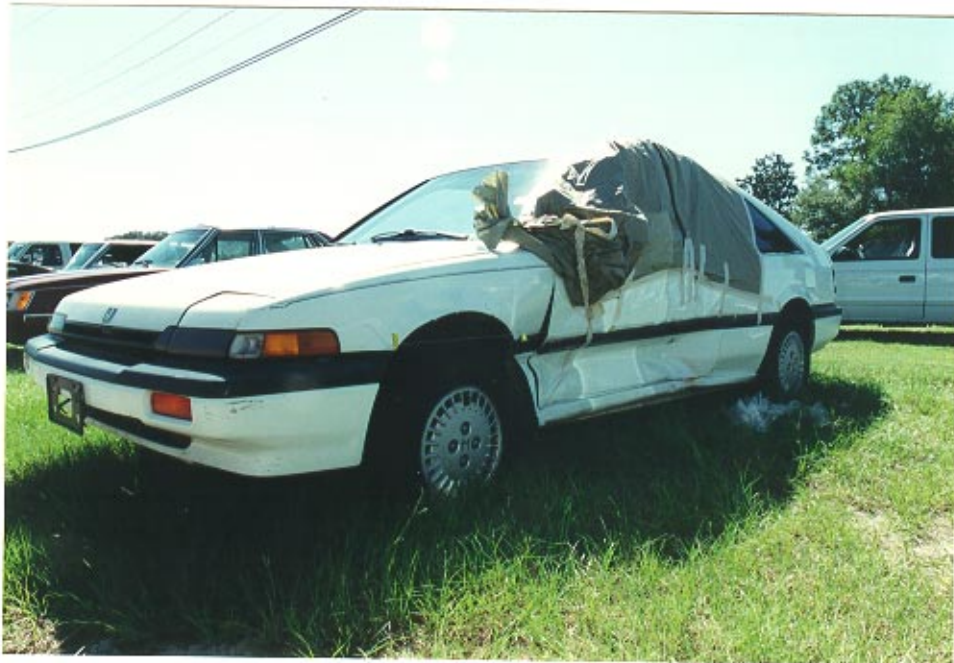
The left side impact produced damage to the door, front fender, A-pillar, sill, quarter panel, and the door glazing.

42. Impact damage to the left side area of the struck Honda Accord.

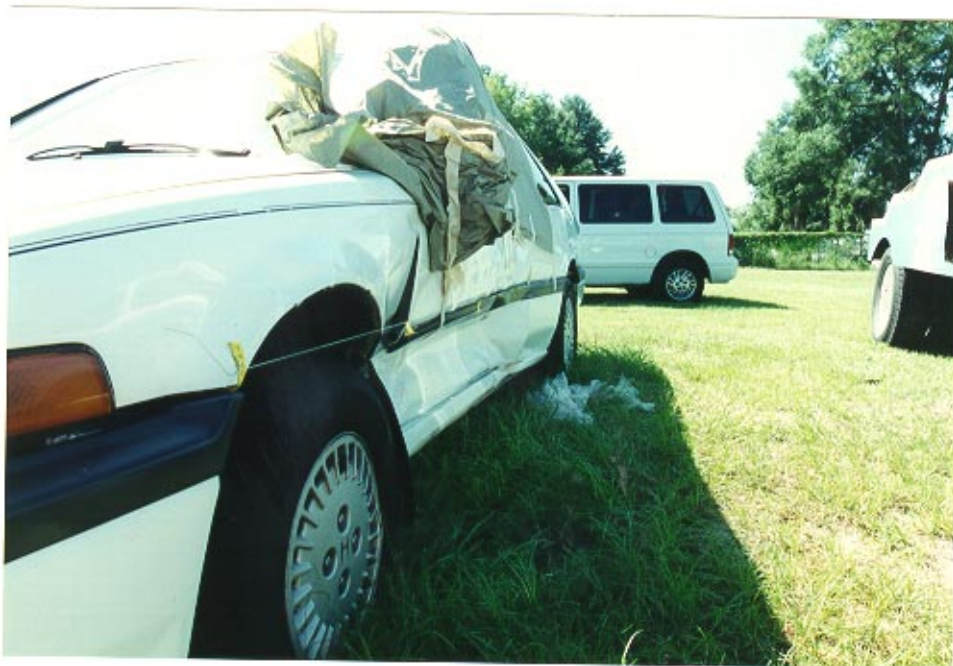
The 1986 Honda Accord sustained moderate left side damage. Maximum crush was 18.4 cm (7.25") located on the left door below the rub strip 180.6 cm (71.1") forward of the rear axle. Direct contact damage began 95.89 cm (37.75") forward of the rear axle and extended 115.6 cm (45.5") forward to the left A-pillar. The combined induced and direct contact damage began 24.77 cm (9.75") forward of the rear axle and extended 261.6 cm (103.0") forward to the leading edge of the left front wheel opening. Crush values at the lower door level were as follows:  $C_1 = 0$  cm,  $C_2 = 6.4$  cm (2.5"),  $C_3 = 19.1$  cm (7.5"),  $C_4 = 18.4$  cm (7.25"),  $C_5 = 10.8$  cm (4.25"),  $C_6 = 0$  cm.

43. Longitudinal view documenting the extent of side crush.

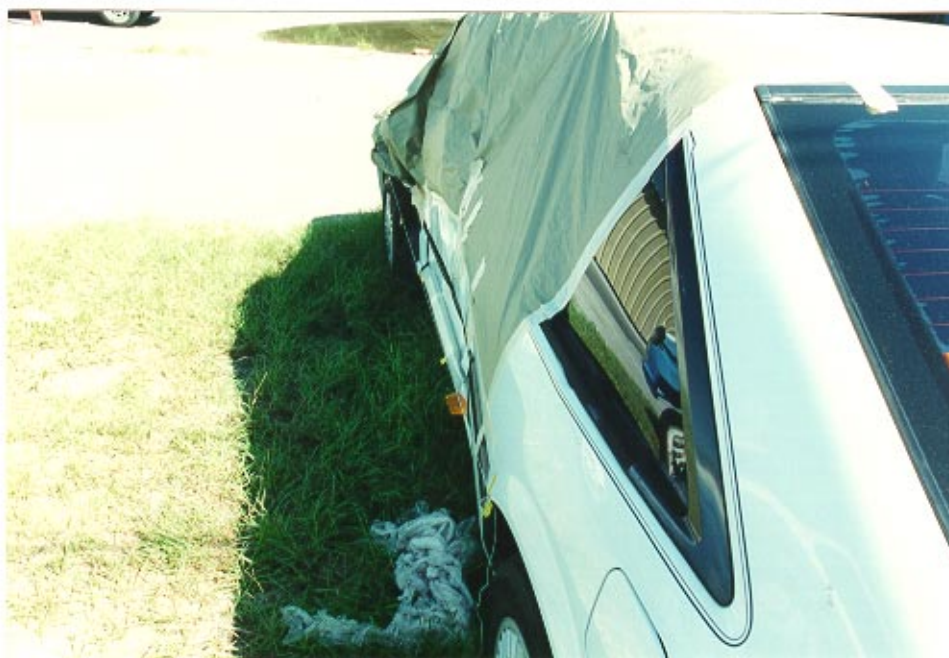
44. Rear view documenting the extent of left side crush.

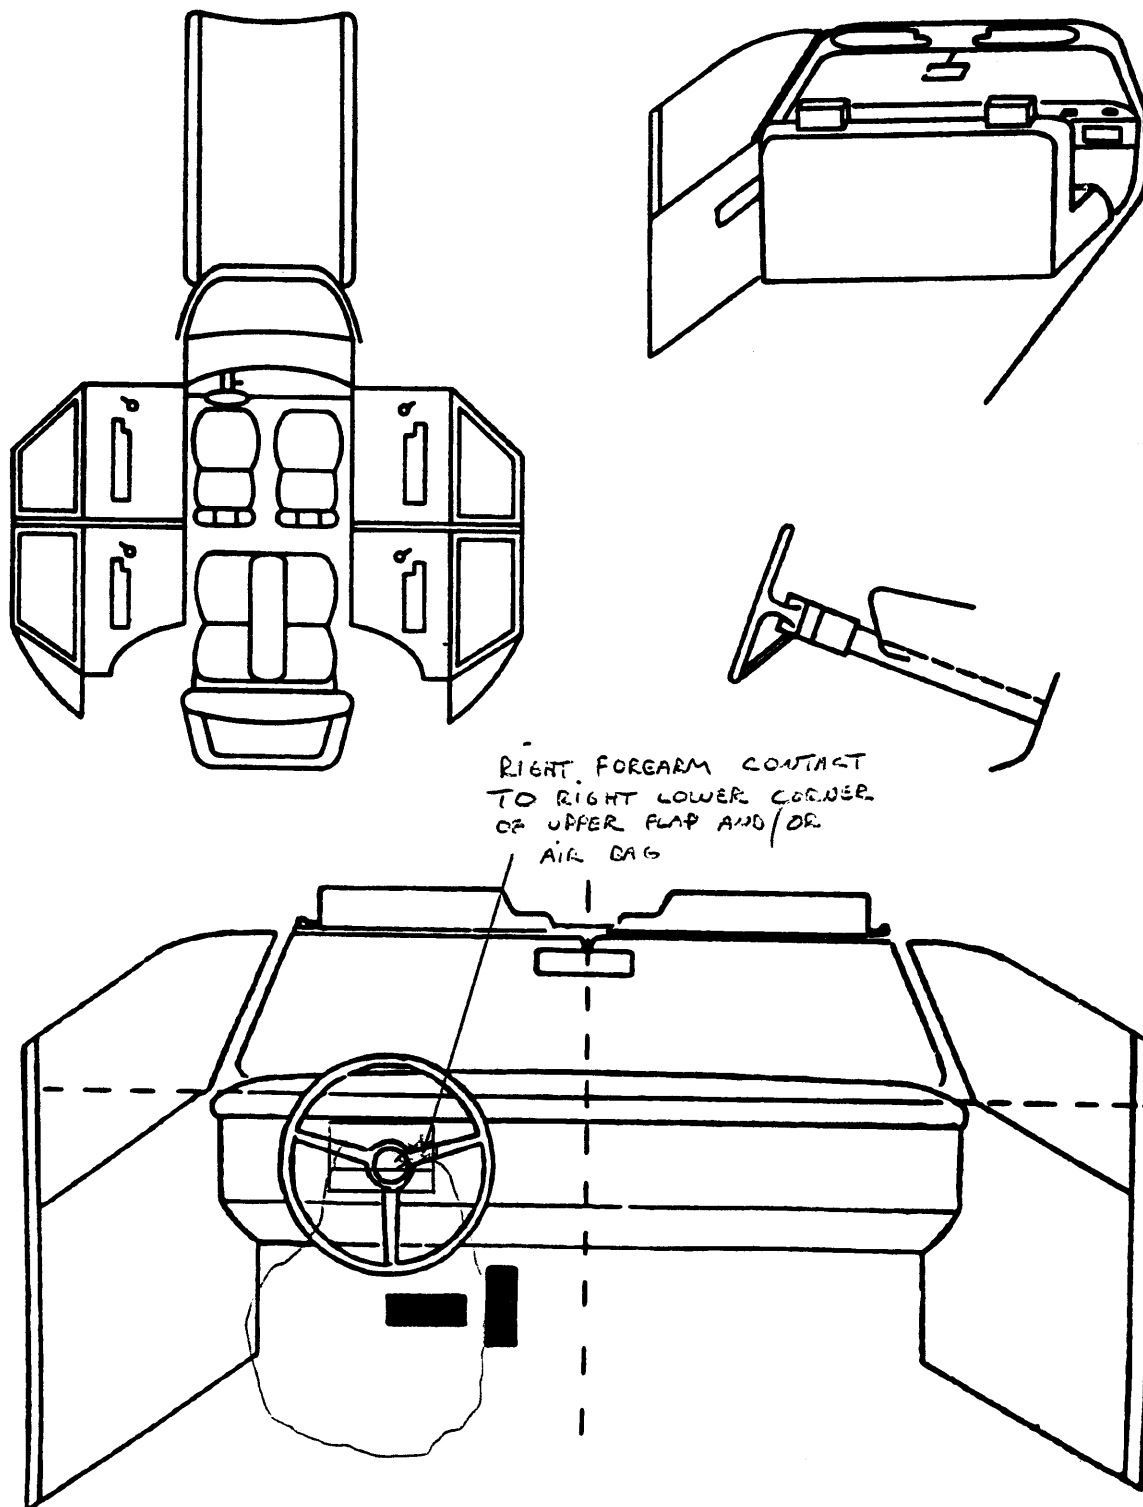
RIGHT FOREARM CONTACT  
TO RIGHT LOWER CORNER  
OF UPPER FLAP AND/OR  
AIR BAG
