**CALSPAN REMOTE AIR BAG DEPLOYMENT INVESTIGATION**

**CALSPAN CASE NO. 95-14**

**VEHICLE #1 - 1994 MAZDA 626**

**VEHICLE #2 - 1988 MAZDA 626**

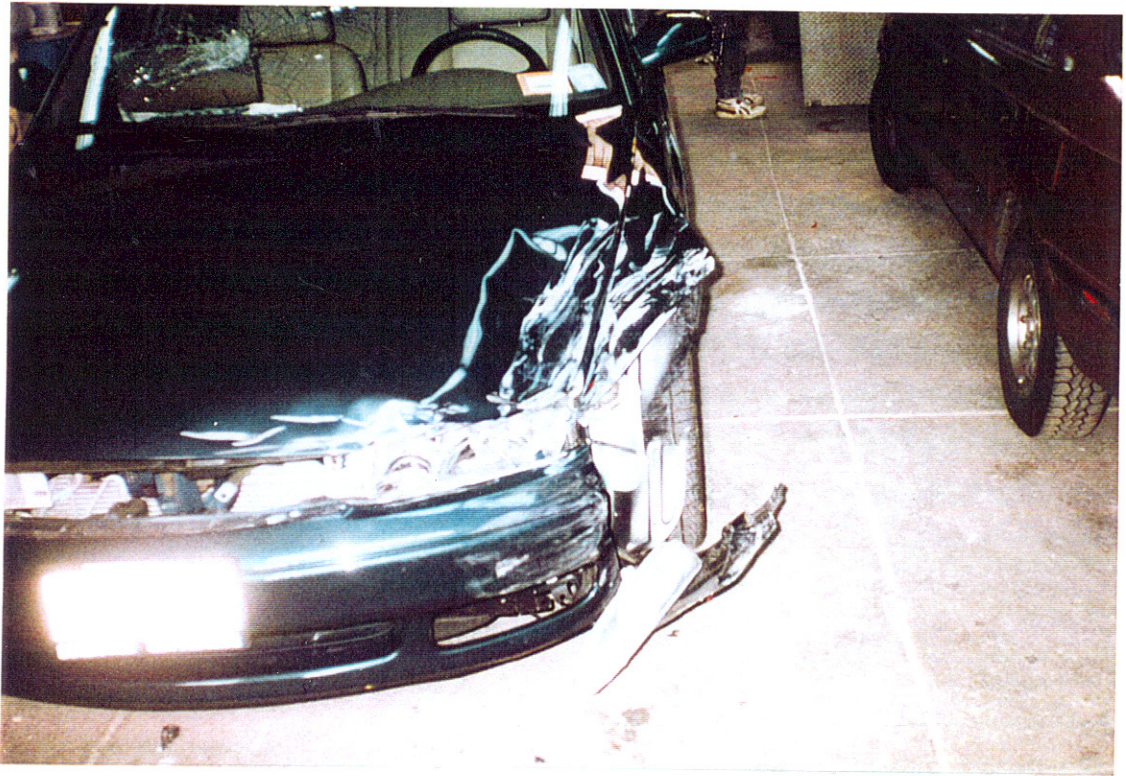
The crash involved contact between the left front bumper corner of both vehicles. Vehicle #1 continued a short distance ("a few feet") to the right and came to the final rest position (FRP) against a cinder block wall. The driver indicated Vehicle #2's forward trajectory was halted by the crash and it came to the FRP at the point of impact (POI). The CDC for Vehicle #1 was estimated from photographs as 11-FLEE-3 (refer to photographs # 1-2 on page A-1).

Vehicle #1 was driven from the scene to the police precinct where it was subsequently towed to a collision shop. Damage to the vehicle included: the front bumper, hood, grille, windshield, left front fender, and radiator. The windshield damage resulted from contact by the passenger air bag module flap during the air bag deployment cycle. The cost of vehicle repair was estimated at \$9,257 (refer to Appendix B).

1. Damage to the front and left side plane of the 1994 Mazda 626 (Vehicle #1).

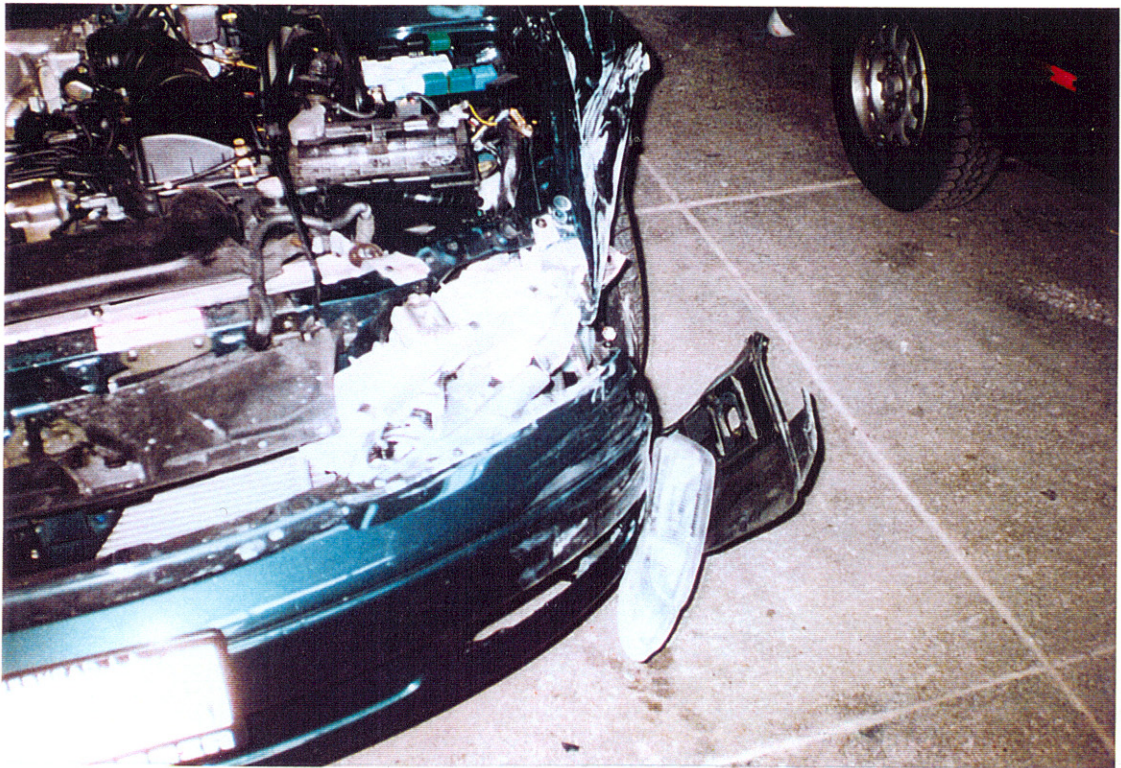
2. View of Vehicle #1 damage with the hood raised.

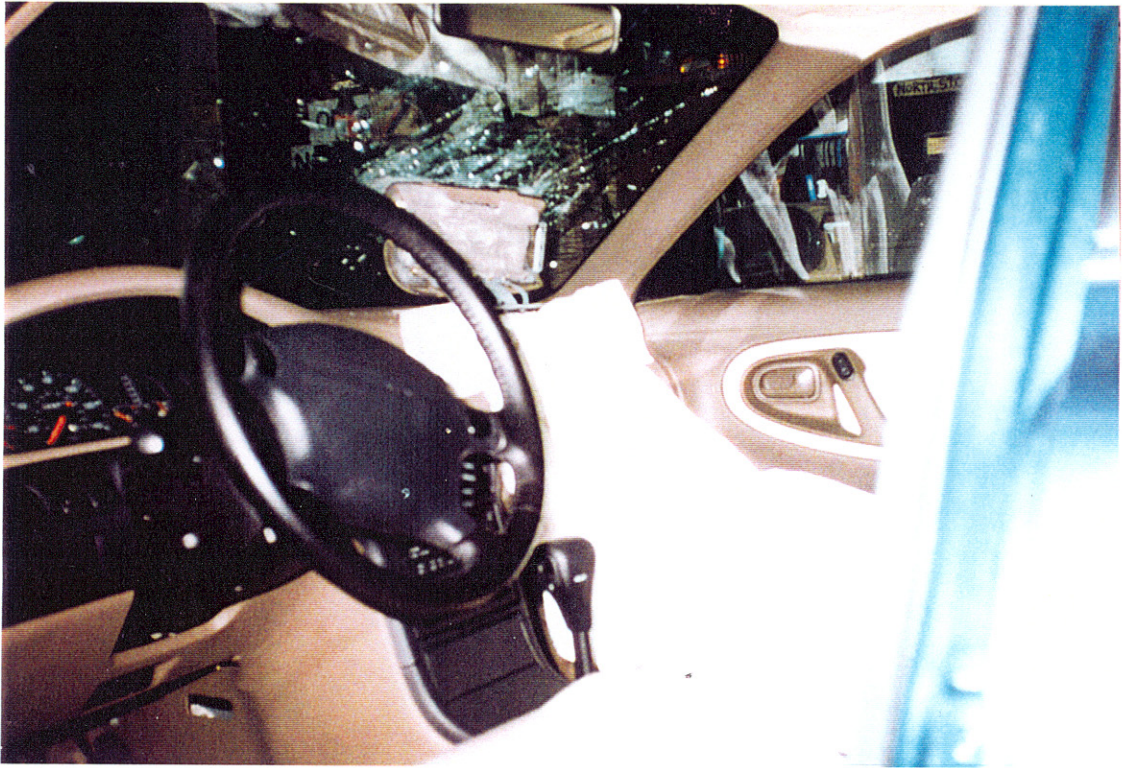
During the crash, the dual air bag system partially initiated the Supplemental Restraint System (SRS) deployment sequence. The driver side air bag failed to open while the passenger side fully

Vehicle #1 was equipped with a dual air bag system which partially deployed during the crash sequence. The driver said the passenger side air bag deployed while the driver side air bag remained packaged within the air bag module. Driver #1 claimed that Driver #2 was the first person to have observed the partial deployment phenomenon after he walked over to Vehicle #1 following the crash.

3. Lateral view of the undeployed driver's side air bag and the deployed passenger side air bag.

Following the completion of collision repairs, Vehicle #1 was transported via flat bed truck to a Mazda dealership where two new replacement air bag modules were installed. Driver #1 was told by the dealer that the air bag electronic system was checked for anomalies. He said the wiring and sensors reportedly checked out positively (i.e., no defects) and that no additional parts (e.g., crash sensors, etc.) aside from the air bag modules were replaced. However, the repair estimate listed the replacement of two air bag sensors (refer to Appendix B for an itemized component repair list). Additionally, the estimate only listed the replacement of the passenger side air bag and not the driver side.
