**CALSPAN ON-SITE AIR BAG DEPLOYMENT INVESTIGATION
CALSPAN CASE NO. 95-19
VEHICLE: 1993 SUBARU IMPREZA
LOCATION: PENNSYLVANIA**

14. Sponsoring Agency Code	
15. Supplementary Notes On-site investigation of an alleged inadvertent deployment of the driver's side air bag in a 1993 Subaru Impreza.

CALSPAN ON-SITE AIR BAG DEPLOYMENT INVESTIGATION
CALSPAN CASE NO. 95-19
VEHICLE: 1993 SUBARU IMPREZA
LOCATION: PENNSYLVANIA

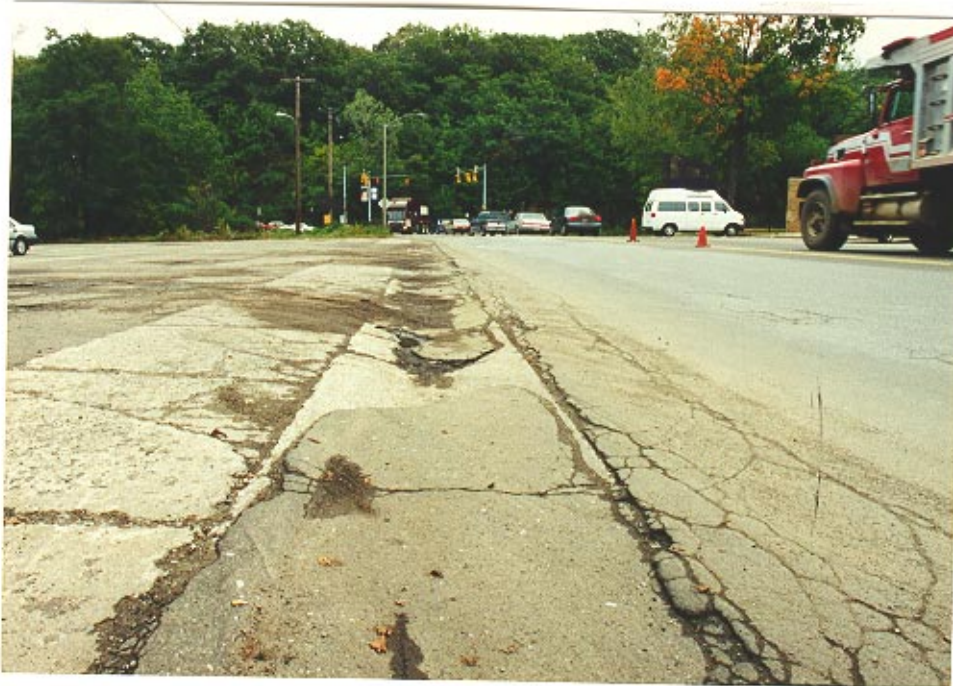
4. Longitudinal view of the concrete rain gutter in the area of the left turn maneuver.

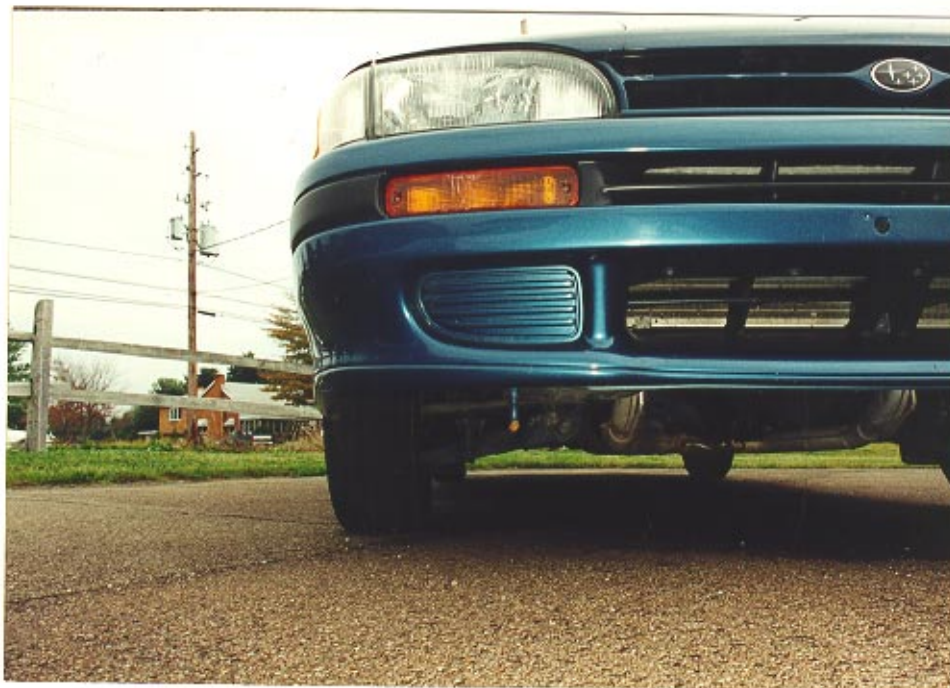
8. Location and exposure of the right tie-down bracket.

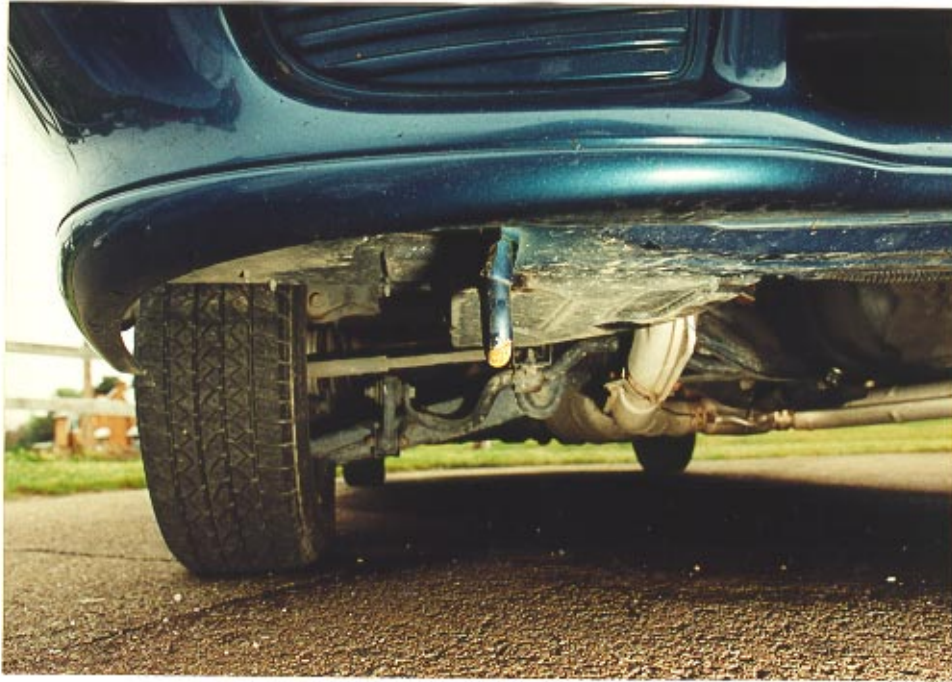
The service manager at the dealership noted a recent contact which abraded the right tie-down bracket that was mounted below the front bumper and forward of the right front axle position at the front corner of the unibody chassis. The Subaru was inspected at the local dealership approximately 2.5 weeks following the deployment event. The vehicle was found locked and reportedly untouched since arriving at the dealership. There was no external damage or contact noted to the body or bumper components of the vehicle. The U-shaped right tie-down bracket was heavily abraded on the lower leading edge (refer to Photograph Nos. 8-12). This bracket was formed from 1.3 cm (0.5") diameter round stock and was attached (probably welded) in a fore and aft configuration to the unibody of the vehicle. Directly above the radiuses, the bracket was 11.4 cm (4.5") in width and narrowed to 11.1 cm (4.375") at its attachment point to the chassis. The tie-down bracket protruded 4.8 cm (1.875") below the unibody and was exposed 4.4 cm (1.75") below the bumper fascia and integral air dam and 5.4 cm (2.125") below the lower radiator support panel. The abrasion involved the leading edge of the bracket and extended 3.8-4.8 cm (1.5-1.875") from the mounting point. There was no visual displacement or deformation to the bracket.

9. Contact damage to the right tie-down bracket.

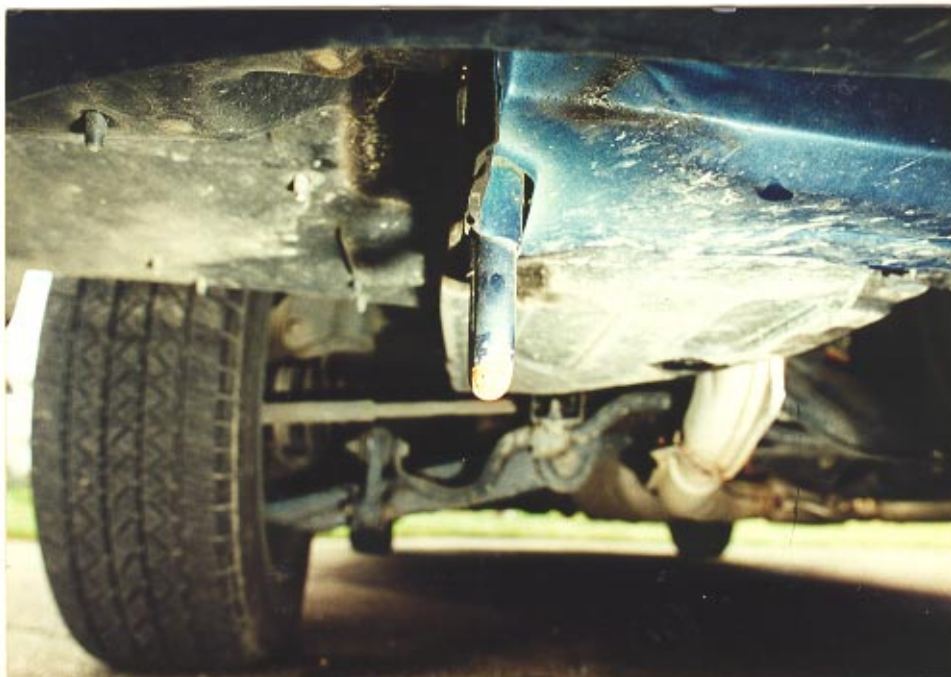
10. Close-up view of the contact damage.

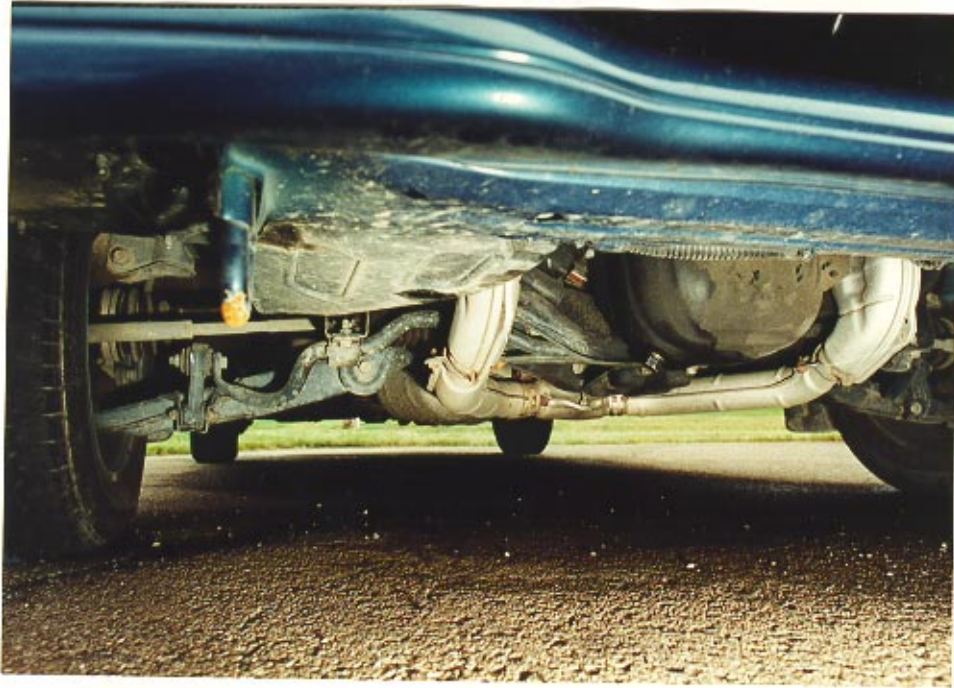
The Subaru was subsequently driven into the dealership's service department and elevated on a floor lift for a more thorough undercarriage inspection. The undercarriage of the vehicle was carefully examined and no additional contact evidence or damage was observed. The factory undercoating that was applied to the area directly above the tie-down bracket was cracked in an irregular pattern (refer to Photograph No. 12). The high density polyethylene right inner fender liner was removed to provide visual inspection to the chassis and mounting point of the bracket (refer to Photograph No. 13). There was no visual residual damage to the unibody chassis of the vehicle. This was confirmed by a certified Subaru technician and the service manager.

11. Undercarriage view of the vehicle showing lack of additional contact damage.

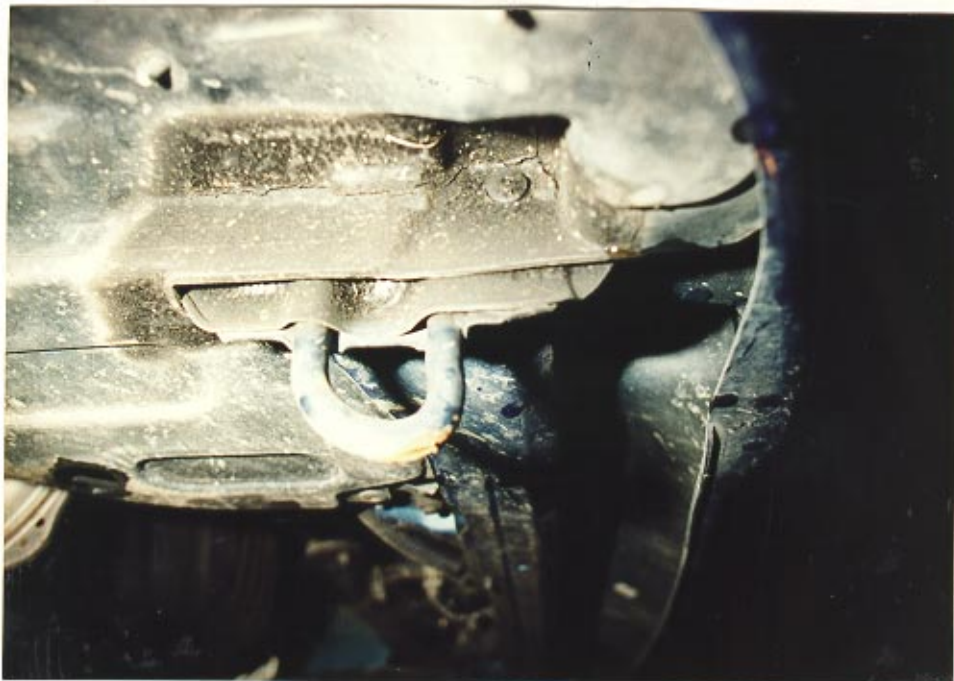
12. Cracking to undercarriage undercoat sealer directly above the right tie-down bracket.

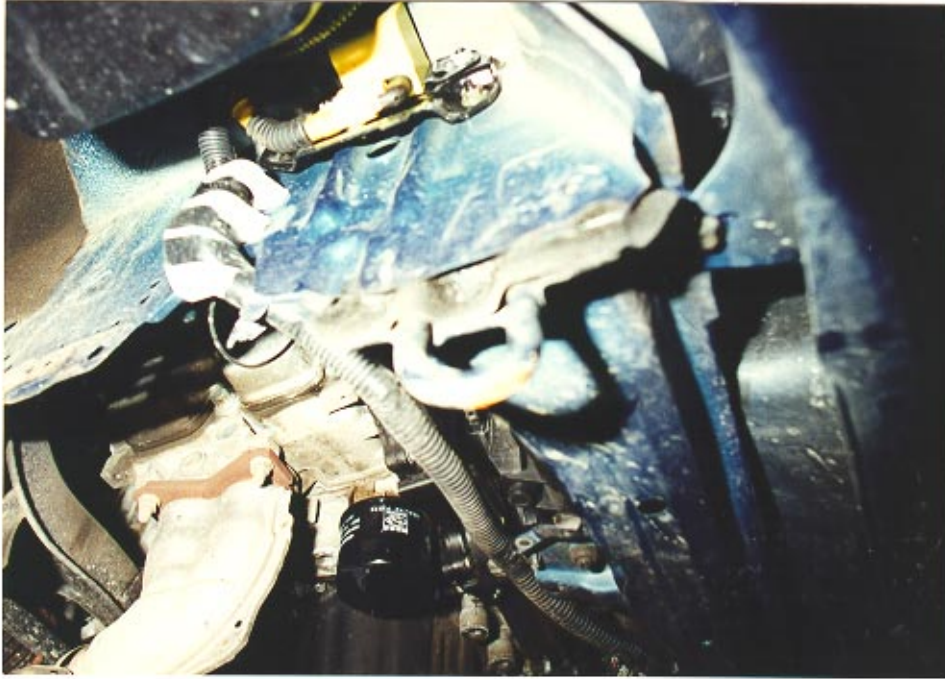
13. Vehicle structure above the tie-down; no residual deformation.

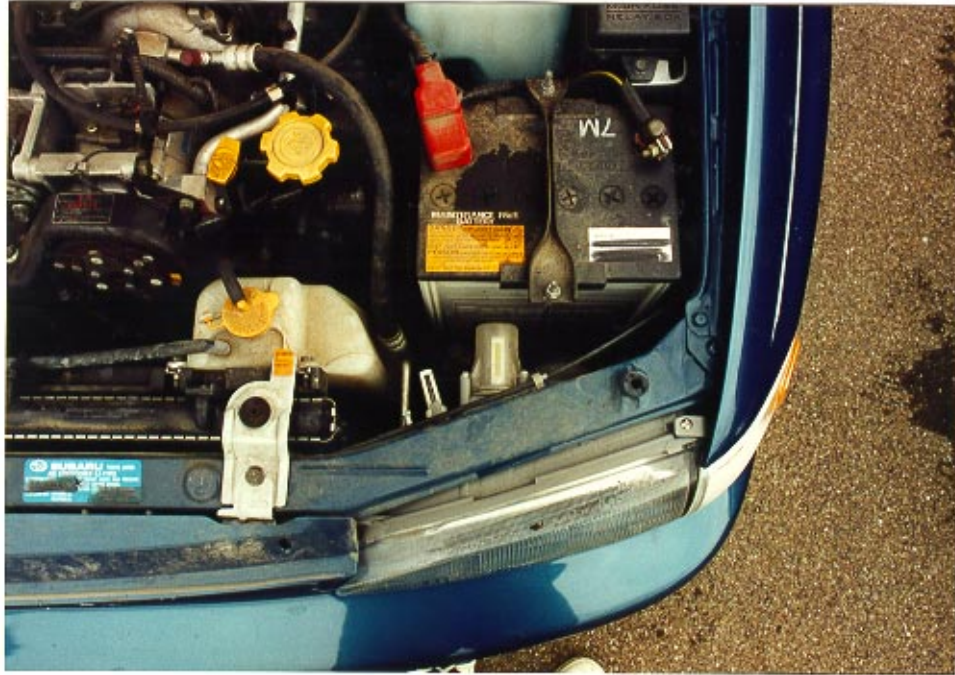
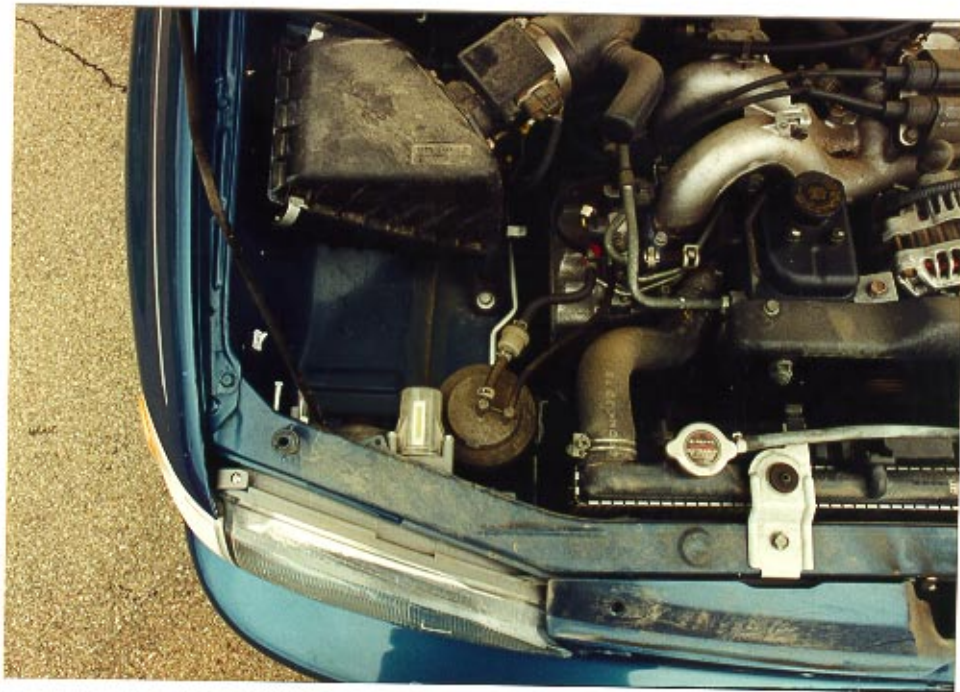
21. & 22. Undeformed areas of the front mounted crash sensors.

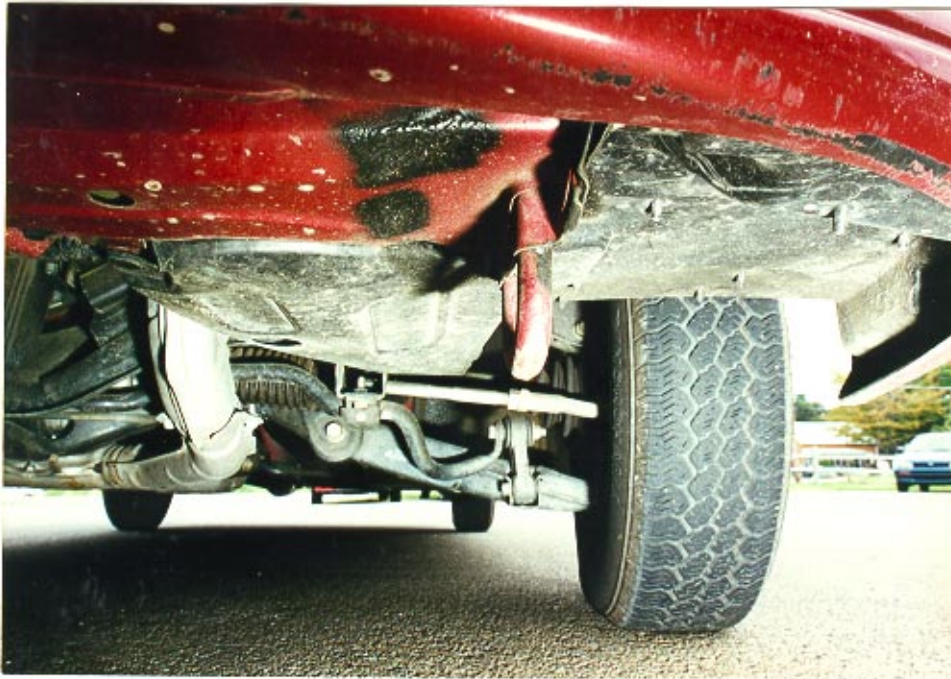
24. Similar contact to the left tie-down bracket of the exemplar vehicle.
This contact did not result in air bag deployment.

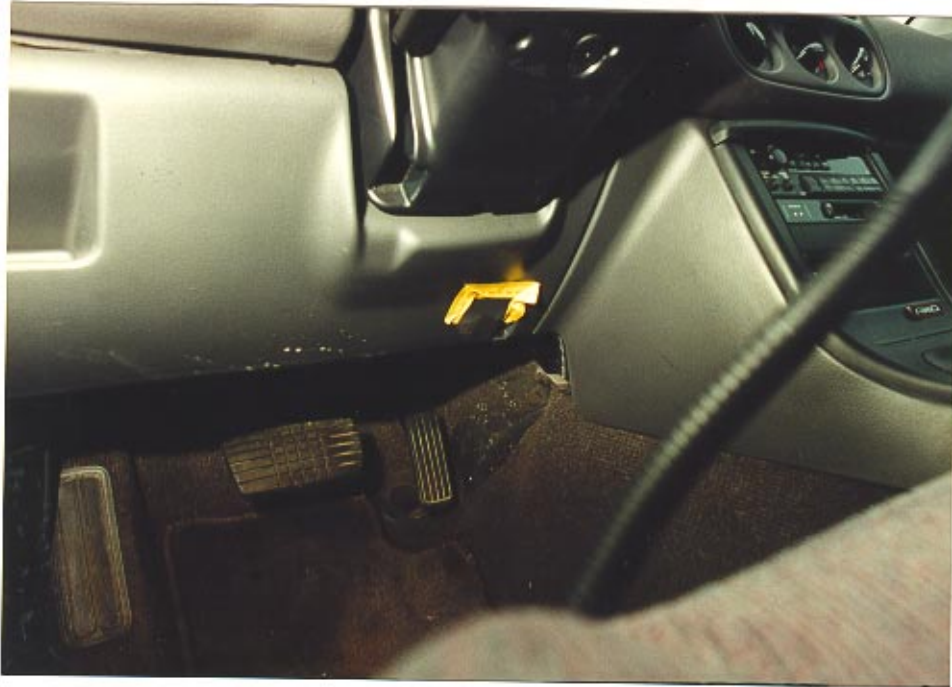
The driver stated that she noted a change in the vehicle's ride as it entered the parking lot, however, she did not specifically detect a deceleration induced by the tie-down bracket contact. The deceleration, however, displaced the driver forward with respect to the decelerating vehicle. This was evidenced by the right knee scuff to the right lower corner of the knee bolster.

27. Possible driver's right knee scuff to the knee bolster.

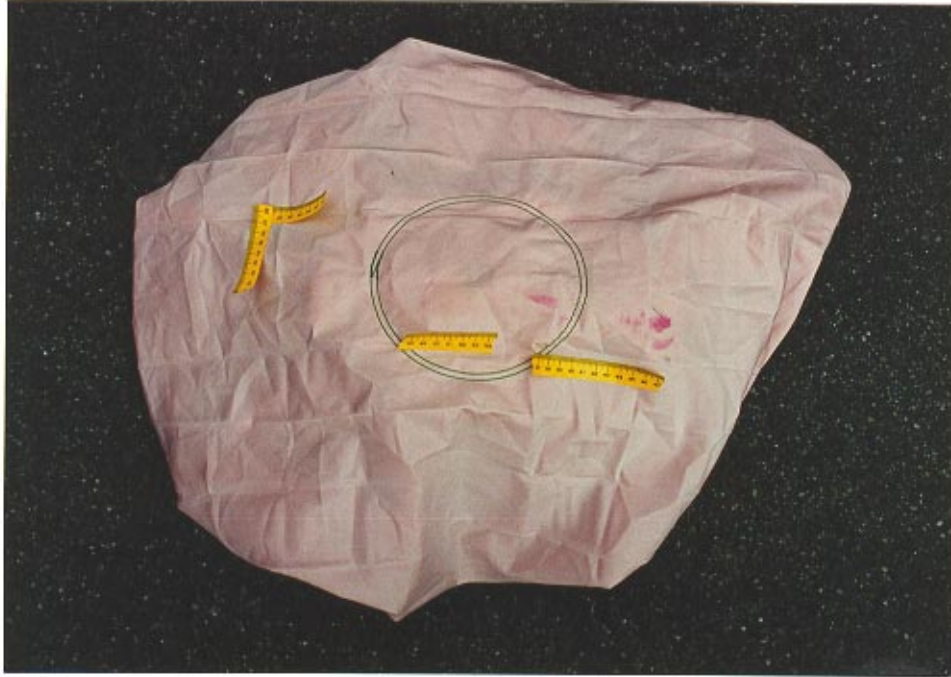
The petite driver was positioned within a close proximity to the steering assembly and air bag module. The deploying air bag contacted the driver's face, anterior neck, chest and left forearm. She was wearing facial makeup and lipstick which transferred onto the face of the deploying air bag. The lipstick transfer began 9.1-15.0 cm (3.6-5.9") right of the air bag's centerline and extended 2.3-4.8 cm (0.9-1.9") below the horizontal centerline (refer to Photograph No. 29). An additional lipstick transfer was noted within the tether reinforcement and was located 2.8-7.4 cm (1.1-2.9") right of center and 2.0-4.4 cm (0.8-1.75") below the center point. This transfer blended into a flesh-tone makeup transfer that was contained within the tether reinforcement circle. This transfer extended 0-5.1 cm (0.0-2.0") left of center and from 0.6 cm (0.25") above the horizontal centerline to 5.1 cm (2.0") below the referenced axis. A second area of makeup transfer was noted 12.7-16.5 cm (5.0-6.5") left of center and 1.0-4.4 cm (0.4-1.75") below the horizontal centerline. This wide-band of makeup resulted from the bag expanding across the driver's face. The driver's prescription eyeglasses remained on her face and were not displaced or damaged from air bag deployment. The right side of the knee bolster was scuffed from an apparent right knee contact by the driver. She did not complain of injury to the lower extremities.

29. Driver's lipstick and makeup transfer on air bag.
