**SAFETY COMPLIANCE TESTING FOR
FMVSS NO. 216
ROOF CRUSH RESISTANCE**

**MAZDA MOTOR CORPORATION
2003 MAZDA 6, PASSENGER CAR
NHTSA NO. C35401**

**GENERAL TESTING LABORATORIES, INC.
1623 LEEDSTOWN ROAD
COLONIAL BEACH, VIRGINIA 22443**

FINAL REPORT

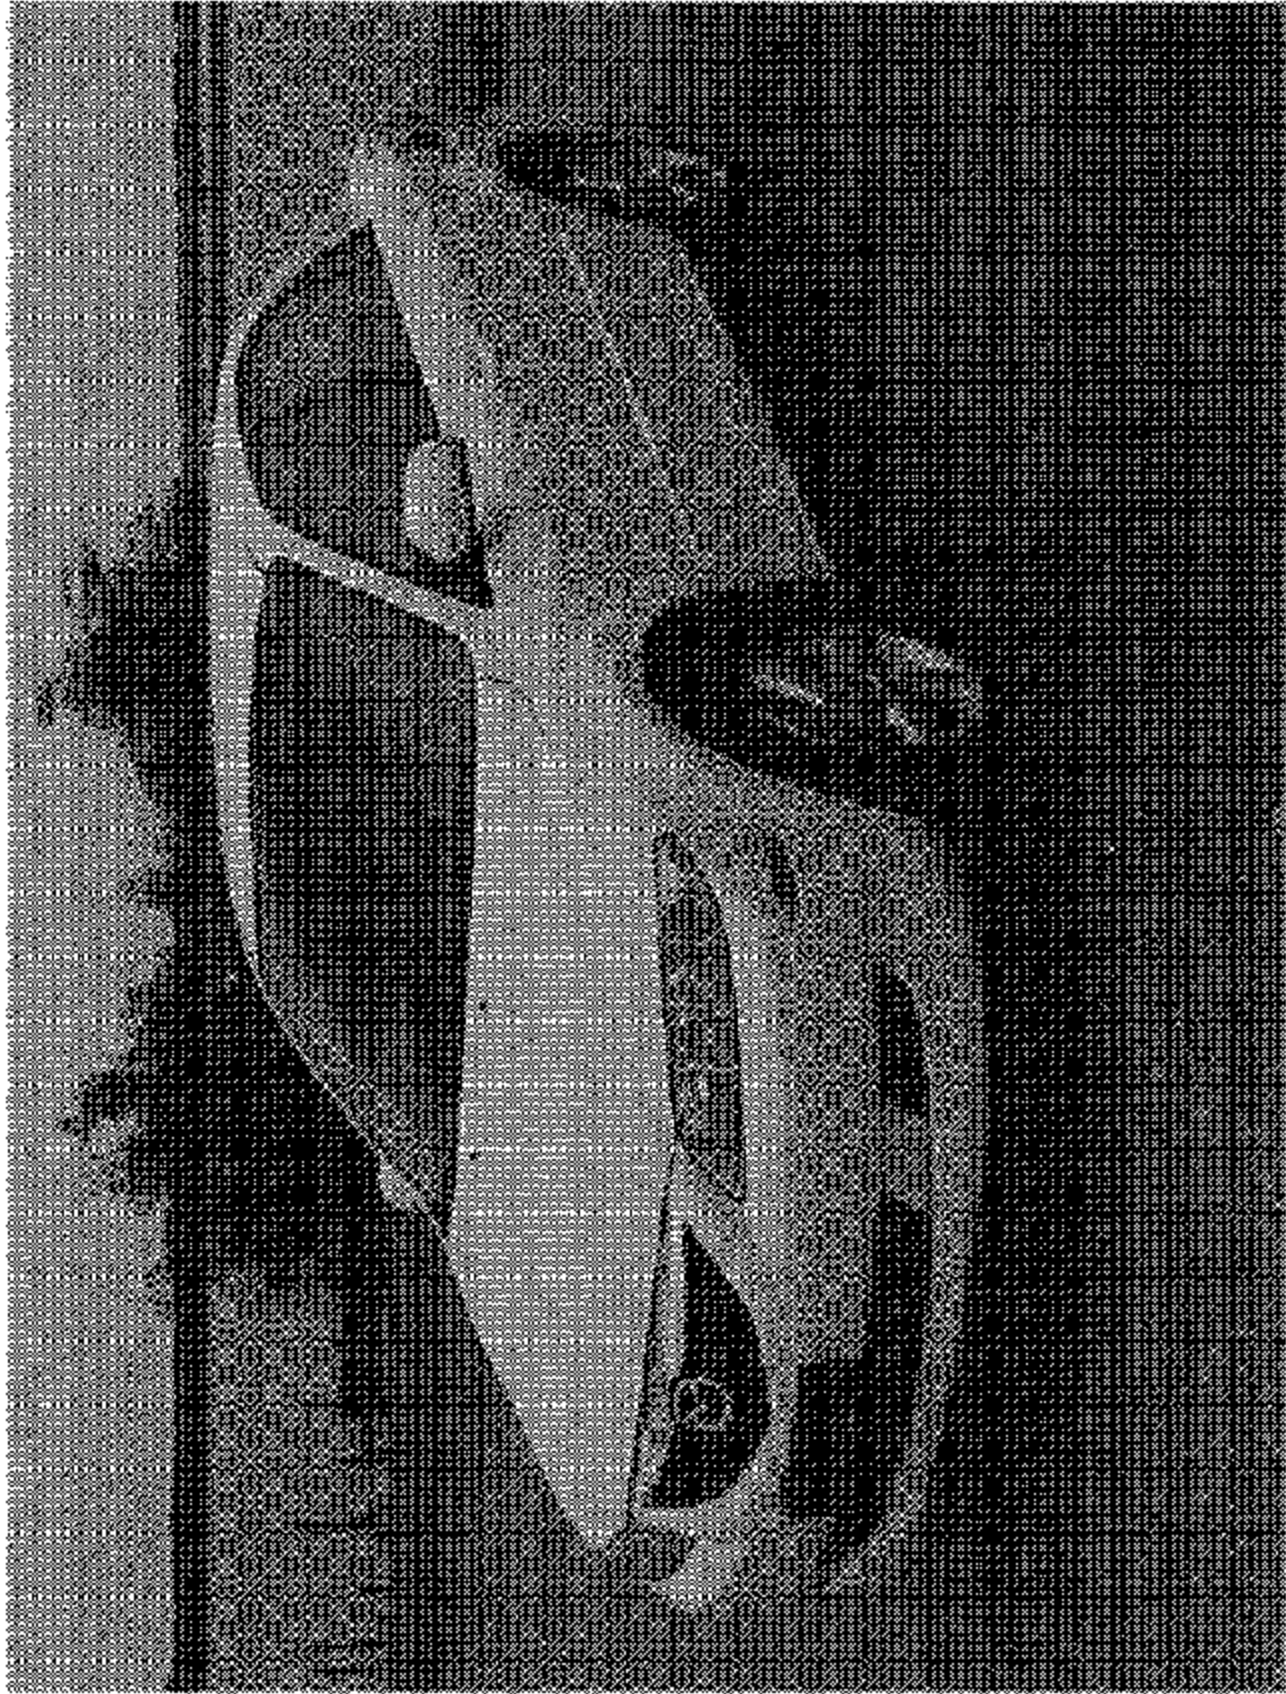
FIGURE 5.21
3/4 FORWARD VIEW OF VEHICLE ON TESTED
SIDE AFTER TESTING

RESULTS: Flattened area above driver's side front door approximately 600mm long x 150 mm wide and pushed down 20 mm. Small dent above driver side rear door approximately 300 mm long x 150 mm wide and pushed down 4 mm. Windshield glass has multiple cracks but is still intact. All doors and side glass windows still operate.

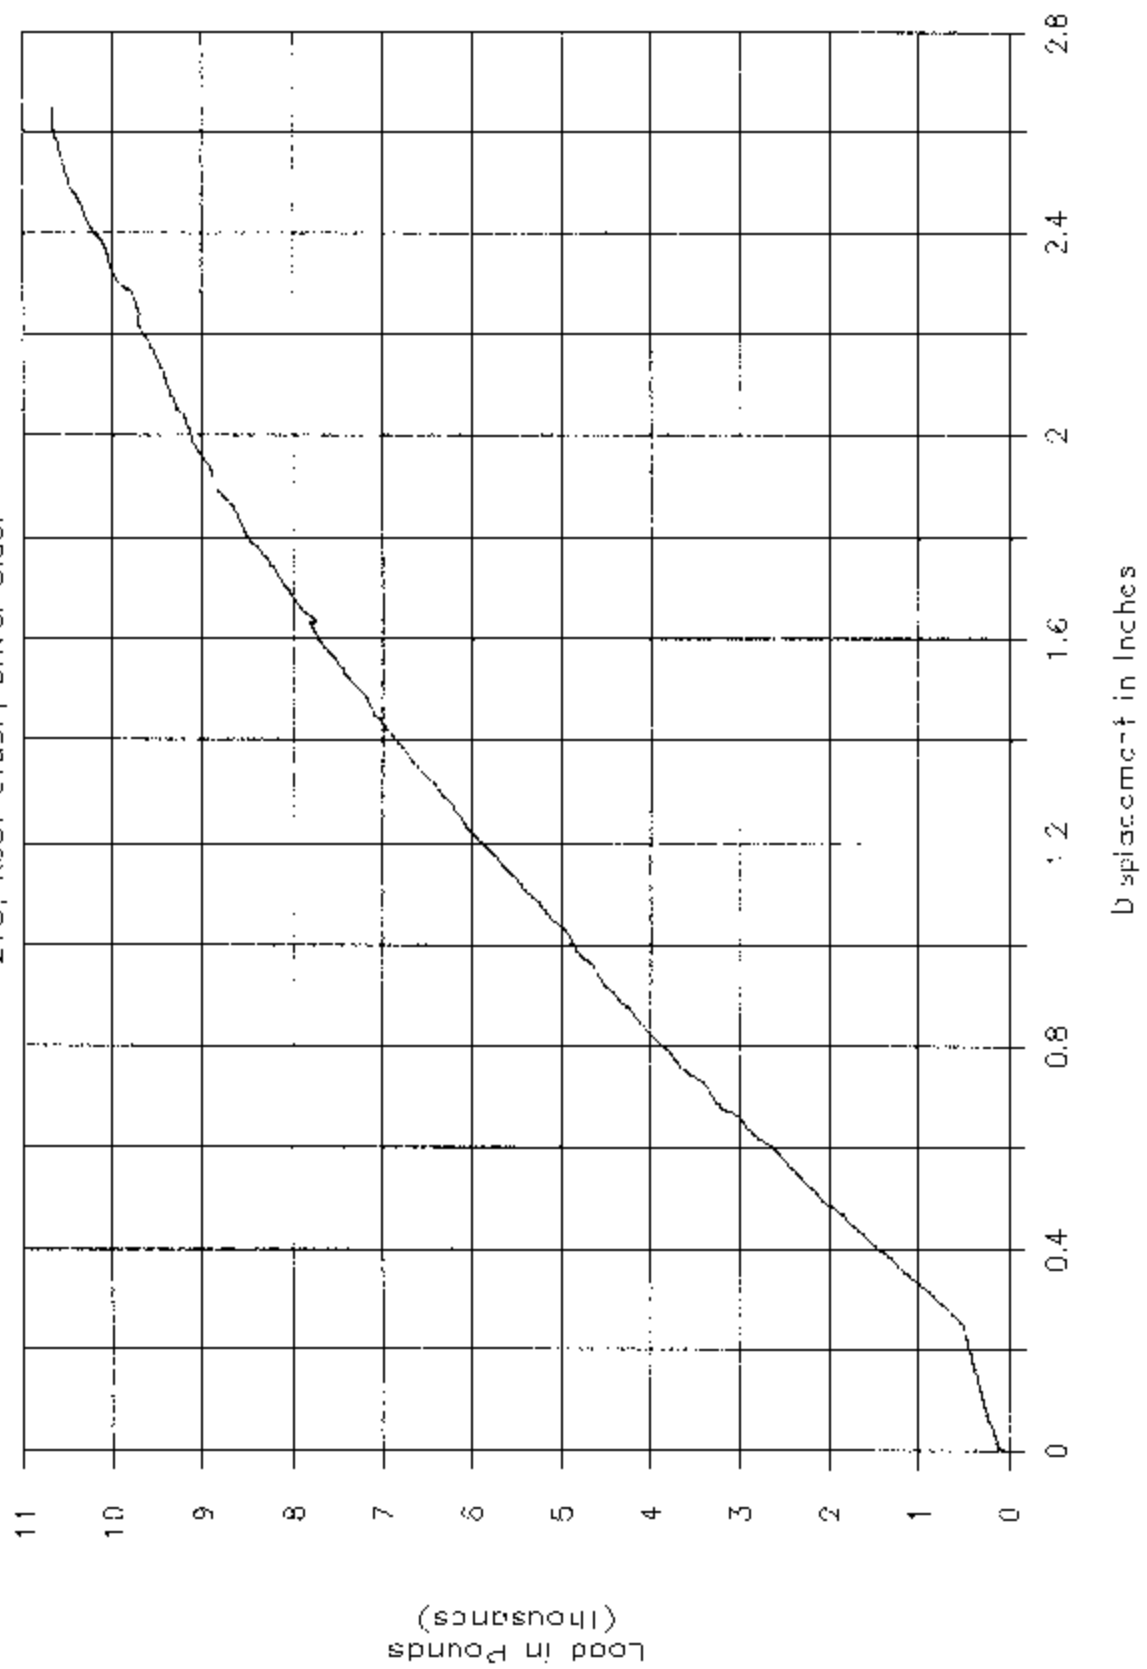
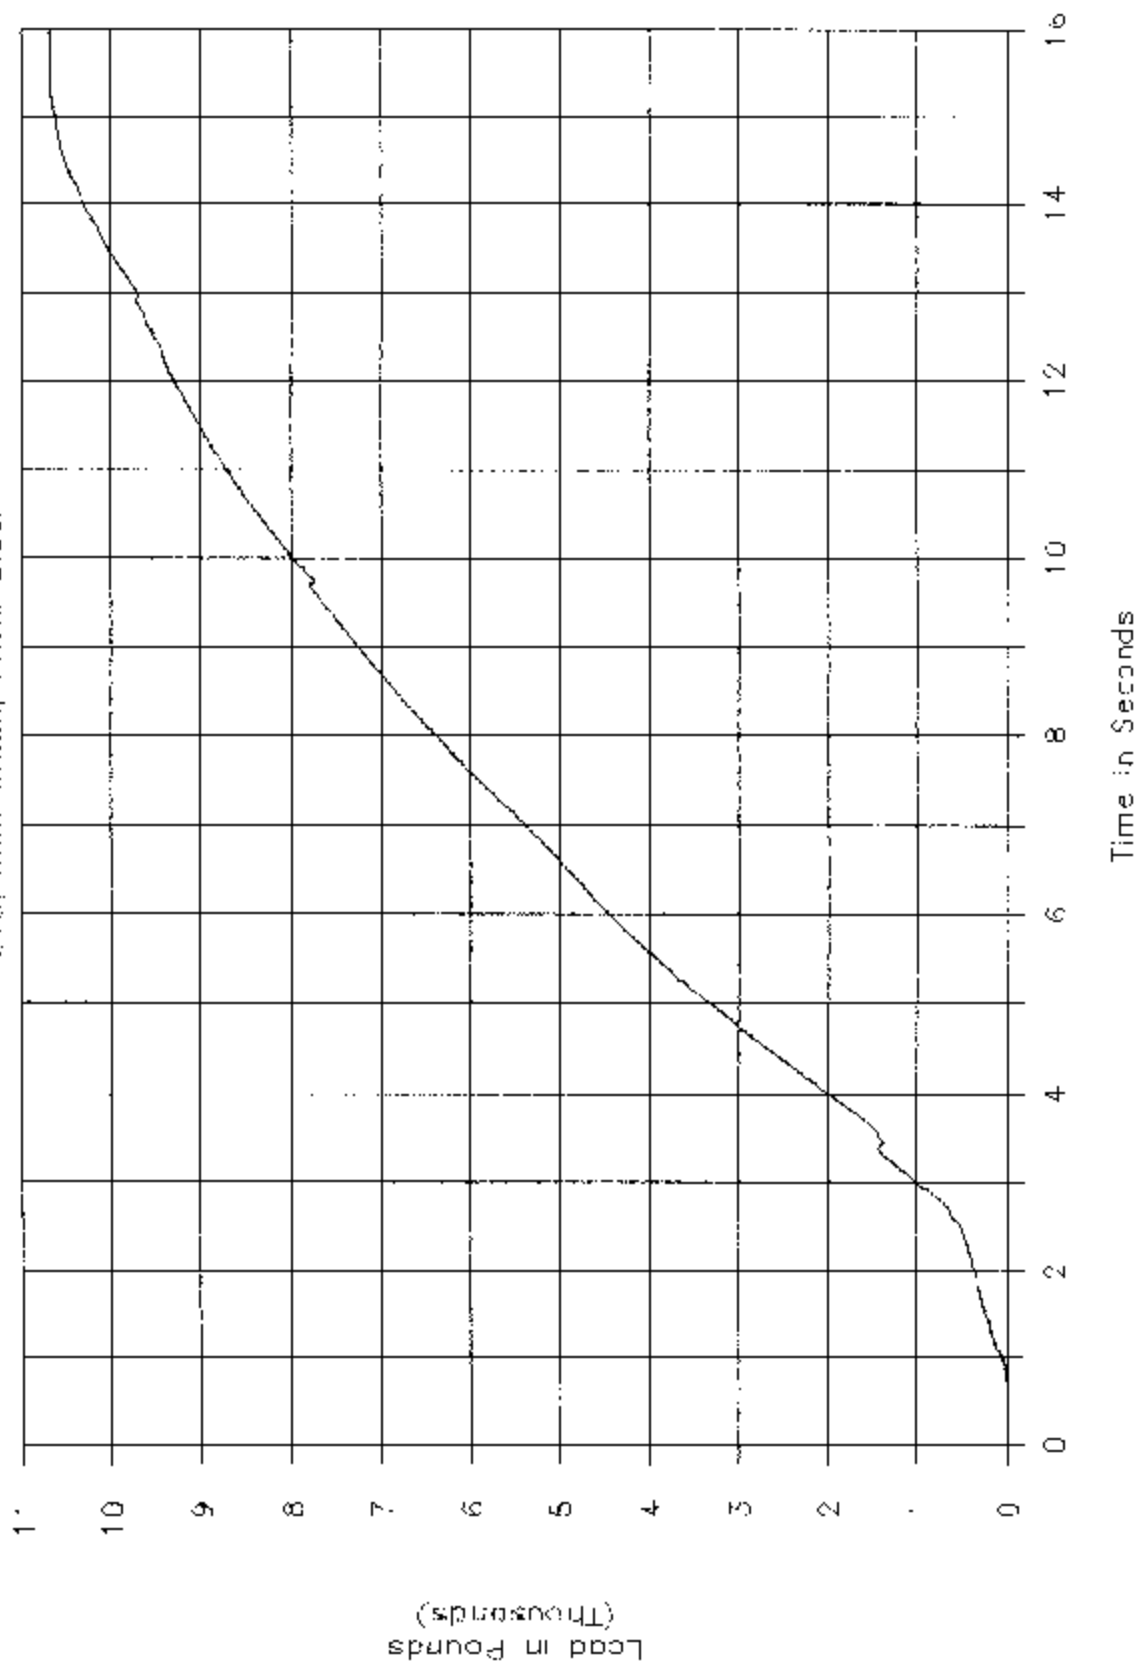
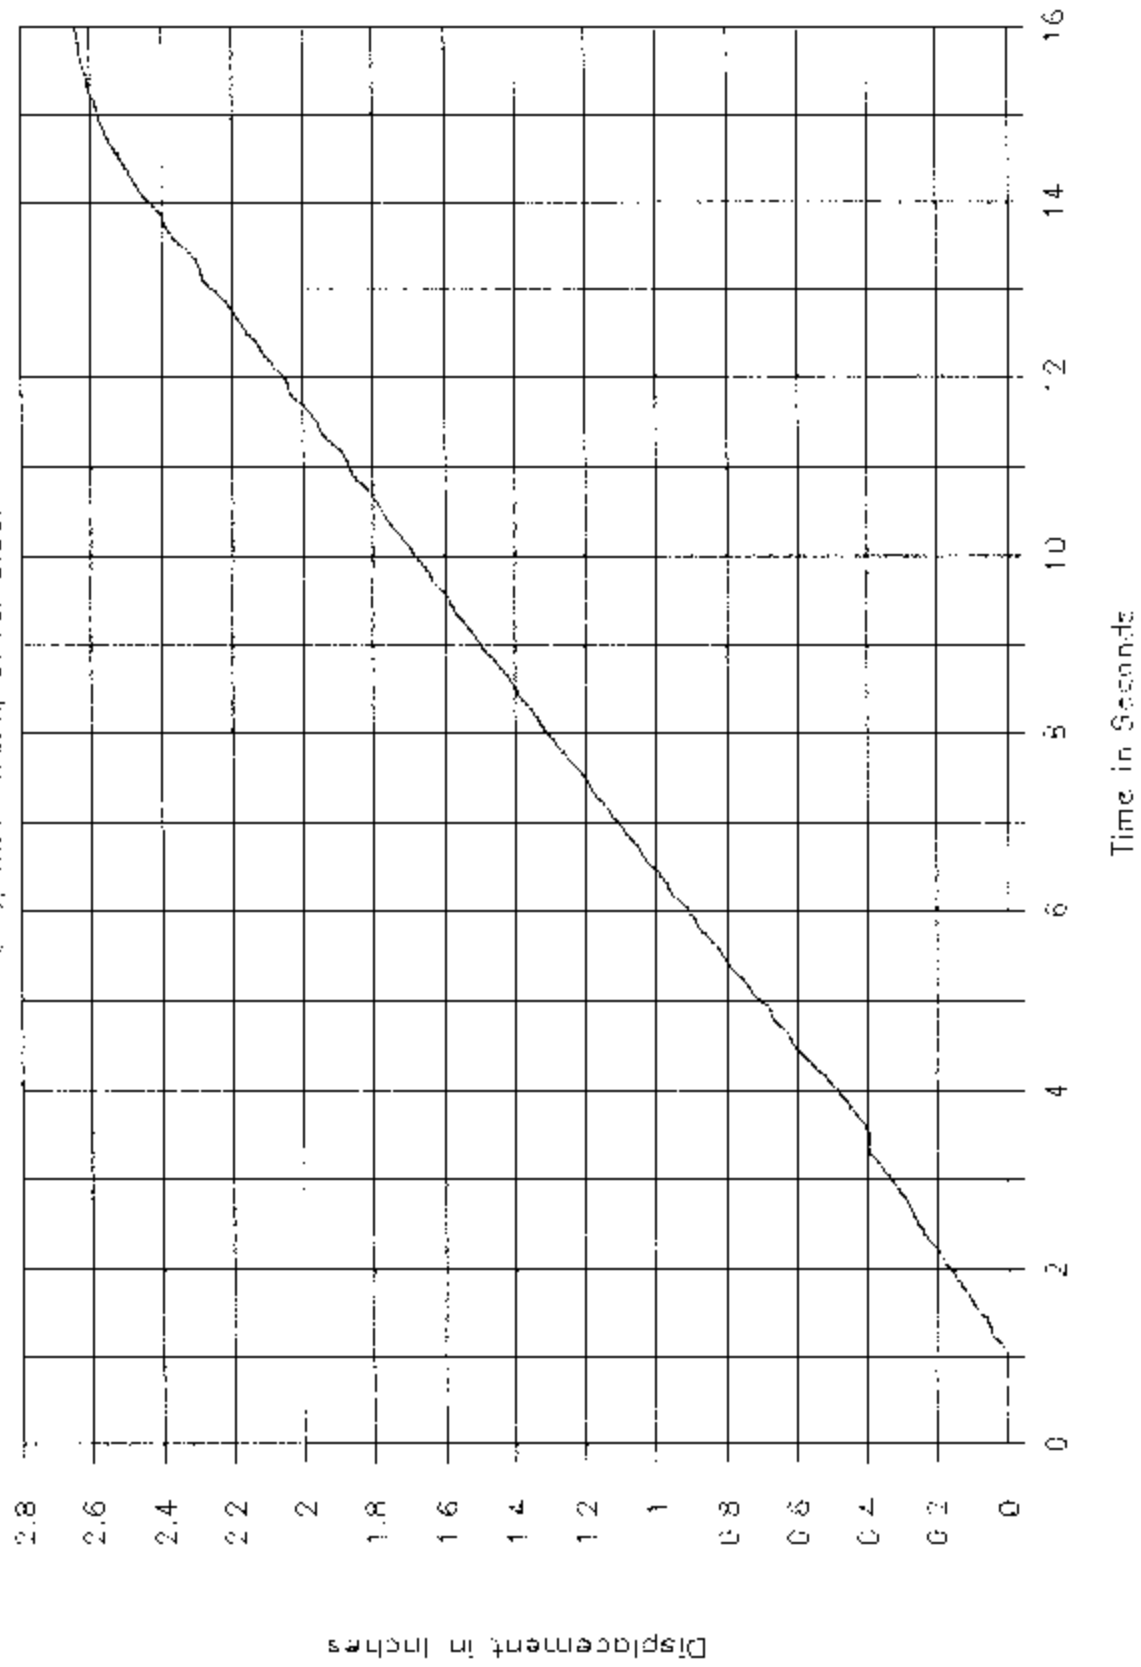
216, Roof Crush, Driver Side.

- (1) The maximum roof crush resistance was 47,563 N at 67.3 mm
- (2) The rate of loading was 5.08 mm/sec (.2 in/sec)
- (3) The required roof crush resistance of 20,889 N was at 24.6 mm
