REPORT NUMBER 214-GTL-06-001

SAFETY COMPLIANCE TESTING FOR FMVSS NO. 214S SIDE IMPACT PROTECTION (STATIC)

HYUNDAI MOTOR COMPANY
2006 HYUNDAI SONATA, PASSENGER CAR
NHTSA NO. C60502

GENERAL TESTING LABORATORIES, INC.
1623 LEEDSTOWN ROAD
COLONIAL BEACH, VIRGINIA 22443

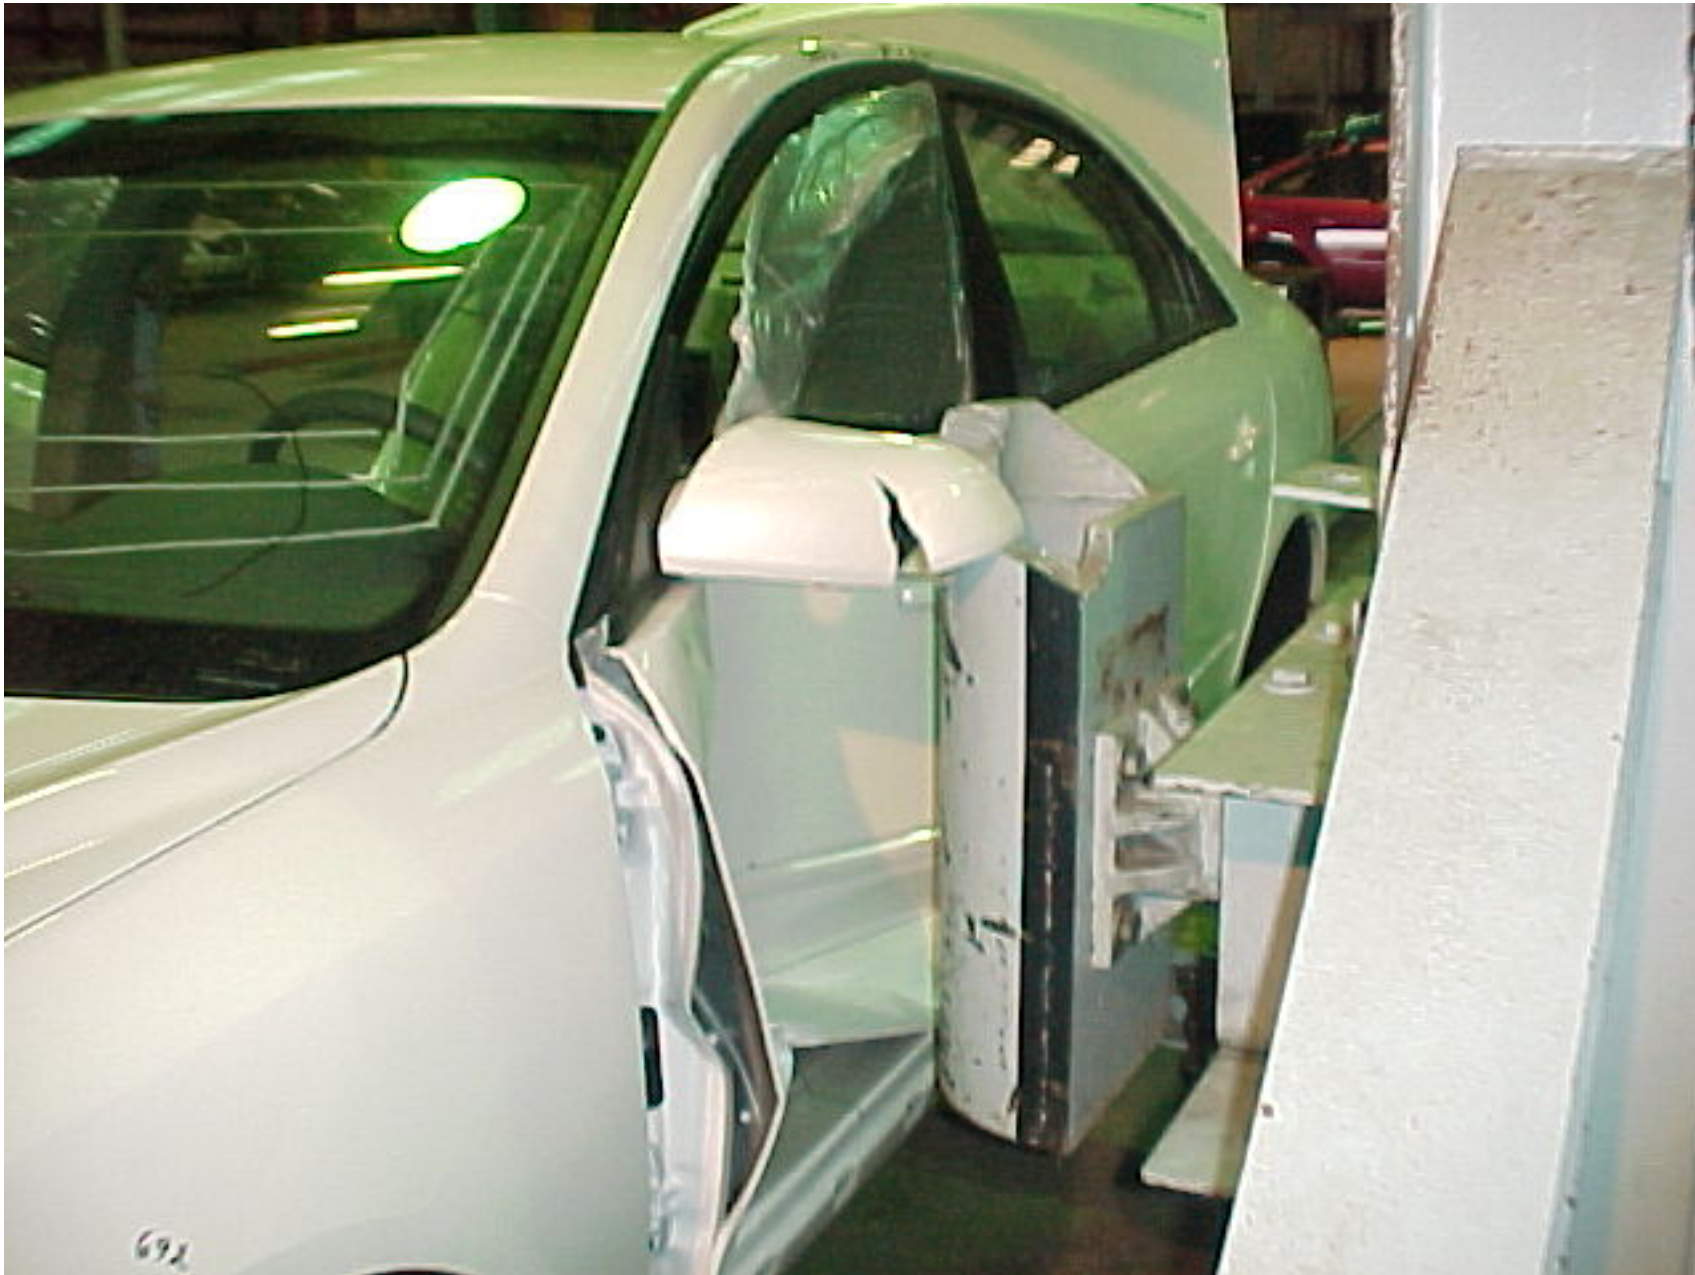
- A. The initial crush resistance was 3241 lbs.
 B. The intermediate crush resistance was 4976 lbs.
 C. The peak crush resistance was 10,336 lbs at 13.25 inches
 D. The rate of loading was .2"/sec

- A. The initial crush resistance was 3236 lbs.
- B. The intermediate crush resistance was 4971 lbs.
- C. The peak crush resistance was 10,260 lbs at 13.25 inches

FIGURE 5.16
POST TEST DOOR OUTSIDE – TEST 1

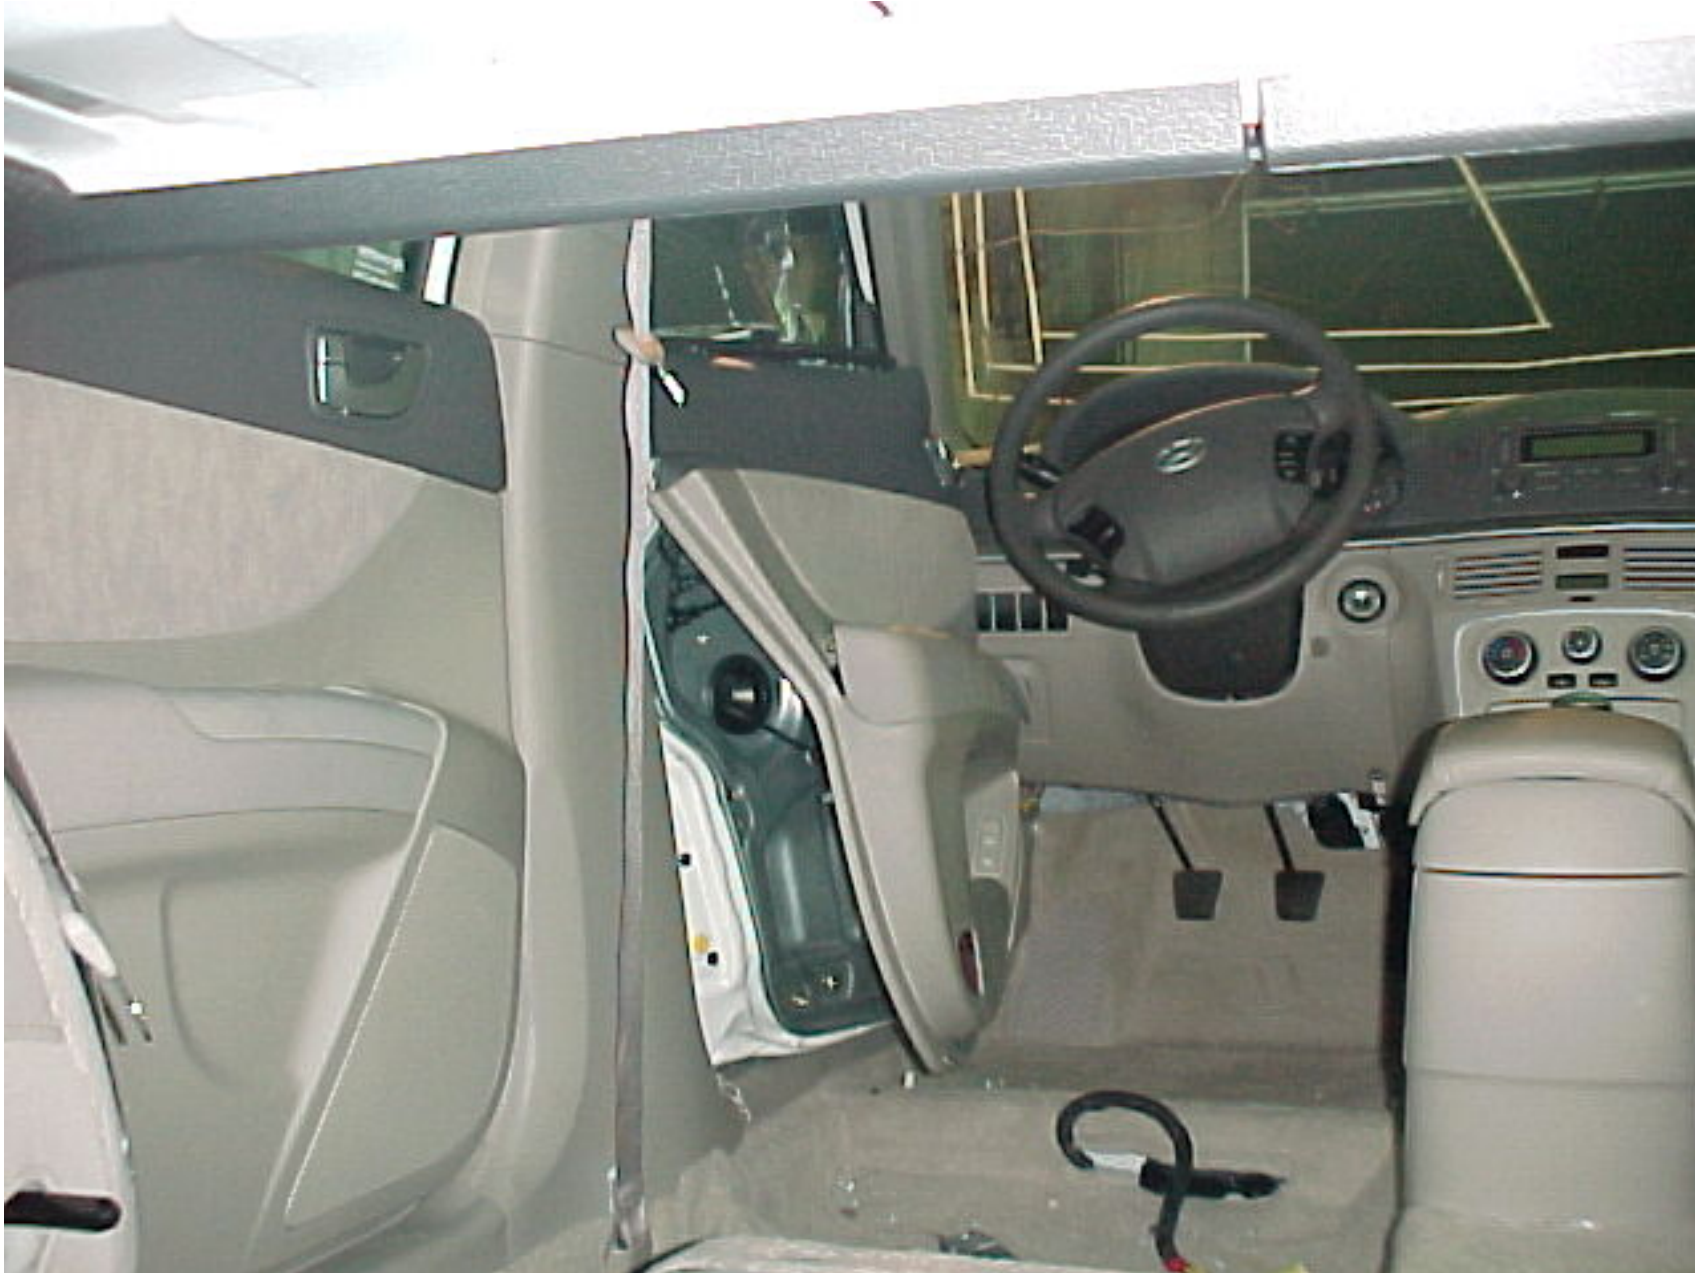
FIGURE 5.17
POST TEST DOOR INSIDE – TEST 1

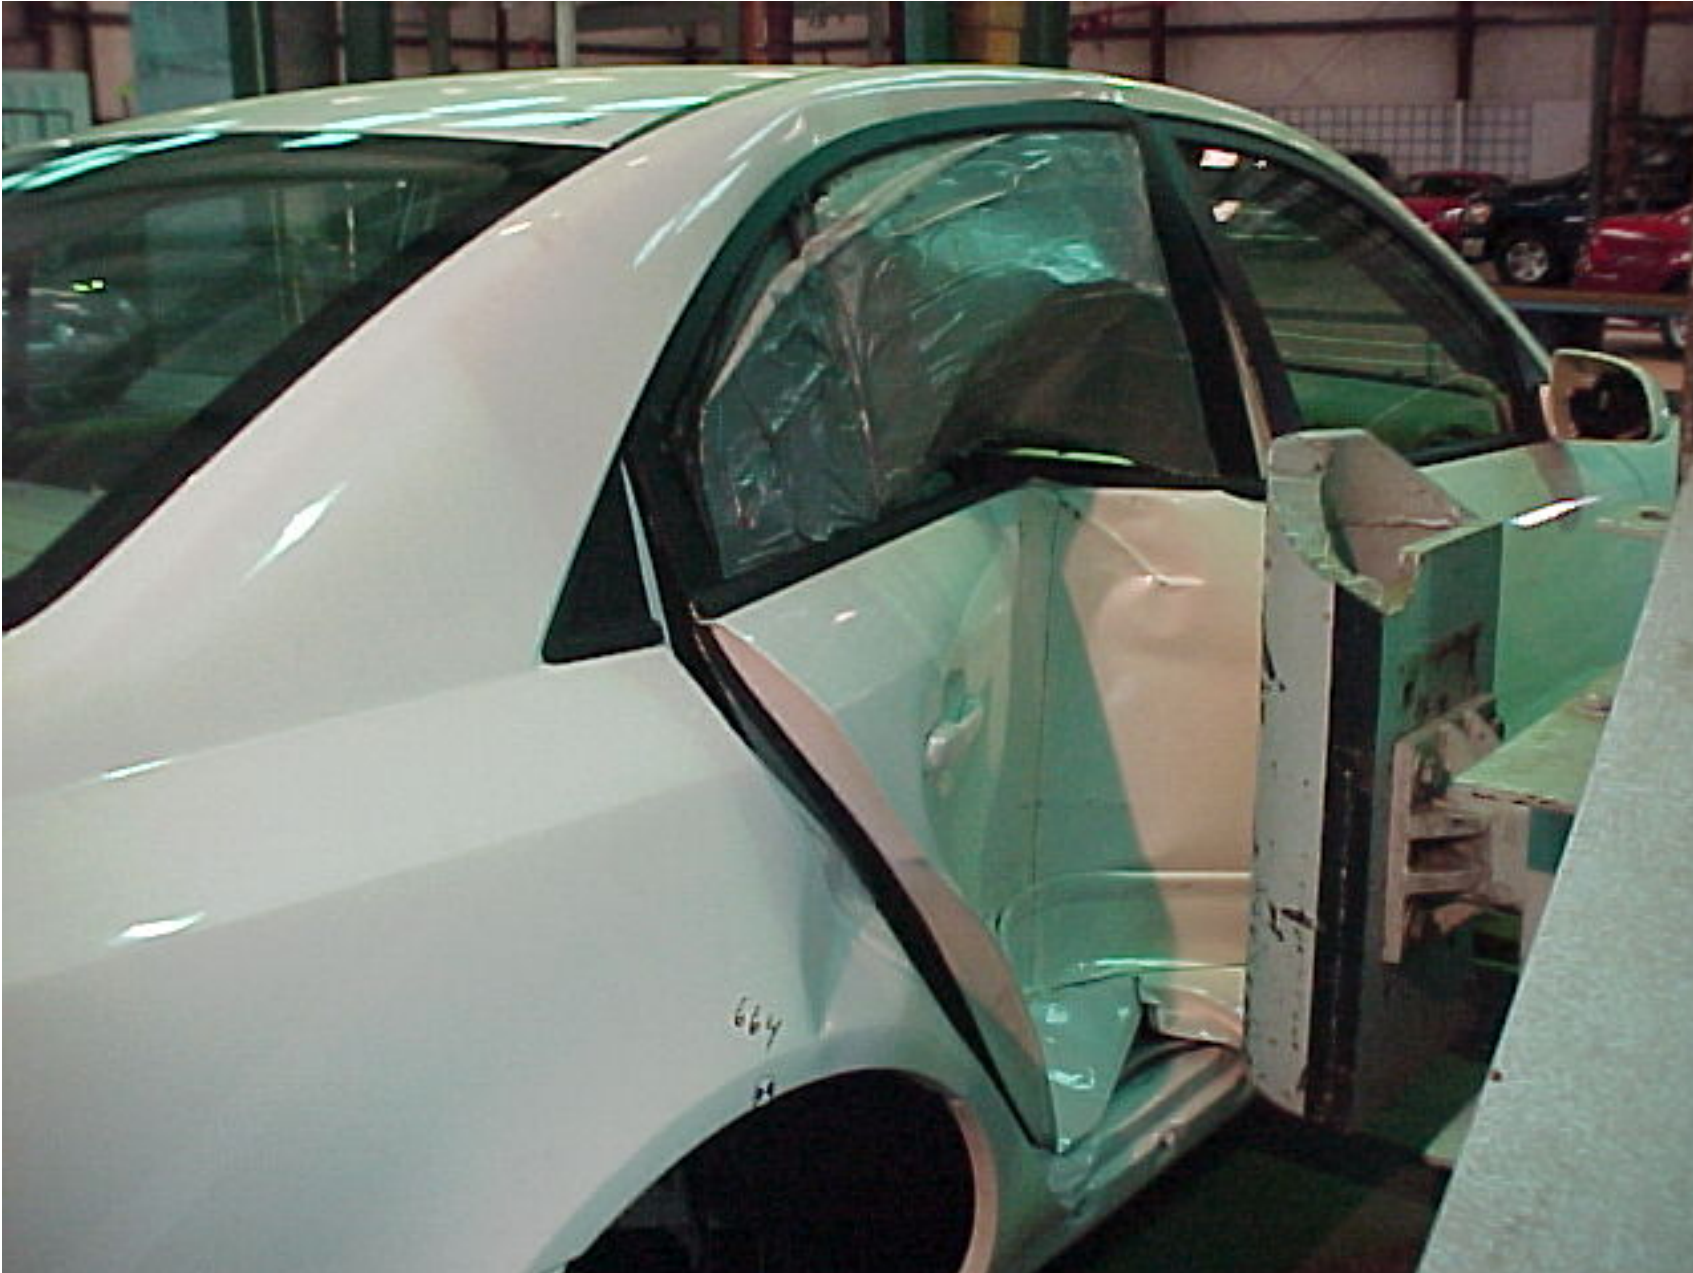
- A. The initial crush resistance was 4226 lbs.
 B. The intermediate crush resistance was 6409 lbs.
 C. The peak crush resistance was 10,966 lbs at 13.14 inches
 D. The rate of loading was .2"/sec

- A. The initial crush resistance was 4268 lbs.
- B. The intermediate crush resistance was 6454 lbs.
- C. The peak crush resistance was 11,003 lbs at 13.04 inches

FIGURE 5.23
POST TEST DOOR OUTSIDE – TEST 2

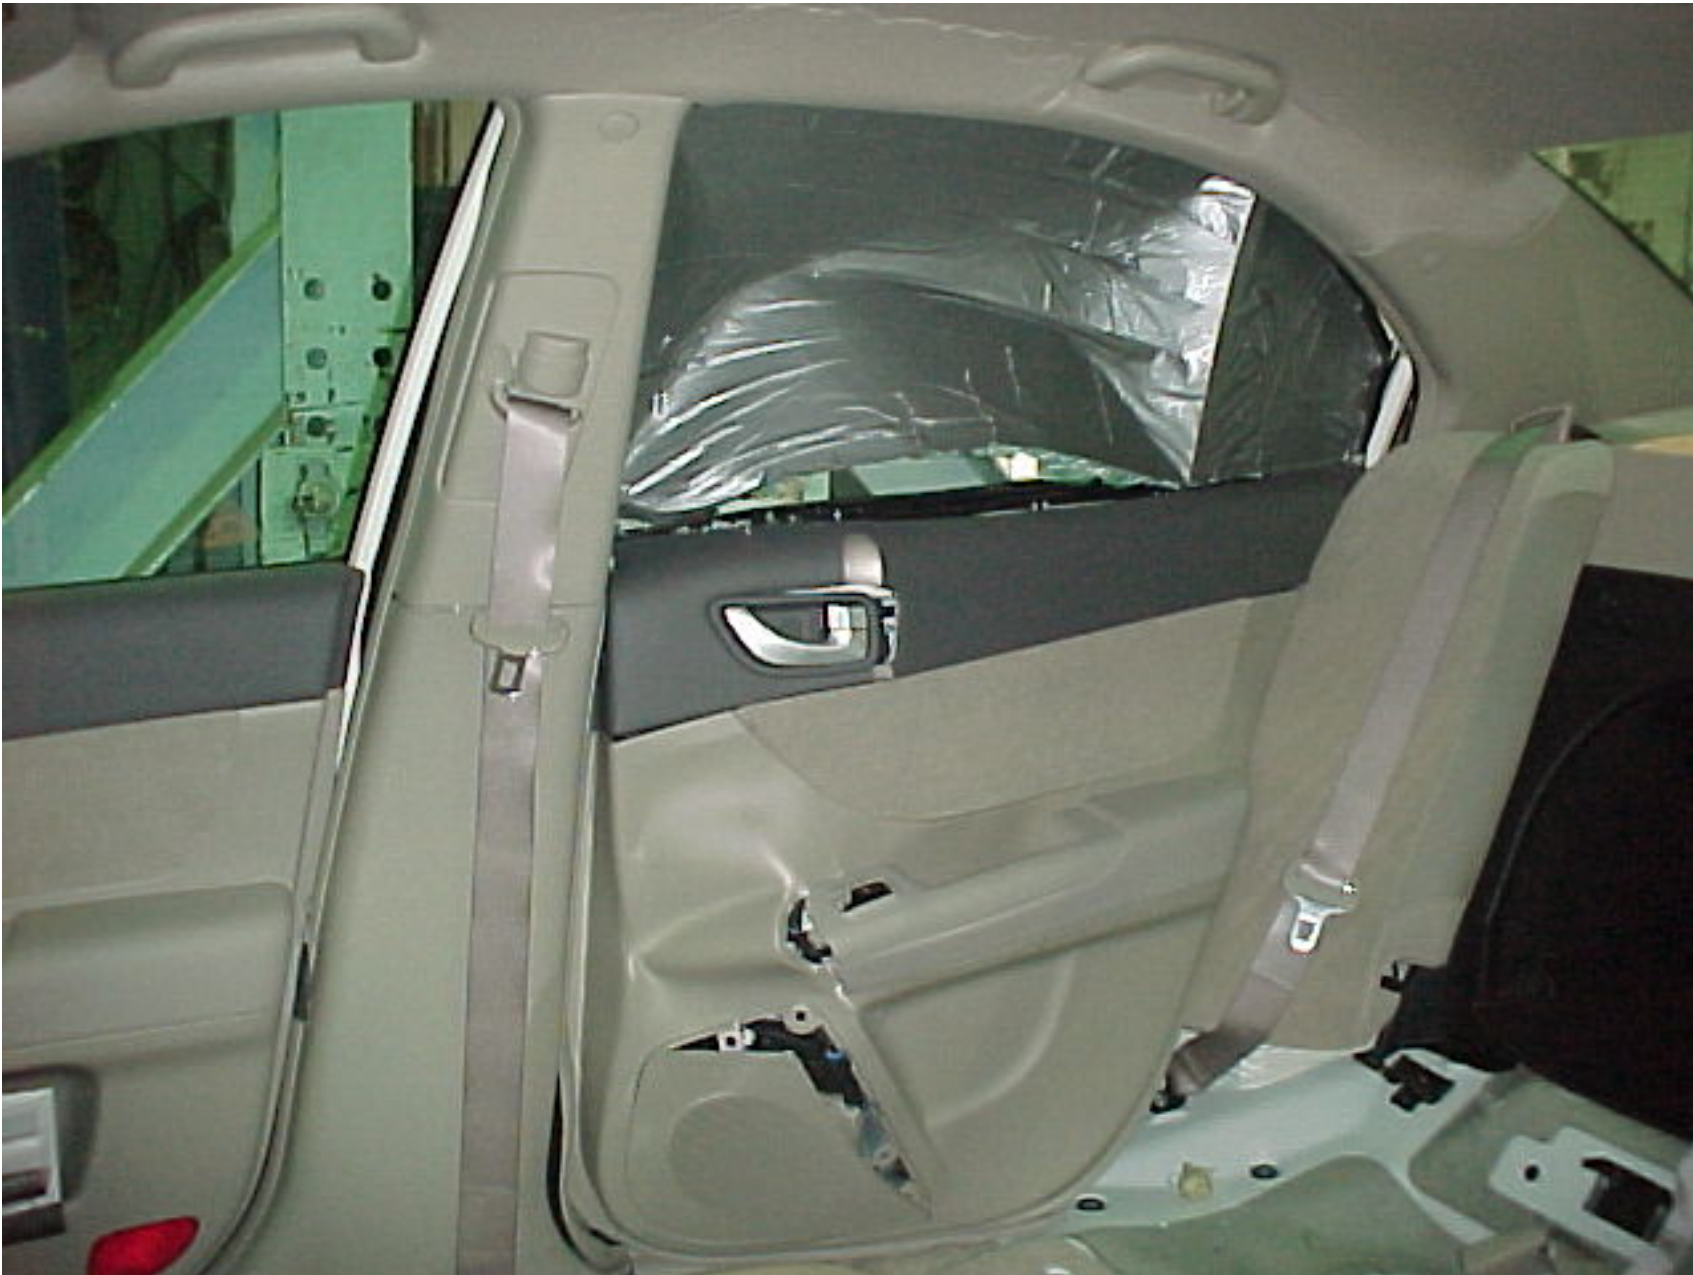
FIGURE 5.24
POST TEST DOOR INSIDE – TEST 2

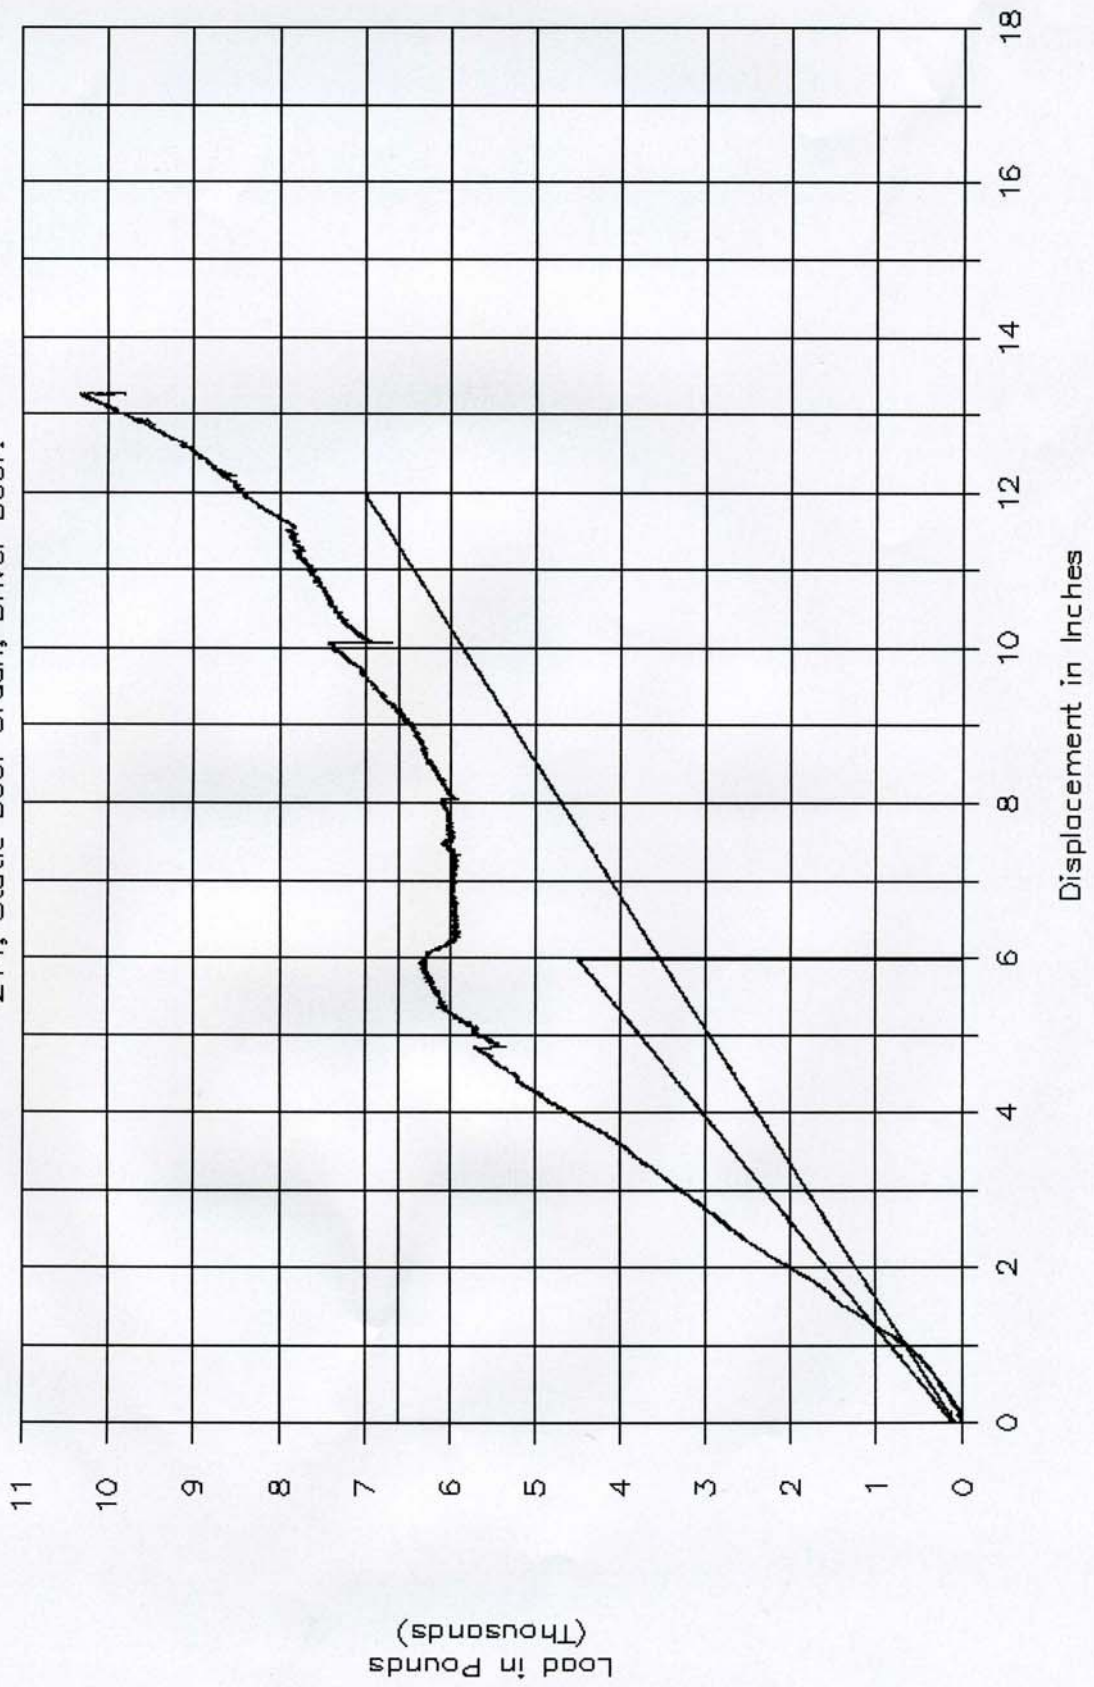
GTL 5579

214, Static Door Crush, Driver Door.

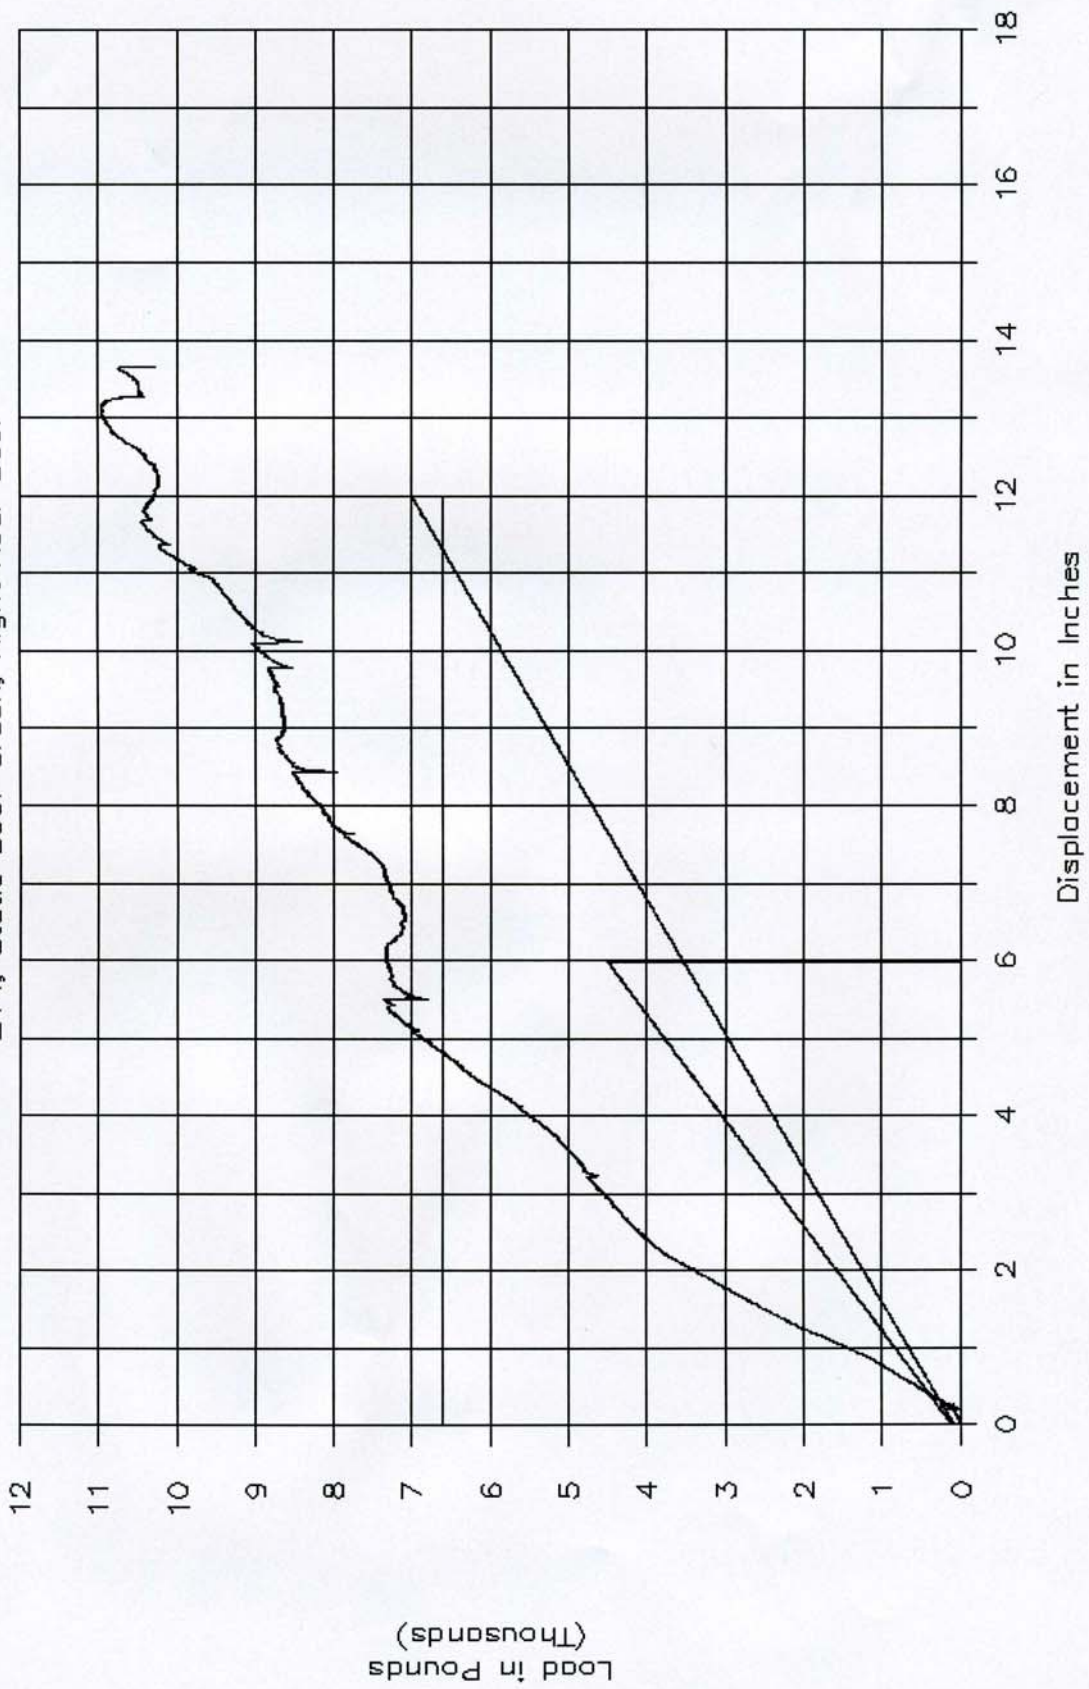
GTL 5580

214, Static Door Crush, Right Rear Door
