REPORT NUMBER 214-GTL-06-004

SAFETY COMPLIANCE TESTING FOR FMVSS NO. 214S SIDE IMPACT PROTECTION (STATIC)

HONDA OF AMERICA MFG., INC.
2006 HONDA CIVIC COUPE, PASSENGER CAR
NHTSA NO. C65301

FINAL REPORT

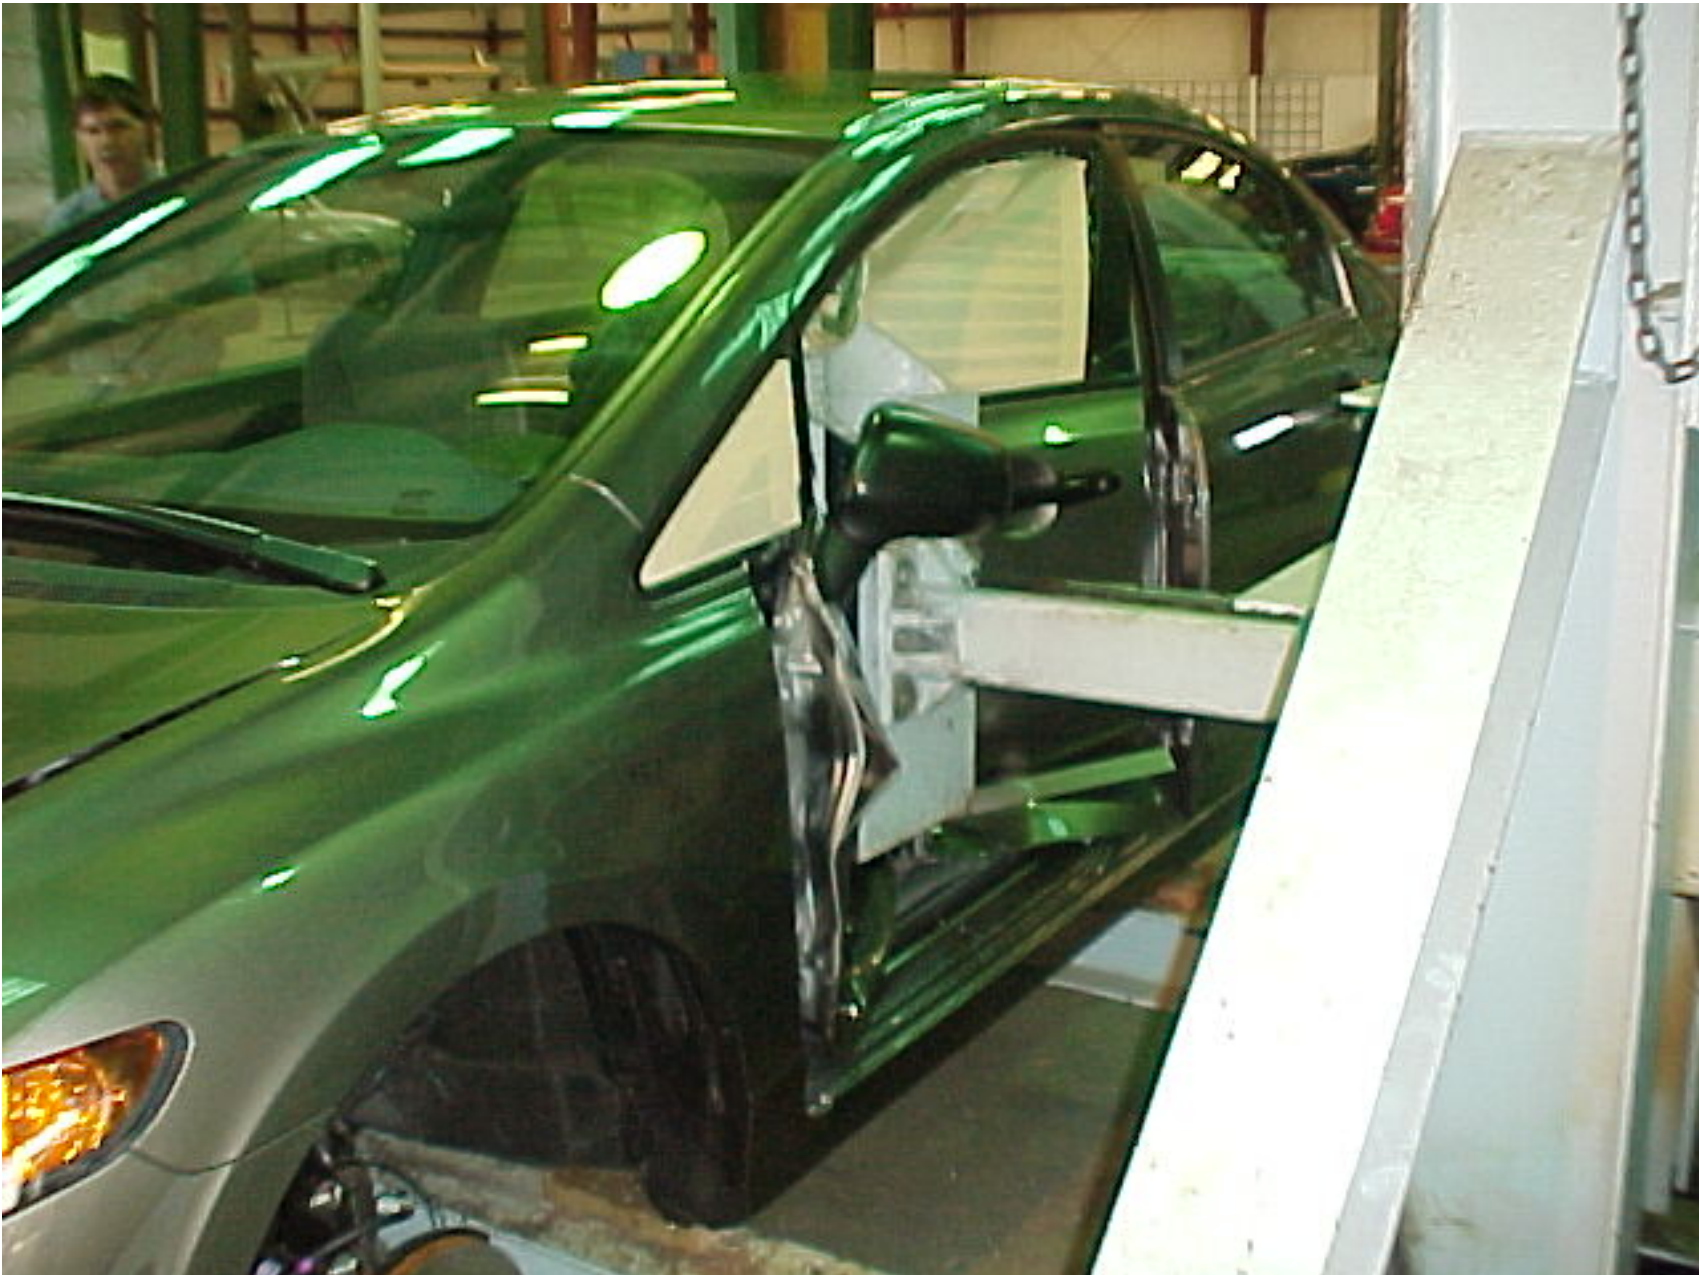
FIGURE 5.14
LOAD DEVICE AGAINST DOOR @ MAX LOAD -
TEST 1

- A. The initial crush resistance was 3728 lbs.
- B. The intermediate crush resistance was 5521 lbs.
- C. The peak crush resistance was 9837 lbs at 13.2 inches

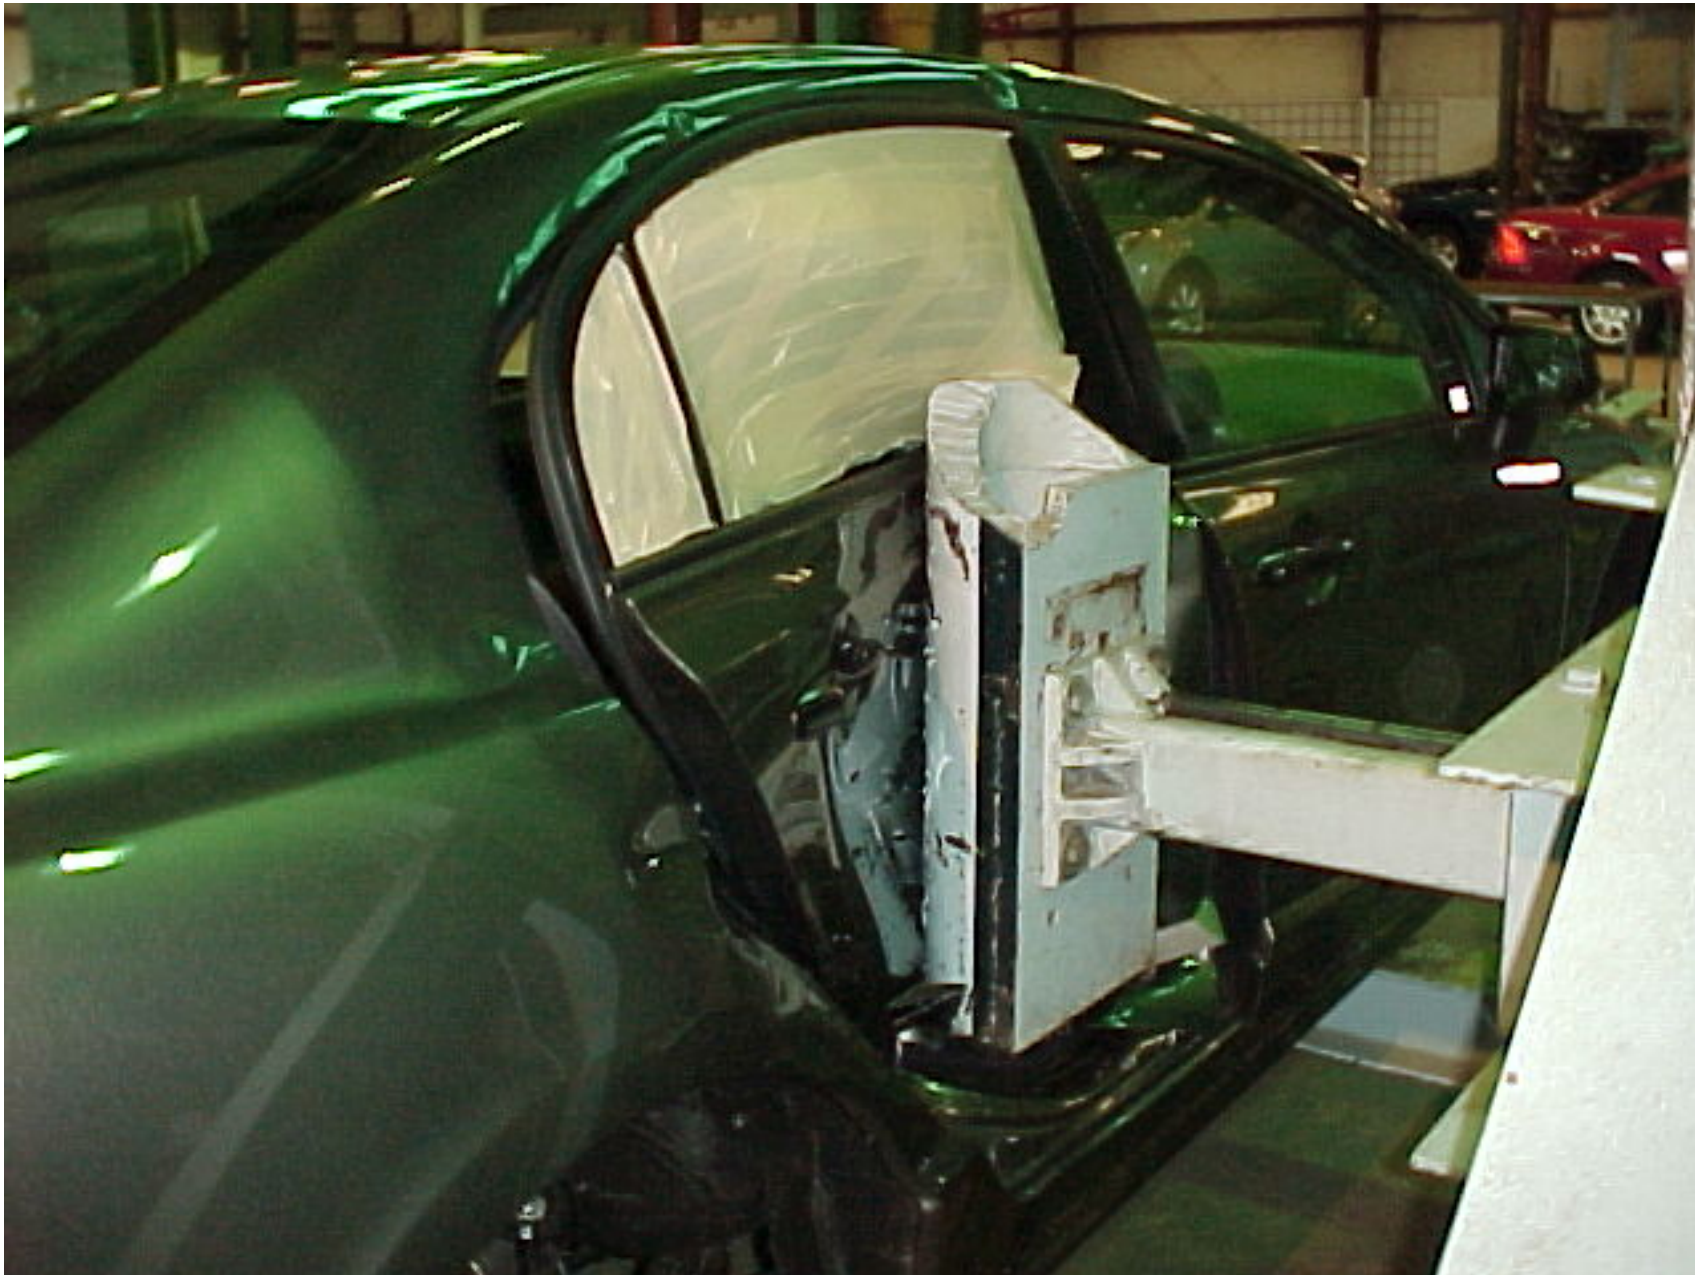
FIGURE 5.21
LOAD DEVICE AGAINST DOOR @ MAX LOAD -
TEST 2

- A. The initial crush resistance was 5585 lbs.
- B. The intermediate crush resistance was 9360 lbs.
- C. The peak crush resistance was 14,726 lbs at 11.60 inches

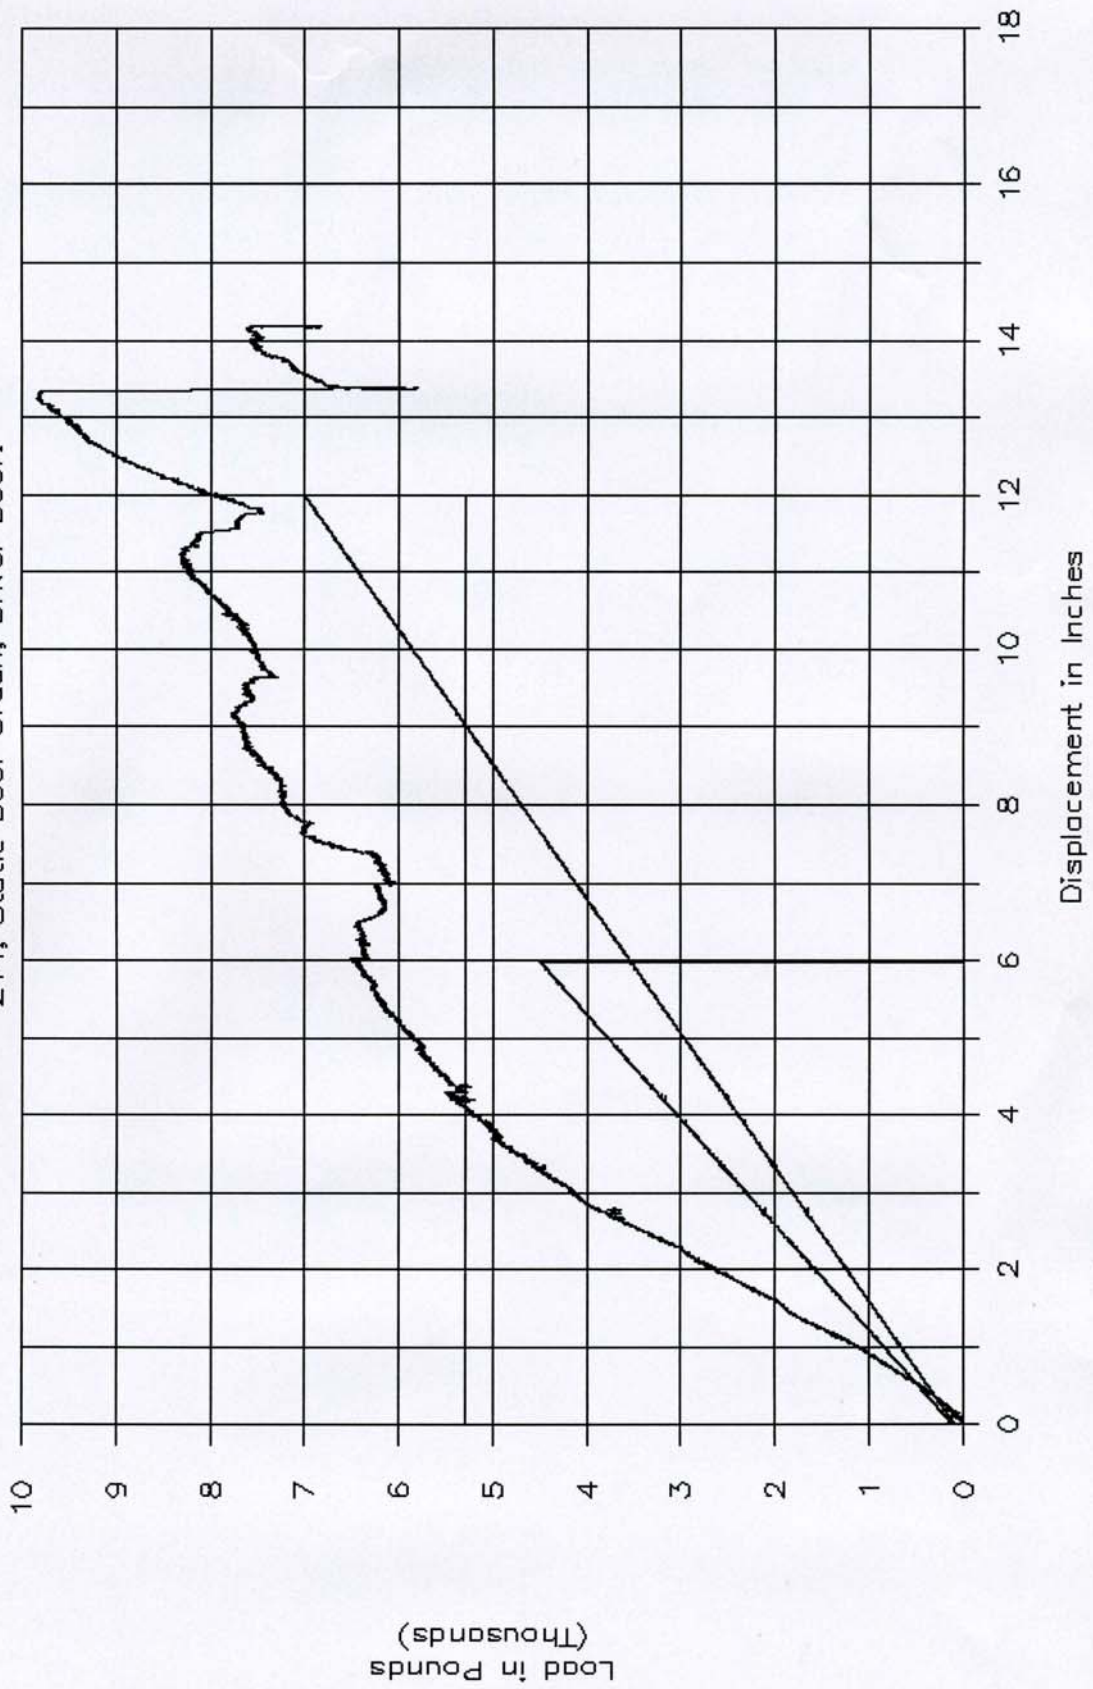
GTL 5585

214, Static Door Crush, Driver Door.

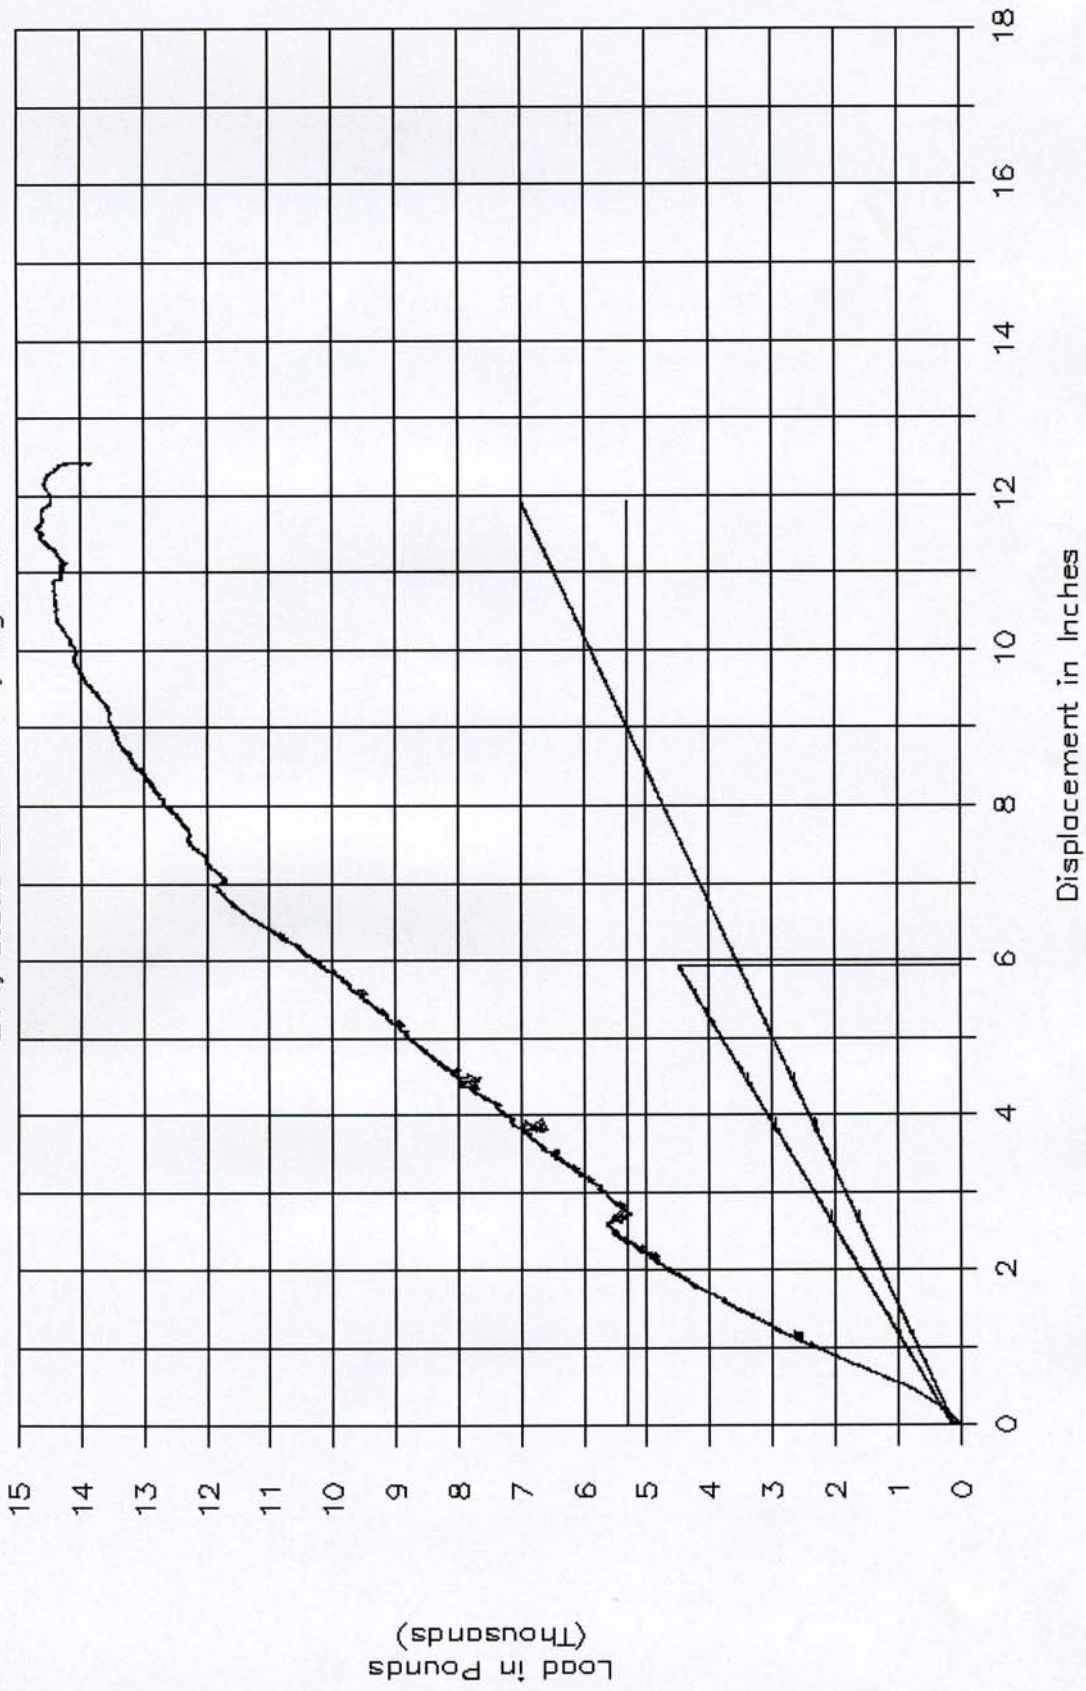
GTL 5586

214, Static Door Crush, Right Rear Door
