REPORT NUMBER: 201P-CAL-07-01

**SAFETY COMPLIANCE TESTING FOR FMVSS 201
RIGID POLE SIDE IMPACT TEST**

DAIMLERCHRYSLER CORPORATION
2007 JEEP COMPASS
SUV

NHTSA NUMBER: C70311

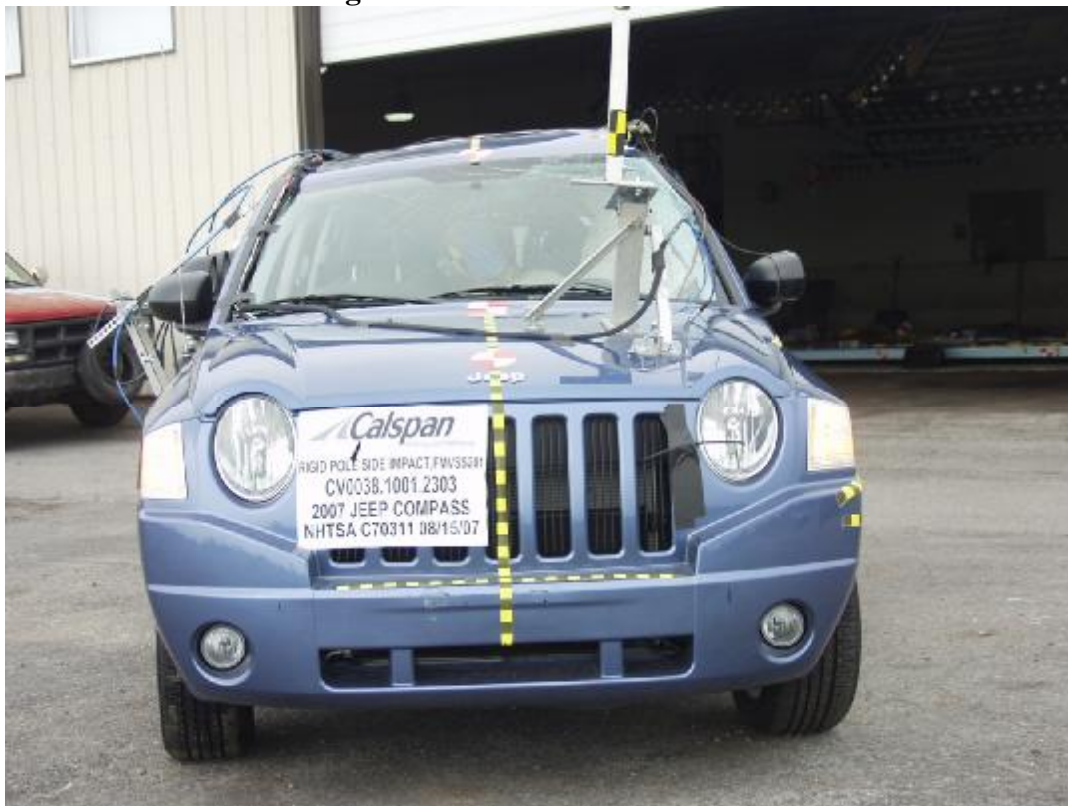
Figure A-6: Post-Test Front View

| Windshield: | Severe cracking on upper left portion |

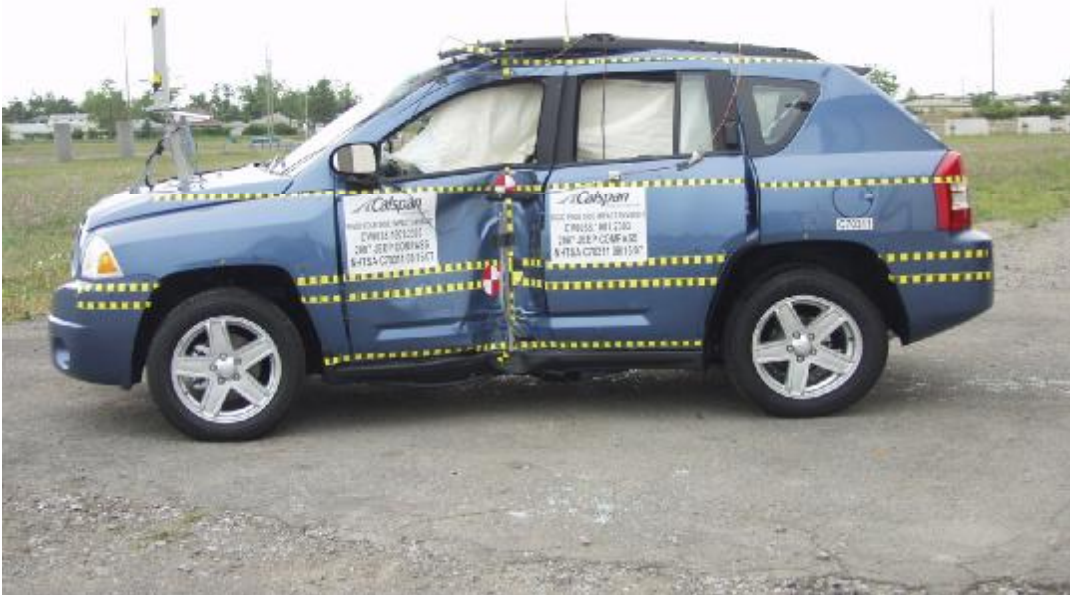
Figure A-10: Post-Test Left Side View

1. LEVEL 1 (341 mm above ground) = 239 millimeters

2. LEVEL 2 (612 mm above ground) = 310 millimeters

3. LEVEL 3 (686 mm above ground) = 315 millimeters

4. LEVEL 4 (980 mm above ground) = 303 millimeters

5. LEVEL 5 (1539 mm above ground) = 511 millimeters

Maximum Post-Test Intrusion = 511 millimeters

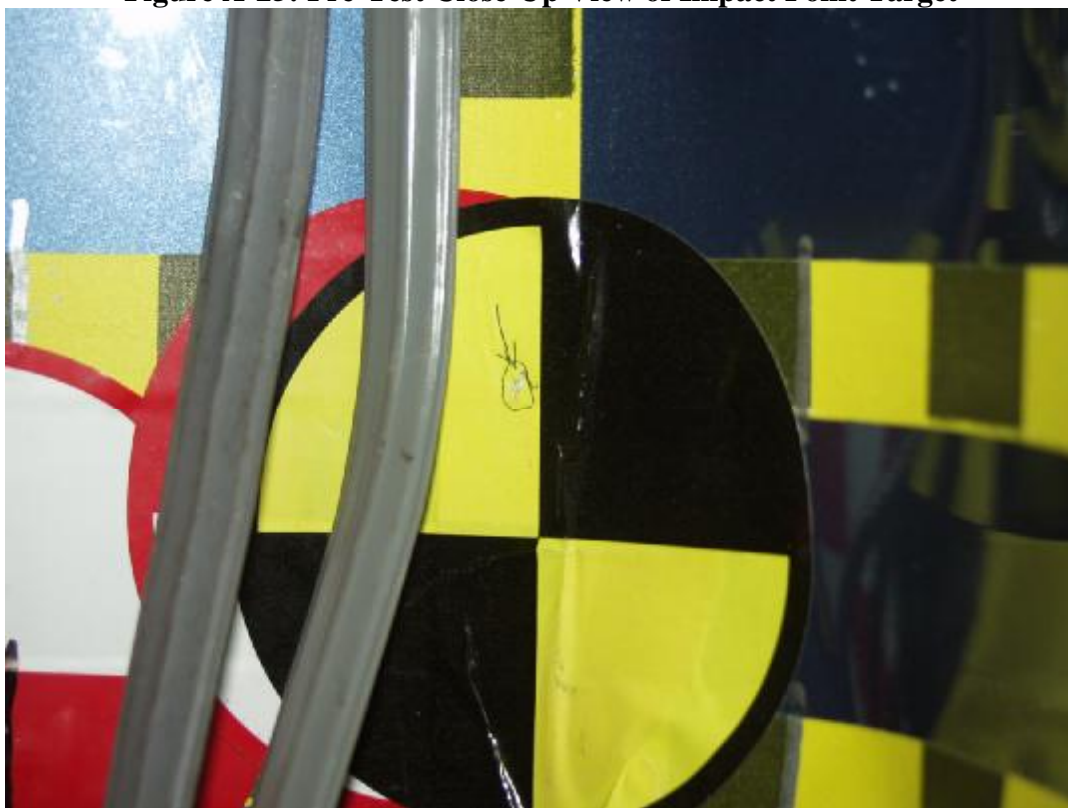
Figure A-26: Post-Test Close-Up View of Impact Point Target
(Note: The impact point was moved approximately 22 mm rearward of initial pre-test Target location)
