REPORT NUMBER: 305-CAL-08-01

**SAFETY COMPLIANCE TESTING FOR FMVSS 305
ELECTRIC POWERED VEHICLES: ELECTROLYTE SPILLAGE
AND ELECTRICAL SHOCK PROTECTION**

GENERAL MOTORS CORPORATION
2008 CHEVROLET MALIBU HYBRID
4-DOOR SEDAN

NHTSA NUMBER: C80110

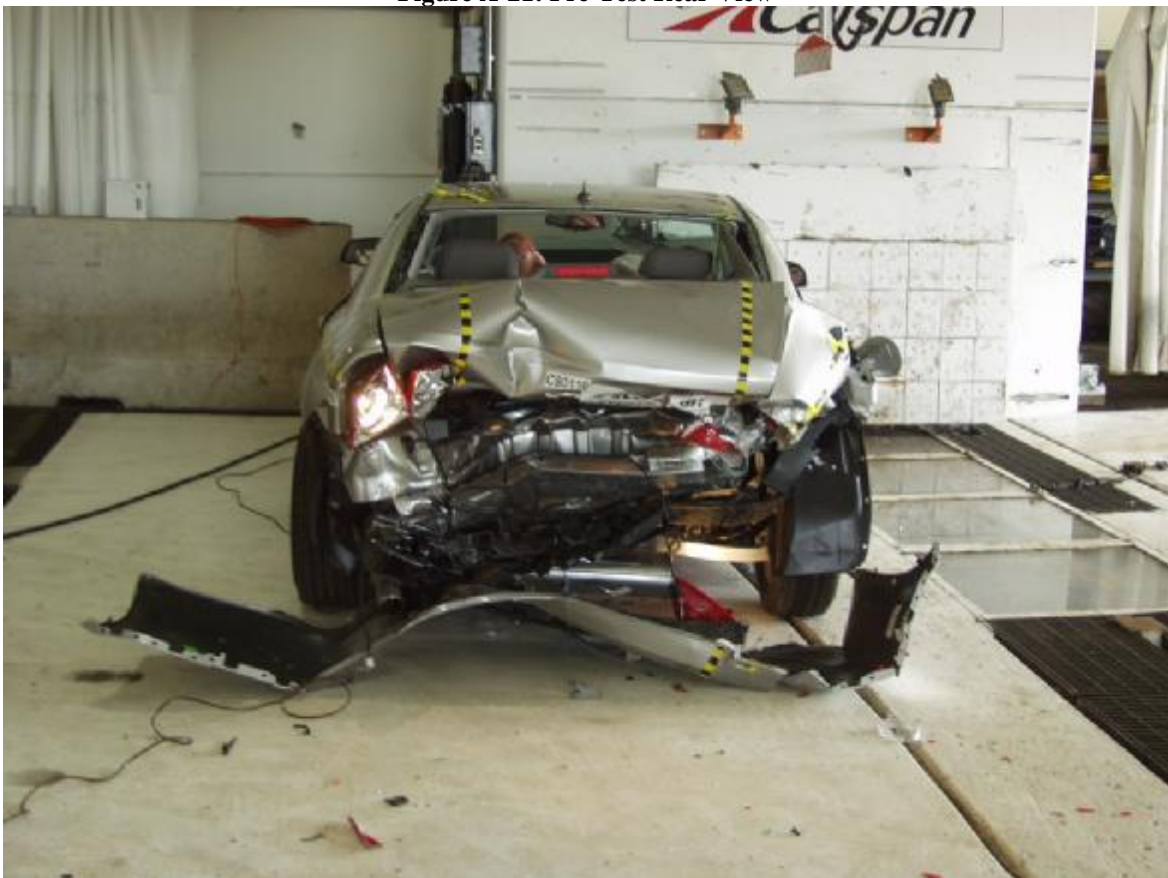
Figure A-22: Post-Test Rear View

Left Side	Centerline	Right Side
Pre-Test	4715	4865	4717
Post-Test	4631	4421	4241
Crush	84	444	476

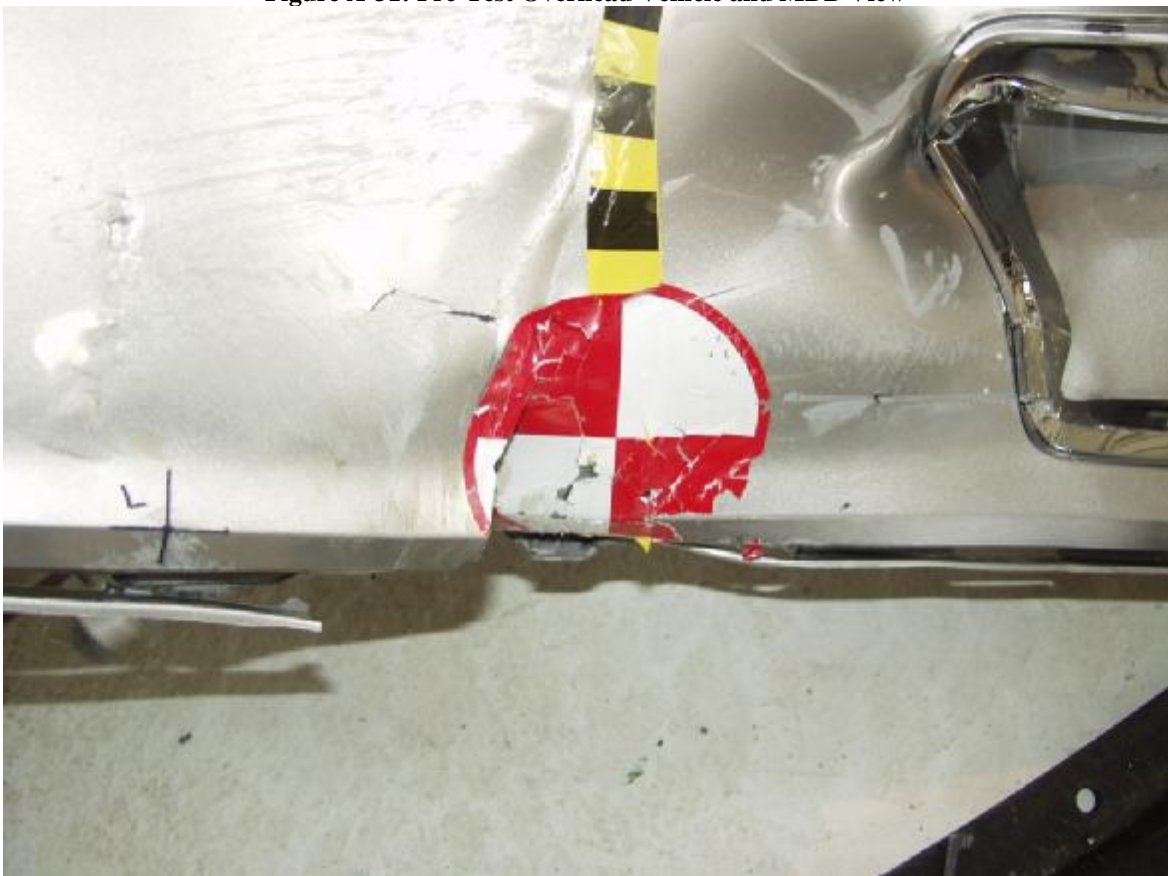
Figure A-32: Post-Test Impact Target View

-7 Vertical distance from target center (+ is above) Tolerance: ±40 mm

7 Horizontal distance from target center (+ is right) Tolerance: ±50 mm

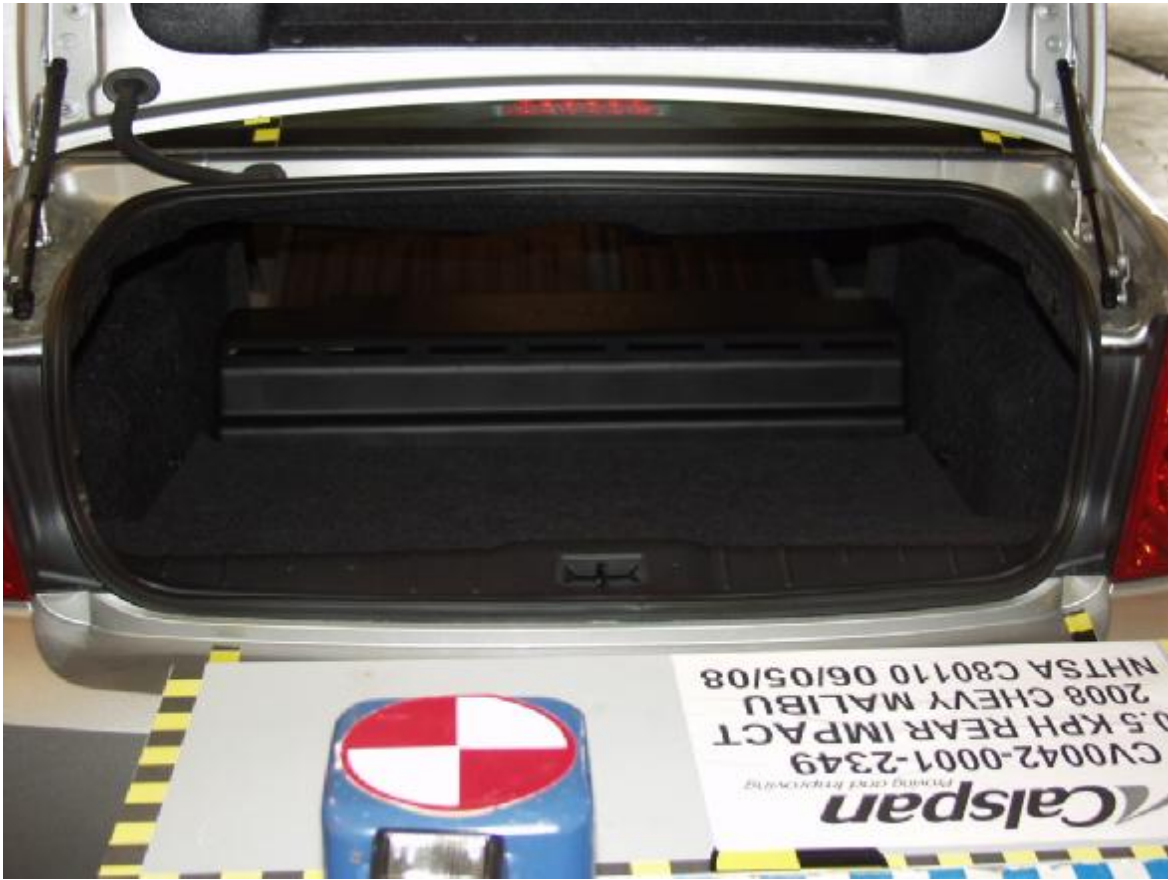
Figure A-39: Pre-Test Battery Compartment View

Trunk and rear folding seats not operable
