**SAFETY COMPLIANCE TESTING FOR
FMVSS NO. 214S
SIDE IMPACT PROTECTION (STATIC)**

**MAZDA MOTOR CORPORATION
2009 MAZDA 3, PASSENGER CAR
NHTSA NO. C95400**

**GENERAL TESTING LABORATORIES, INC.
1623 LEEDSTOWN ROAD
COLONIAL BEACH, VIRGINIA 22443**

1. Report No. 214-GTL-09-002	2. Government Accession No. N/A	3. Recipient's Catalog No. N/A
4. Title and Subtitle Final Report of FMVSS 214 Compliance Testing of 2009 MAZDA 3, PASSENGER CAR NHTSA No. C95400		5. Report Date August 12, 2009

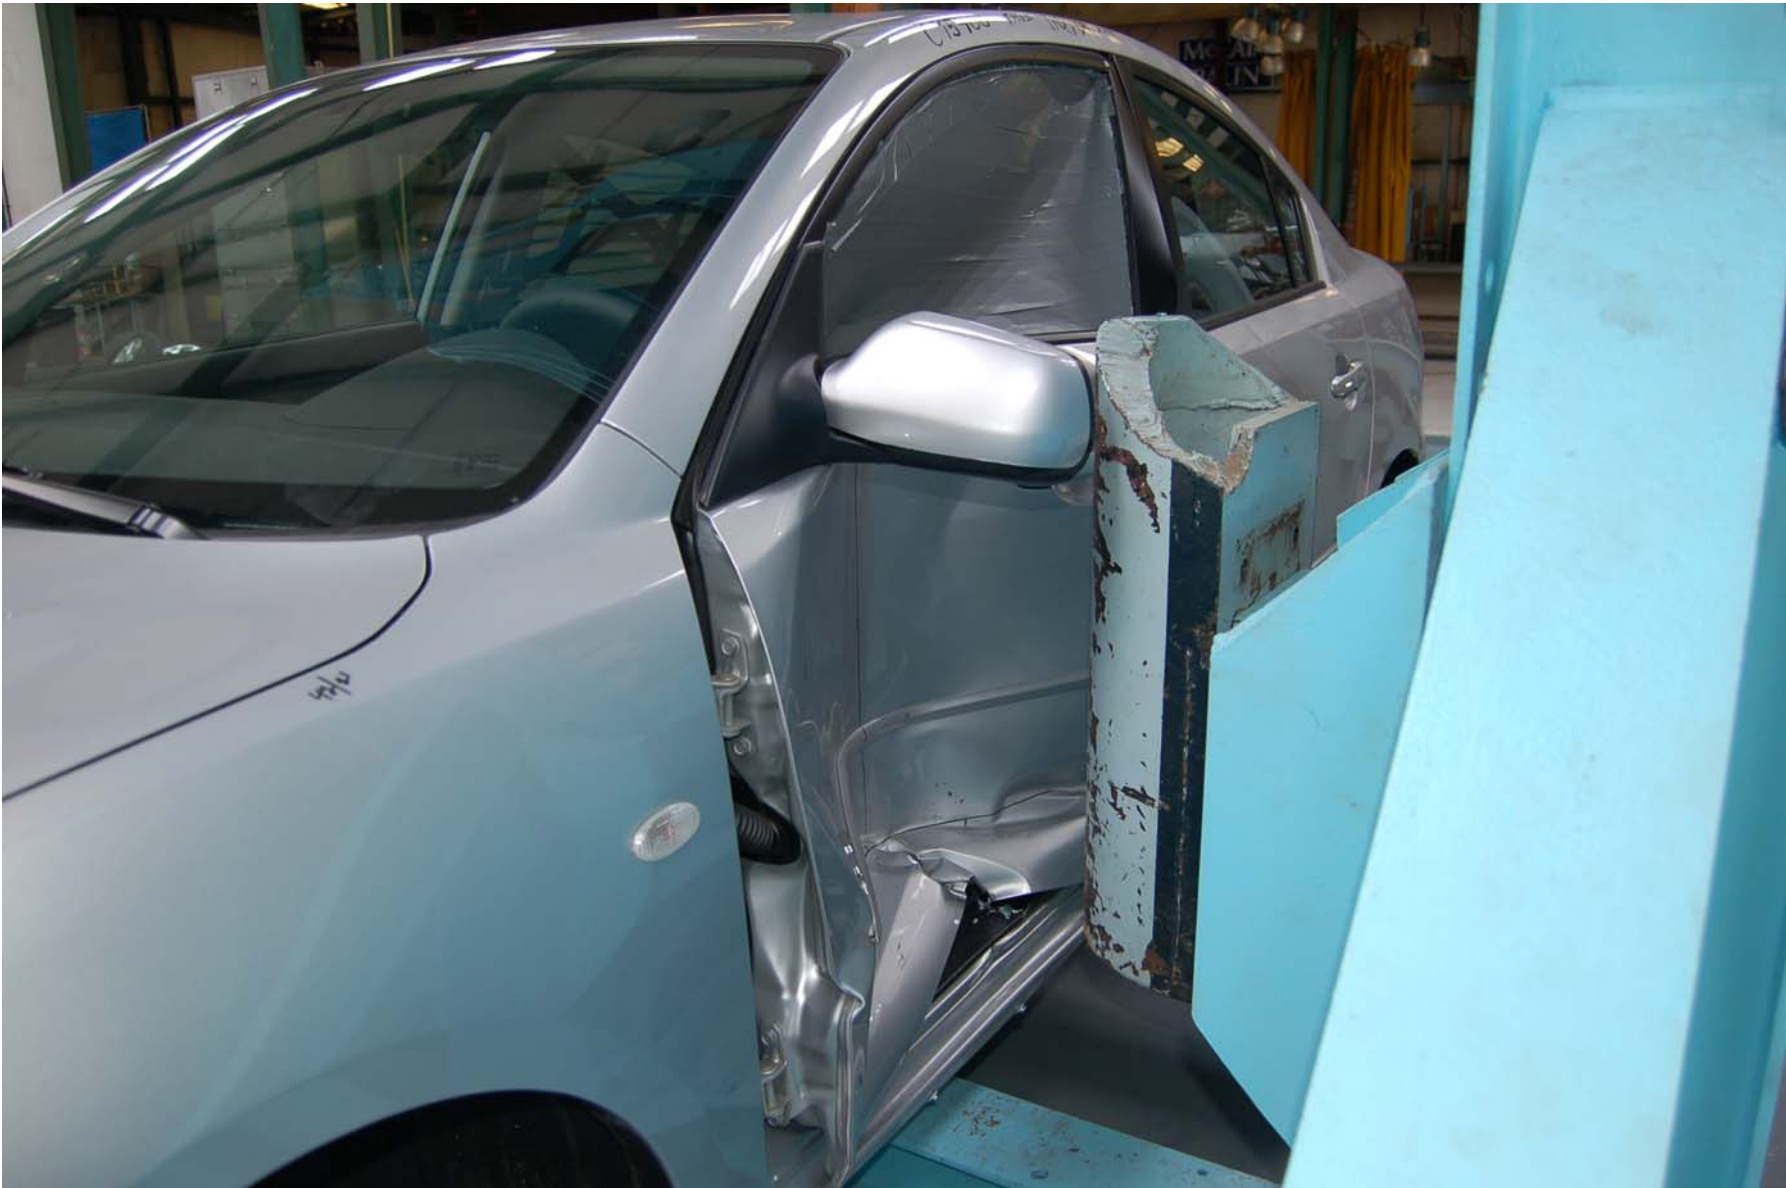
FIGURE 5.19
POST TEST DOOR OUTSIDE – TEST 1

TEST #1 - GTL #6271 (LEFT FRONT DOOR)

- A. The initial crush resistance was 3321 lbs.
 B. The intermediate crush resistance was 4751 lbs.
 C. The peak crush resistance was 9503 lbs at 12.3 inches
 D. The rate of loading was .2"/sec

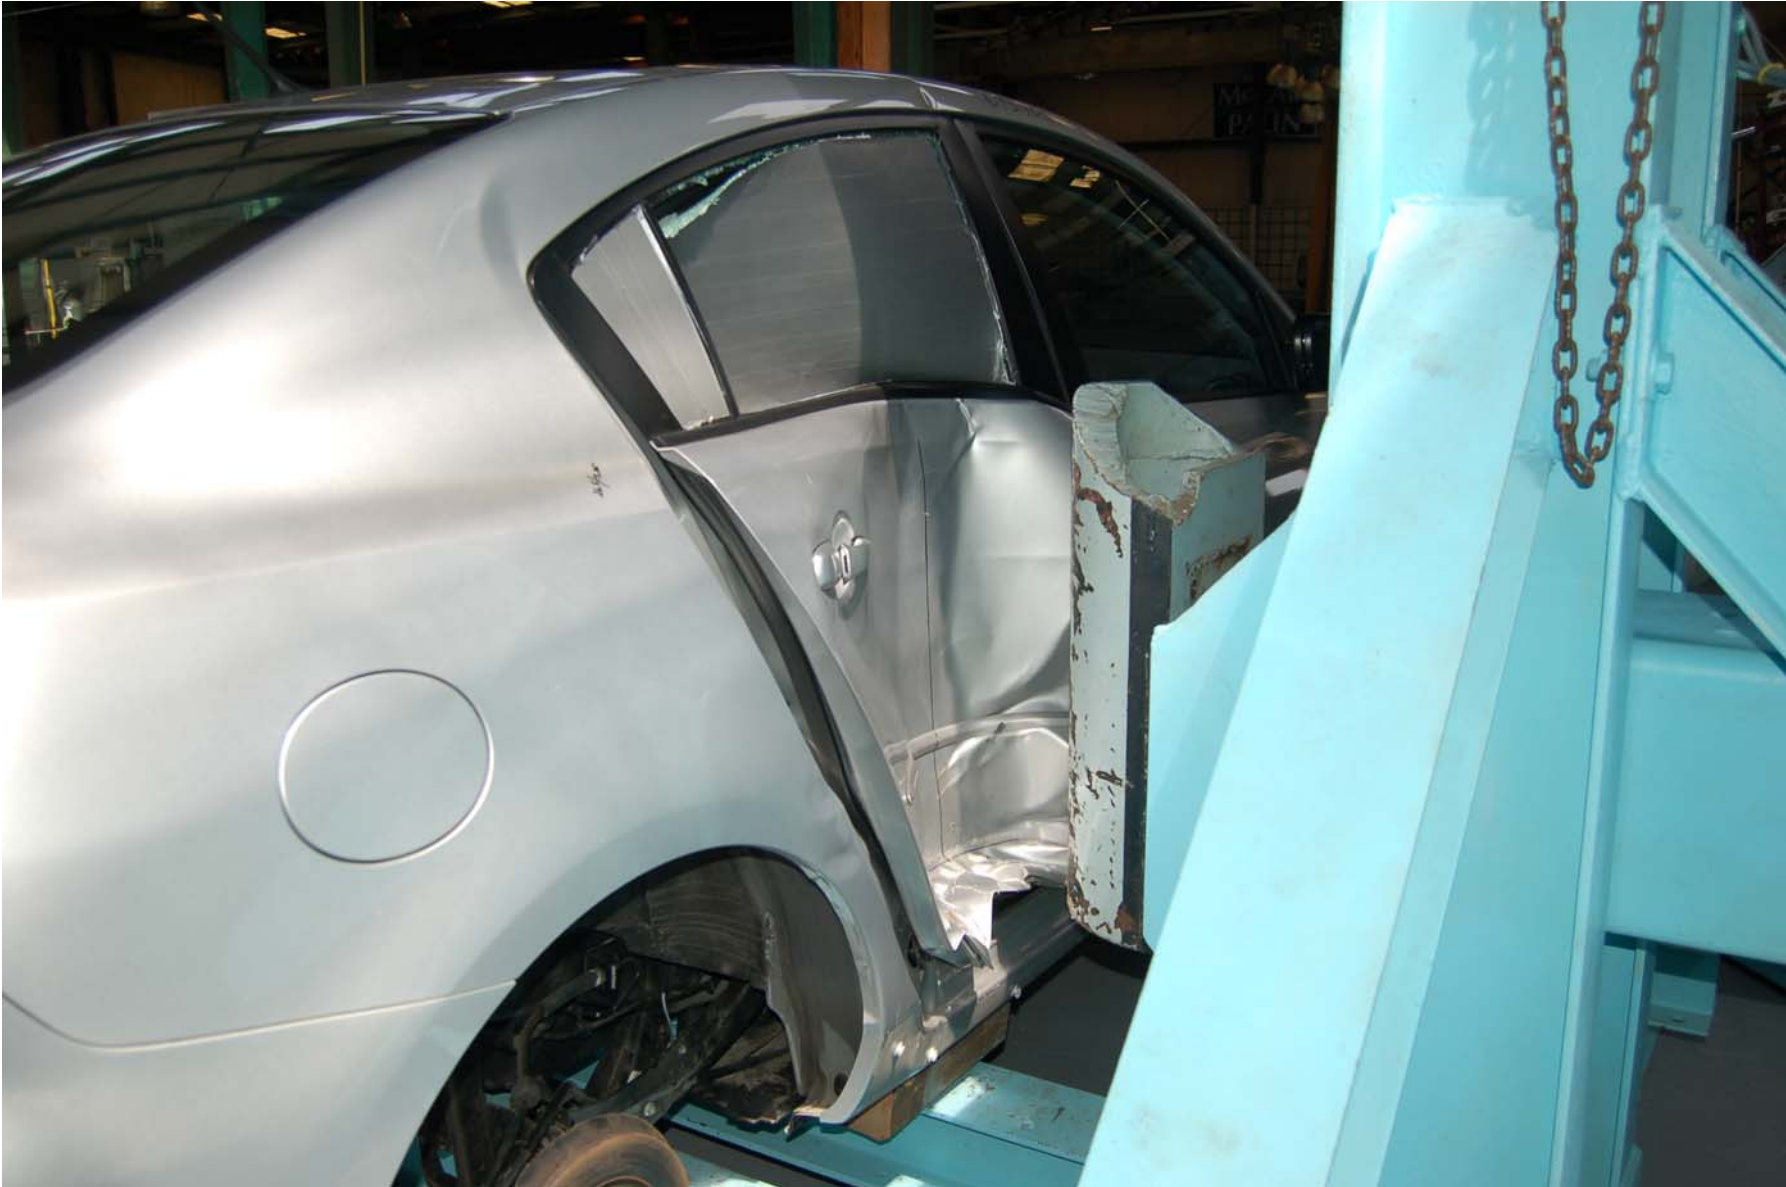
FIGURE 5.29
POST TEST DOOR OUTSIDE – TEST 2

TEST #2 - GTL #6272 (RIGHT REAR DOOR)

- A. The initial crush resistance was 3820 lbs.
 B. The intermediate crush resistance was 7348 lbs.
 C. The peak crush resistance was 15,943 lbs at 12.2 inches
 D. The rate of loading was .2"/sec

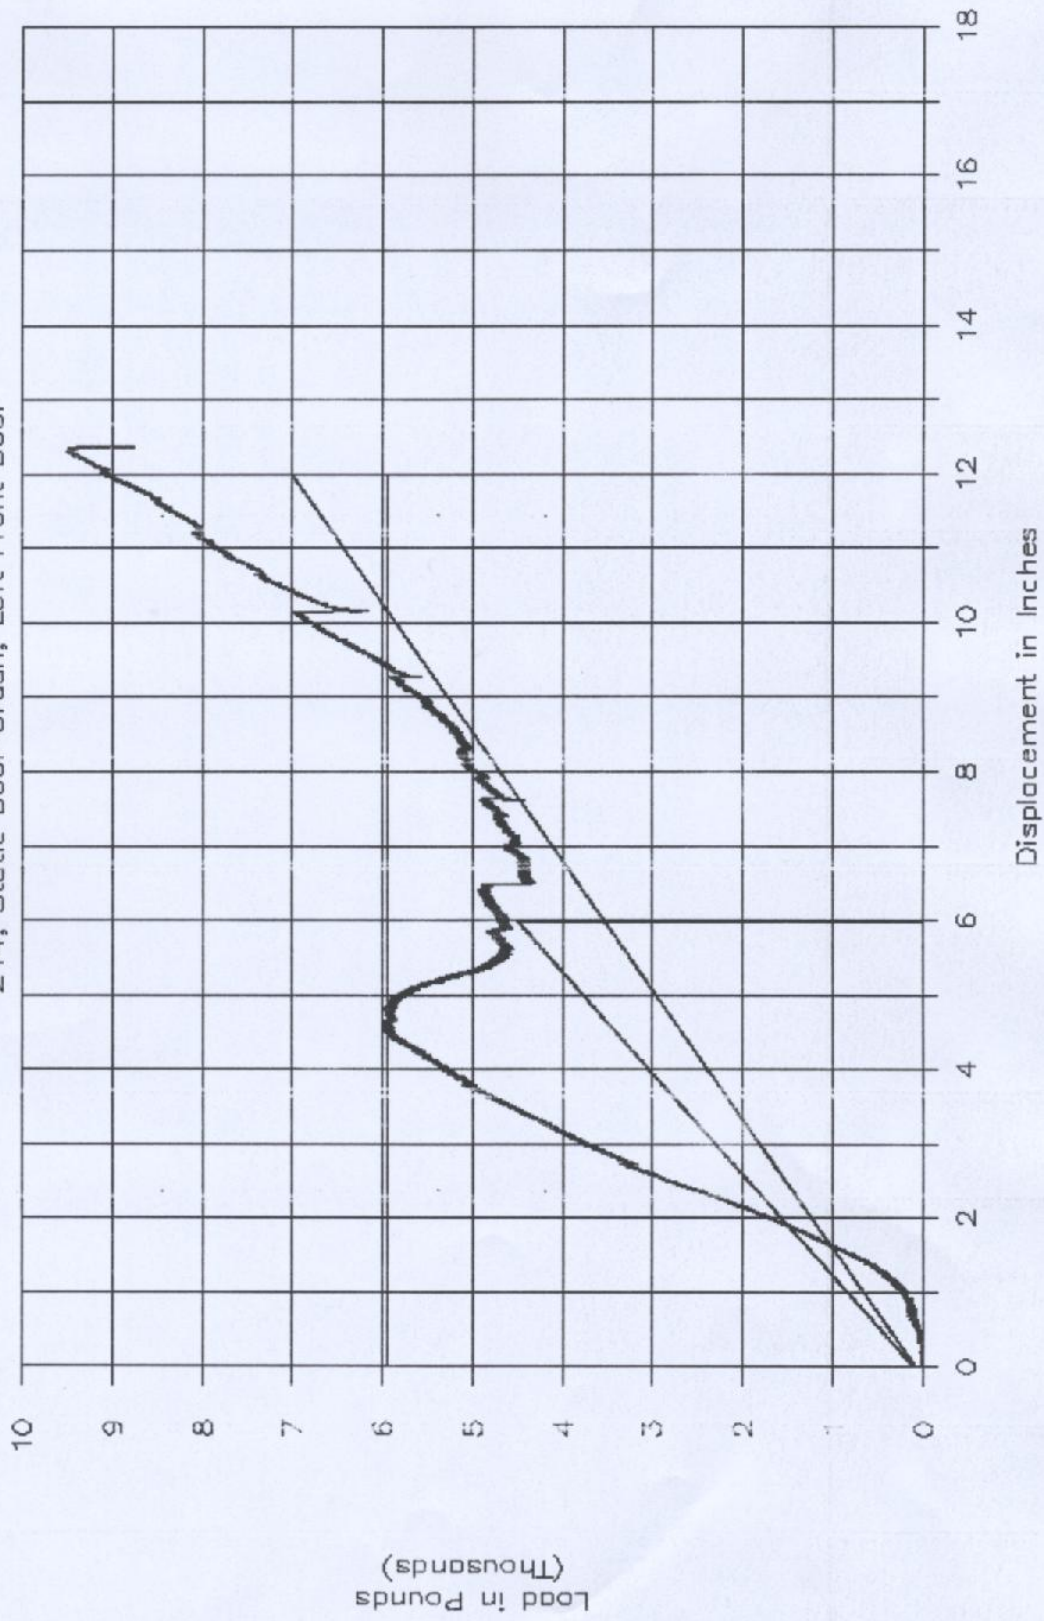
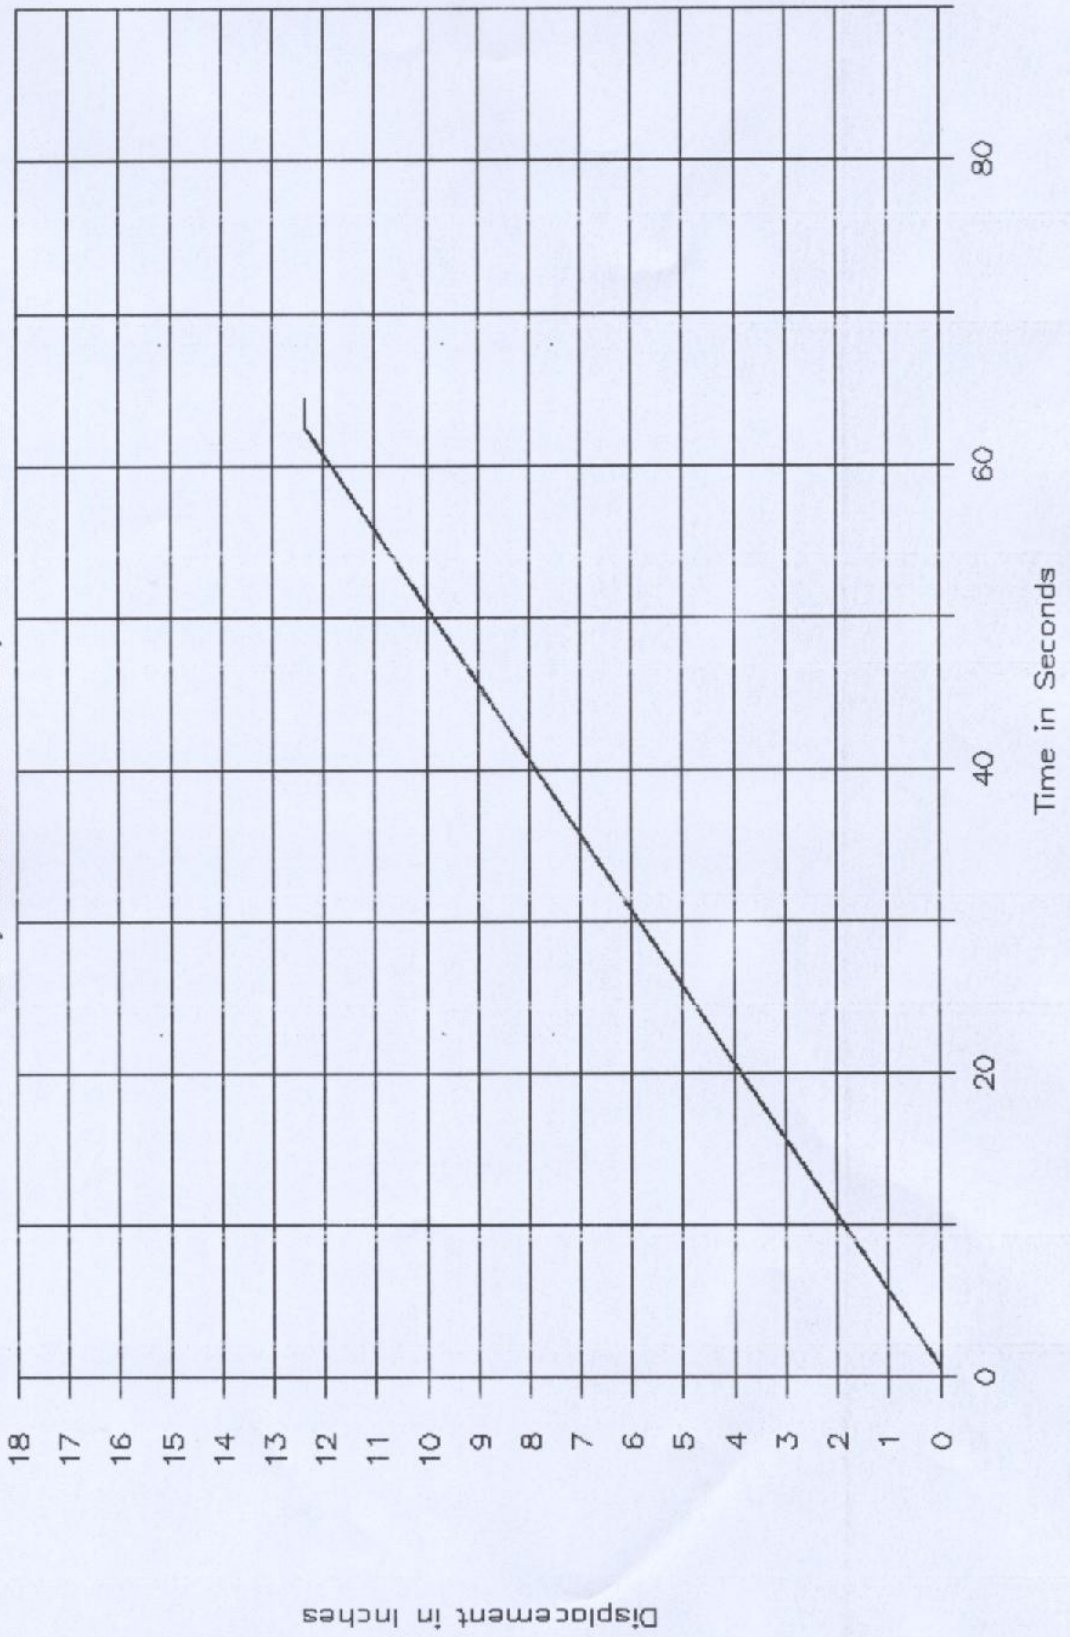
214, Static Door Crush, Left Front Door

TEST #1 - GTL #6271 (LEFT FRONT DOOR)

- A. The initial crush resistance was 3321 lbs.
- B. The intermediate crush resistance was 4751 lbs.
- C. The peak crush resistance was 9503 lbs at 12.3 inches

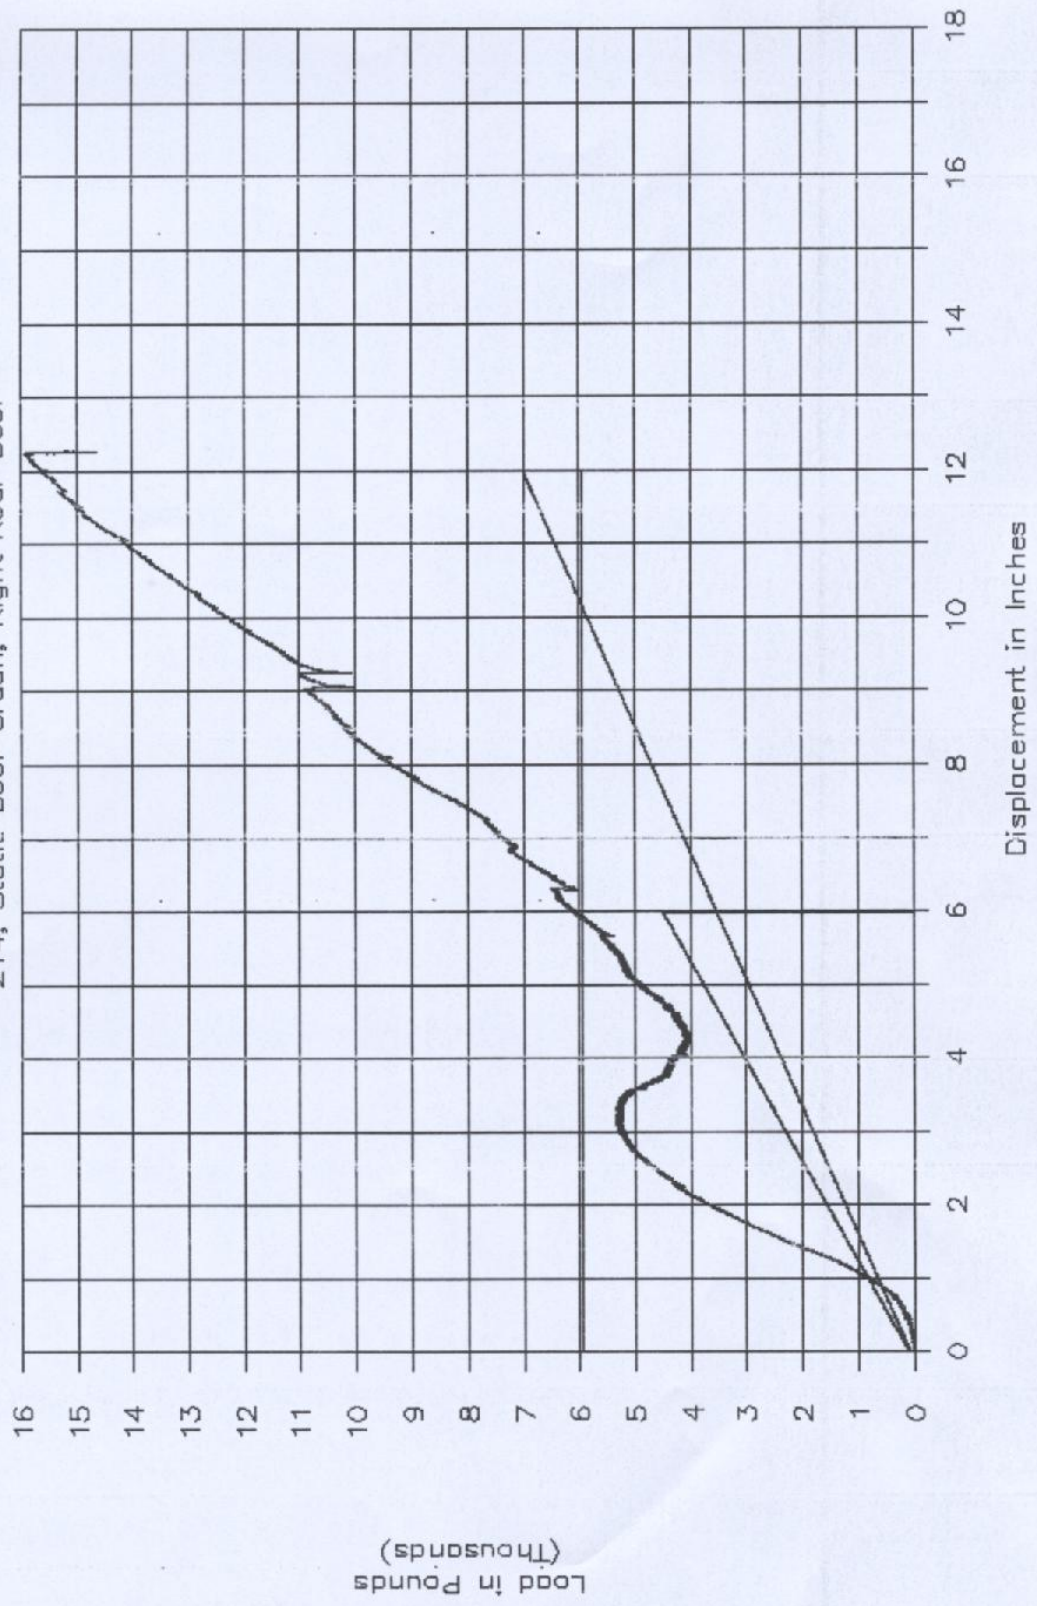
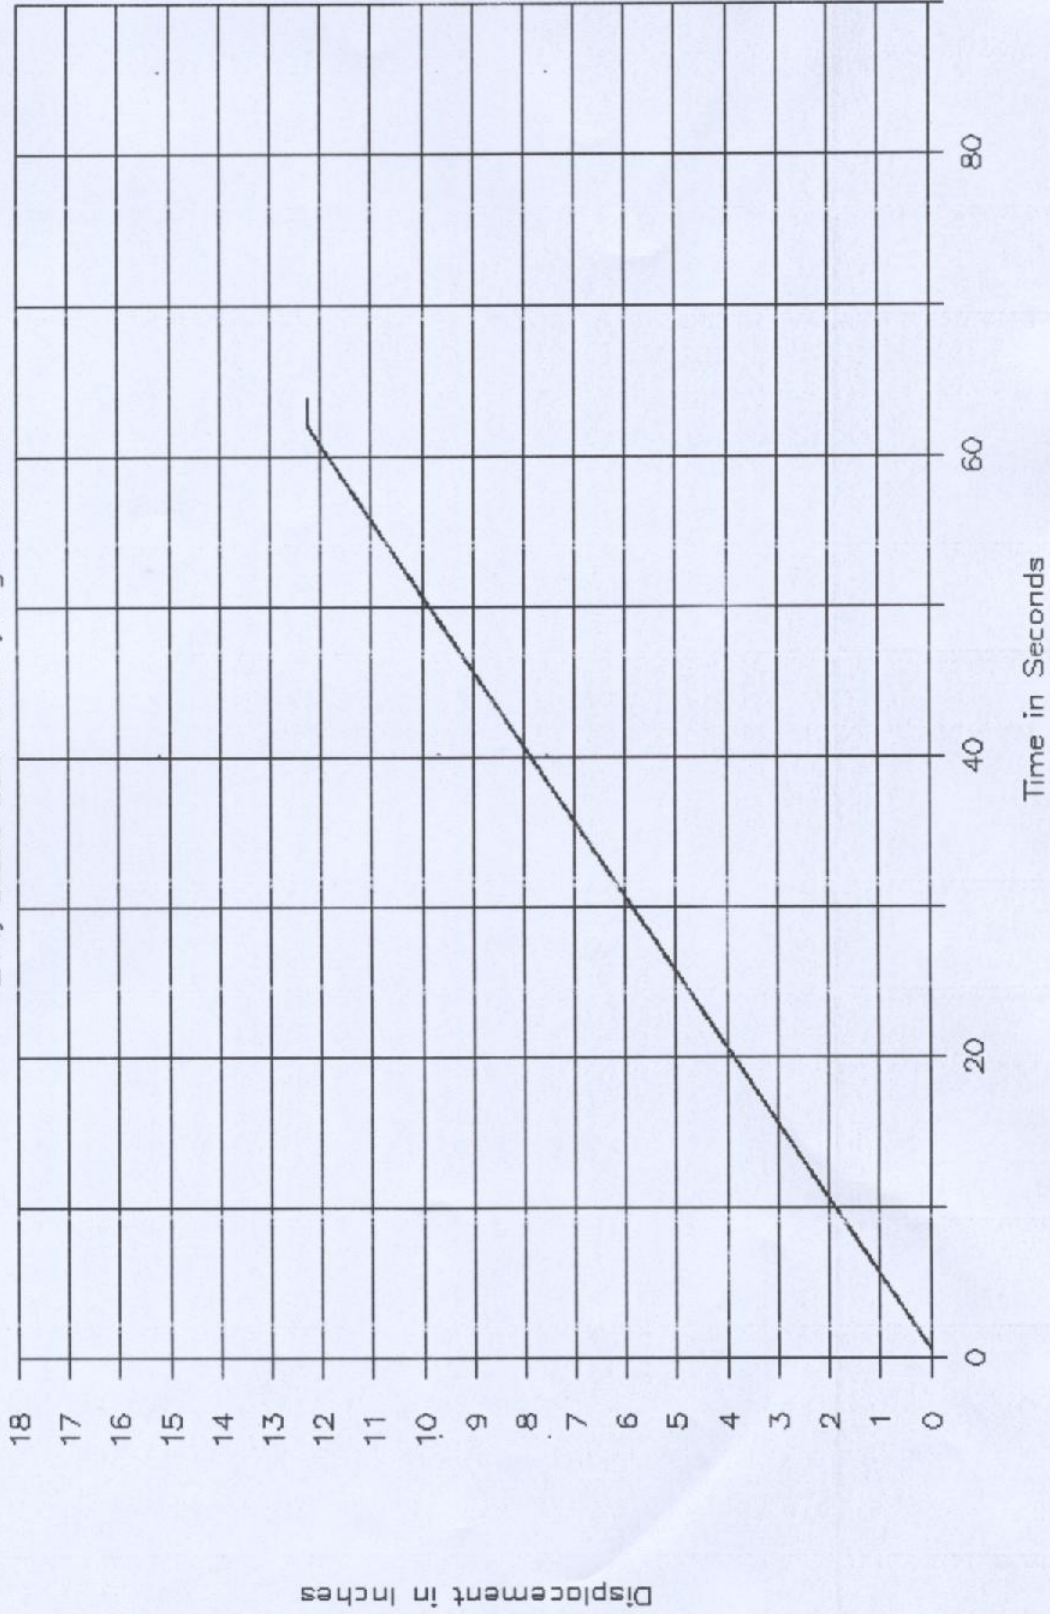
214, Static Door Crush, Right Rear Door

TEST #2 - GTL #6272 (RIGHT REAR DOOR)

- A. The initial crush resistance was 3820 lbs.
- B. The intermediate crush resistance was 7348 lbs.
- C. The peak crush resistance was 15,943 lbs at 12.2 inches
