REPORT NUMBER: 201-CAL-09-04

**SAFETY COMPLIANCE TESTING FOR FMVSS 201
OCCUPANT PROTECTION IN INTERIOR IMPACT**

**GENERAL MOTORS CORPORATION
2009 CHEVROLET TRAILBLAZER**

NHTSA NUMBER: C90104

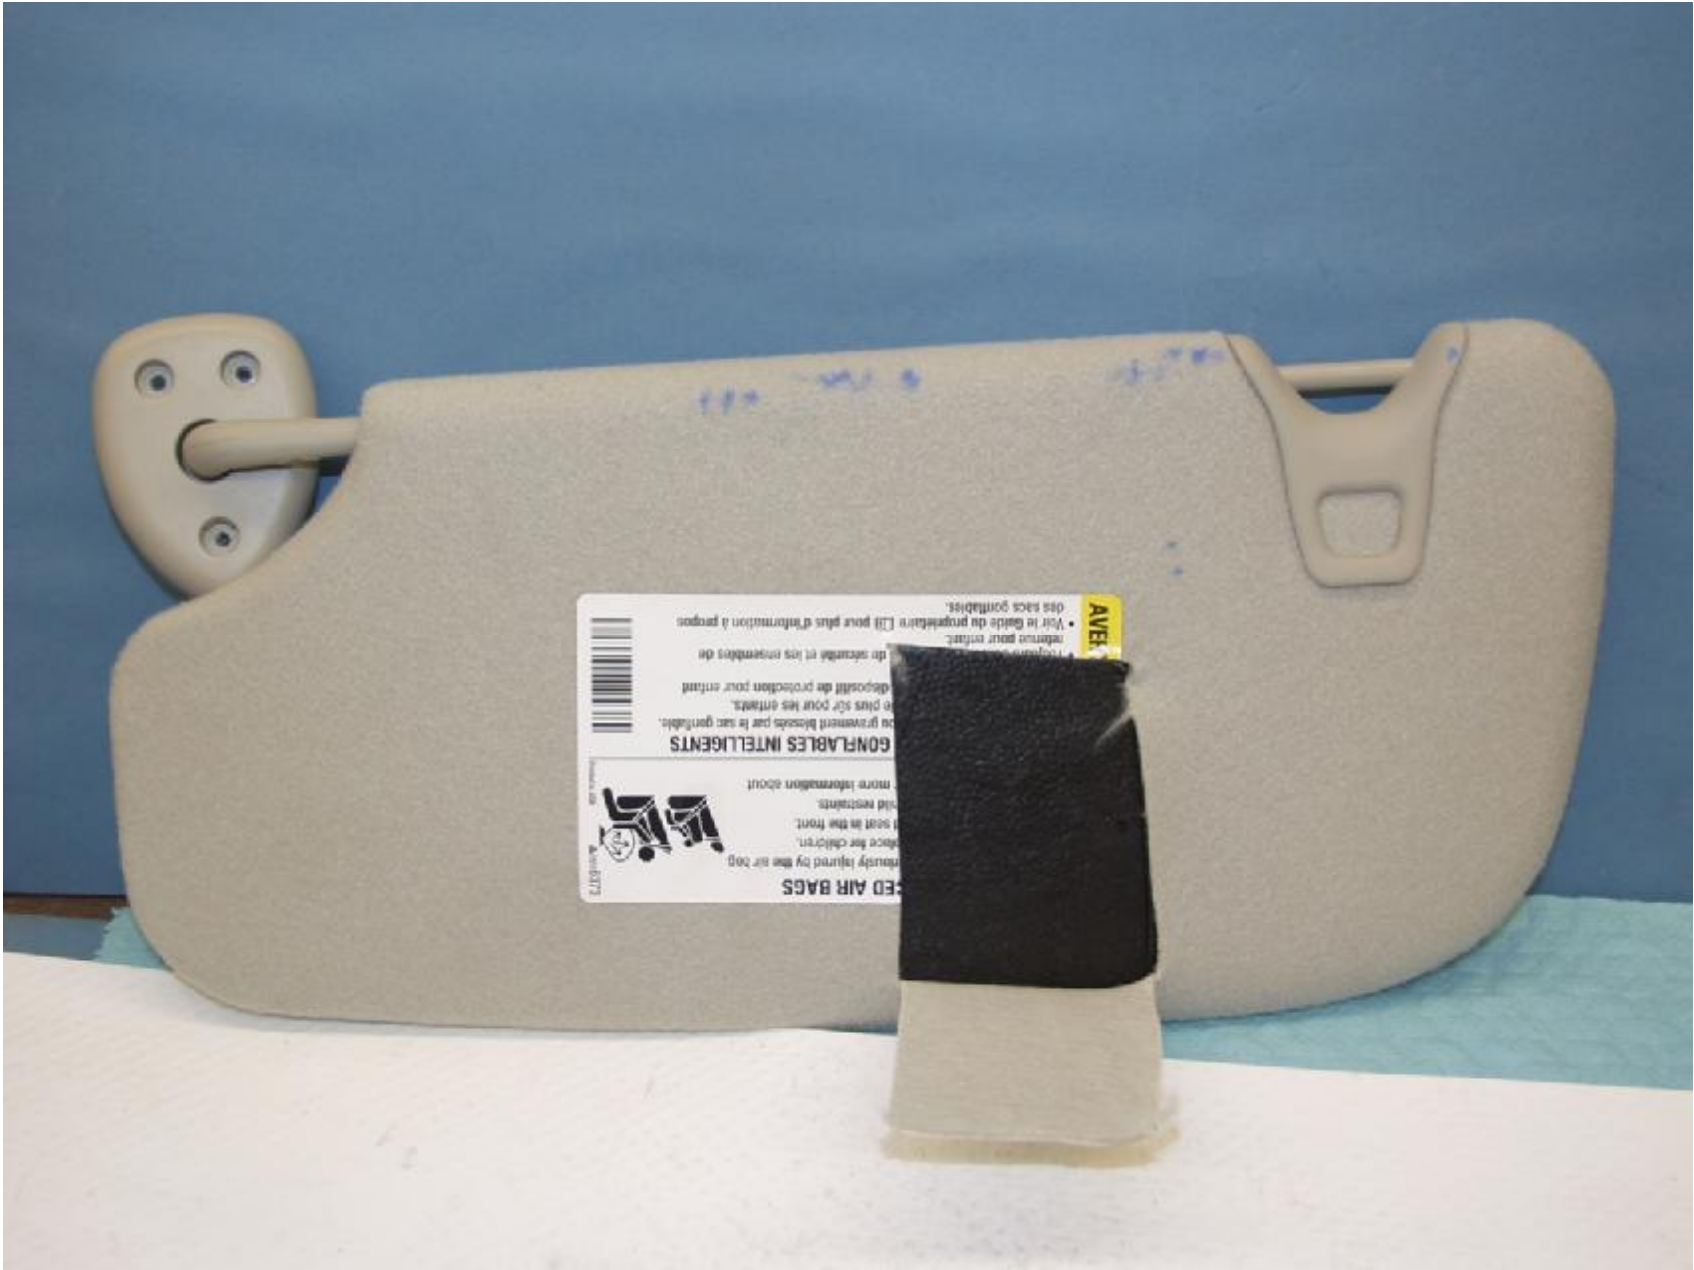
Figure A-7 : SUN VISOR CONSTRUCTION

1. Are sun visors constructed of or covered with energy absorbing material?

YES (PASS): X

2. Are any edges statically contactable by a spherical 165 mm (6.5 inch) diameter head form of radius less than 31.75 mm (1.25 inch)?

NO (PASS): X

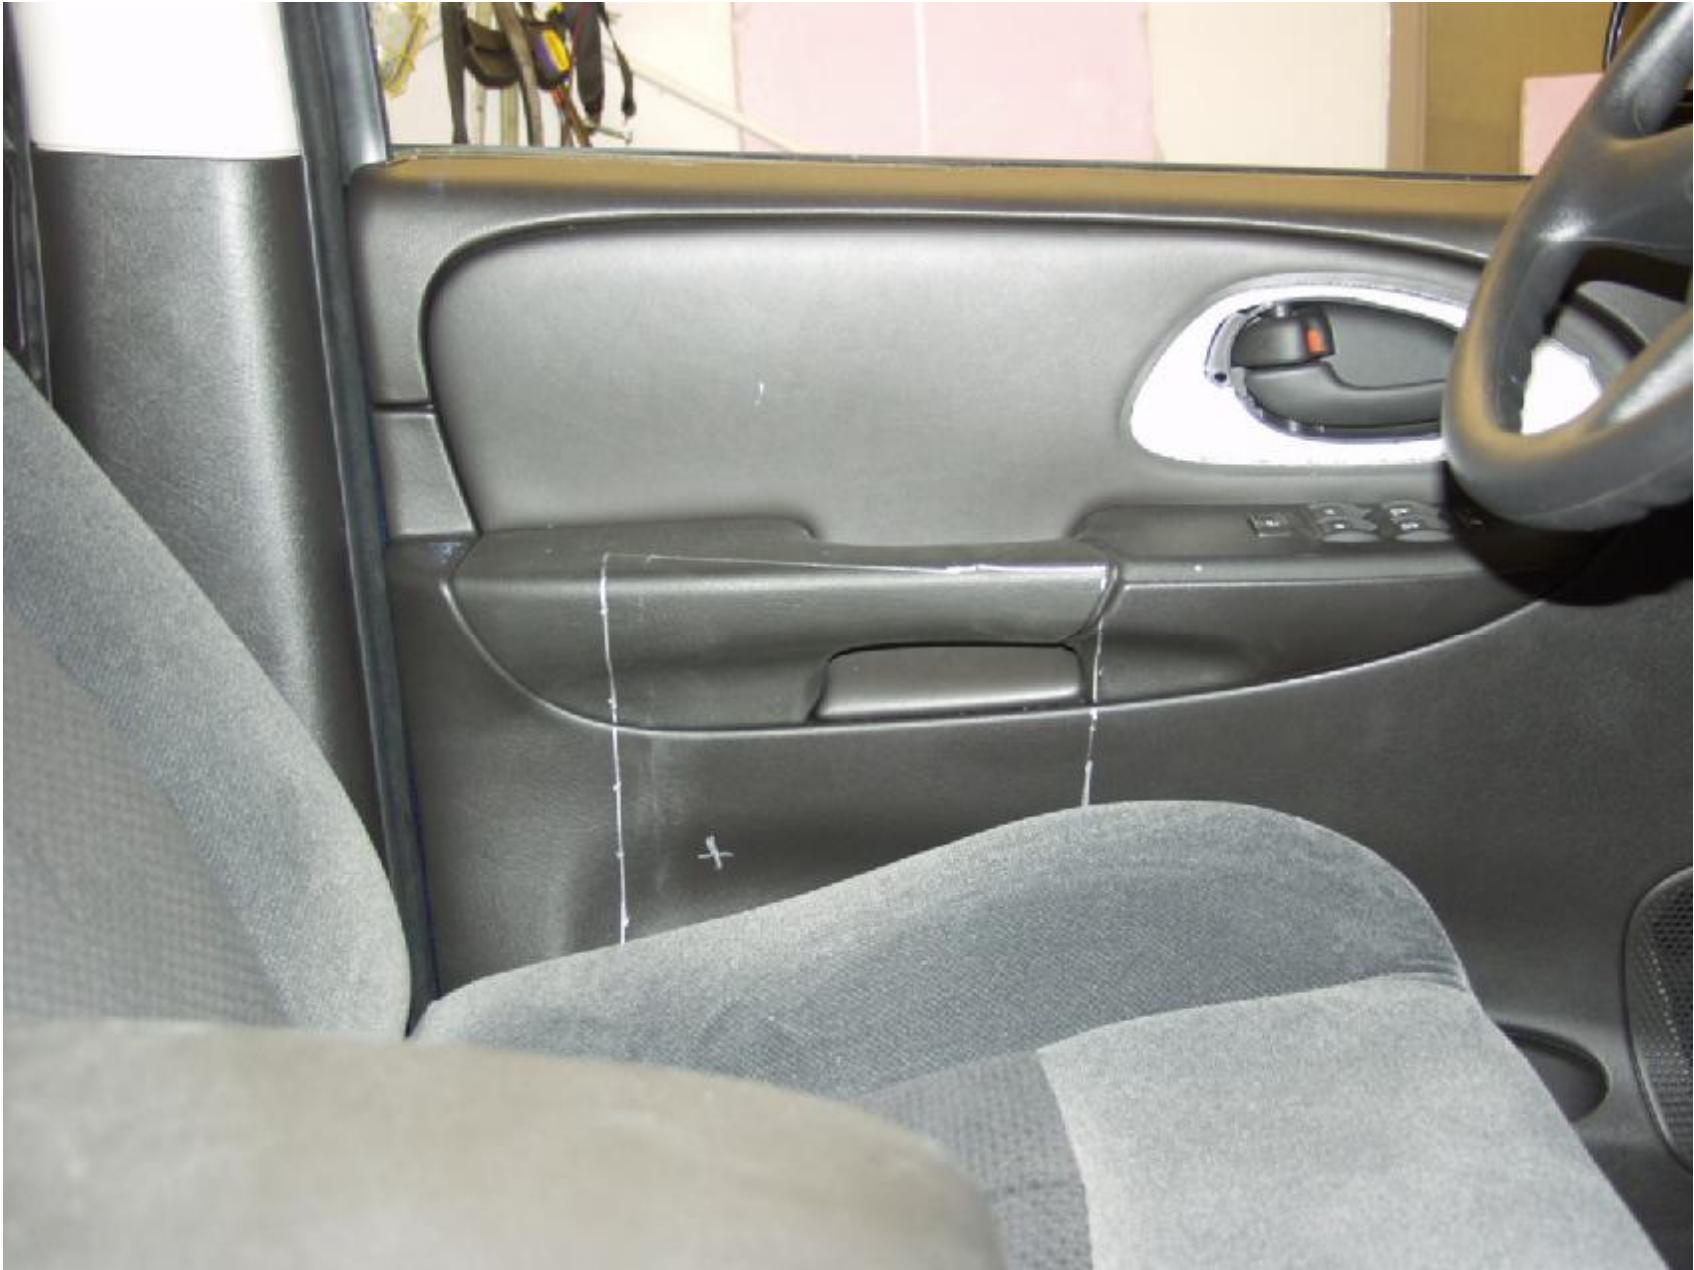
Figure A-8 : ARMREST LEFT FRONT DOOR

3. Does it provide adequate pelvic area impact protection?

YES: X

4. Does it meet at least one of the criteria No. 1 to 3?

YES (PASS): X

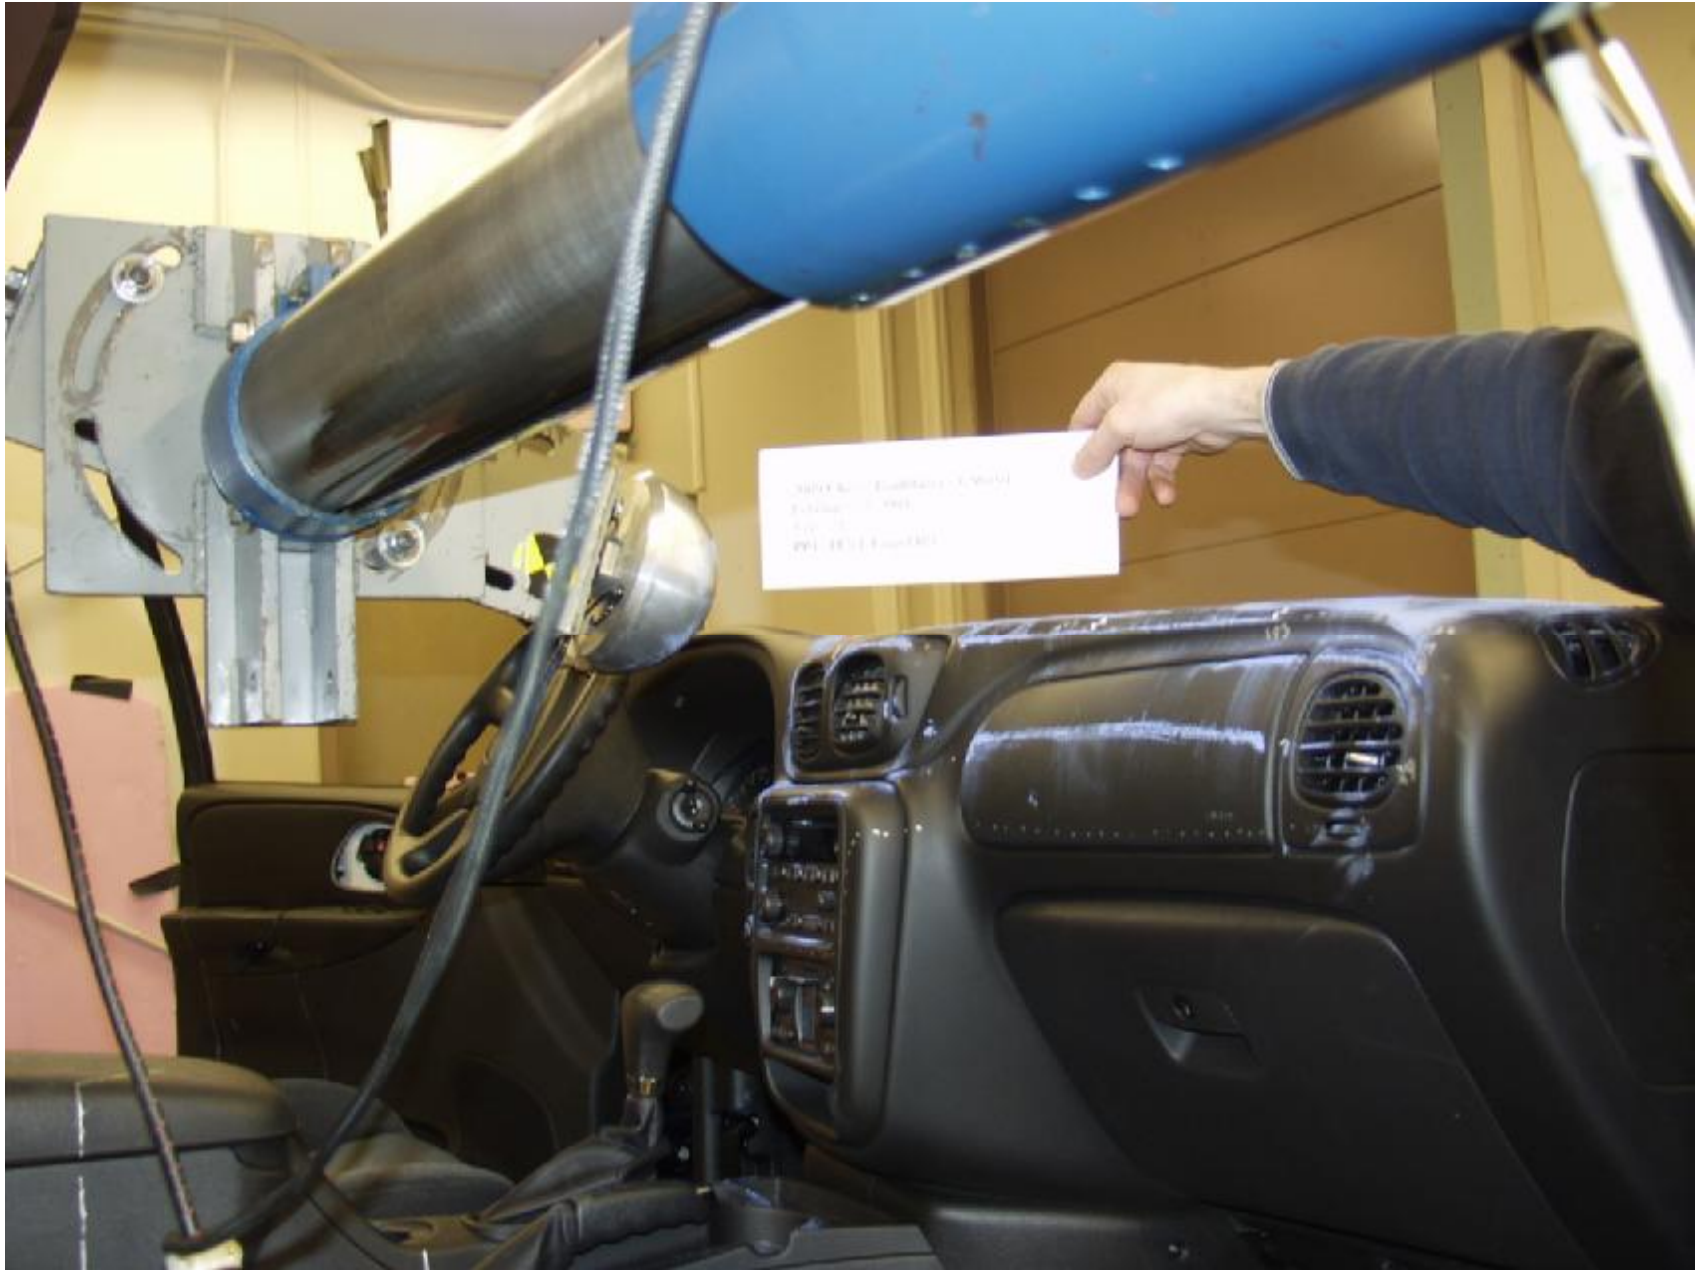
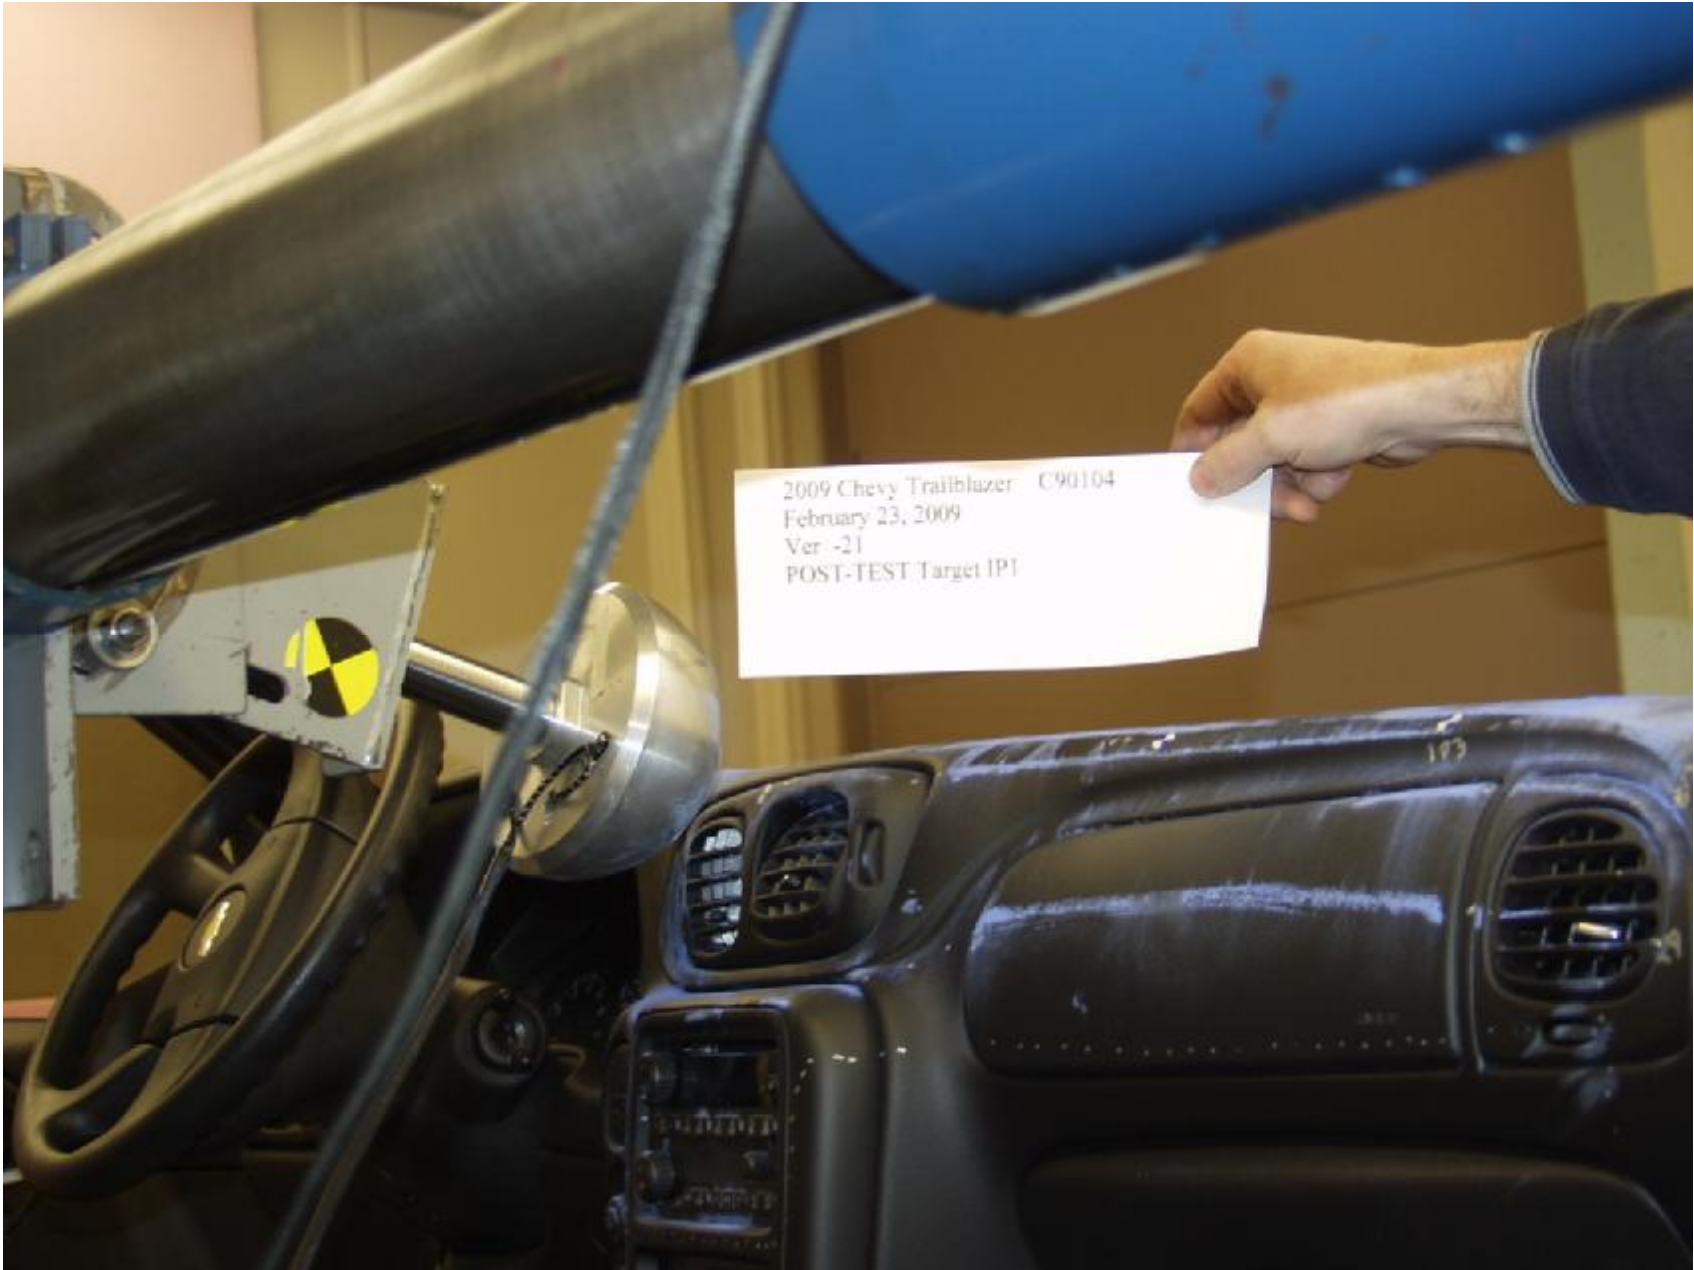
Figure A-14 : INSTRUMENT PANEL IMPACT #1 PRE-TEST

IMPACT LOCATION AND NUMBER				VELOCITY (kph)	PEAK ACCELERATION (3 ms Clip) Gs
TARGET	X (mm)	Y (mm)	ANGLE (degrees)		
CENTER CONSOLE VENT	1969	44	21	18.62	42.74
LEFT SIDE ABOVE AIRBAG	1892	307	55	18.78	52.76
RIGHT SIDE ABOVE AIRBAG	1891	505	53	18.79	51.92

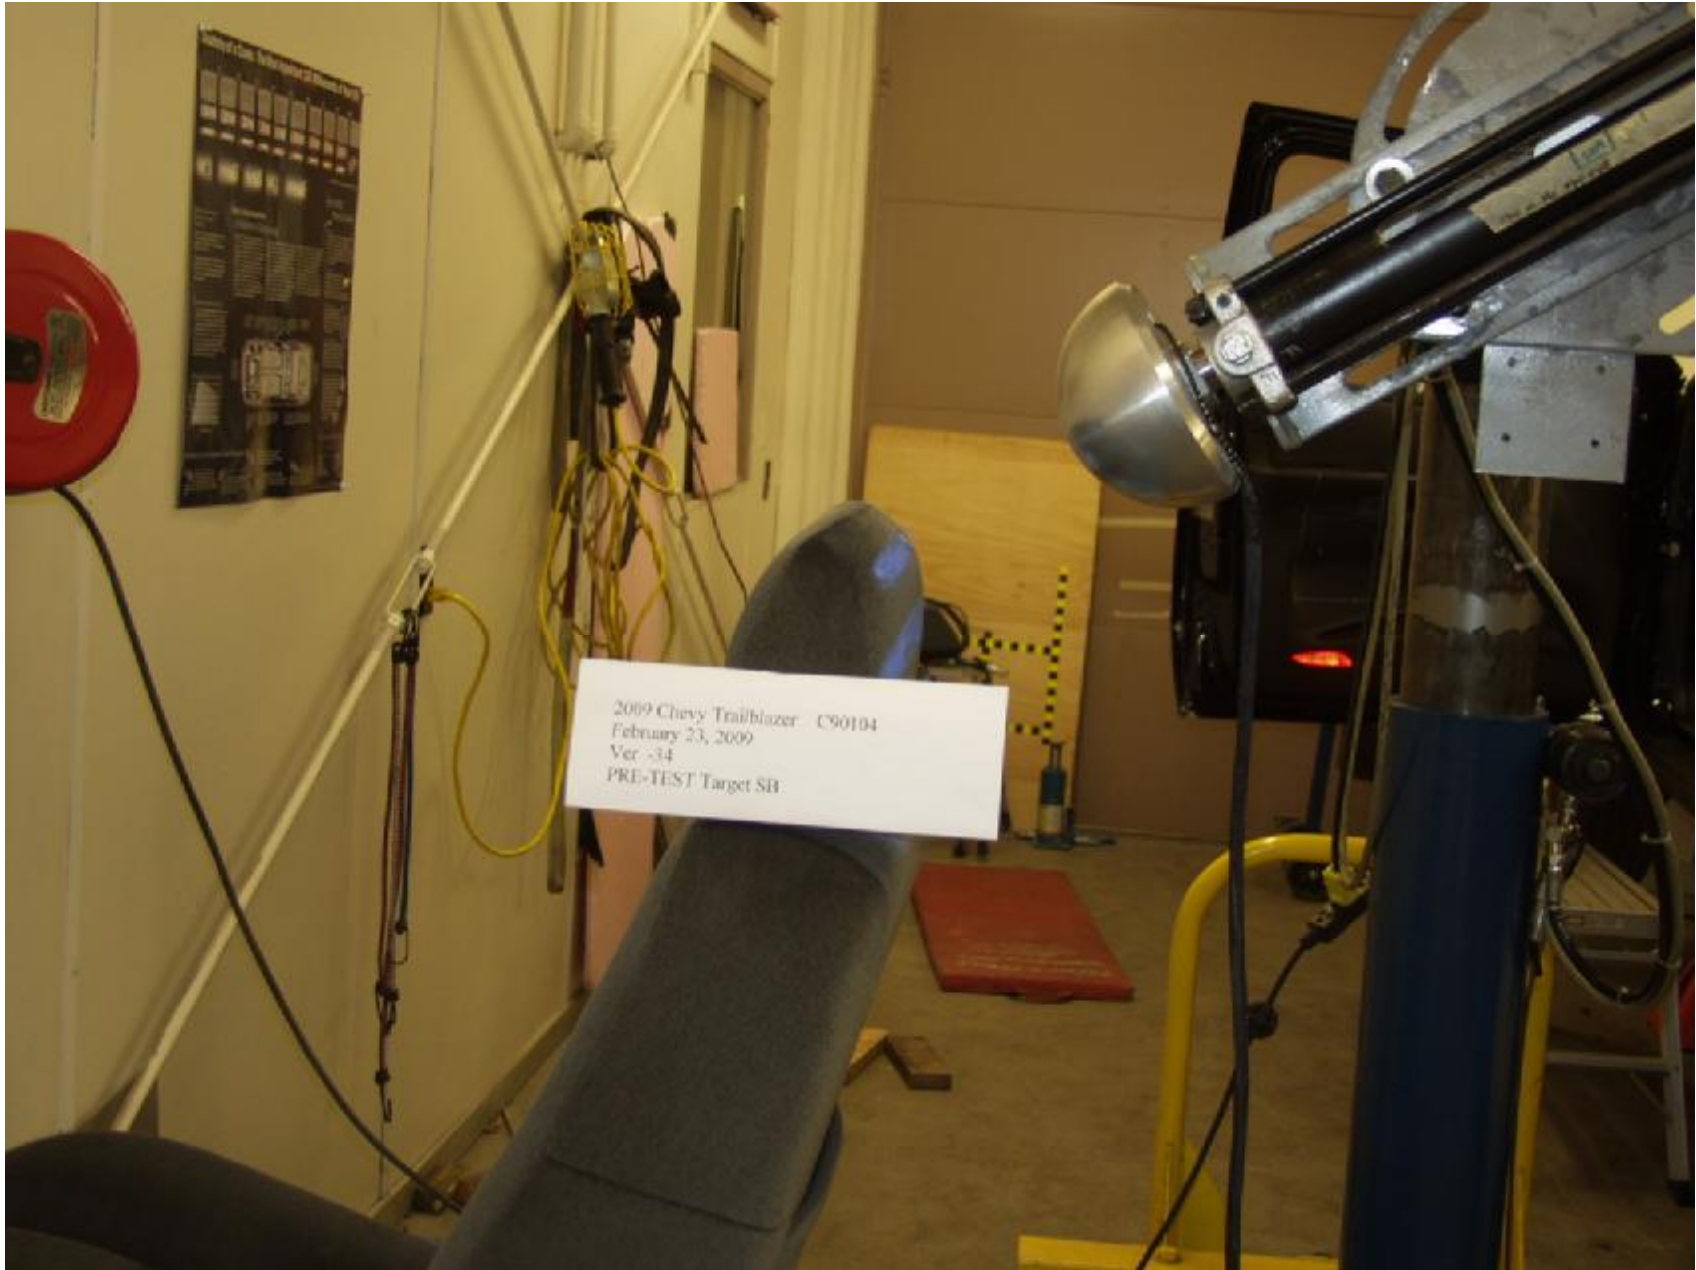
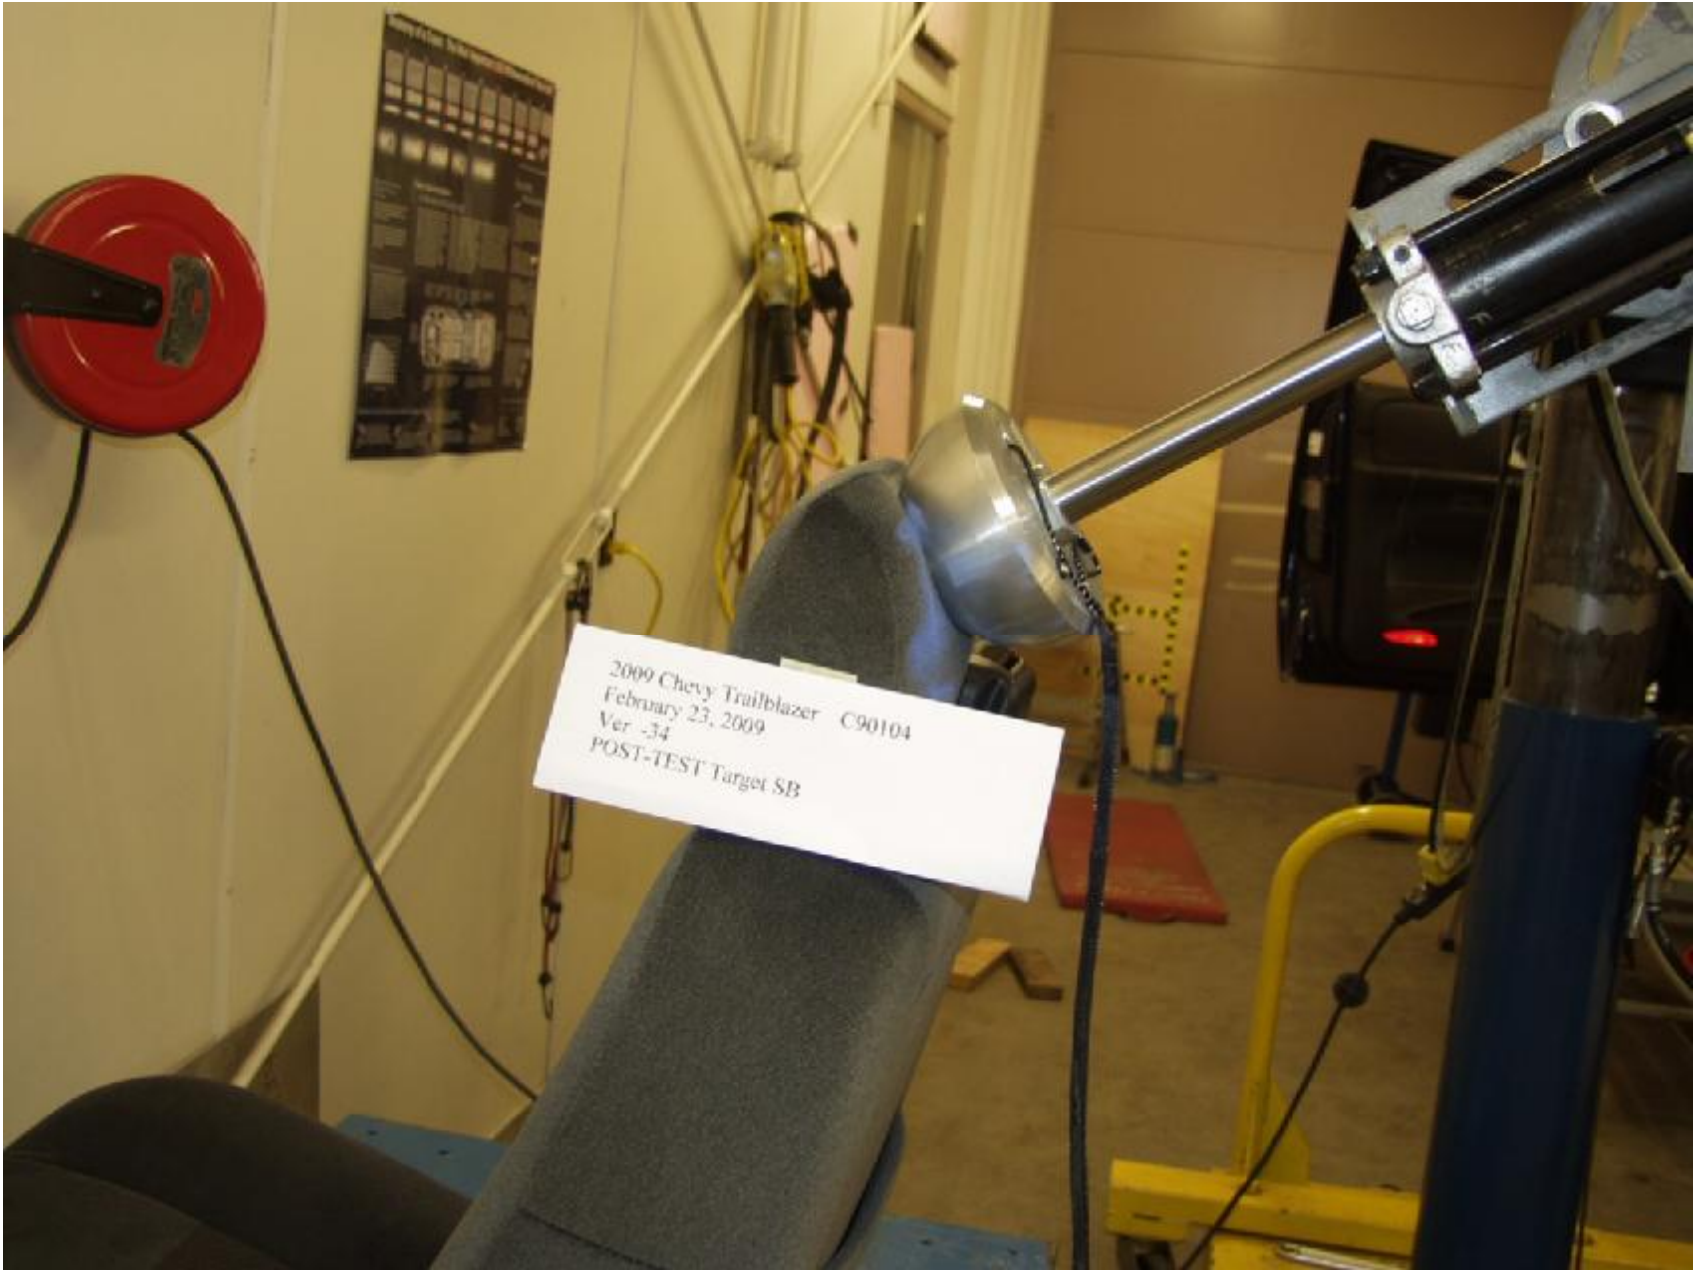
Figure A-21 : HEAD RESTRAINT IMPACT AREA PRE-TEST

IMPACT LOCATION AND NUMBER				VELOCITY (kph)	PEAK ACCELERATION (3 ms Clip) Gs
TARGET	X (mm)	Y (mm)	ANGLE (degrees)		
SEAT BACK HEAD RESTRAINT	2971	366	34	23.65	37.56
