REPORT NUMBER: 201-CAL-09-05

**SAFETY COMPLIANCE TESTING FOR FMVSS 201
OCCUPANT PROTECTION IN INTERIOR IMPACT**

**KIA MOTORS CORPORATION
2009 KIA SEDONA**

NHTSA NUMBER: C90502

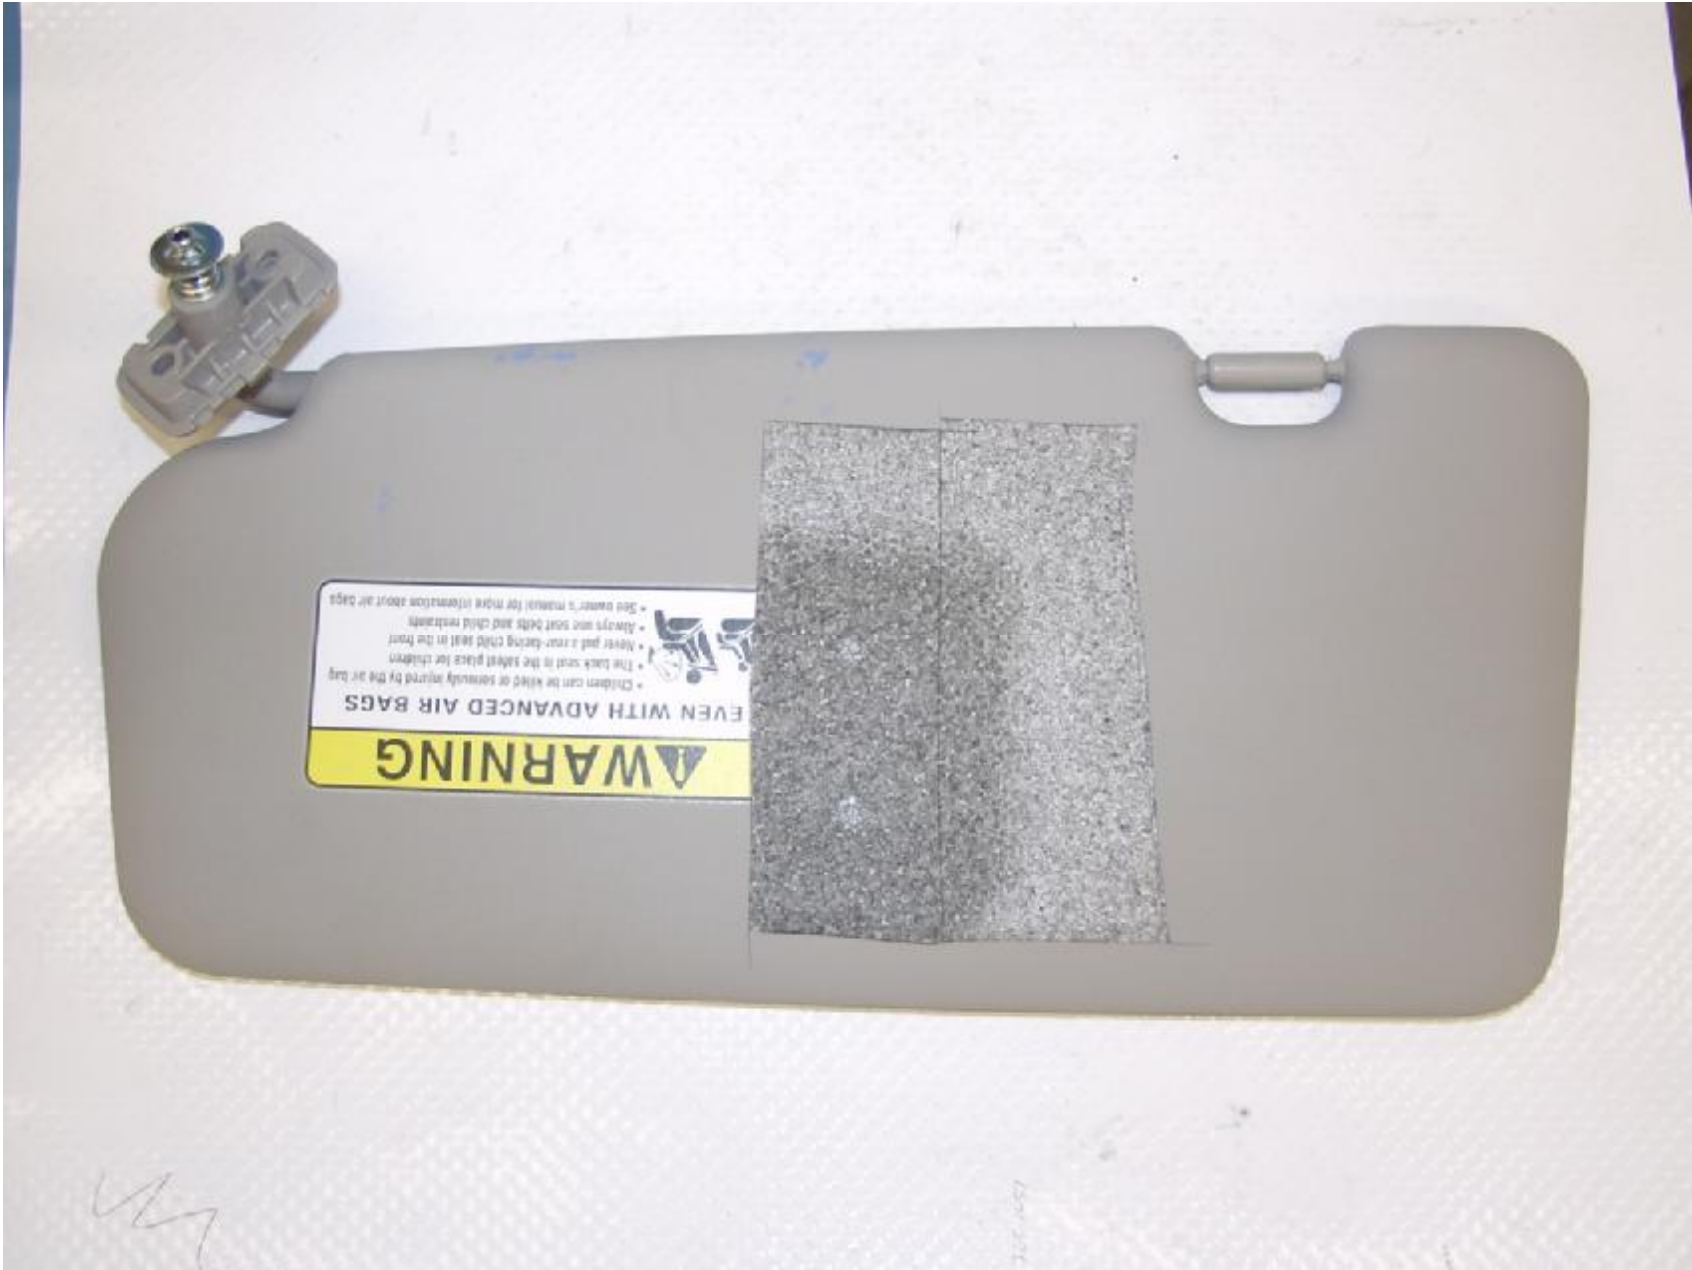
1. Are sun visors constructed of or covered with energy absorbing material?

YES (PASS): X

2. Are any edges statically contactable by a spherical 165 mm (6.5 inch) diameter head form of radius less than 31.75 mm (1.25 inch)?

NO (PASS): X

Figure A-7 : SUN VISOR CONSTRUCTION

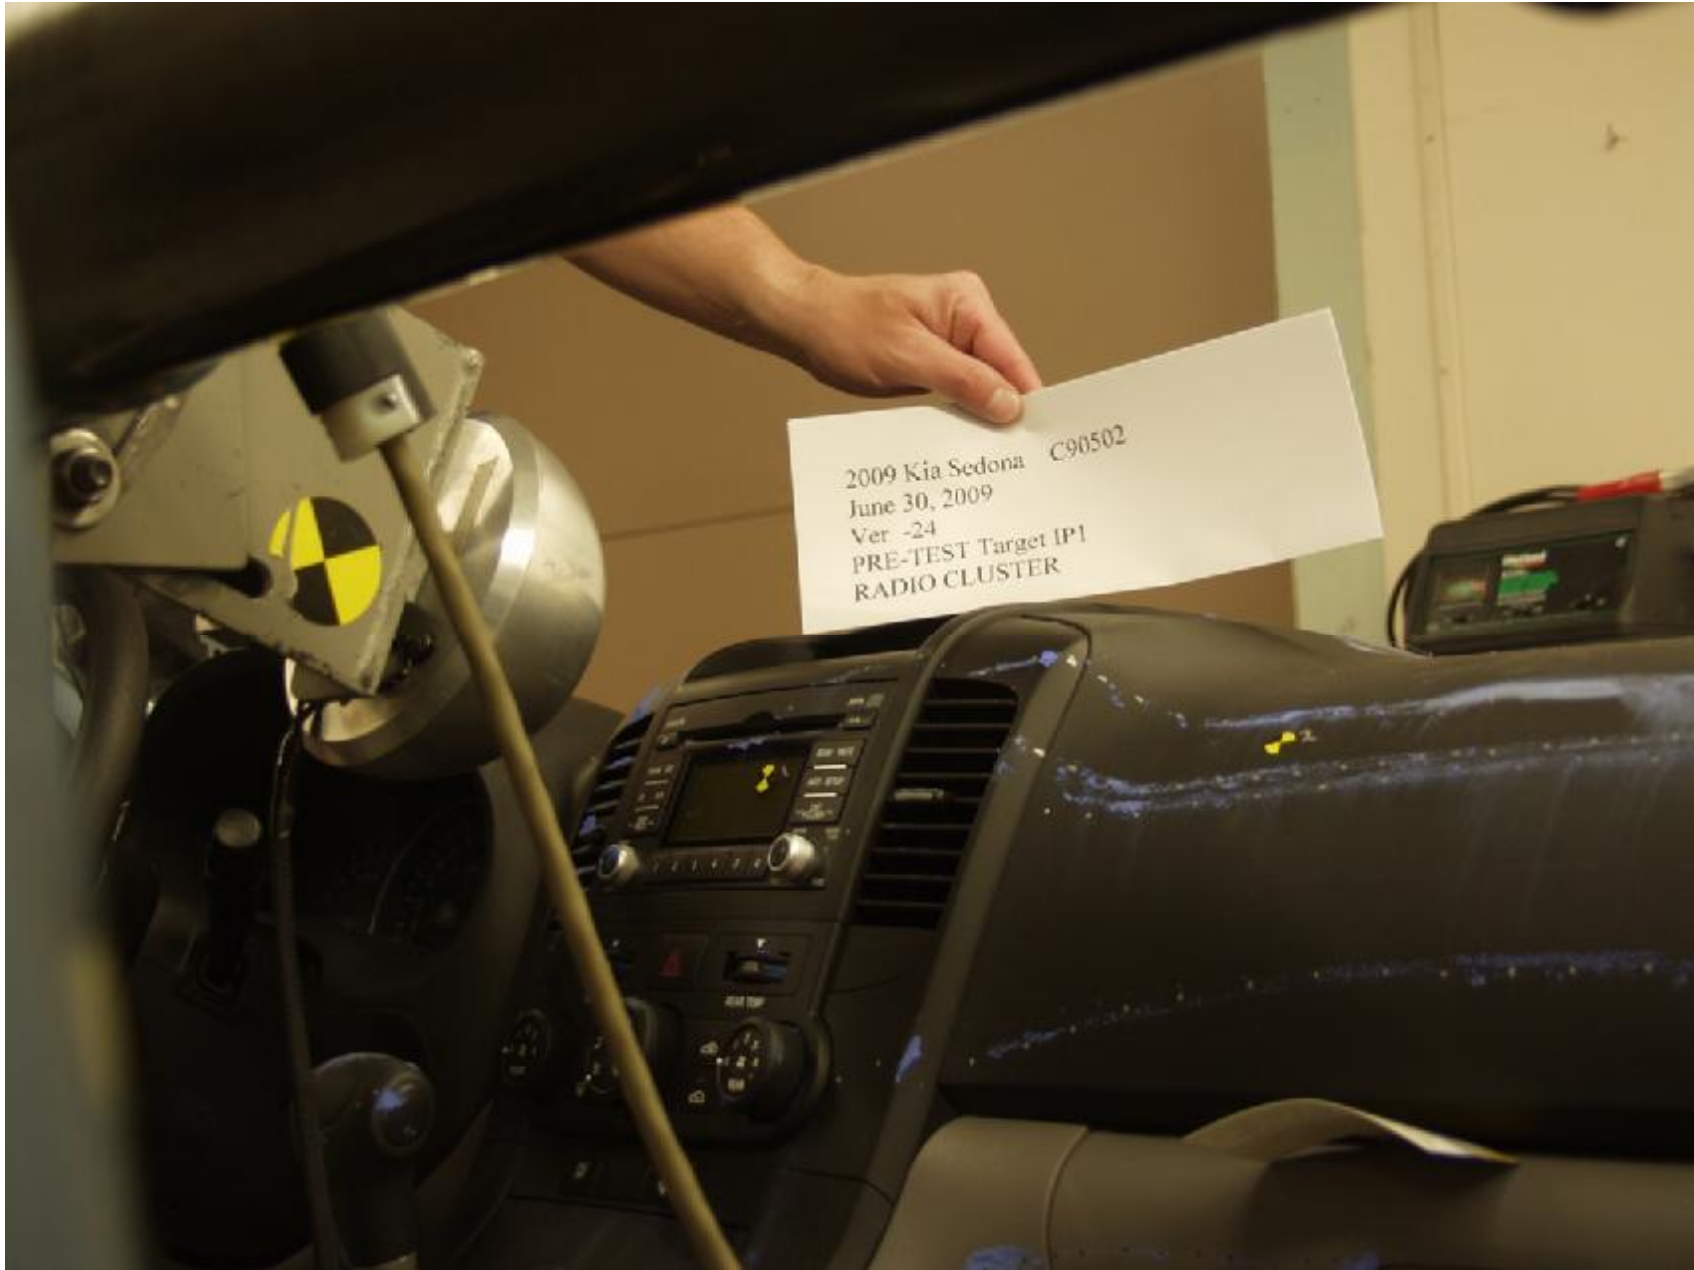
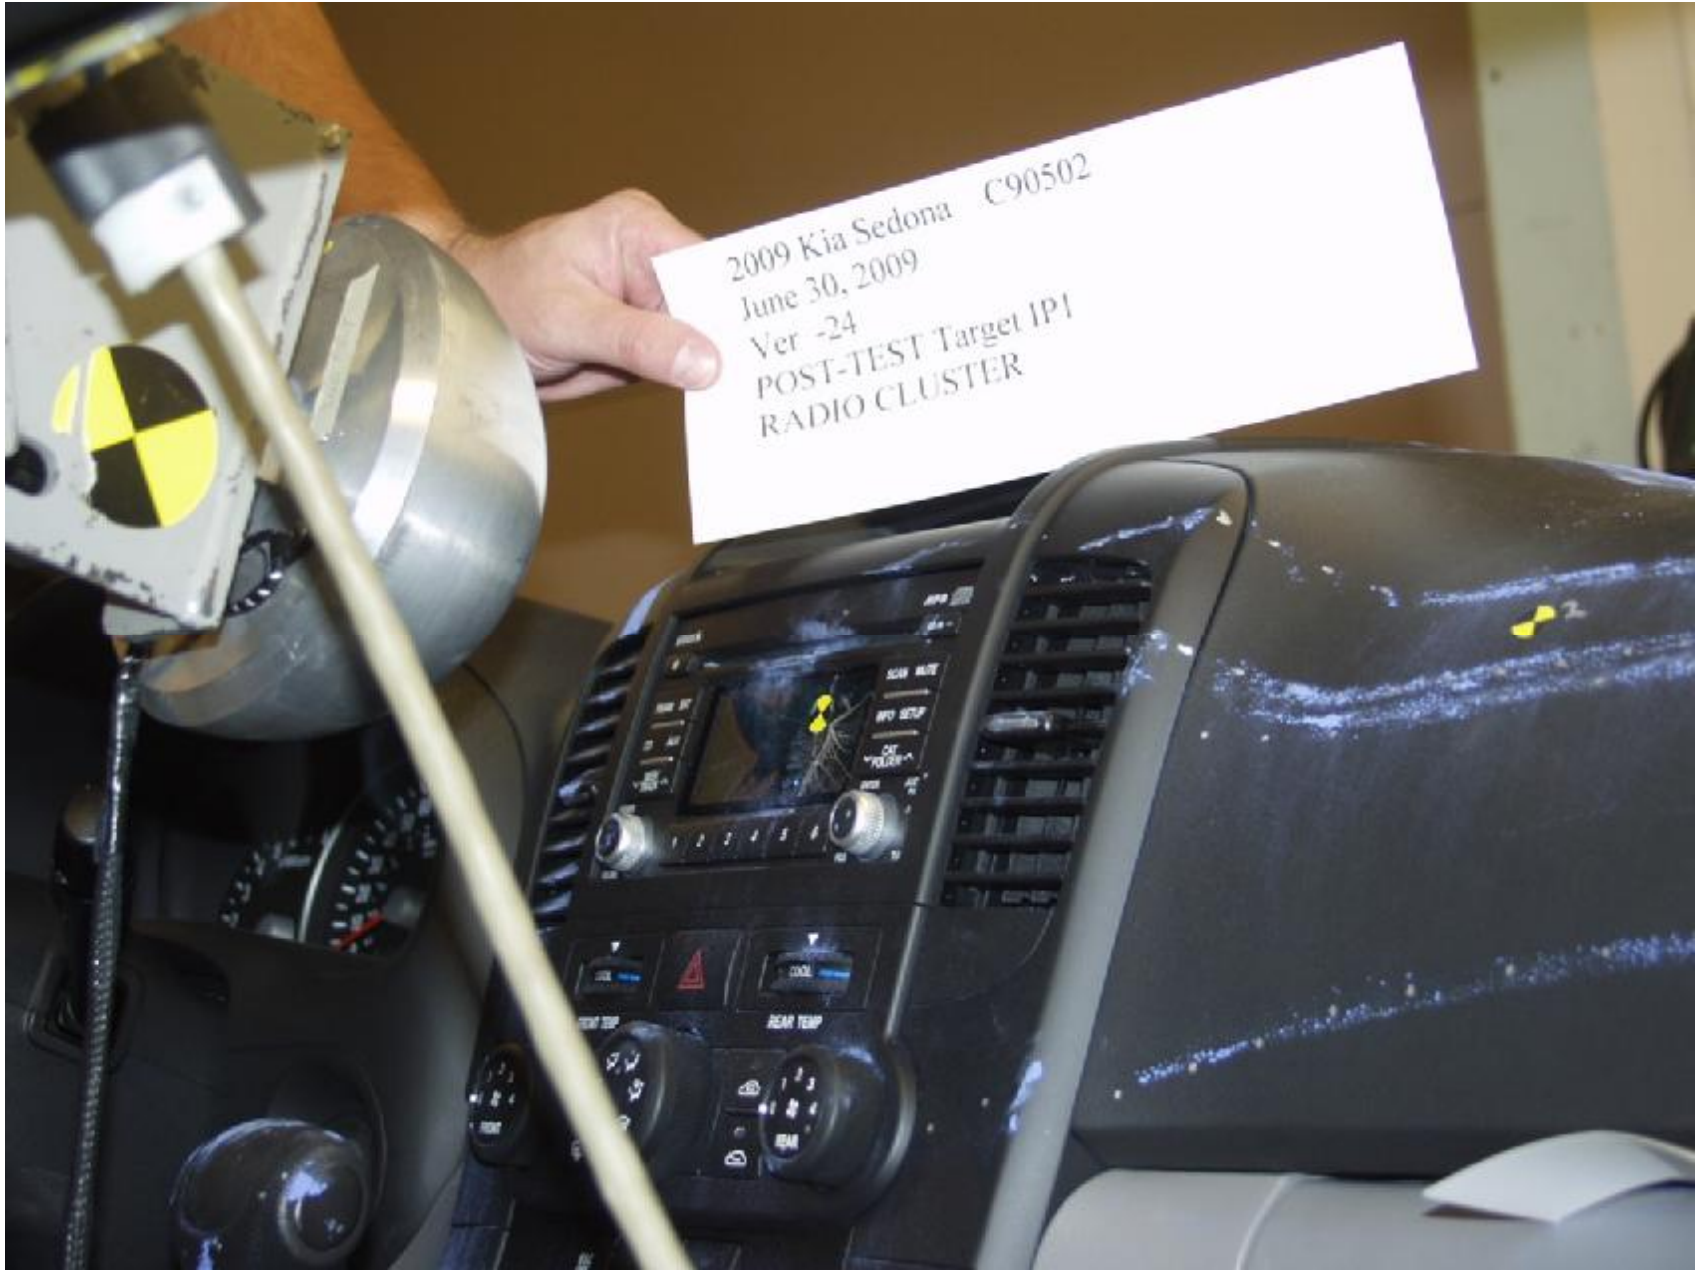
IMPACT LOCATION AND NUMBER				VELOCITY (kph)	PEAK ACCELERATION (3 ms Clip) Gs
TARGET	X (mm)	Y (mm)	ANGLE (degrees)		
Radio Cluster	1680	23	24	18.85	50.07
Left Side of Airbag Cover	1634	290	48	18.67	60.57
Right Side of Airbag Cover	1637	539	55	18.85	50.47

Figure A-15 : INSTRUMENT PANEL IMPACT #1 PRE-TEST

Figure A-16 : INSTRUMENT PANEL IMPACT #1 POST-TEST

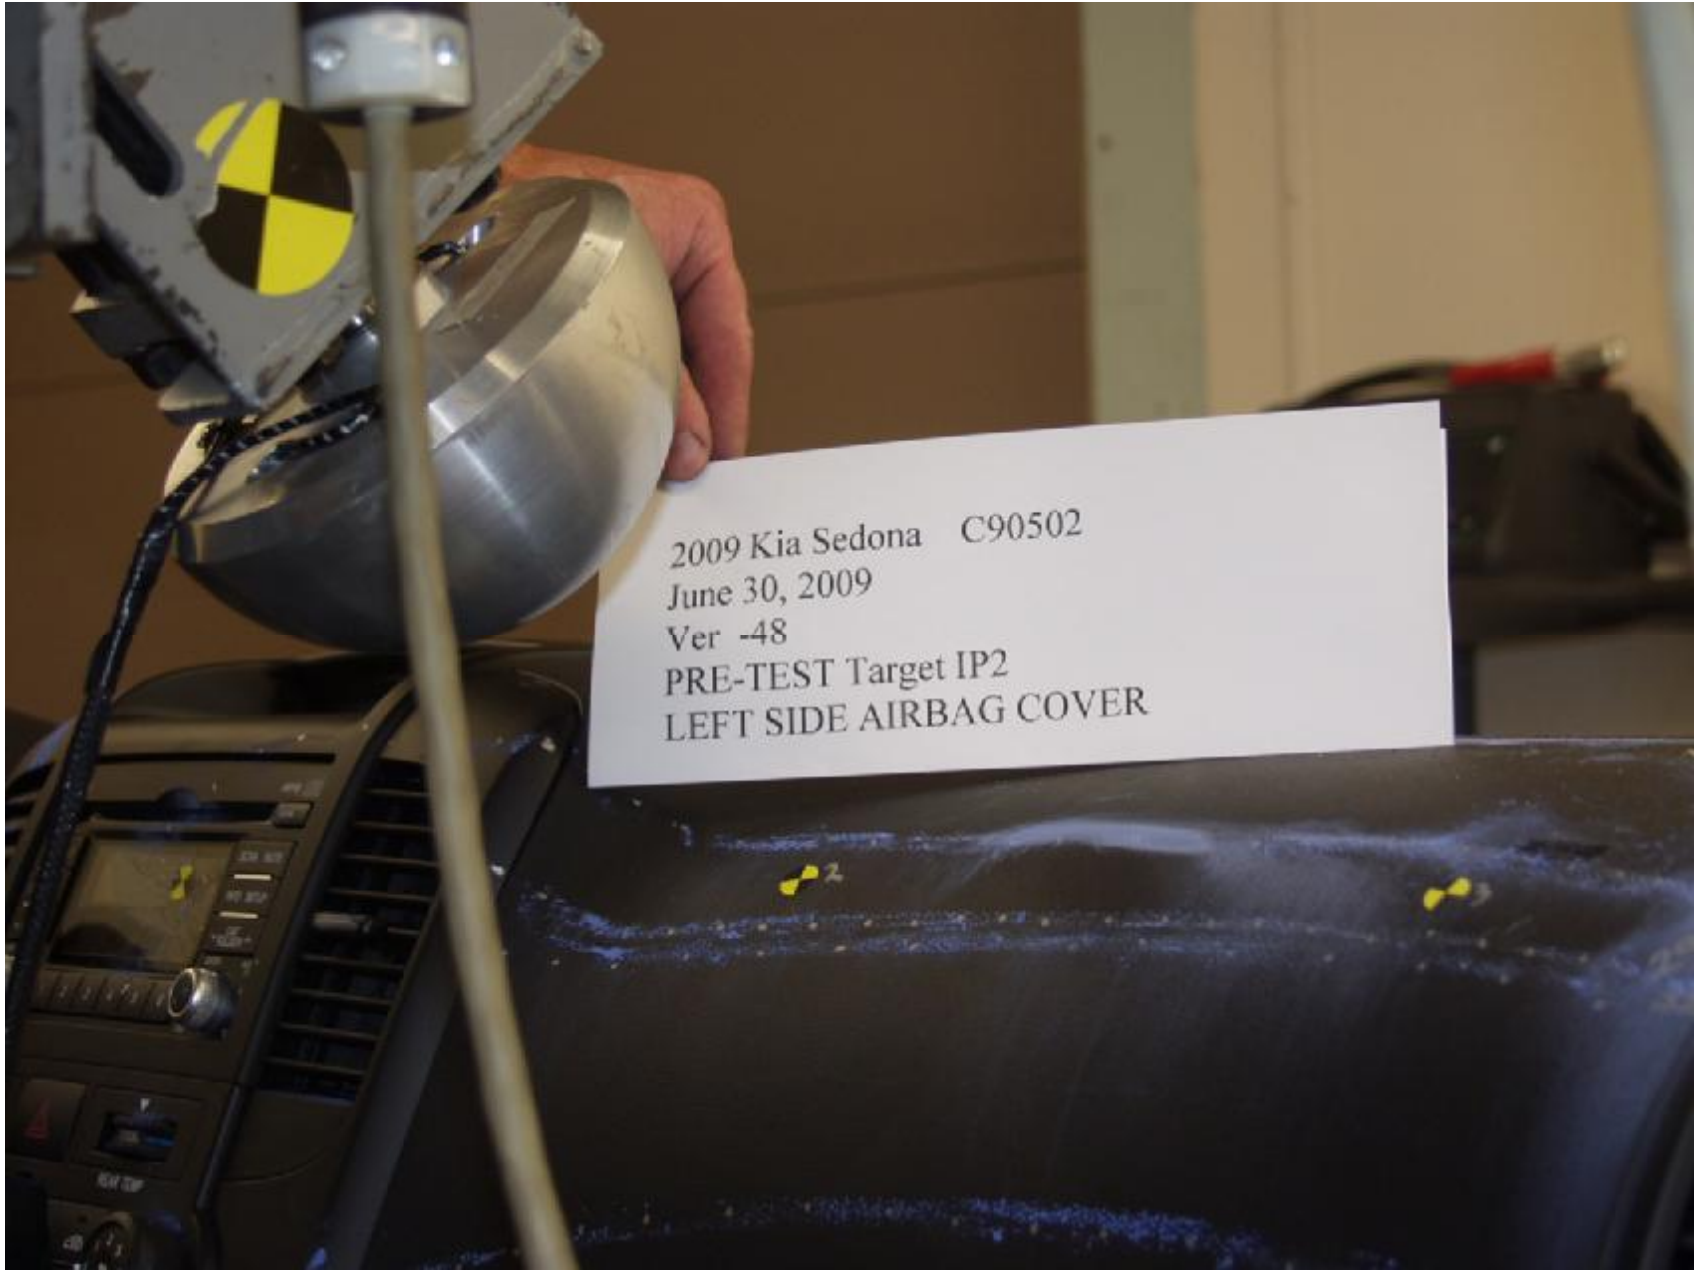
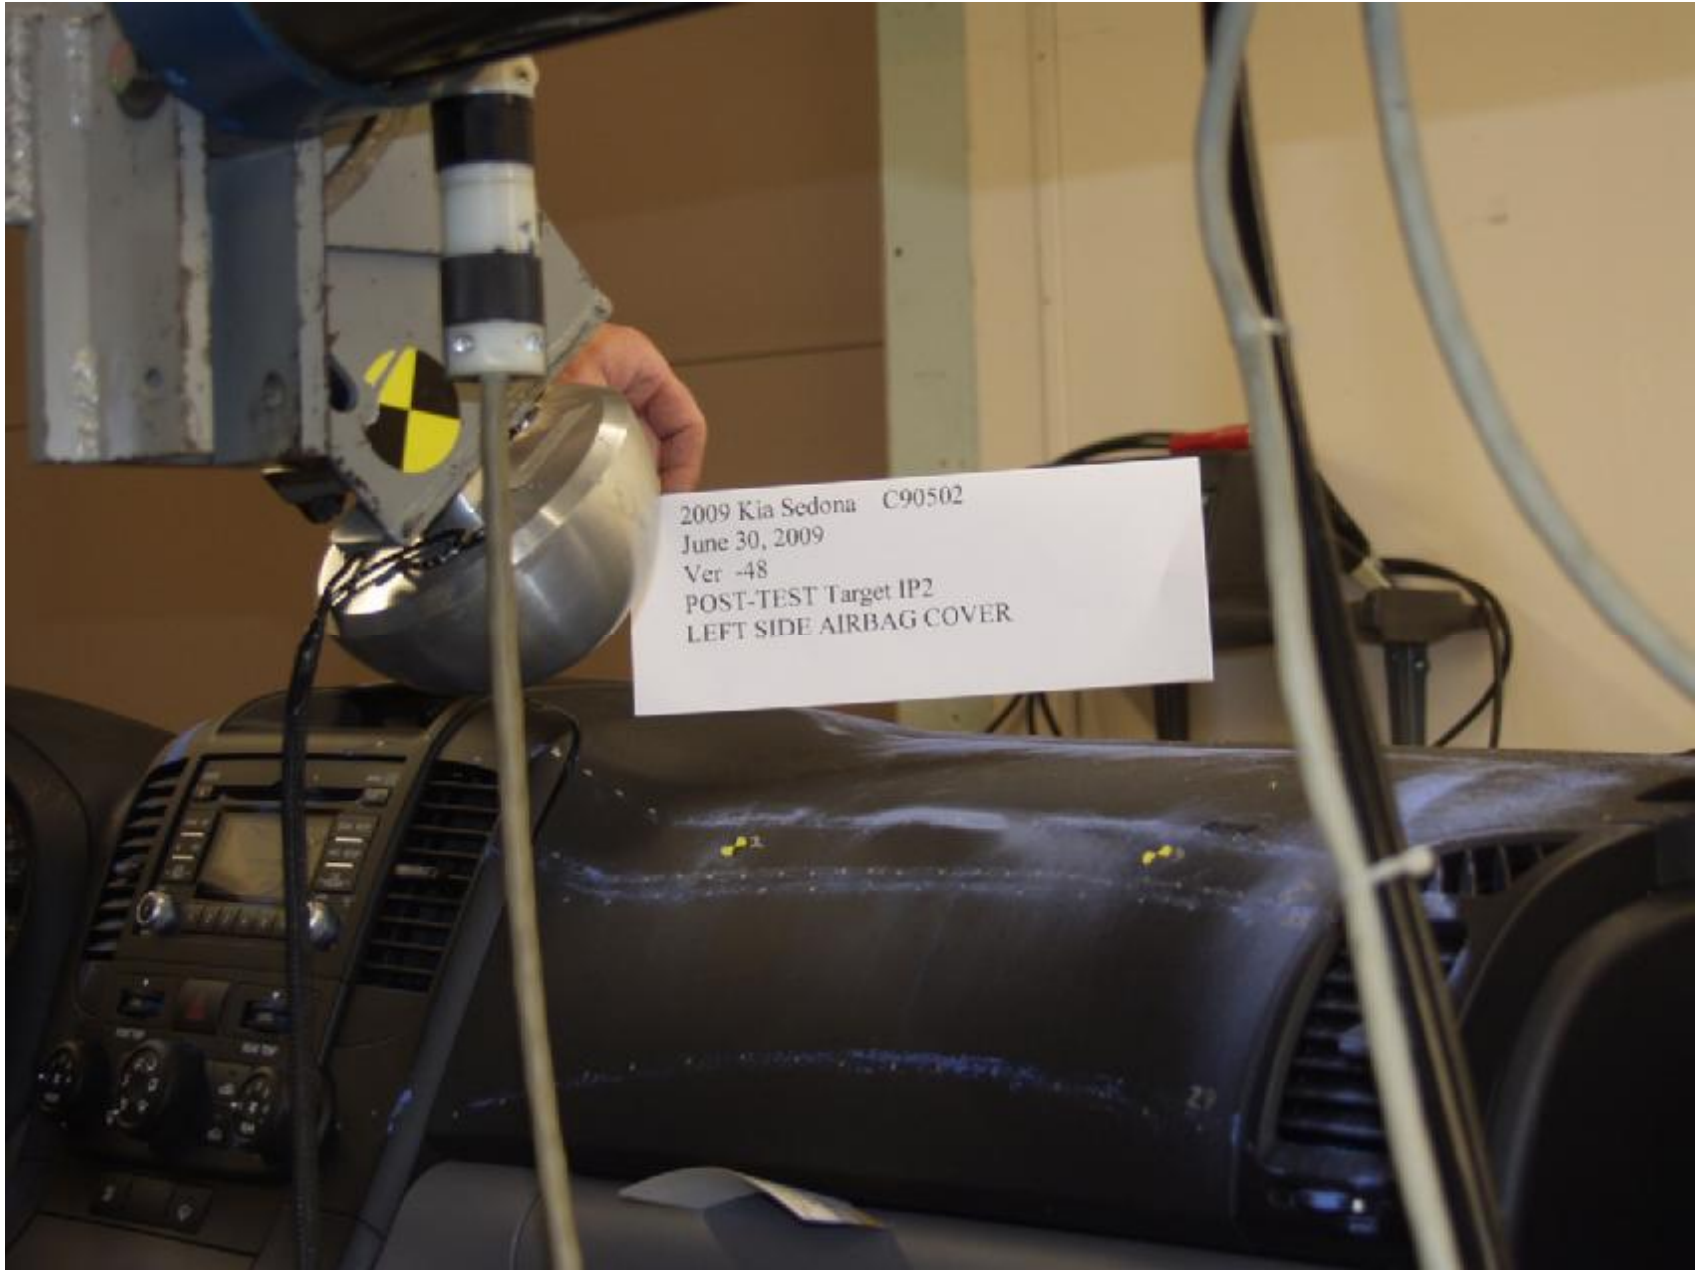
Figure A-17 : INSTRUMENT PANEL IMPACT #2 PRE-TEST

Figure A-18 : INSTRUMENT PANEL IMPACT #2 POST-TEST

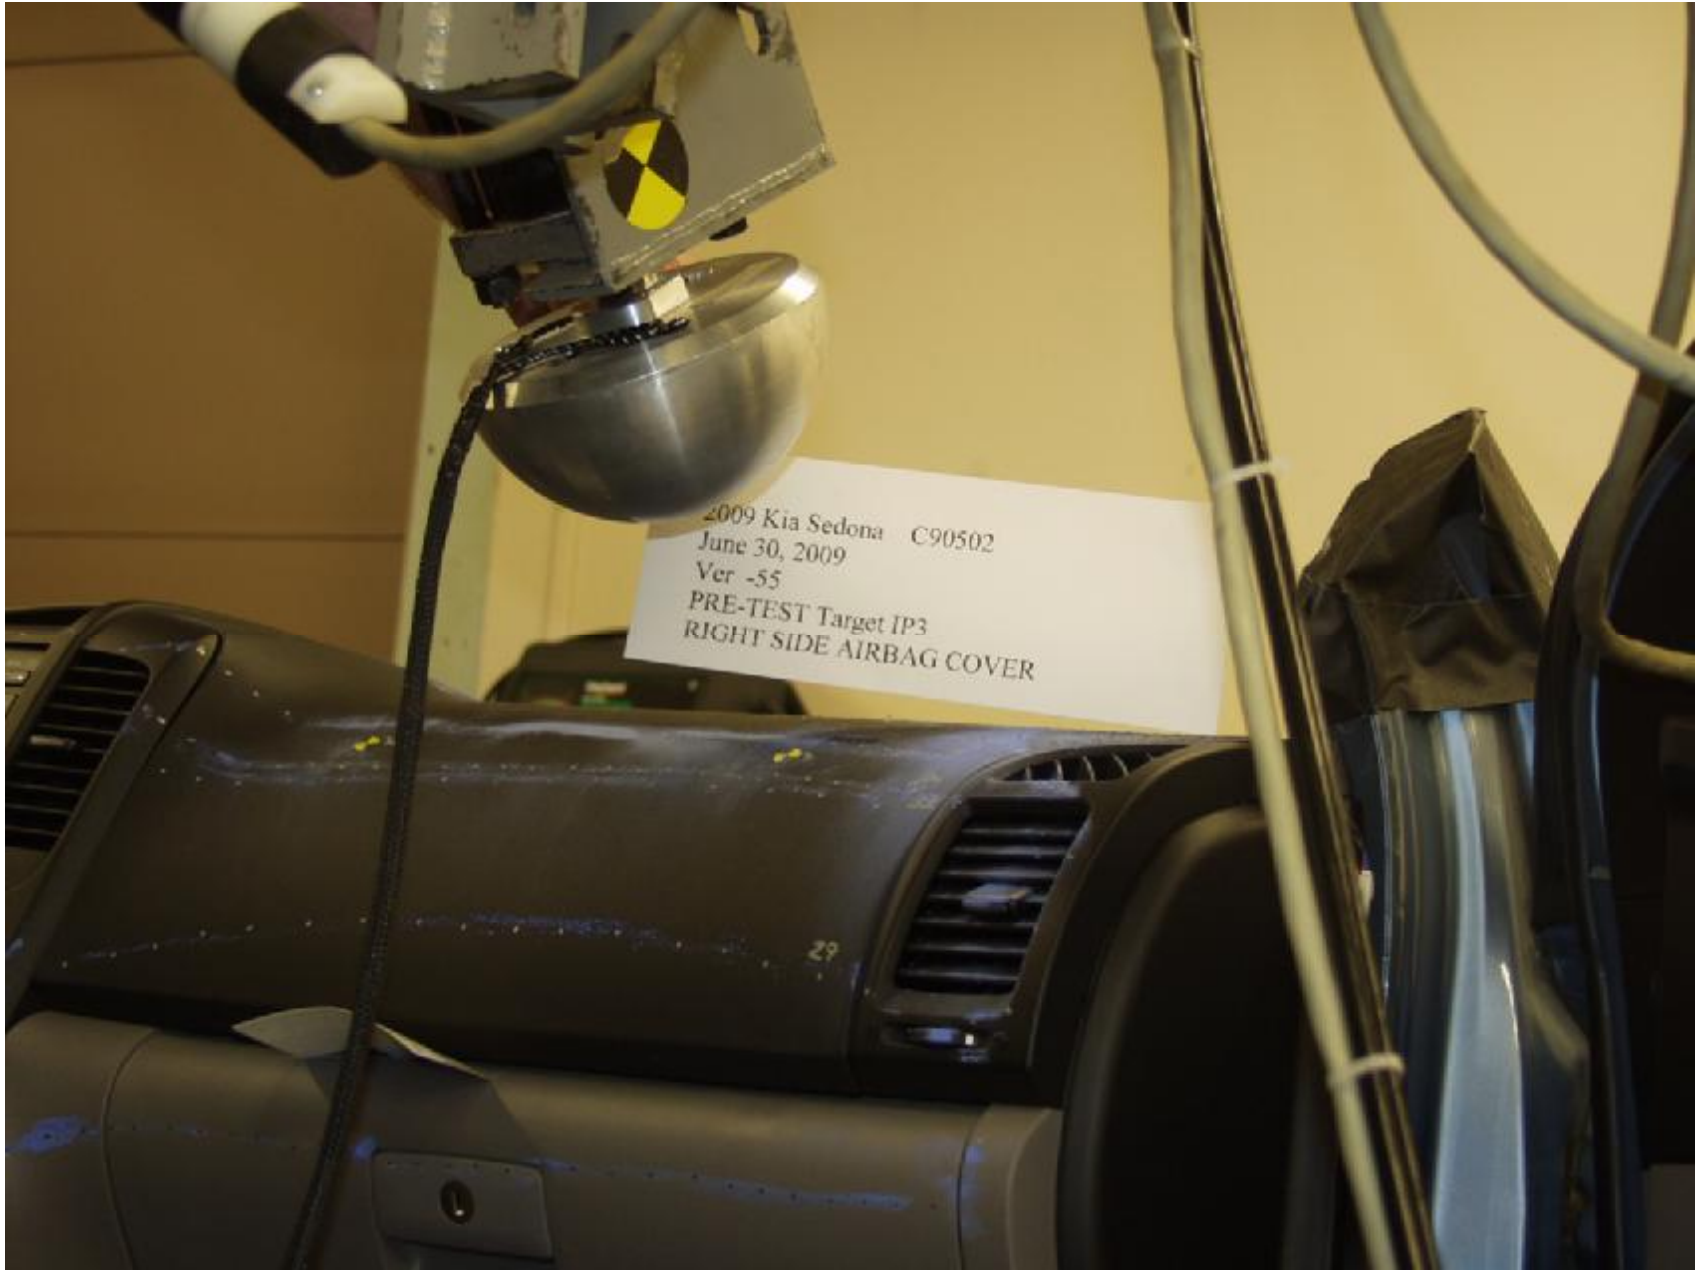
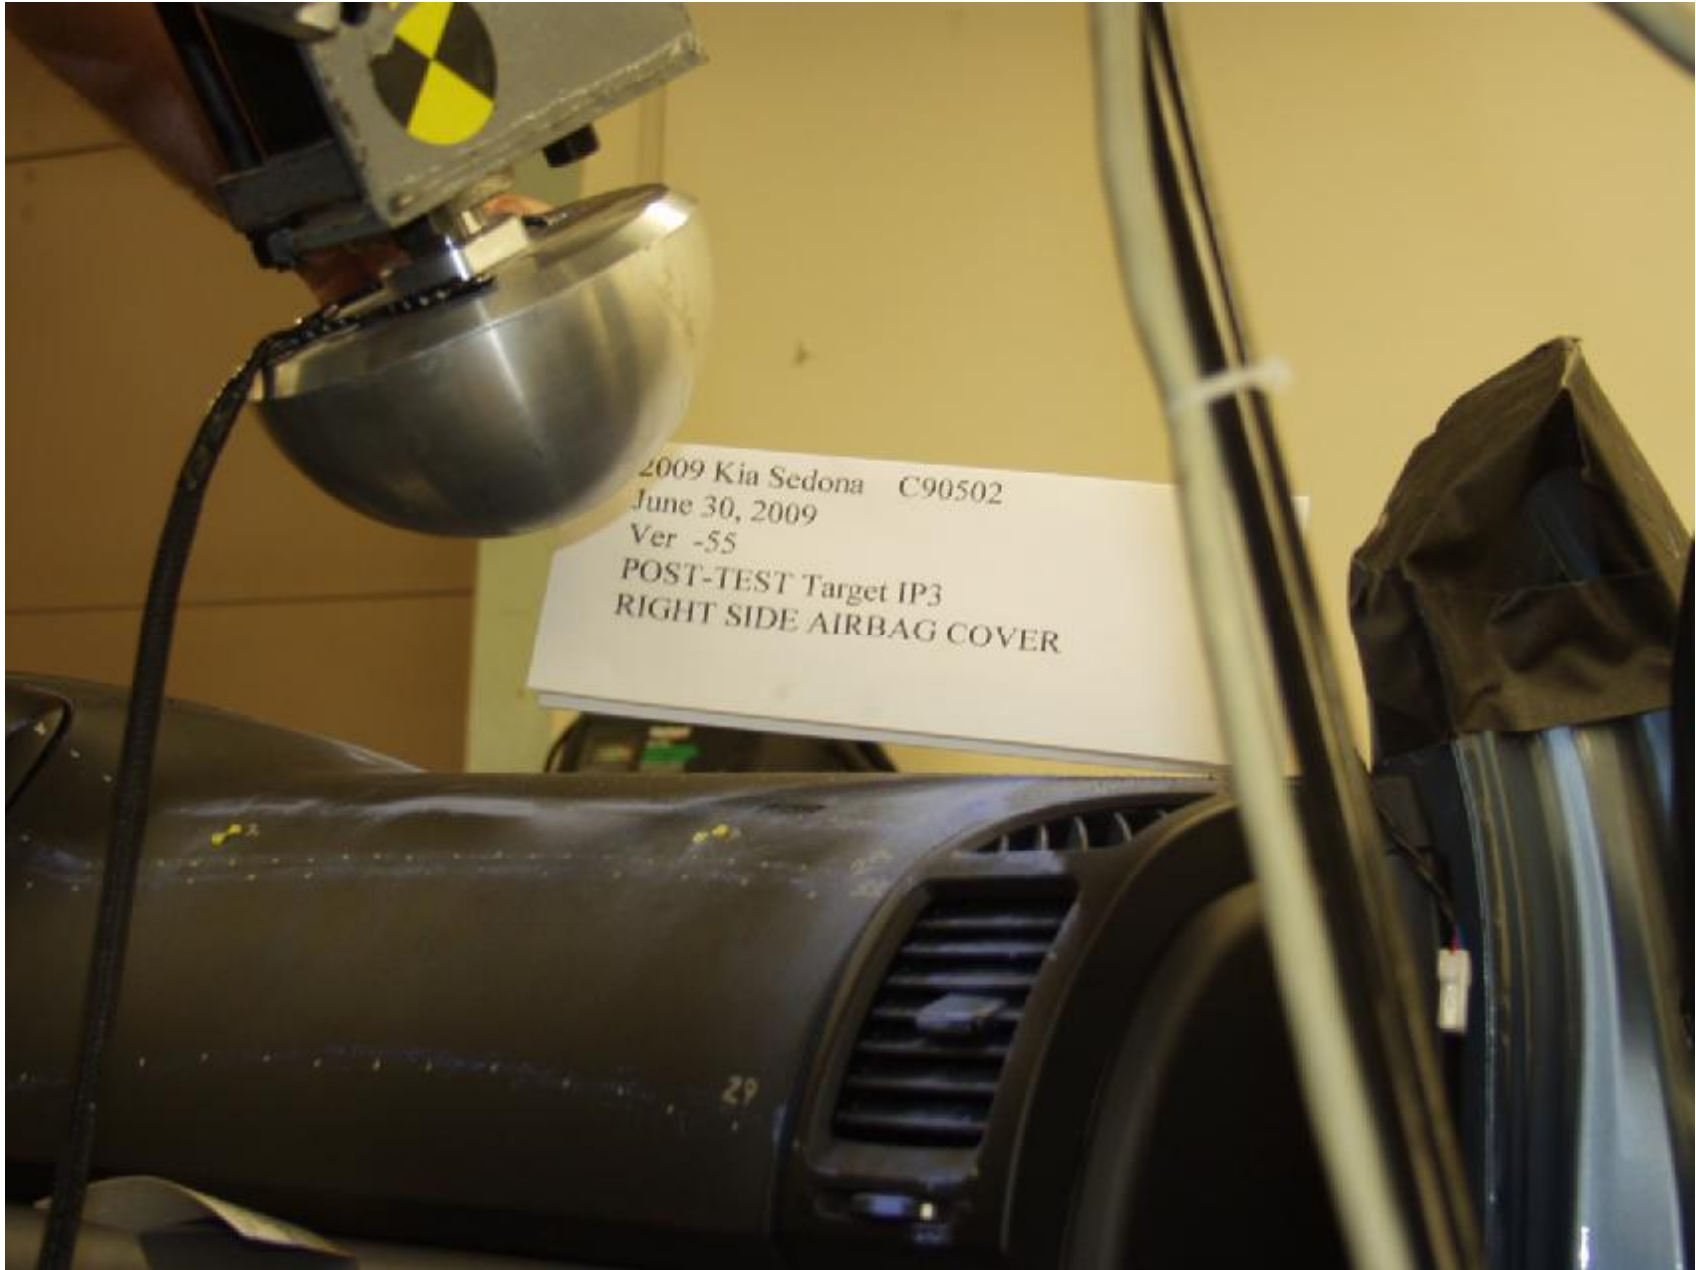
Figure A-19 : INSTRUMENT PANEL IMPACT #3 PRE-TEST

Figure A-20 : INSTRUMENT PANEL IMPACT #3 POST-TEST

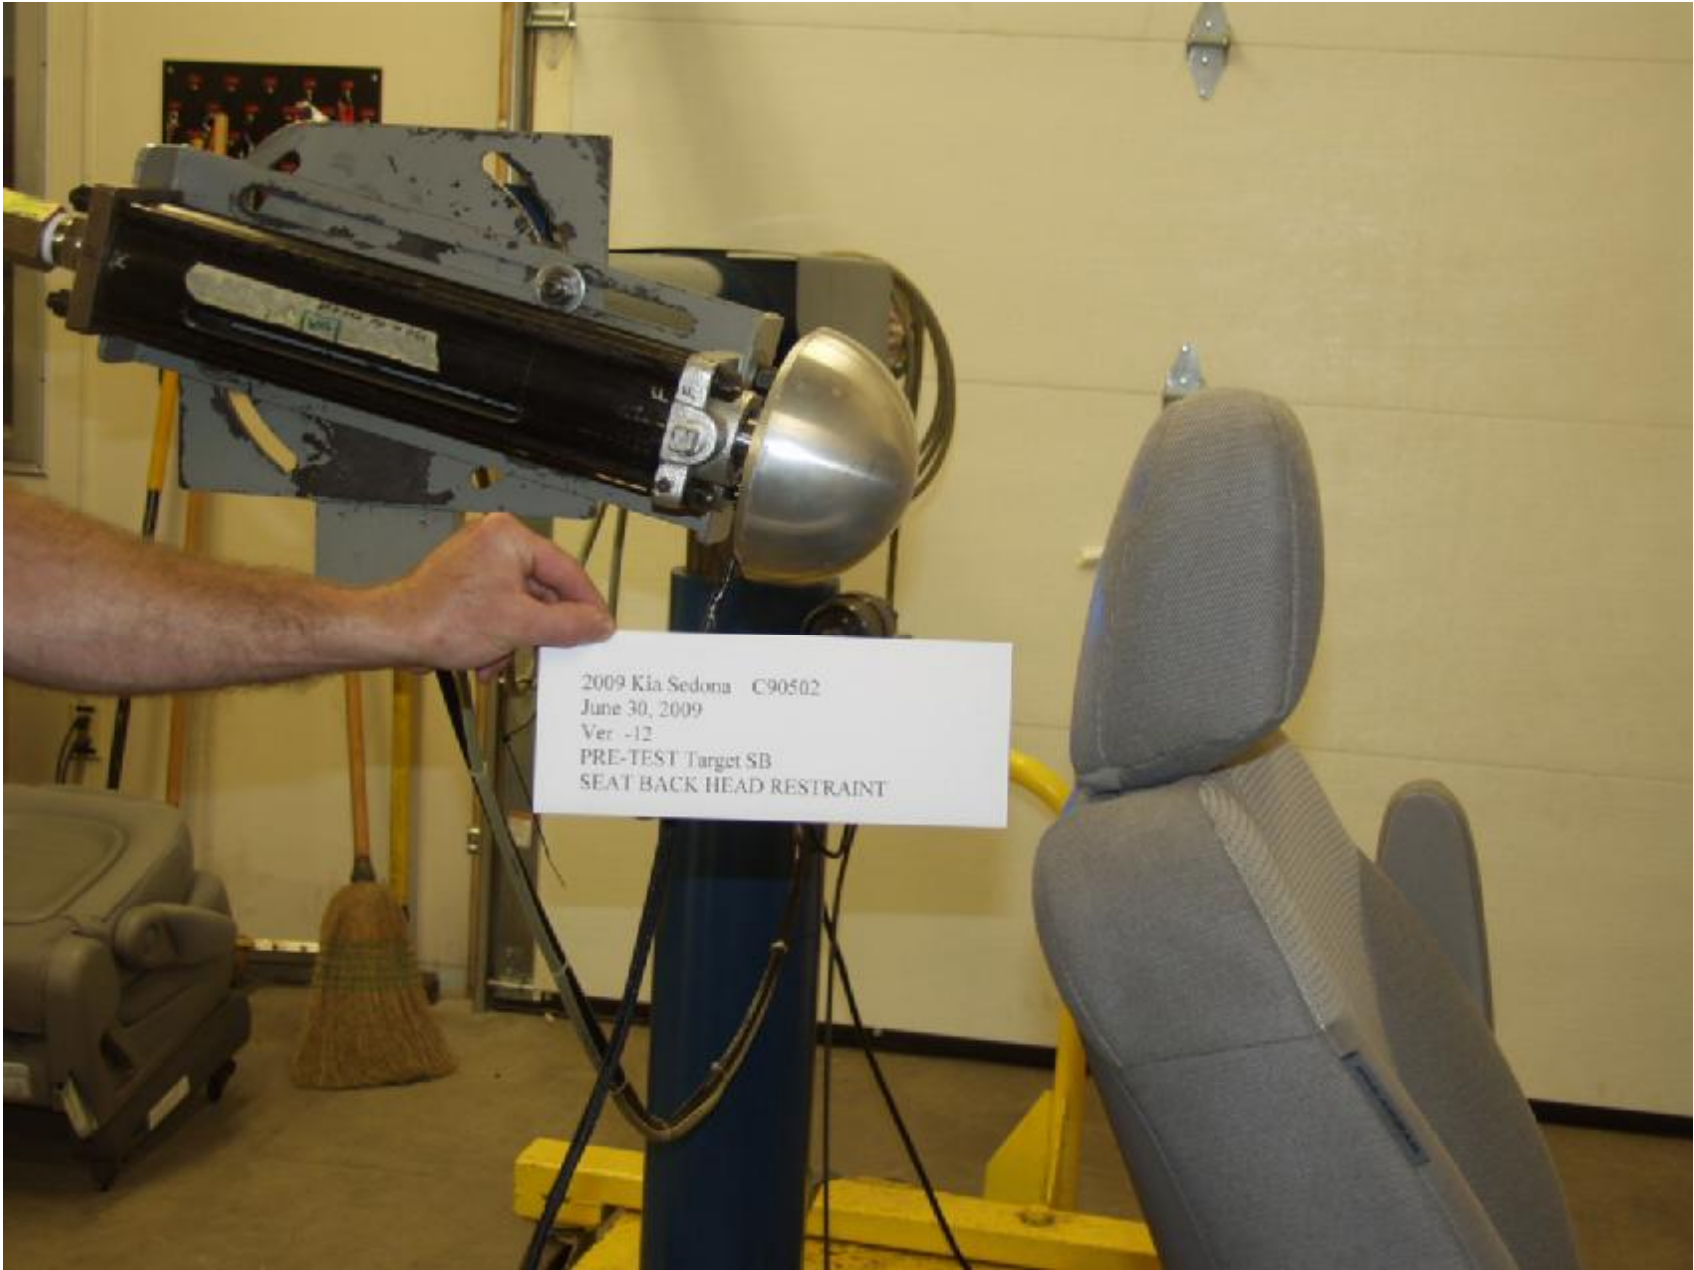
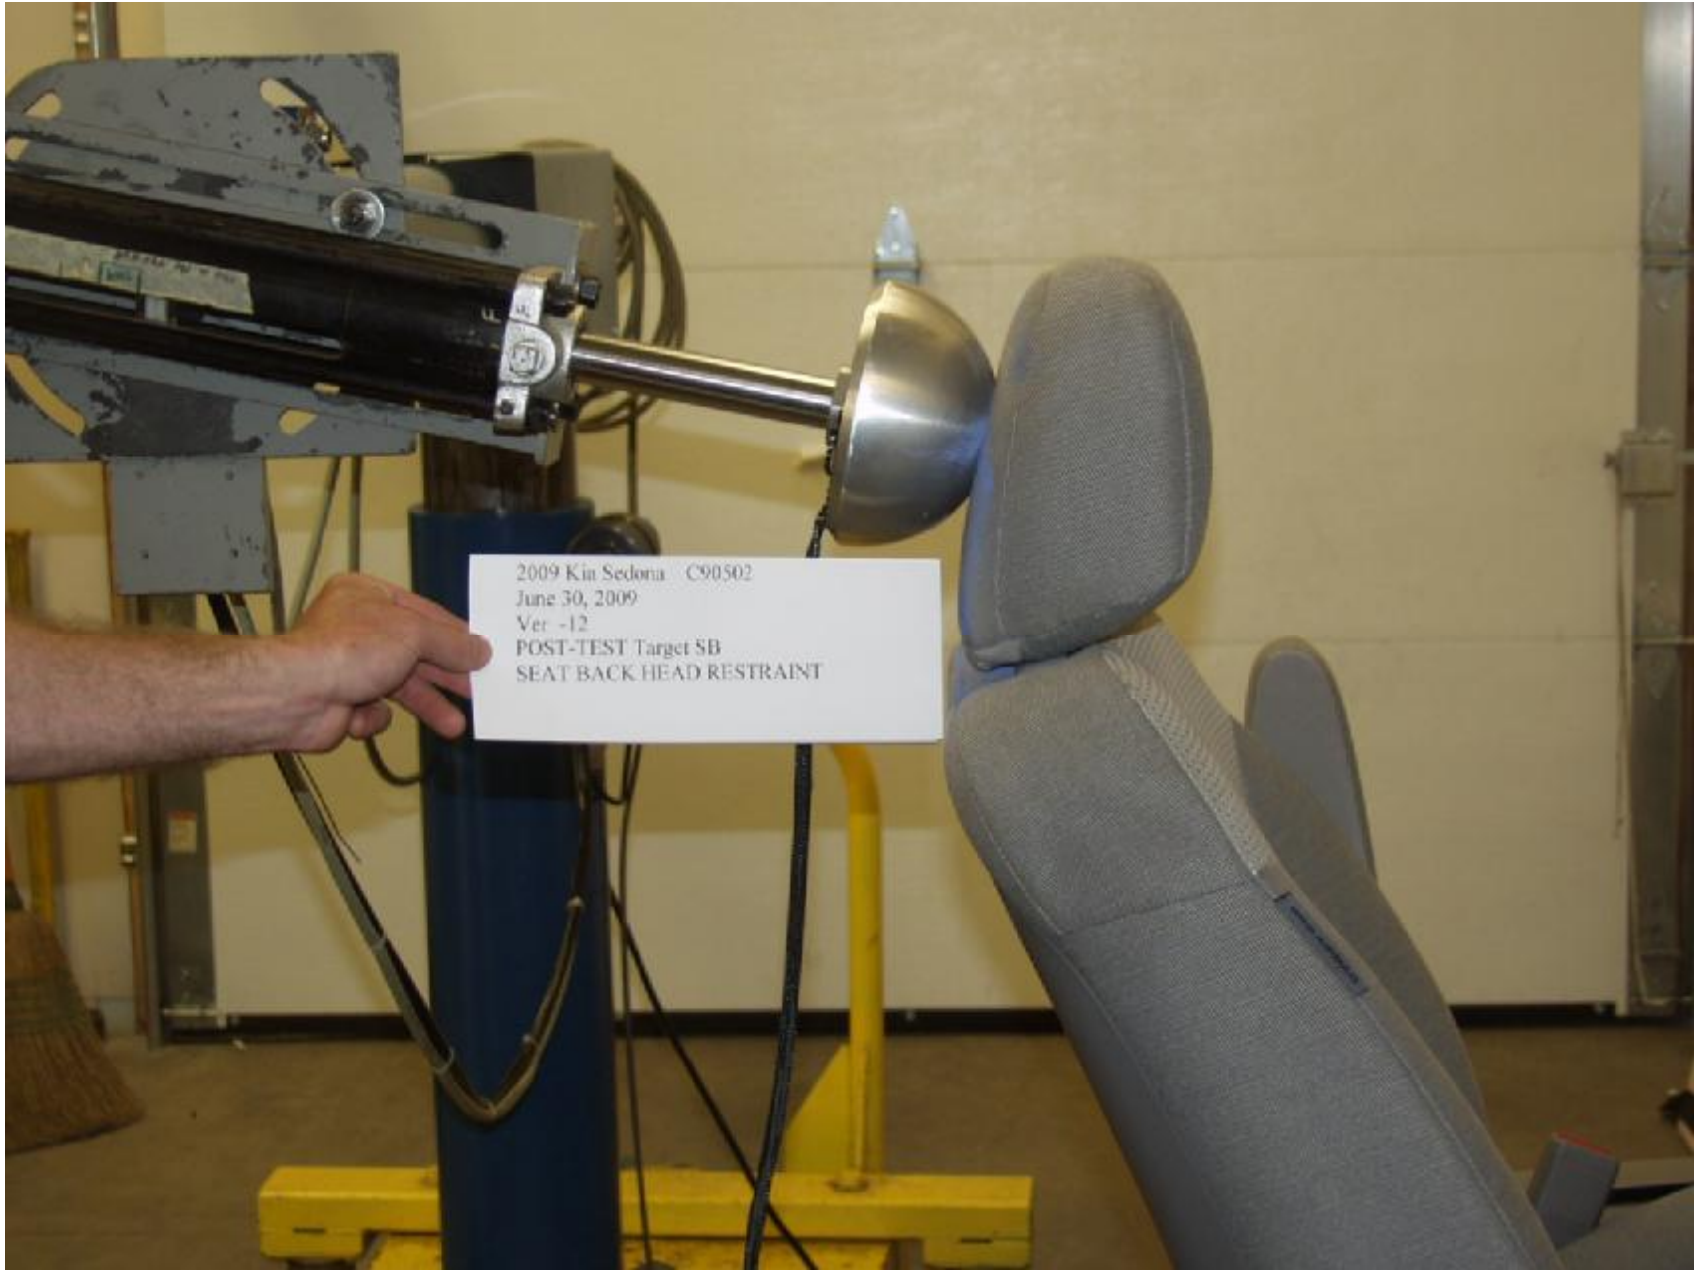
IMPACT LOCATION AND NUMBER				VELOCITY (kph)	PEAK ACCELERATION (3 ms Clip) Gs
TARGET	X (mm)	Y (mm)	ANGLE (degrees)		
Seat Back Head Restraint	2715	423	12	23.55	41.98

Figure A-22 : HEAD RESTRAINT IMPACT AREA PRE-TEST

Figure A-23 : HEAD RESTRAINT IMPACT AREA POST-TEST
