REPORT NUMBER: 201-CAL-09-05

**SAFETY COMPLIANCE TESTING FOR FMVSS 201
OCCUPANT PROTECTION IN INTERIOR IMPACT**

**KIA MOTORS CORPORATION
2009 KIA SEDONA**

NHTSA NUMBER: C90502

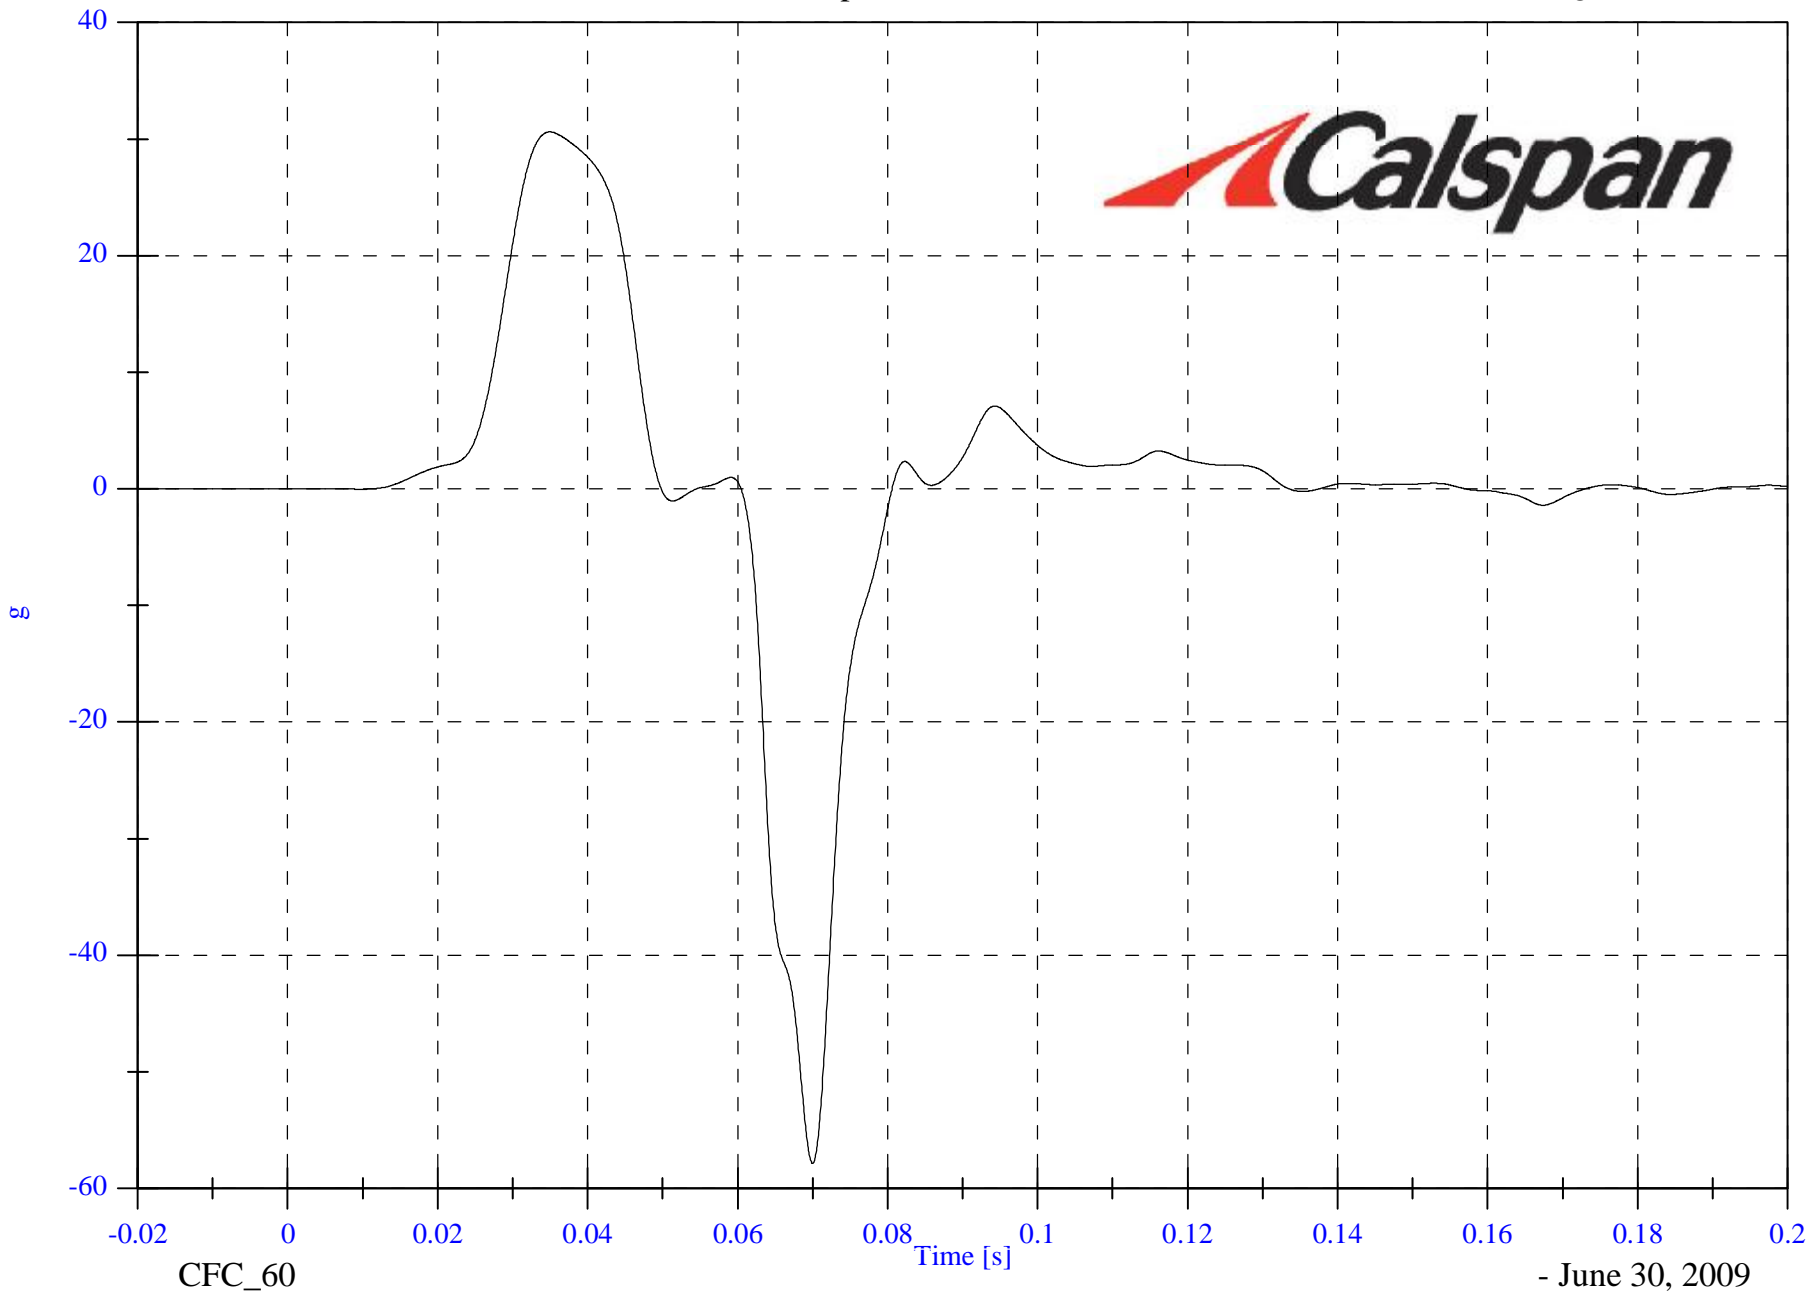
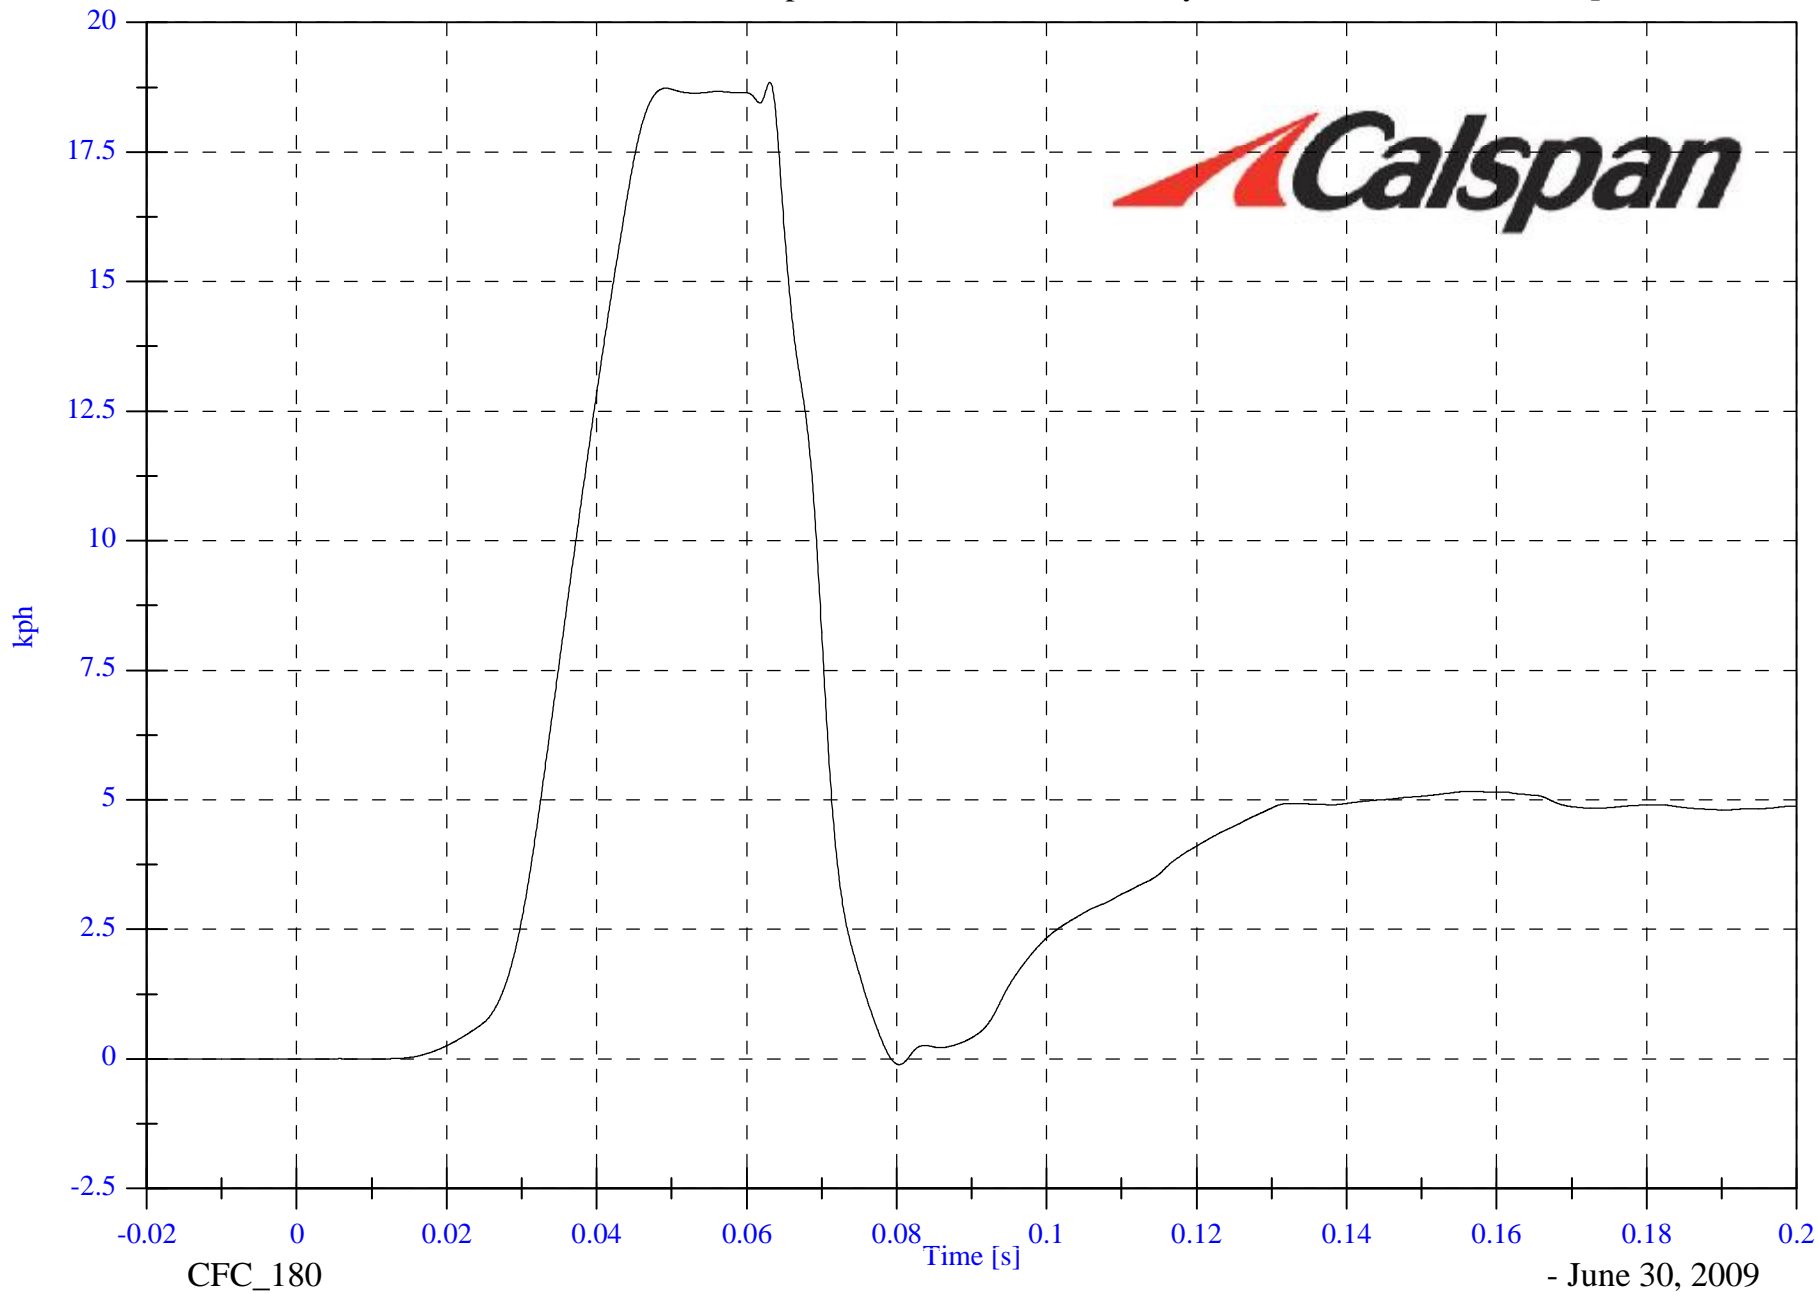
C90502 IP1 IMPACT PLOT #1

Max: 30.6 [g] at 0.035 [s]

Min: -57.8 [g] at 0.070 [s]

Max: 18.8 [kph] at 0.063 [s]

Min: -0.1 [kph] at 0.080 [s]

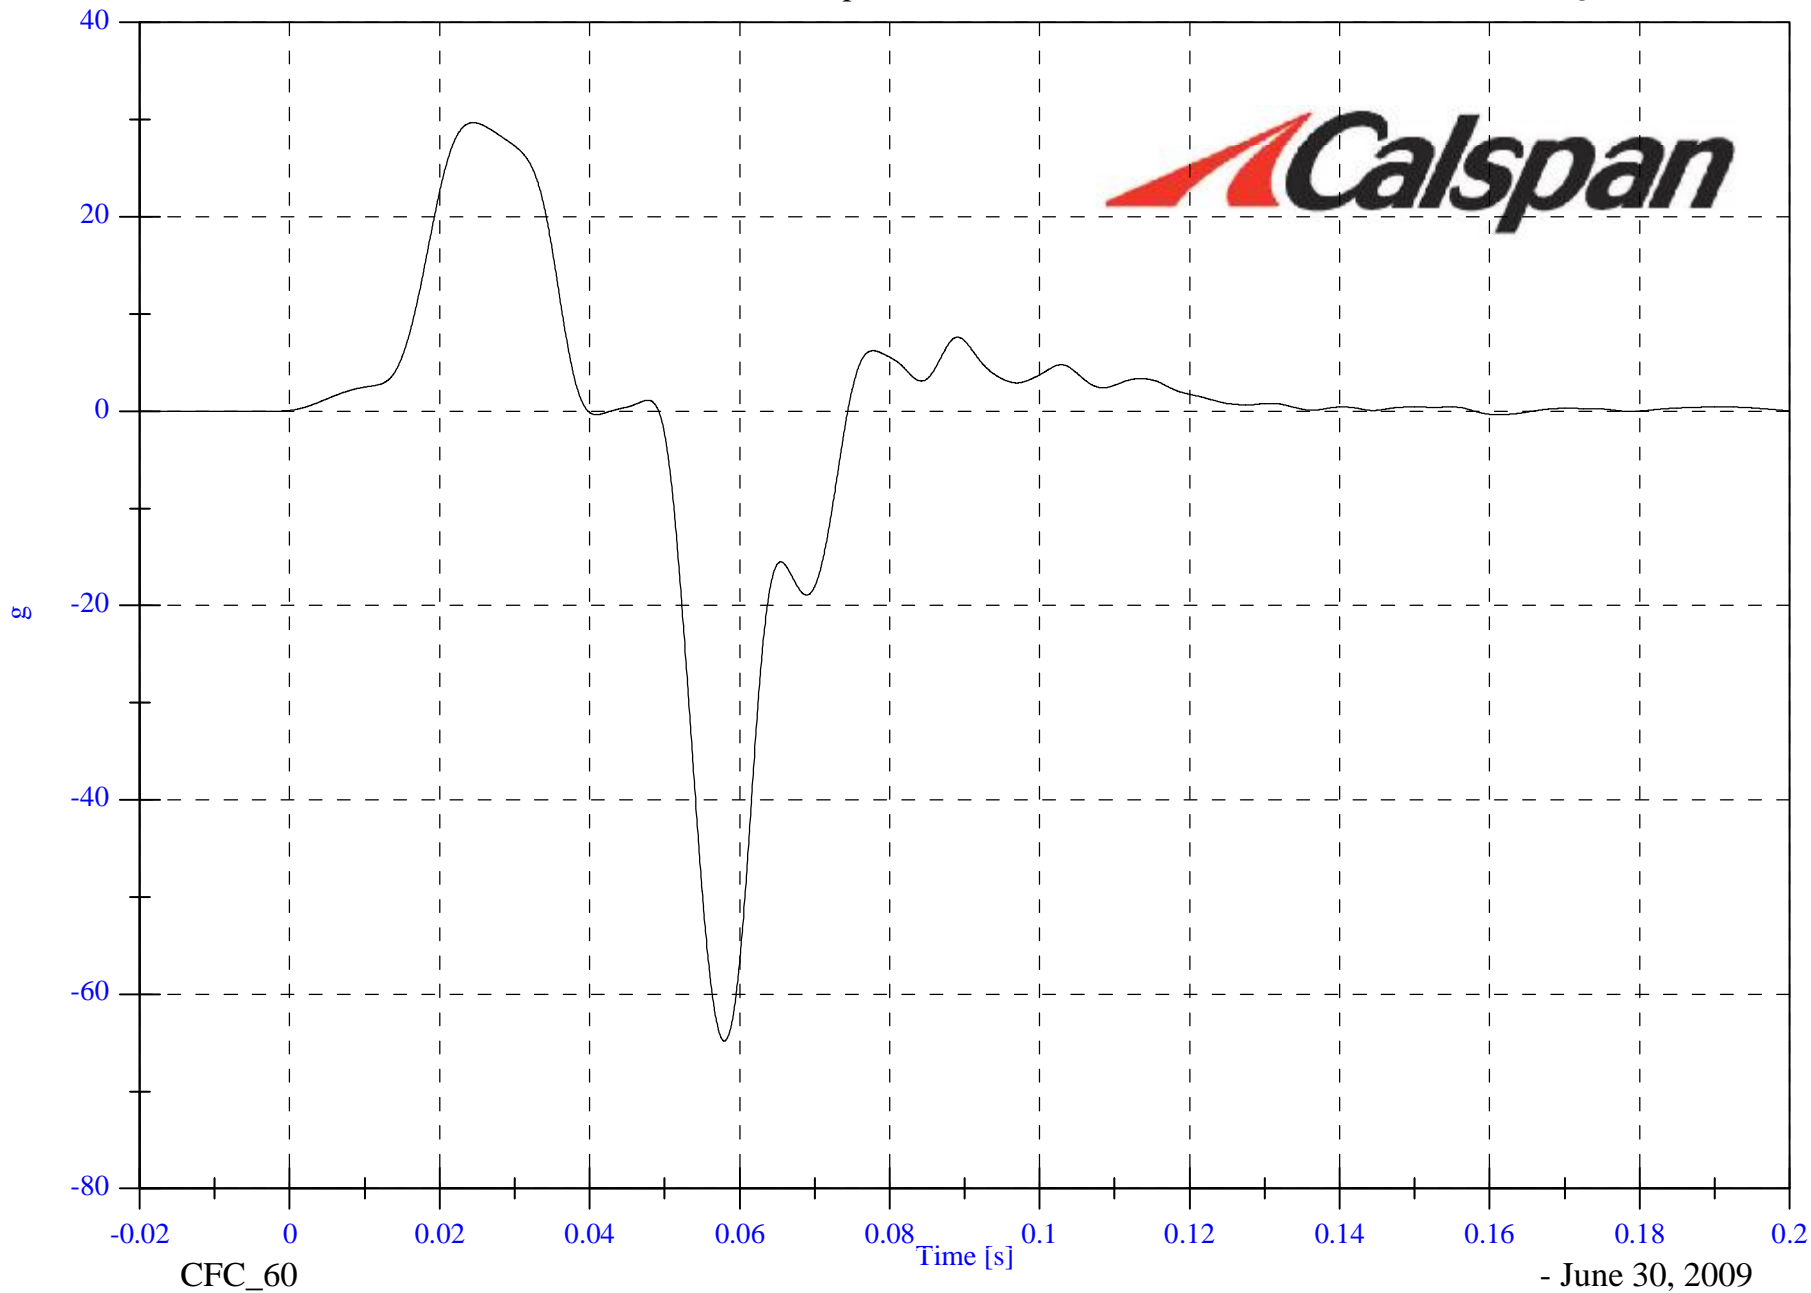
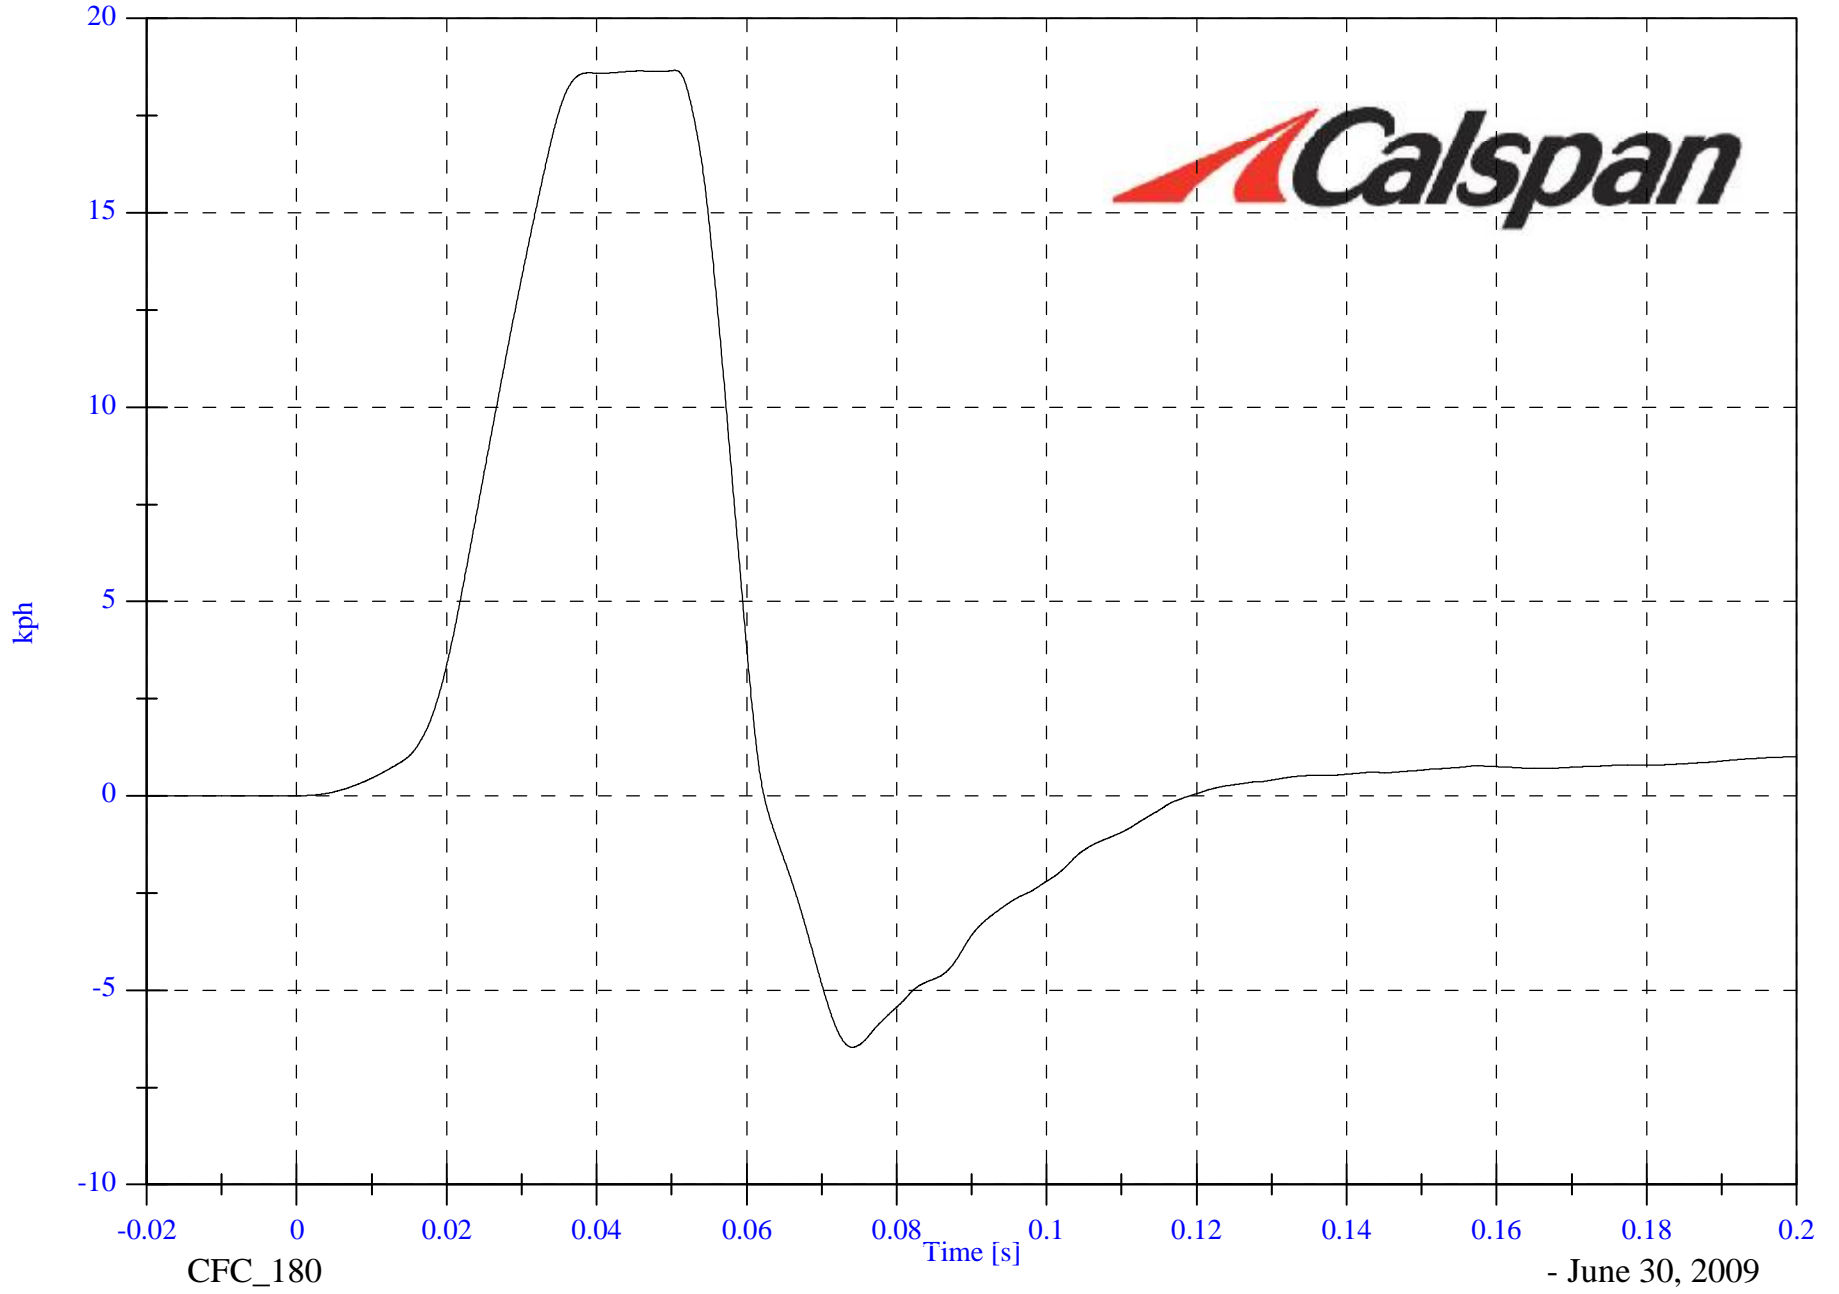
C90502 IP2 IMPACT PLOT #1

Max: 29.7 [g] at 0.024 [s]

Min: -64.8 [g] at 0.058 [s]

Max: 18.7 [kph] at 0.050 [s]

Min: -6.5 [kph] at 0.074 [s]

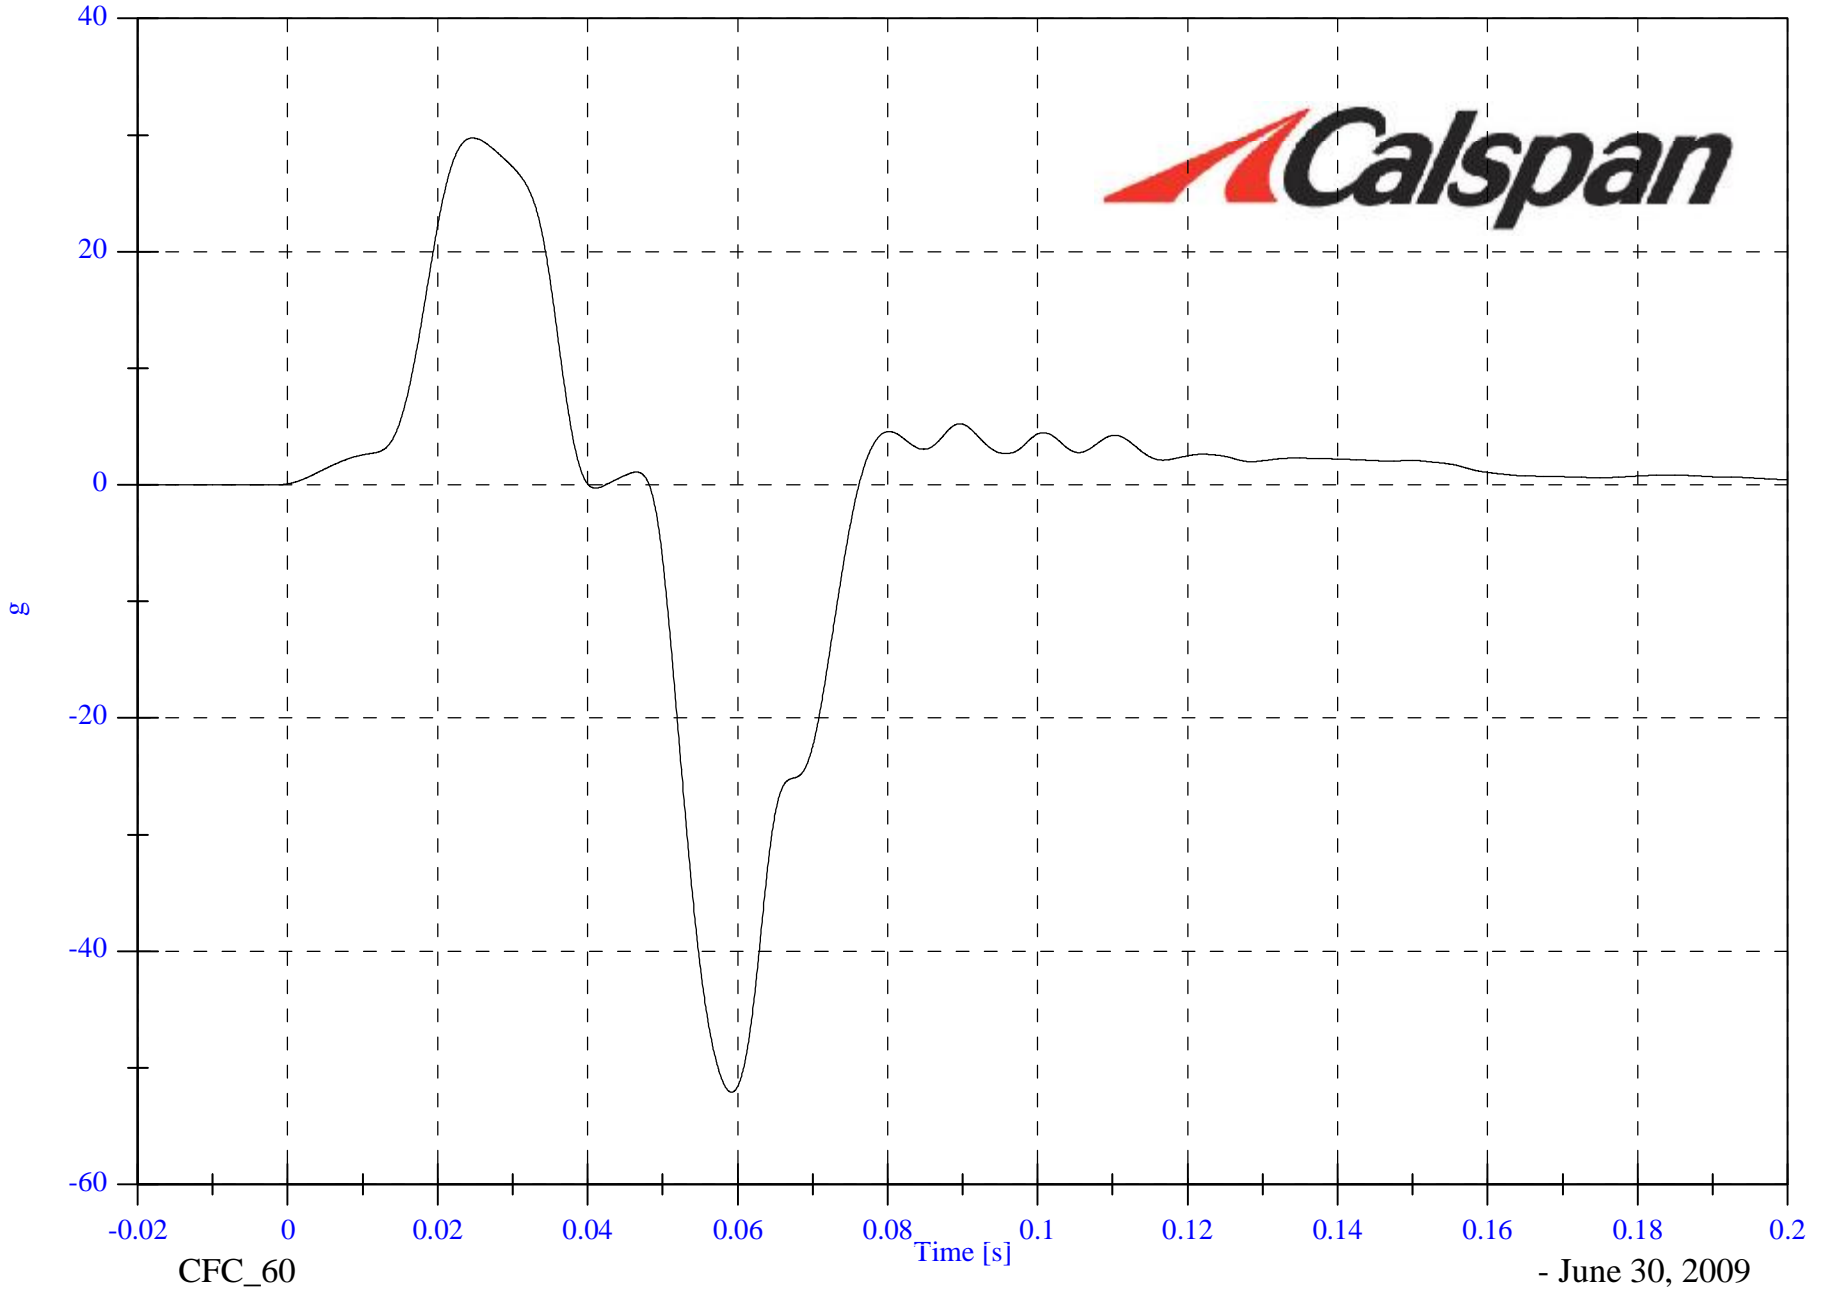
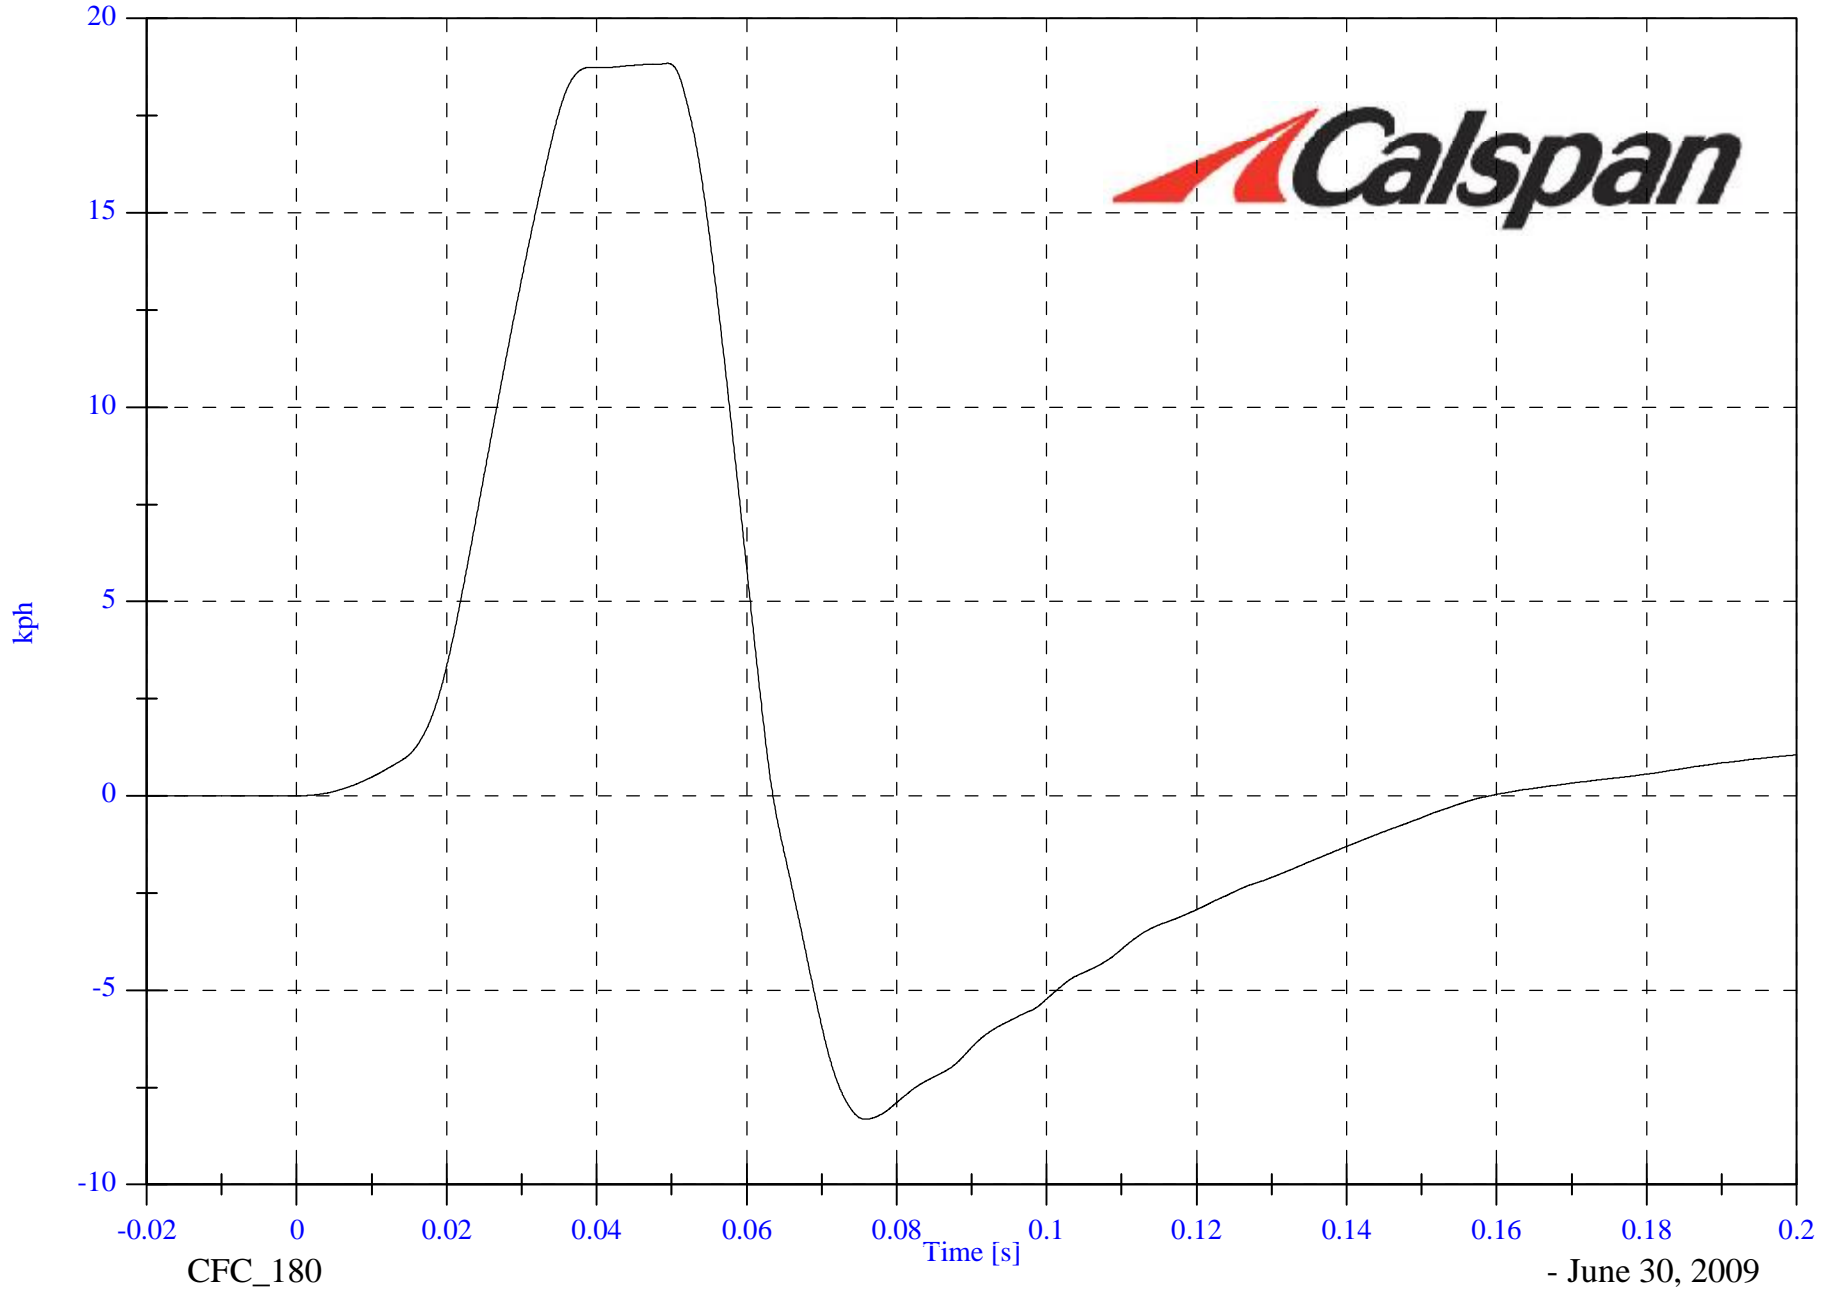
C90502 IP3 IMPACT PLOT #1

Max: 29.8 [g] at 0.025 [s]

Min: -52.1 [g] at 0.059 [s]

Max: 18.8 [kph] at 0.049 [s]

Min: -8.3 [kph] at 0.076 [s]

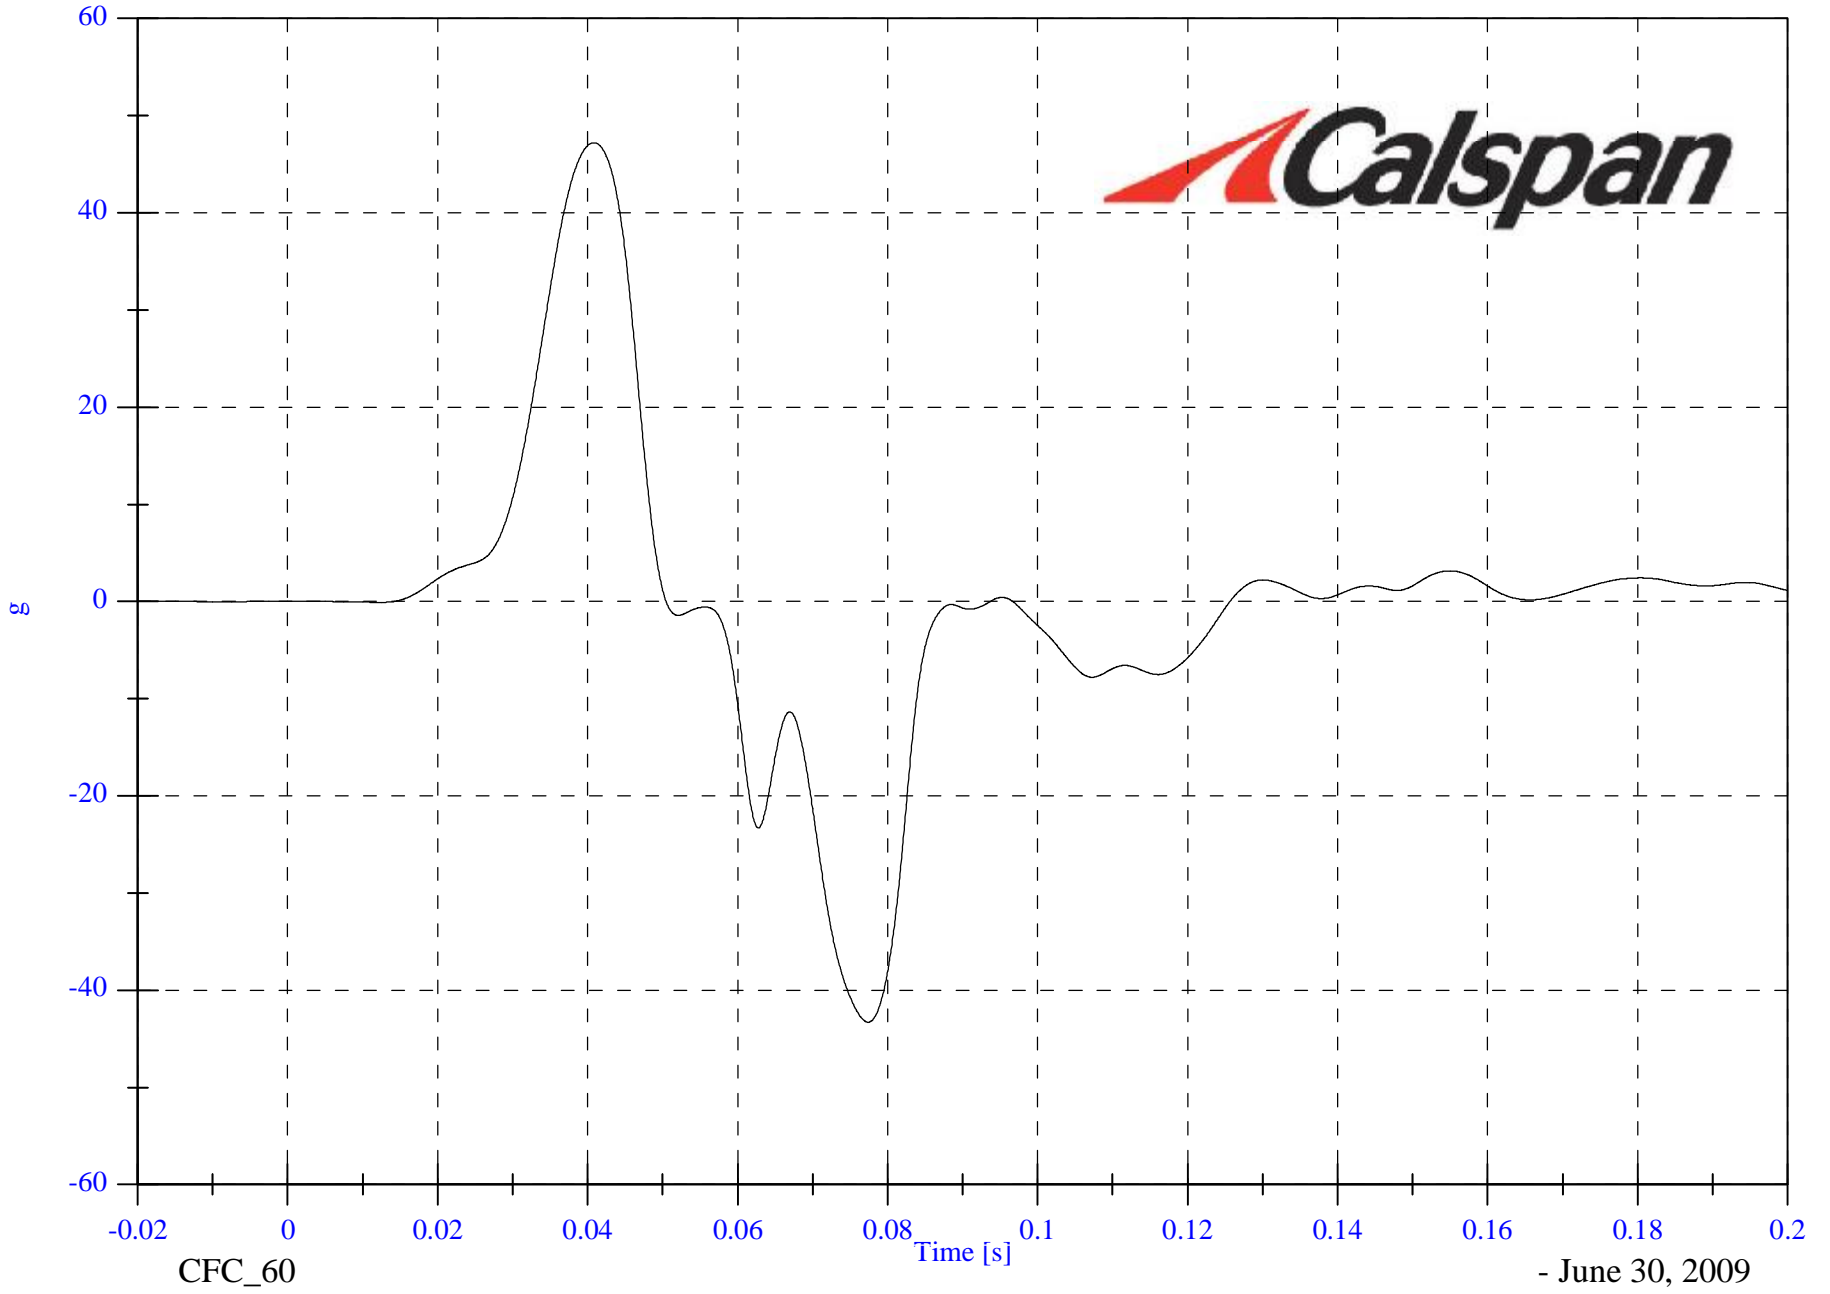
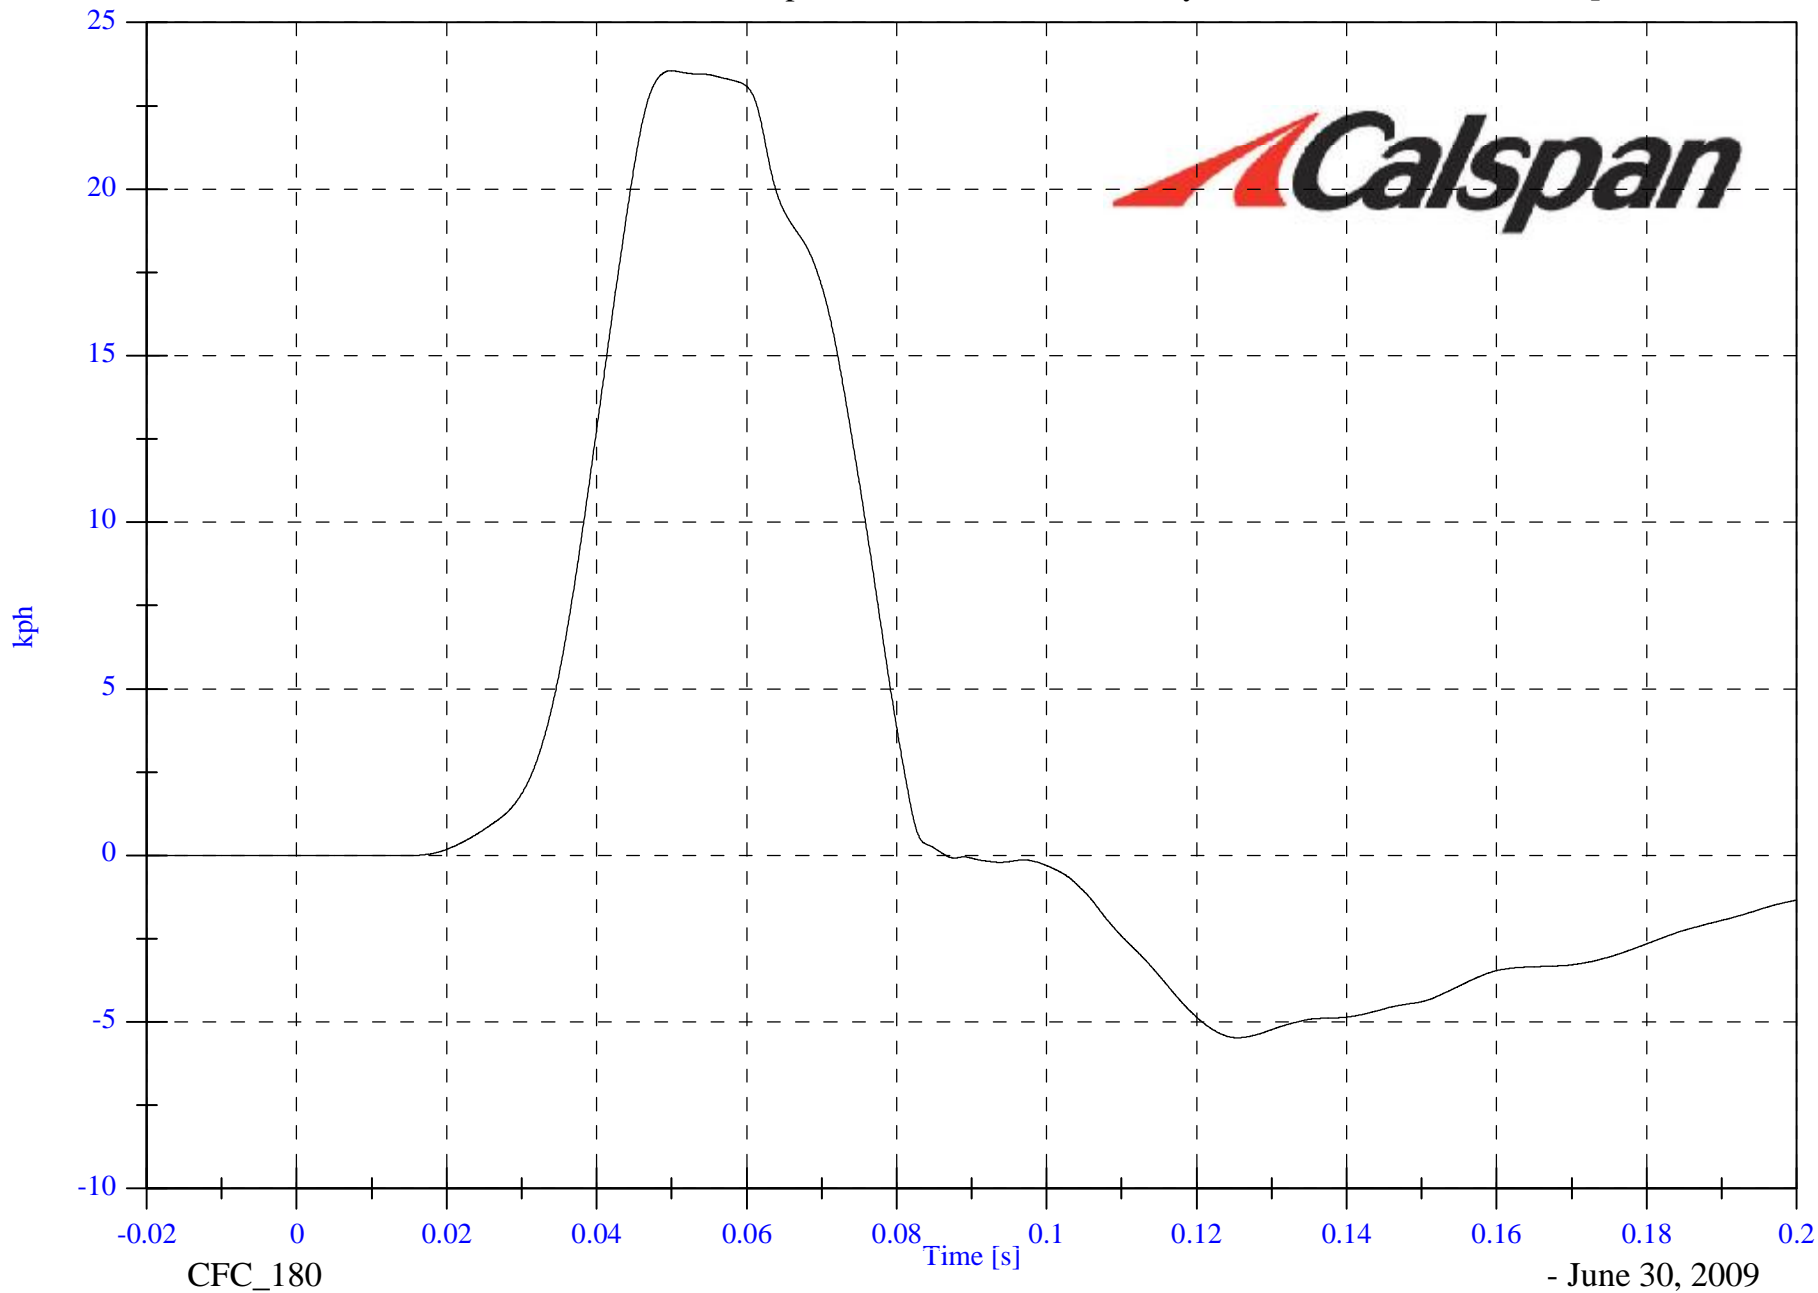
C90502 SB IMPACT PLOT #1

Max: 47.2 [g] at 0.041 [s]

Min: -43.3 [g] at 0.077 [s]

Max: 23.6 [kph] at 0.050 [s]

Min: -5.5 [kph] at 0.125 [s]
