REPORT NUMBER: 301-MGA-2011-008

**SAFETY COMPLIANCE TESTING FOR FMVSS 301R
FUEL SYSTEM INTEGRITY – REAR IMPACT**

**MAZDA MOTOR CORPORATION
2011 MAZDA 2 SPORT MT
NHTSA NUMBER: CB5400**

**PREPARED BY:
MGA RESEARCH CORPORATION
5000 WARREN ROAD
BURLINGTON, WI 53105**

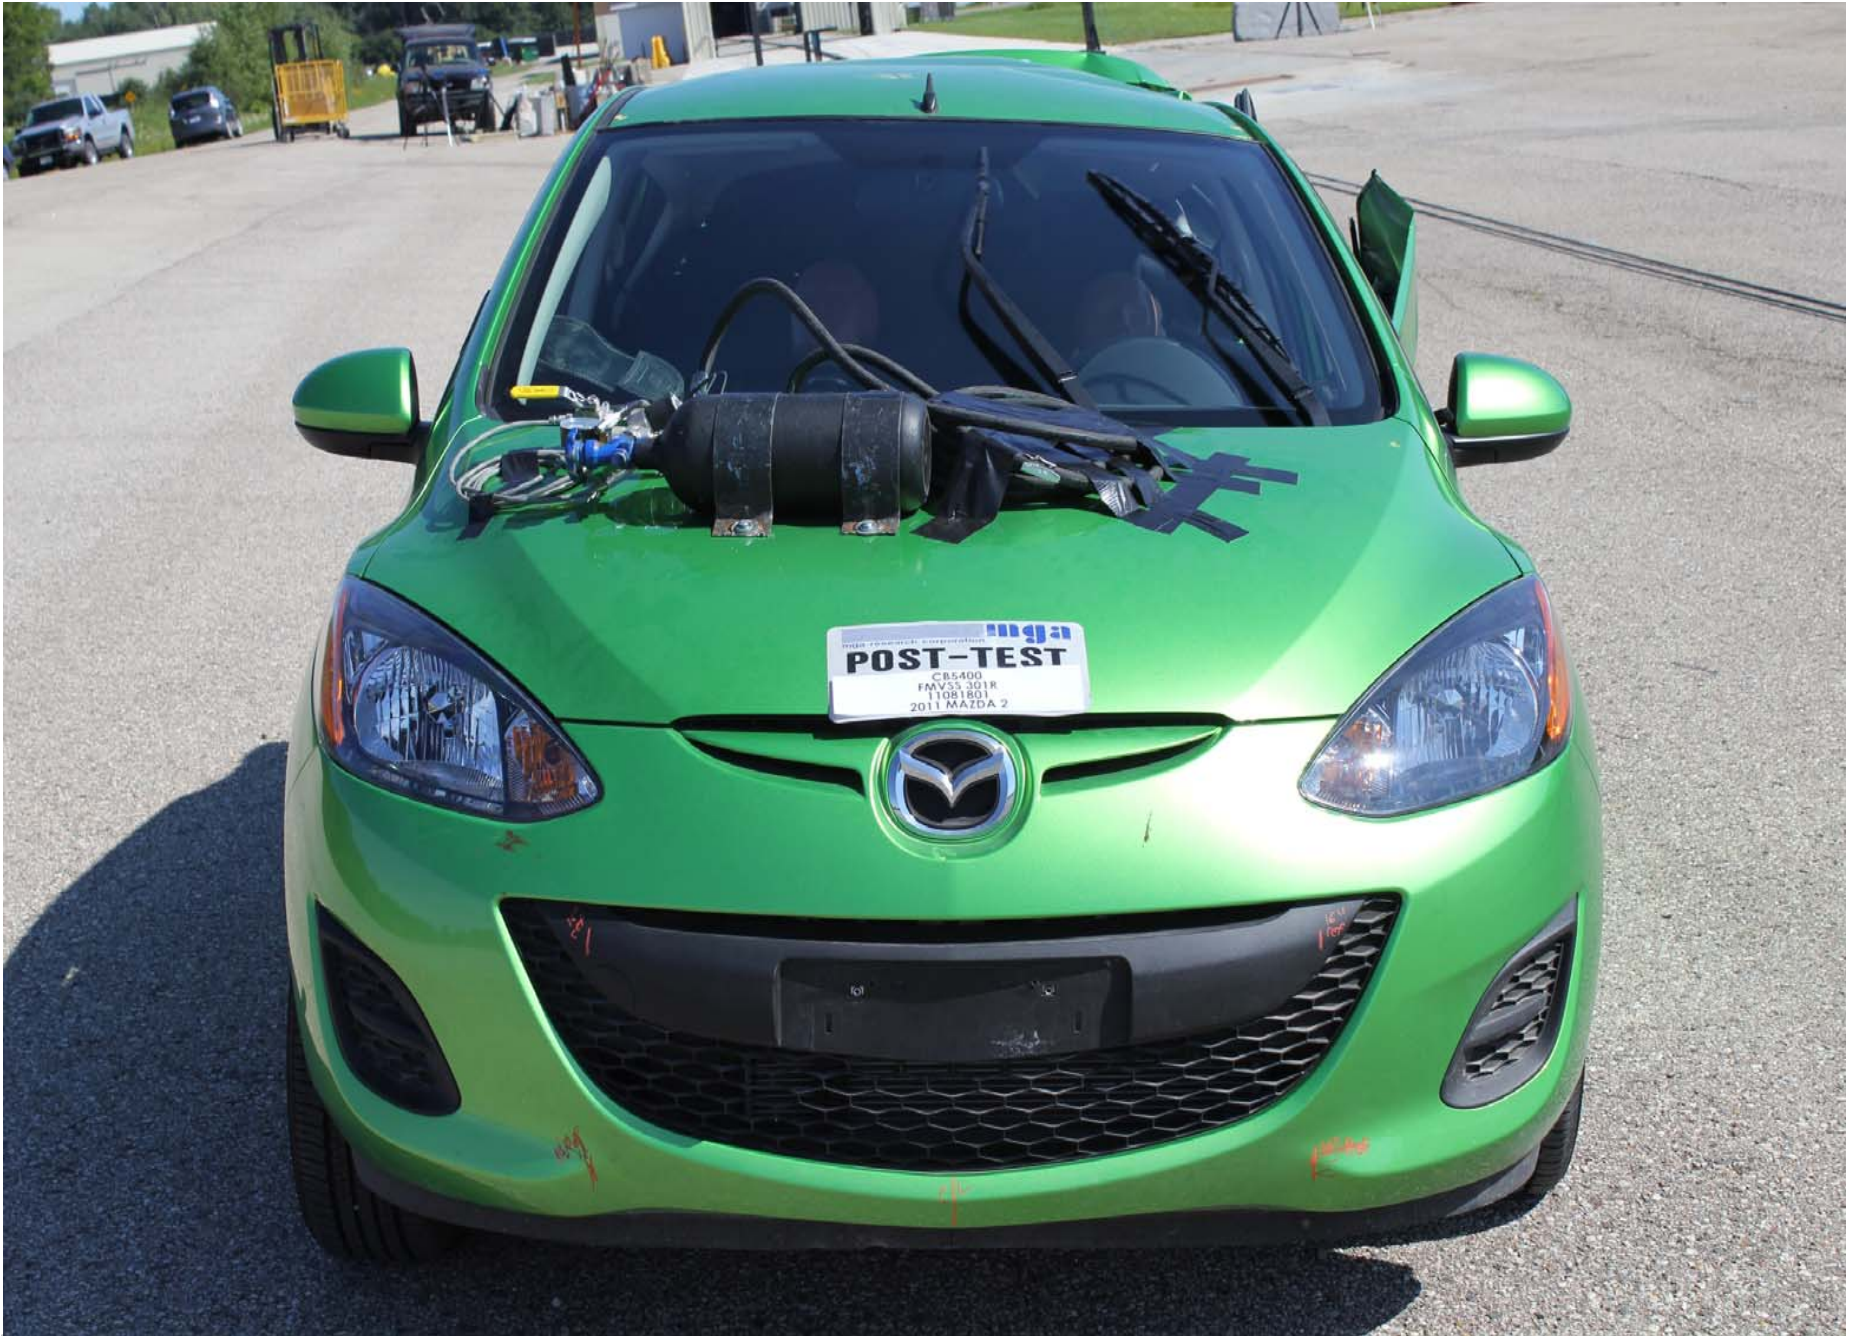
A-4.

Post-Test Front View of Vehicle

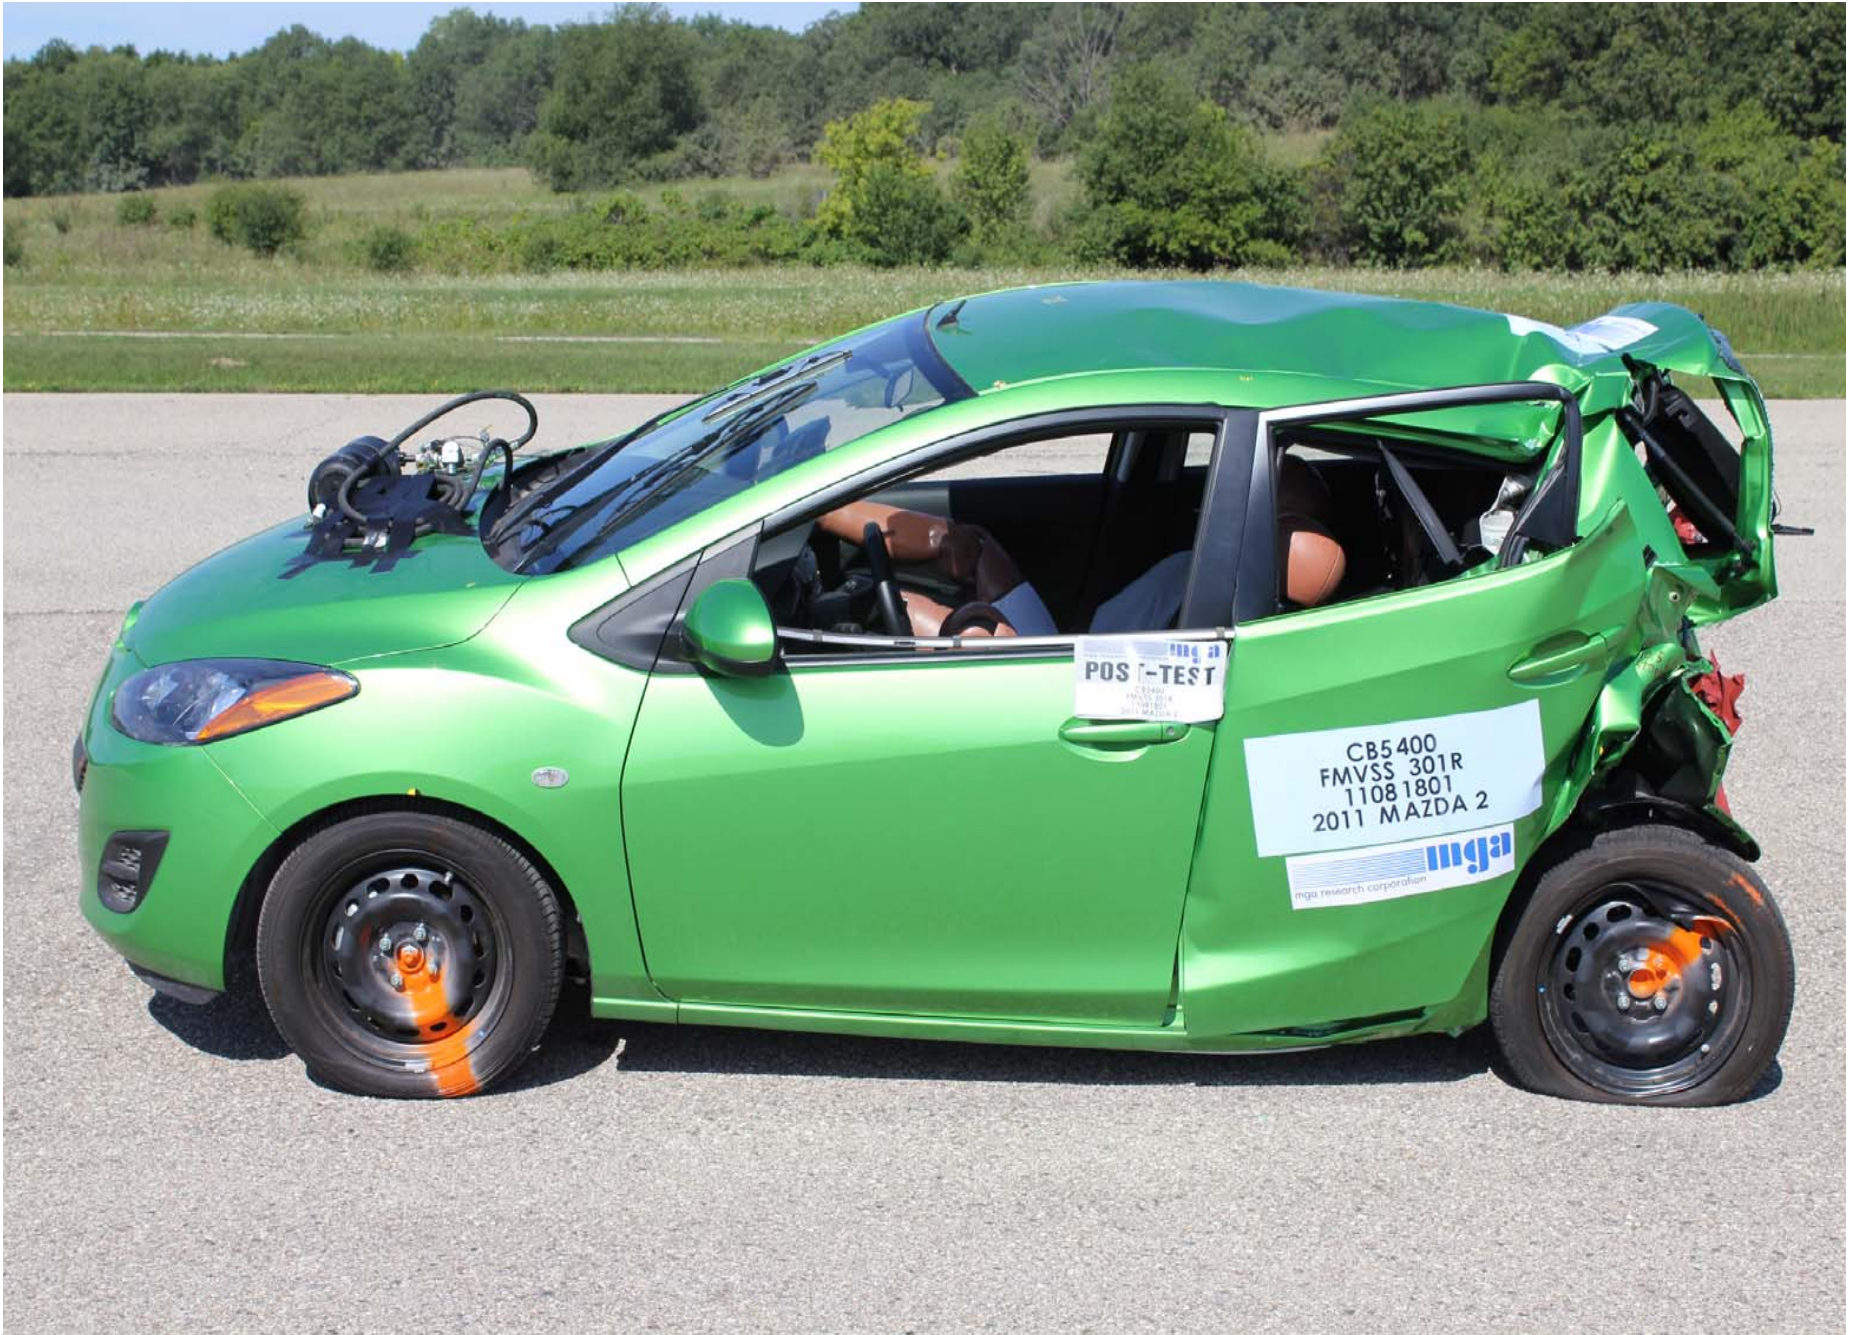
A-6.

Post-Test Left Side View of Vehicle

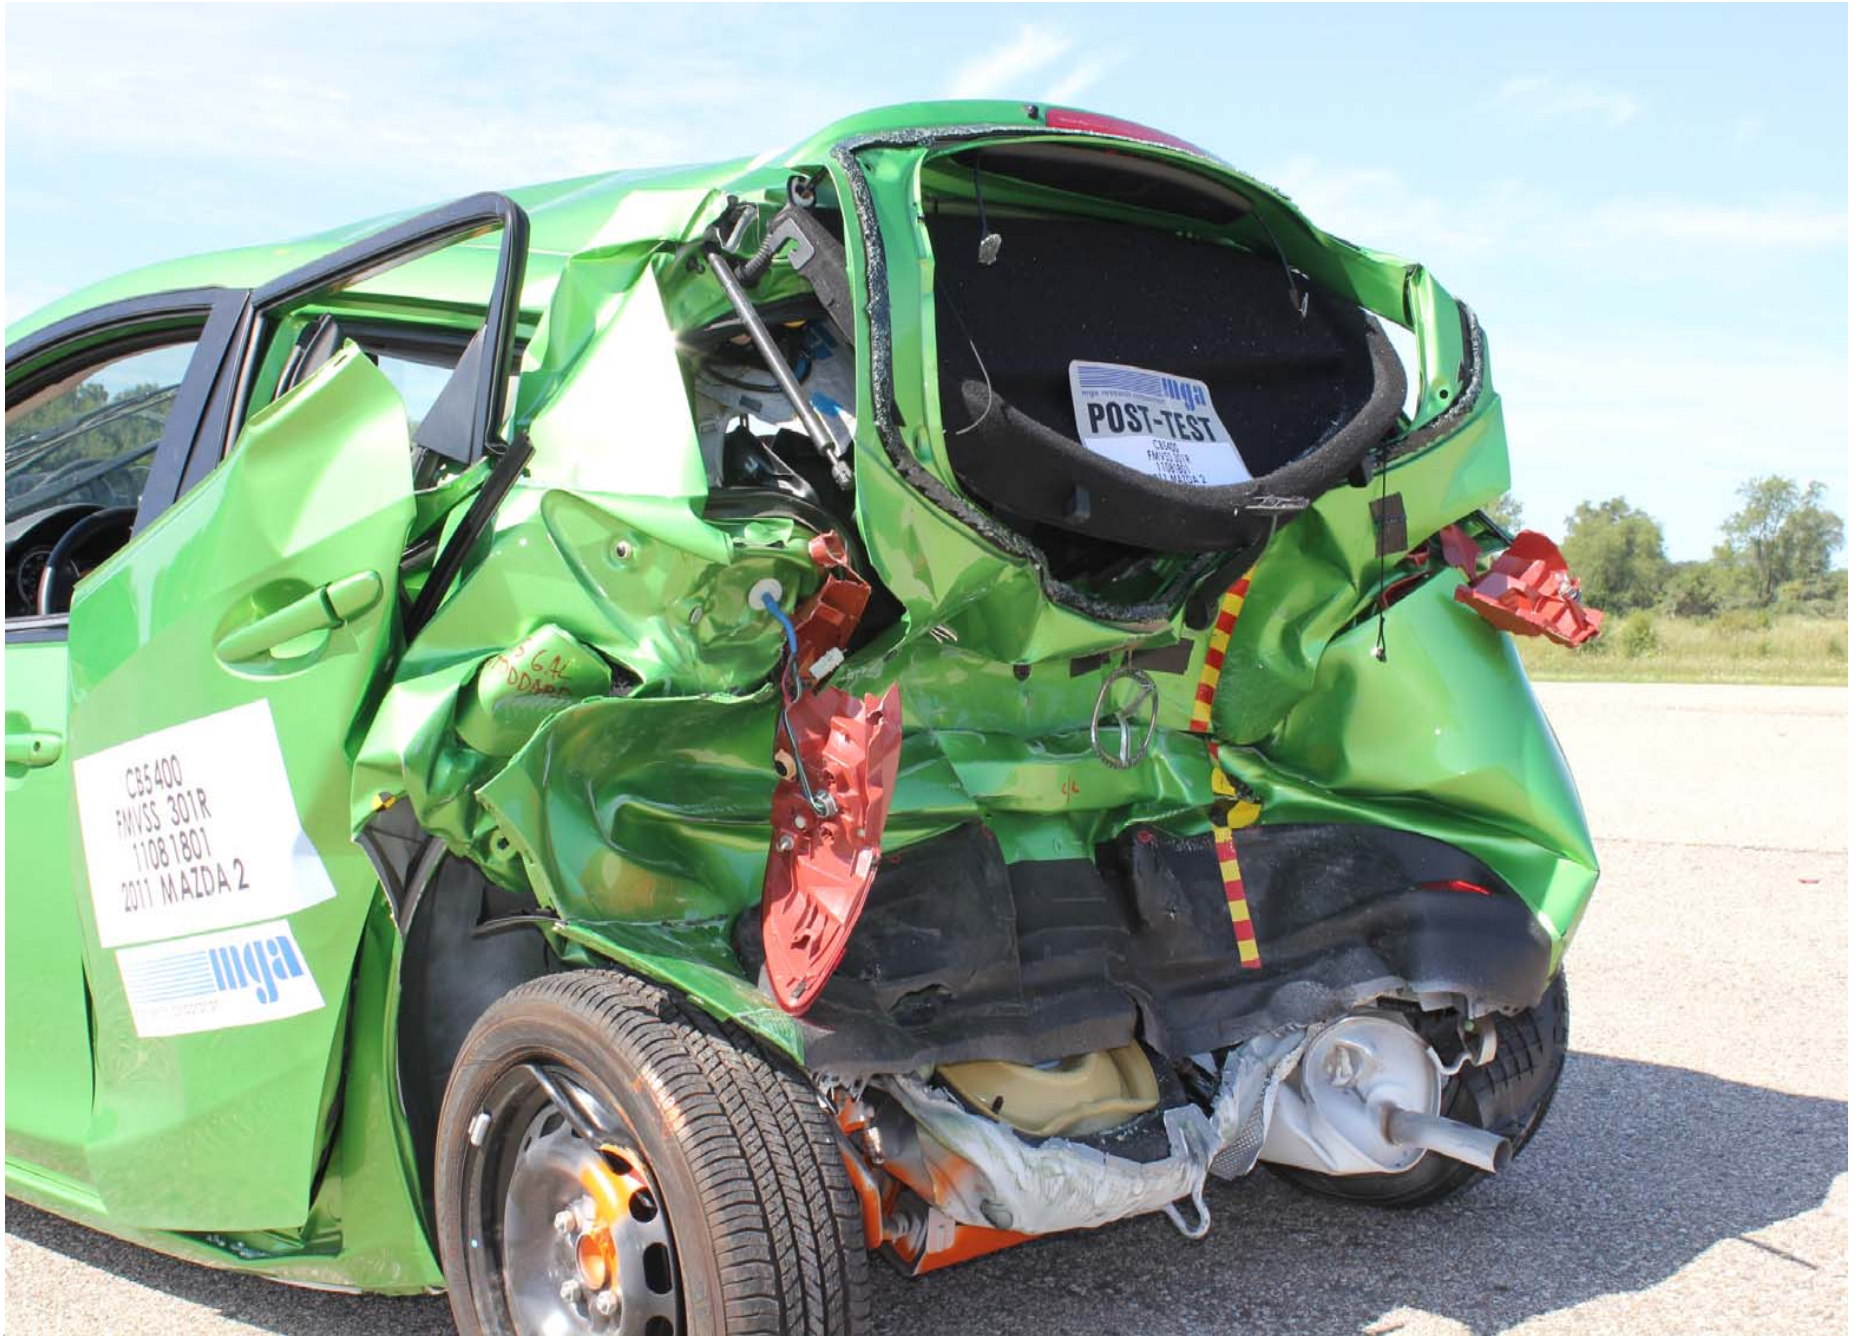
A-8.

Post-Test Left Rear Close-up View of Vehicle

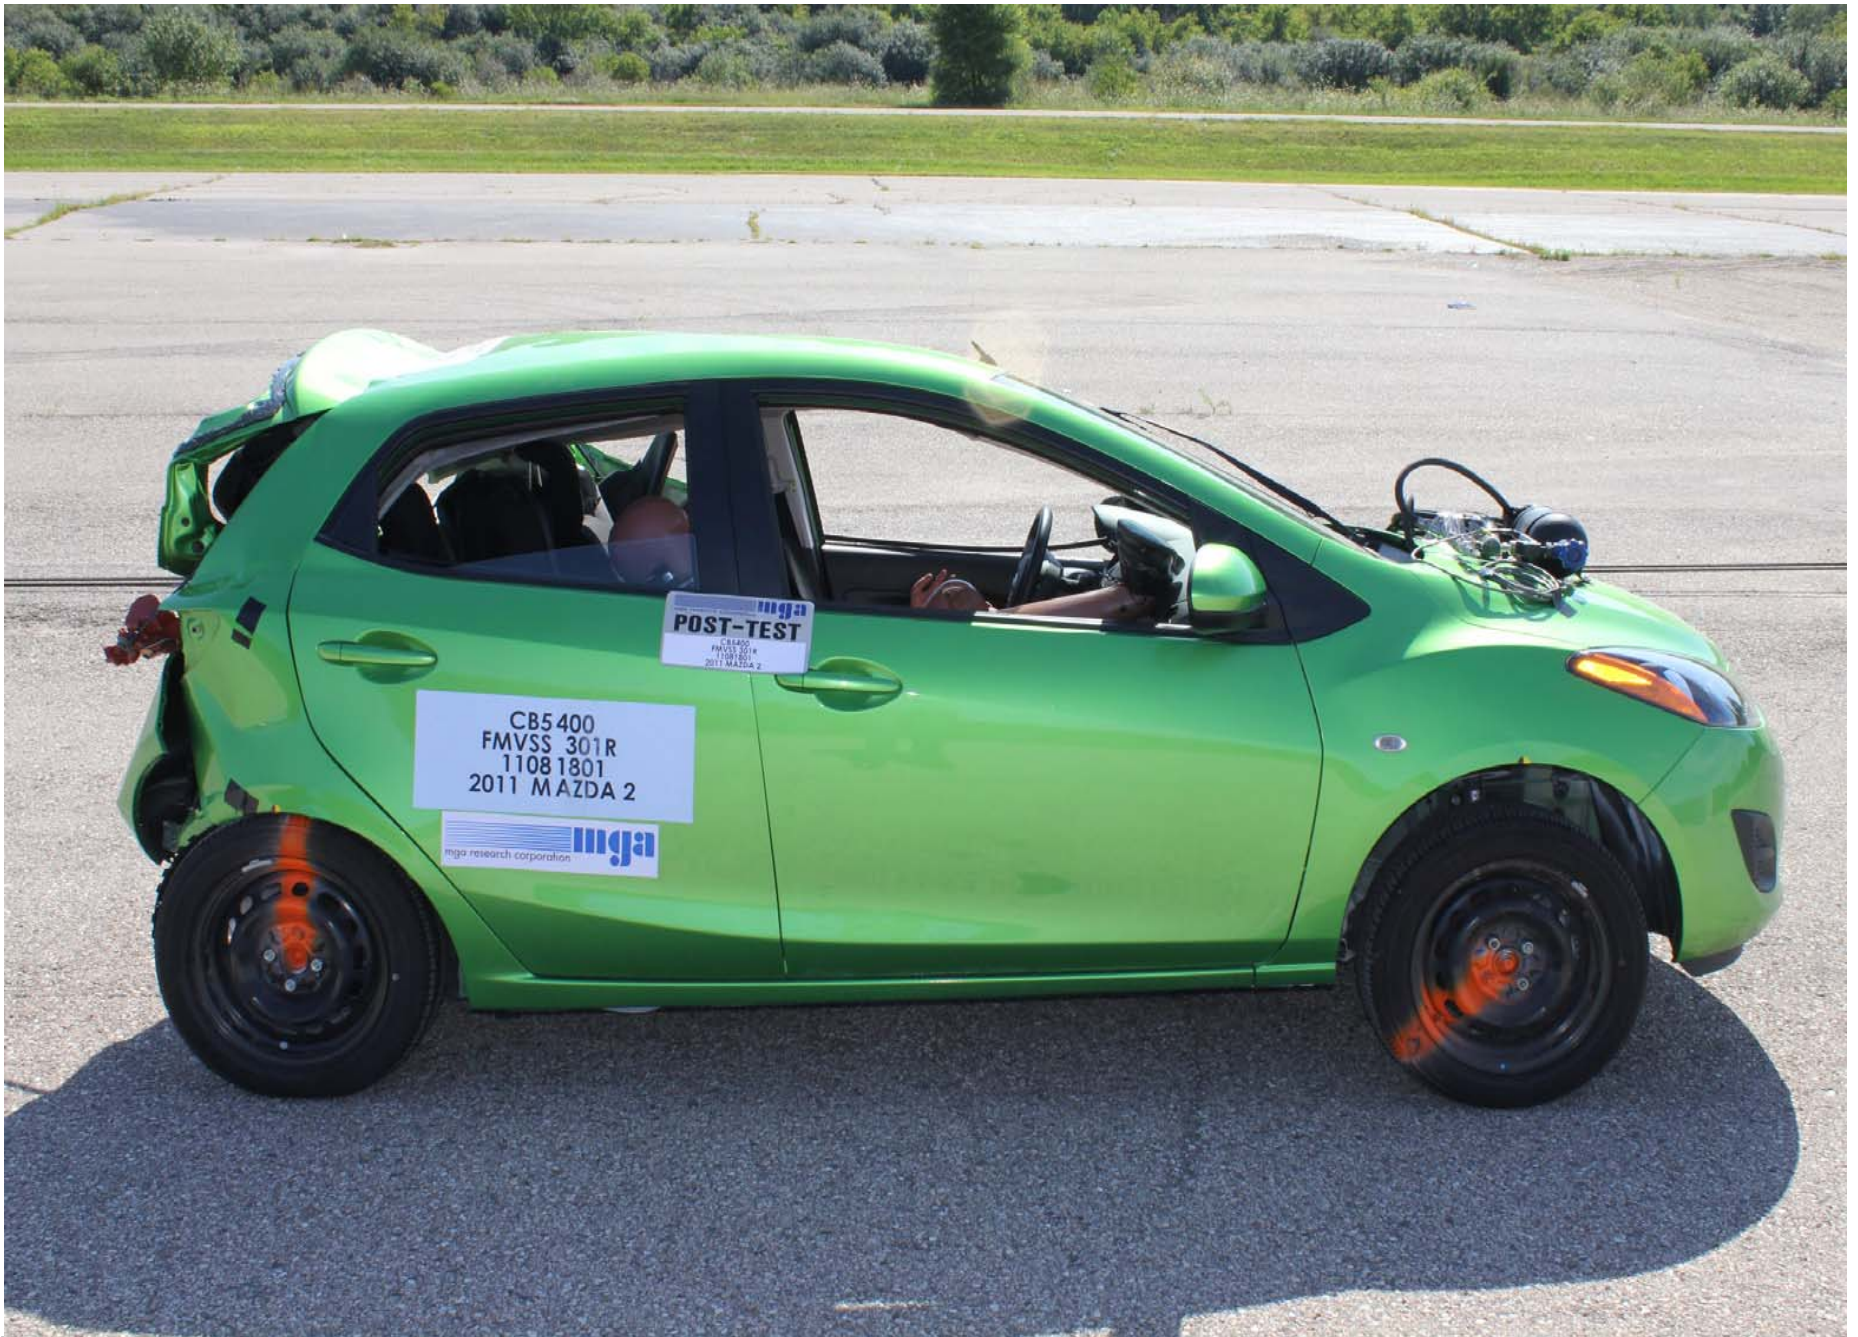
A-10.

Post-Test Right Side View of Vehicle

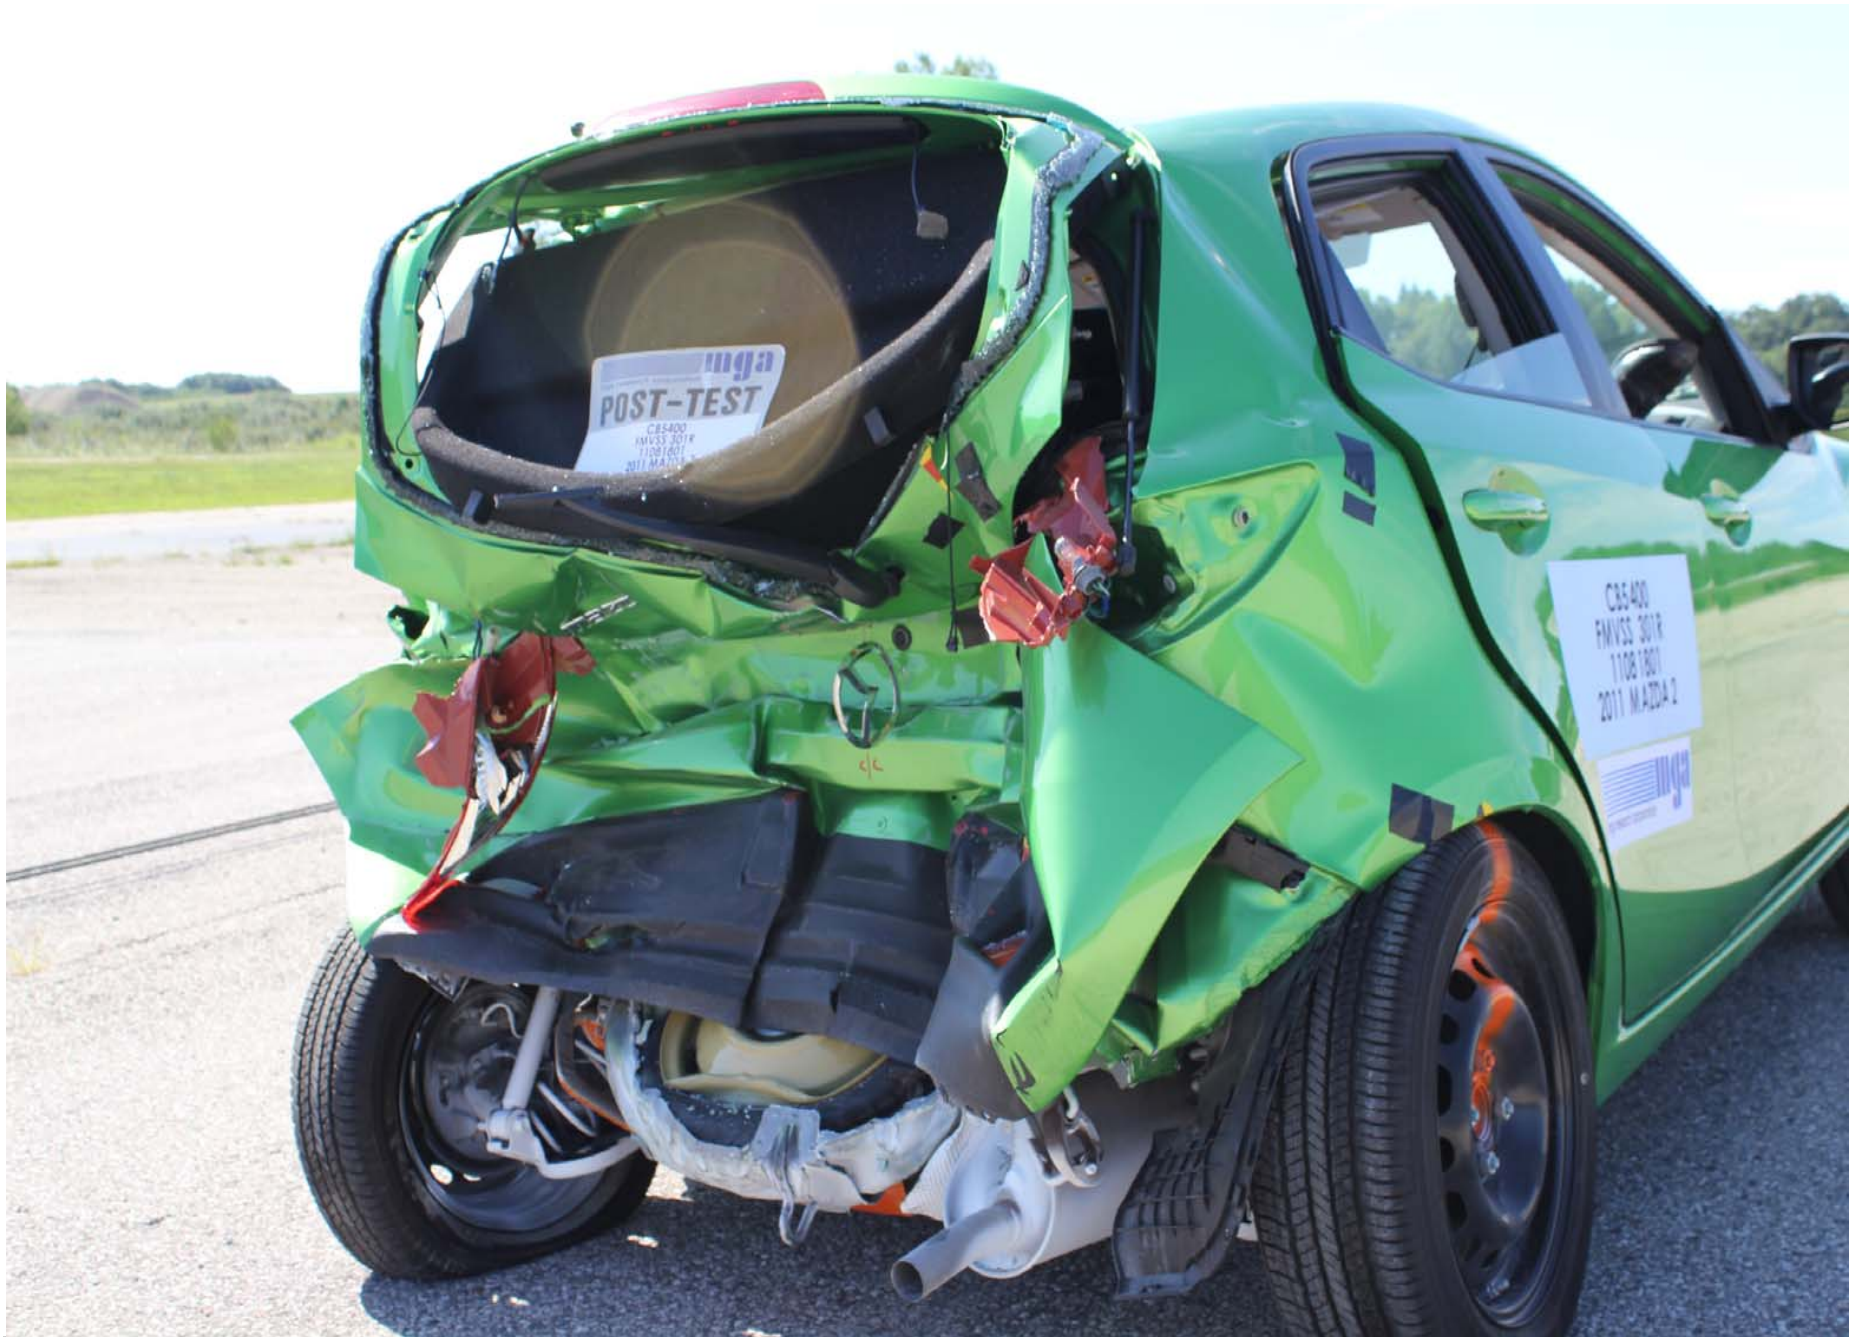
Post-Test Right Rear Close-up View of Vehicle

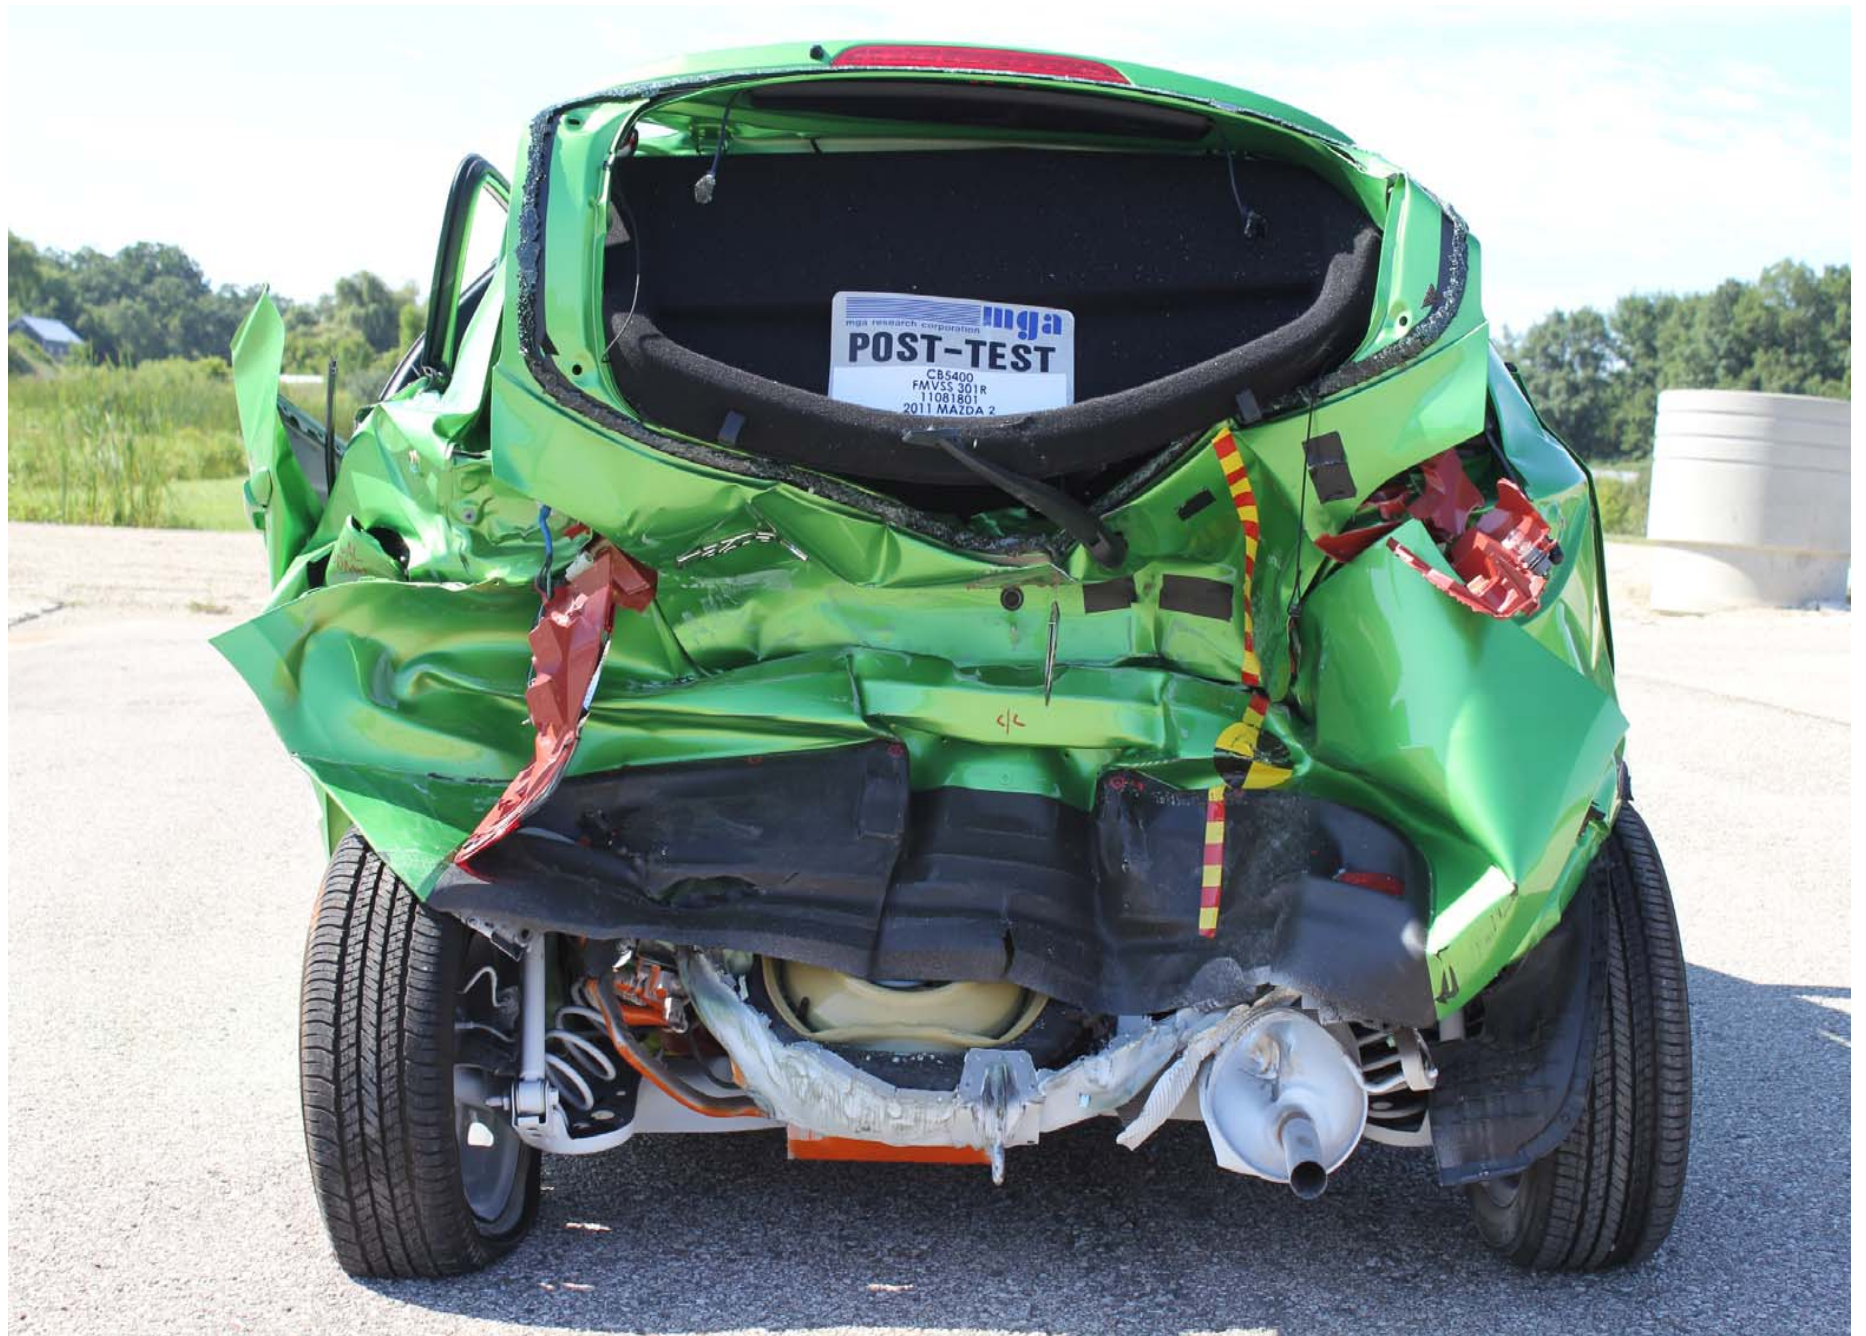
A-14.

Post-Test Rear View of Vehicle

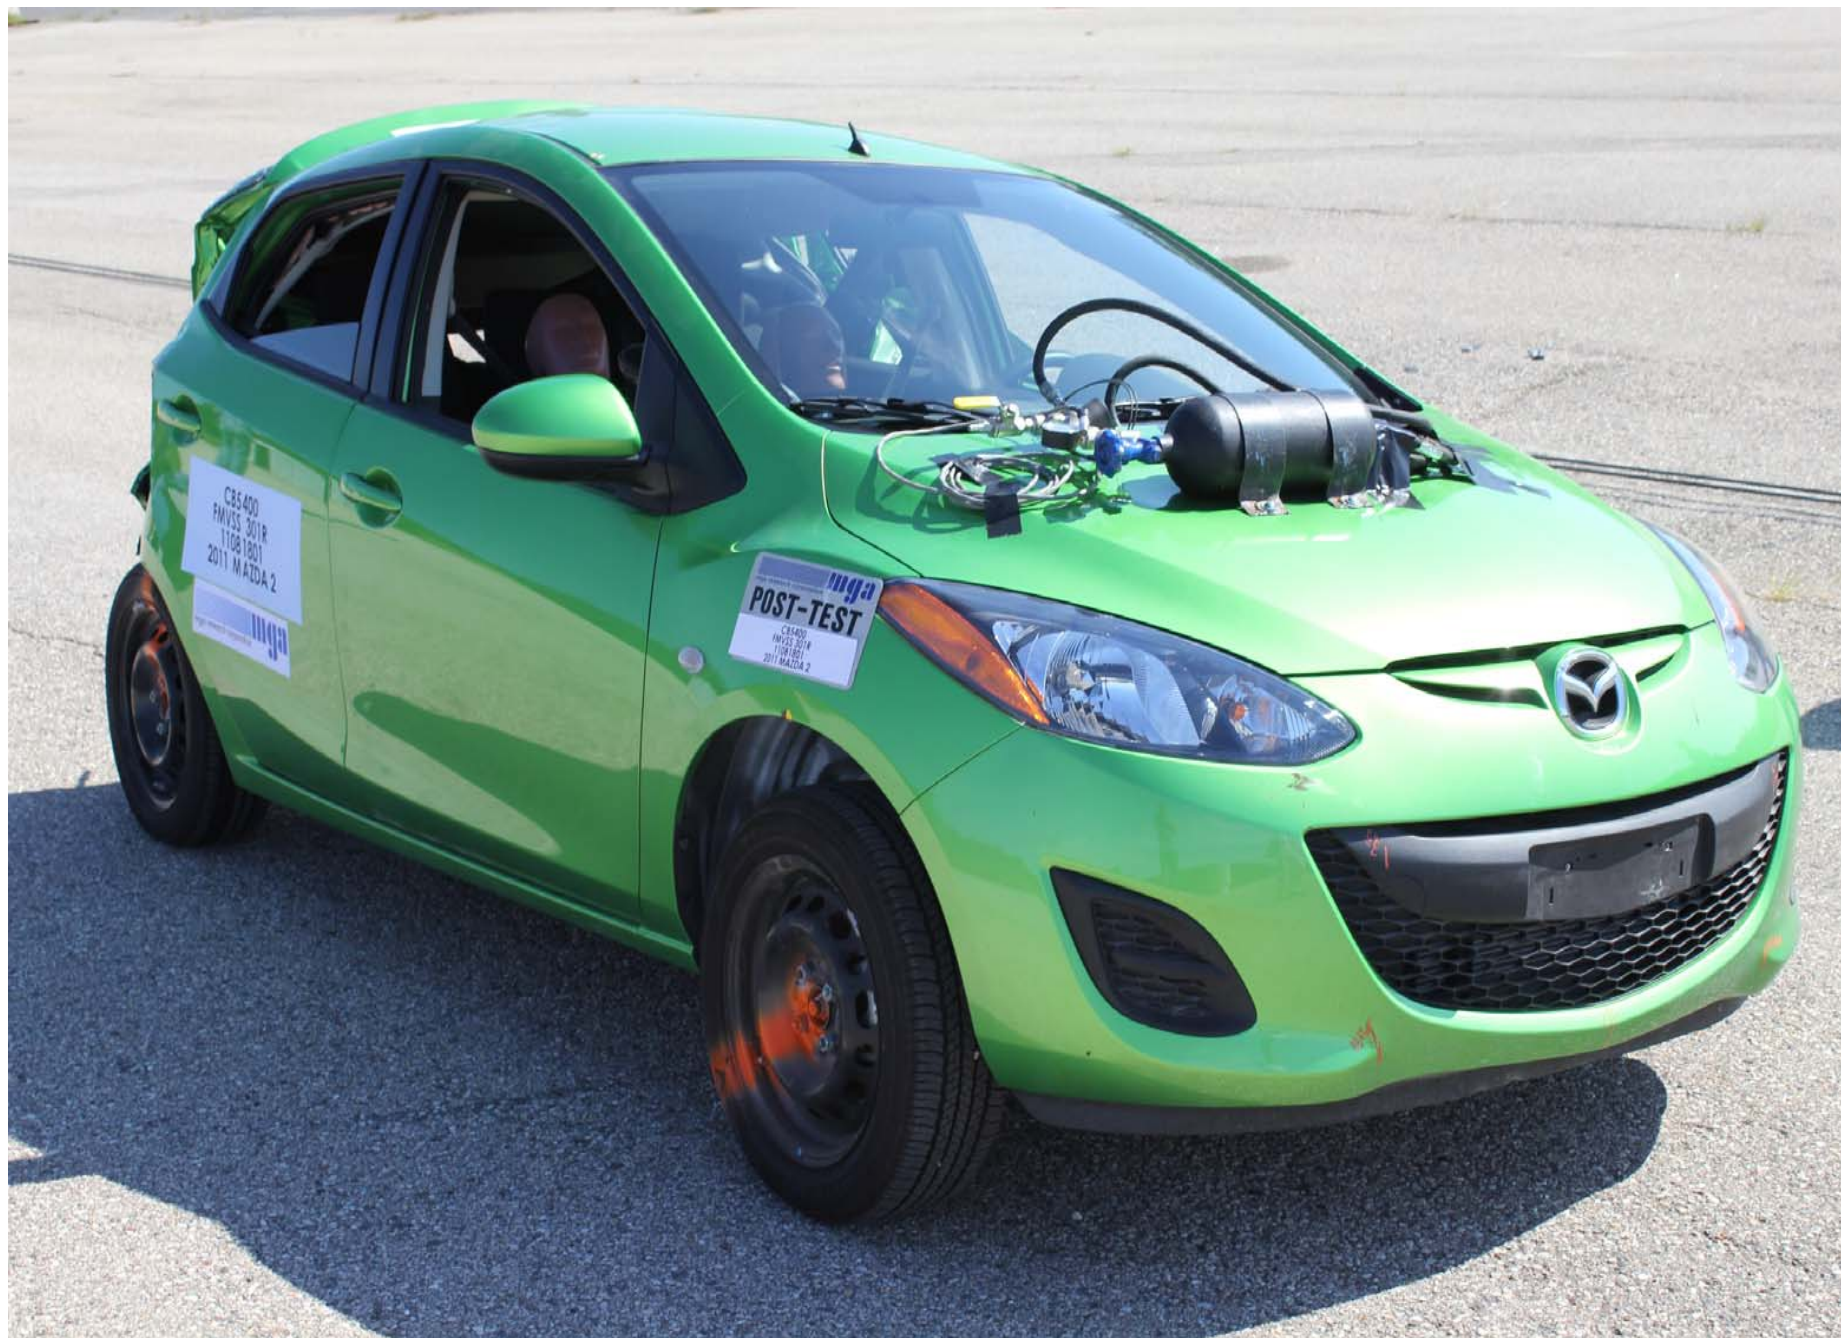
Post-Test ¾ Frontal View From Right Side of Vehicle

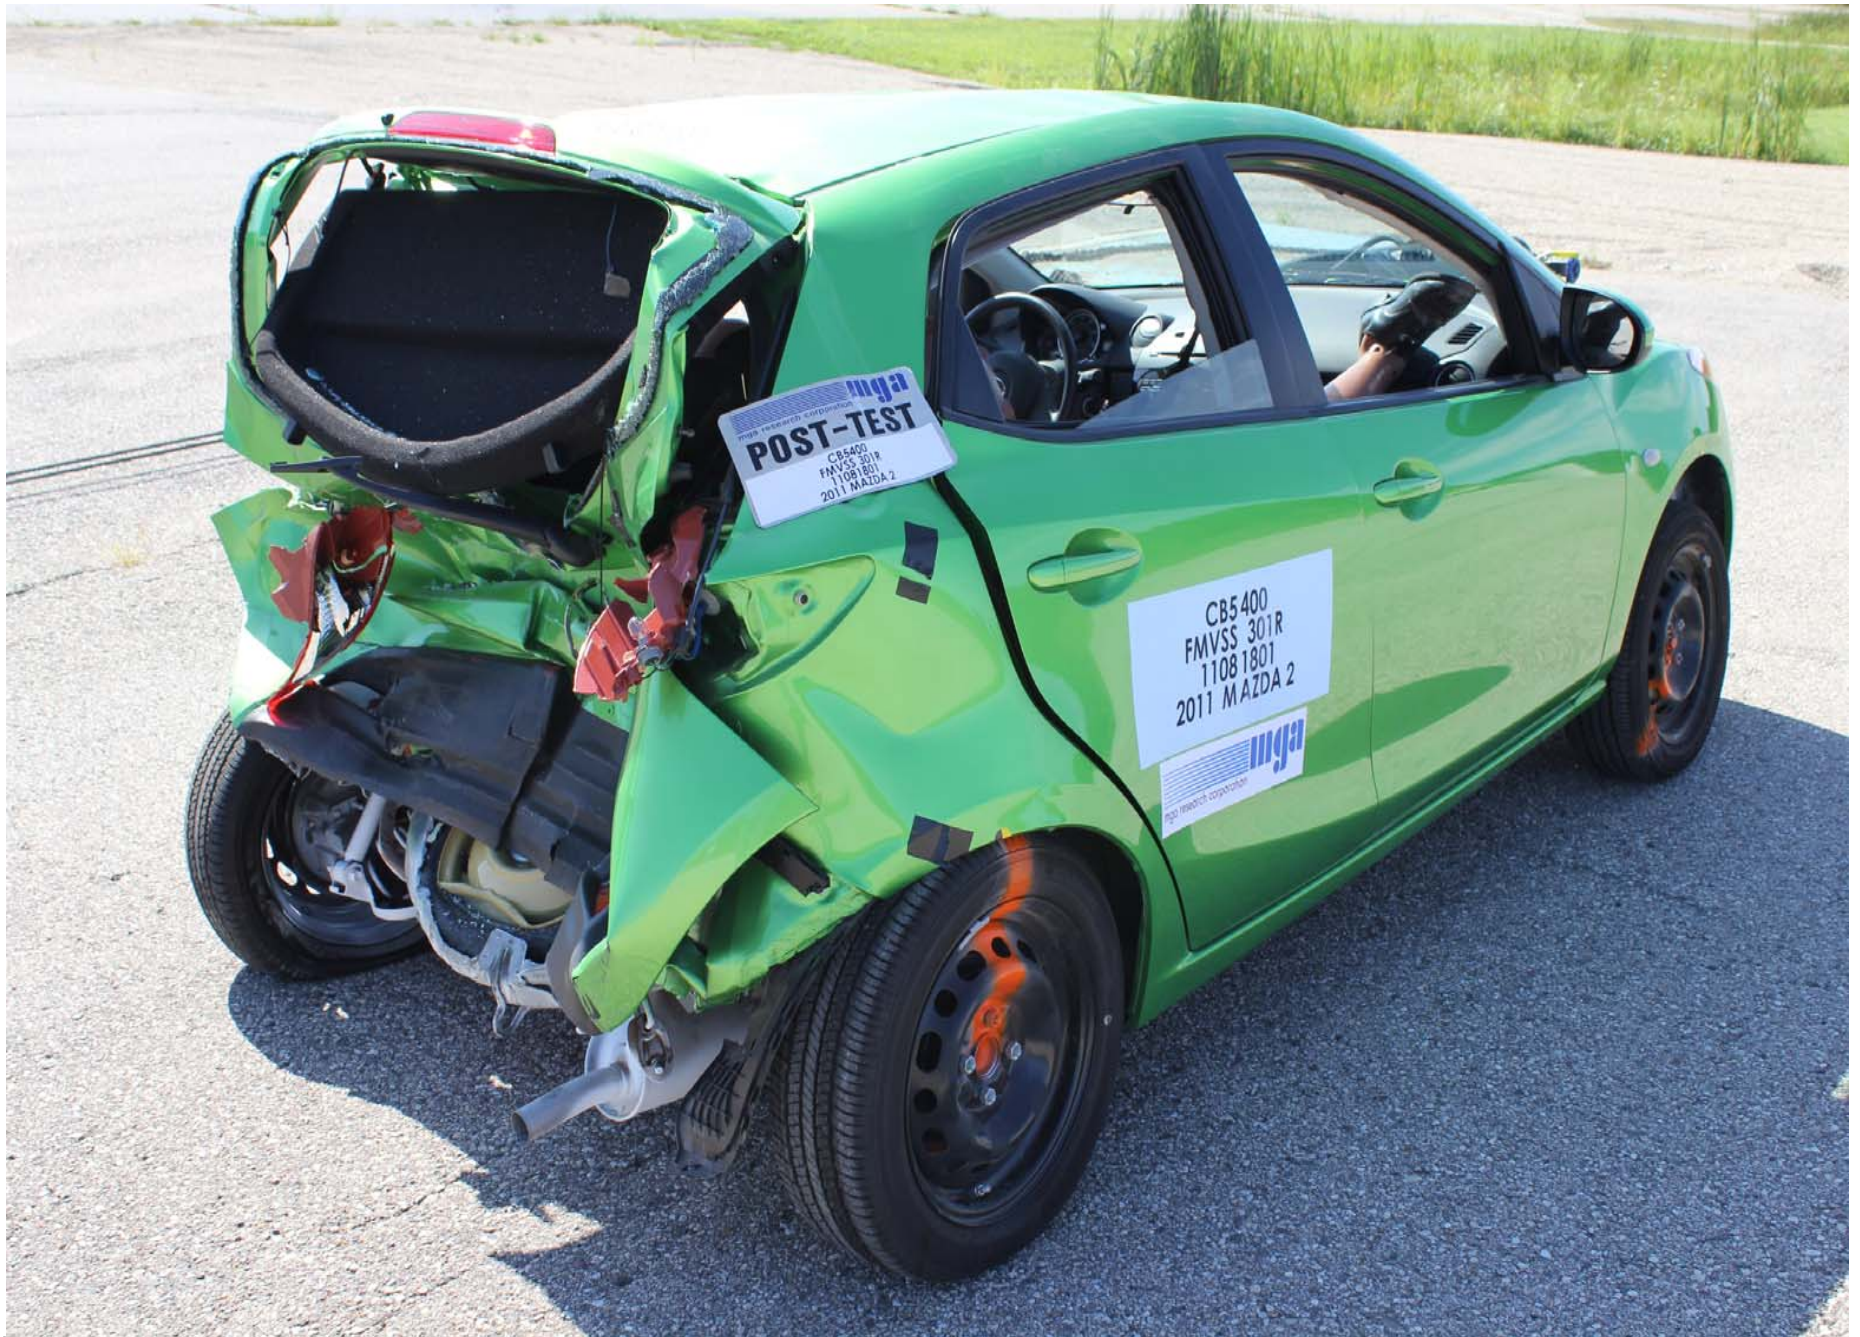
Post-Test ¾ Rear View From Right Side of Vehicle

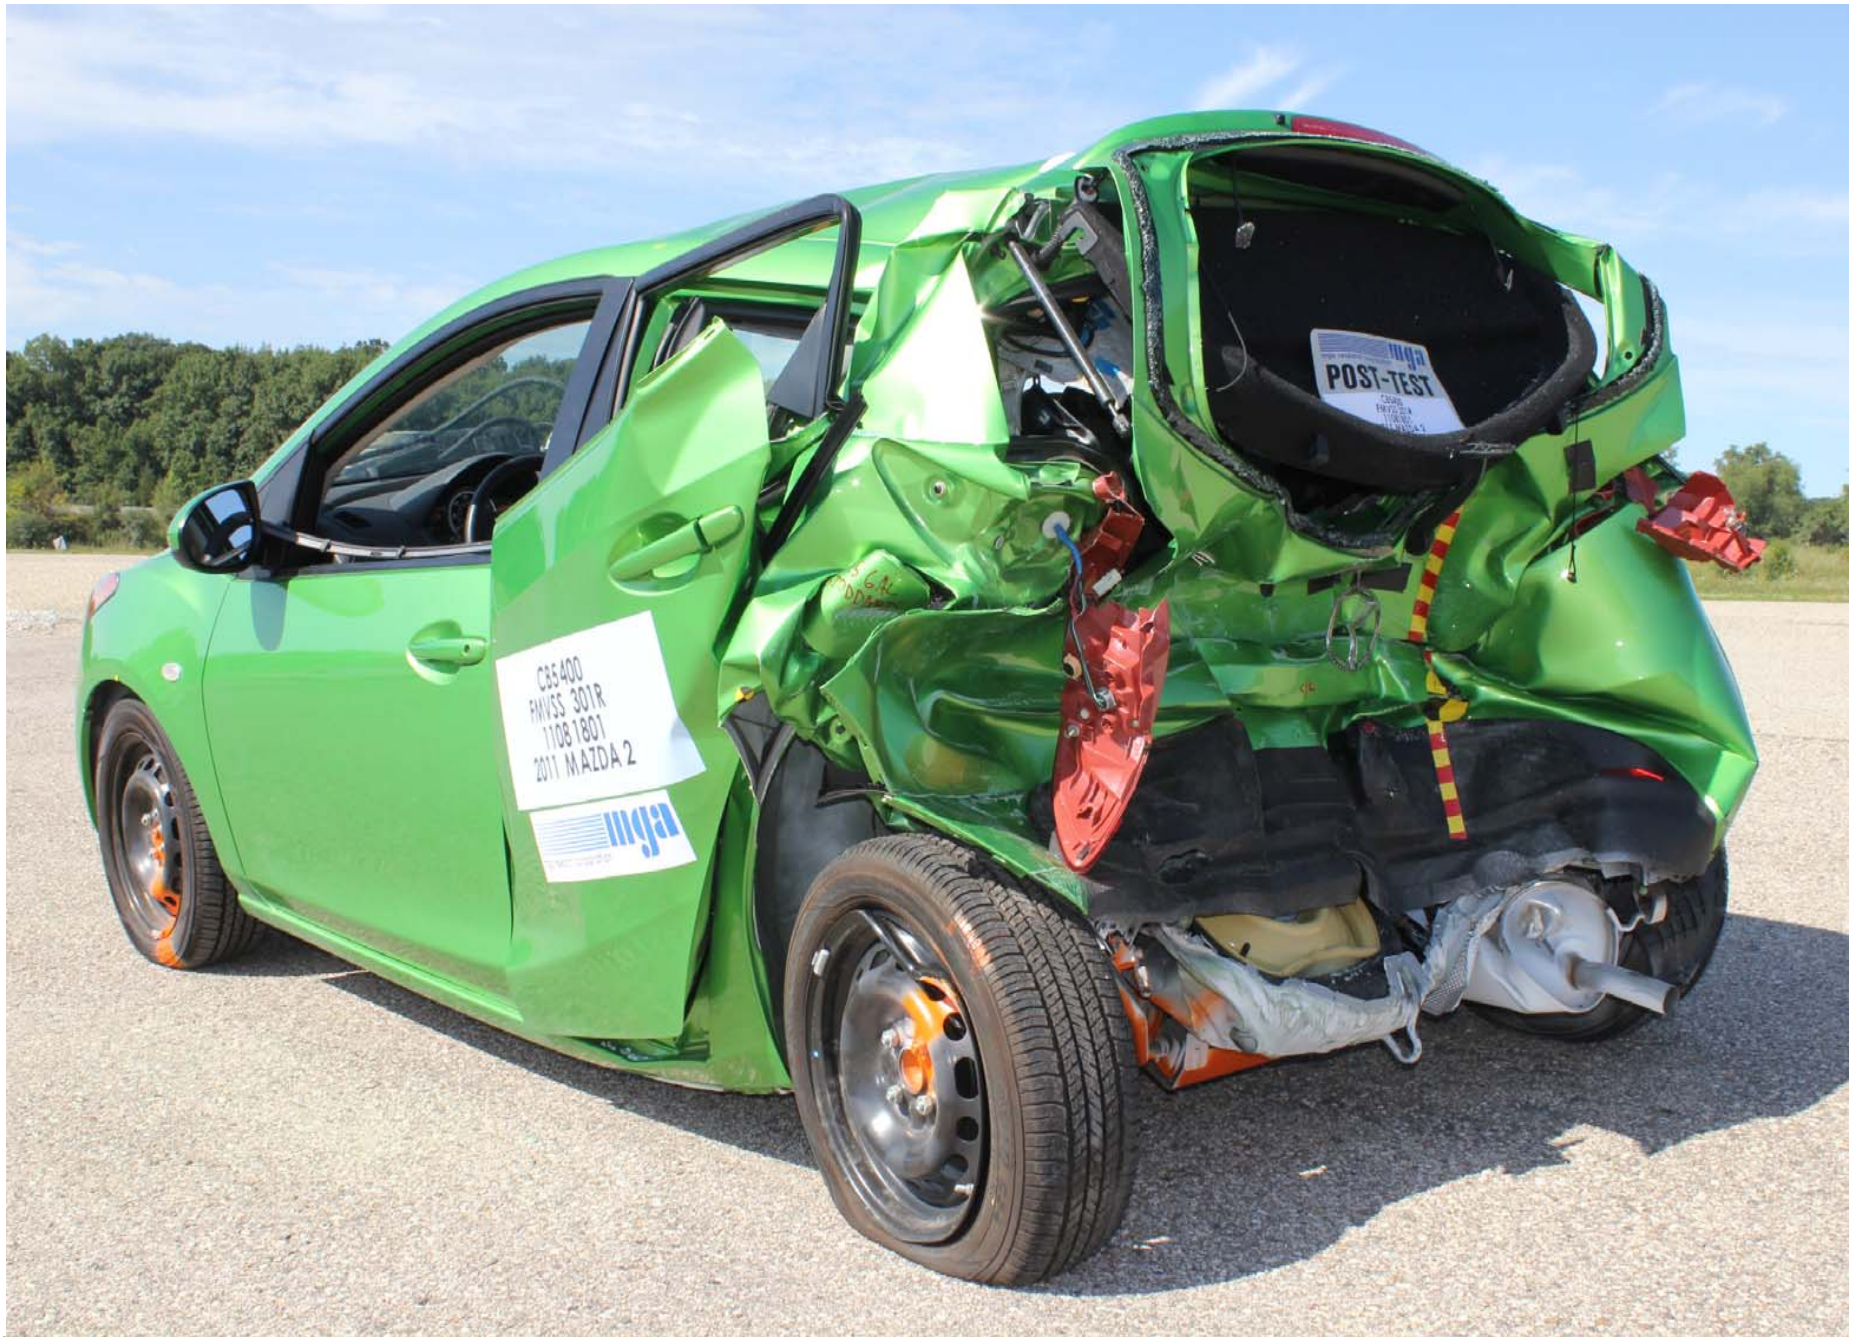
Post-Test ¾ Rear View From Left Side of Vehicle
