REPORT NUMBER: 301-MGA-2011-008

**SAFETY COMPLIANCE TESTING FOR FMVSS 301R
FUEL SYSTEM INTEGRITY – REAR IMPACT**

**MAZDA MOTOR CORPORATION
2011 MAZDA 2 SPORT MT
NHTSA NUMBER: CB5400**

**PREPARED BY:
MGA RESEARCH CORPORATION
5000 WARREN ROAD
BURLINGTON, WI 53105**

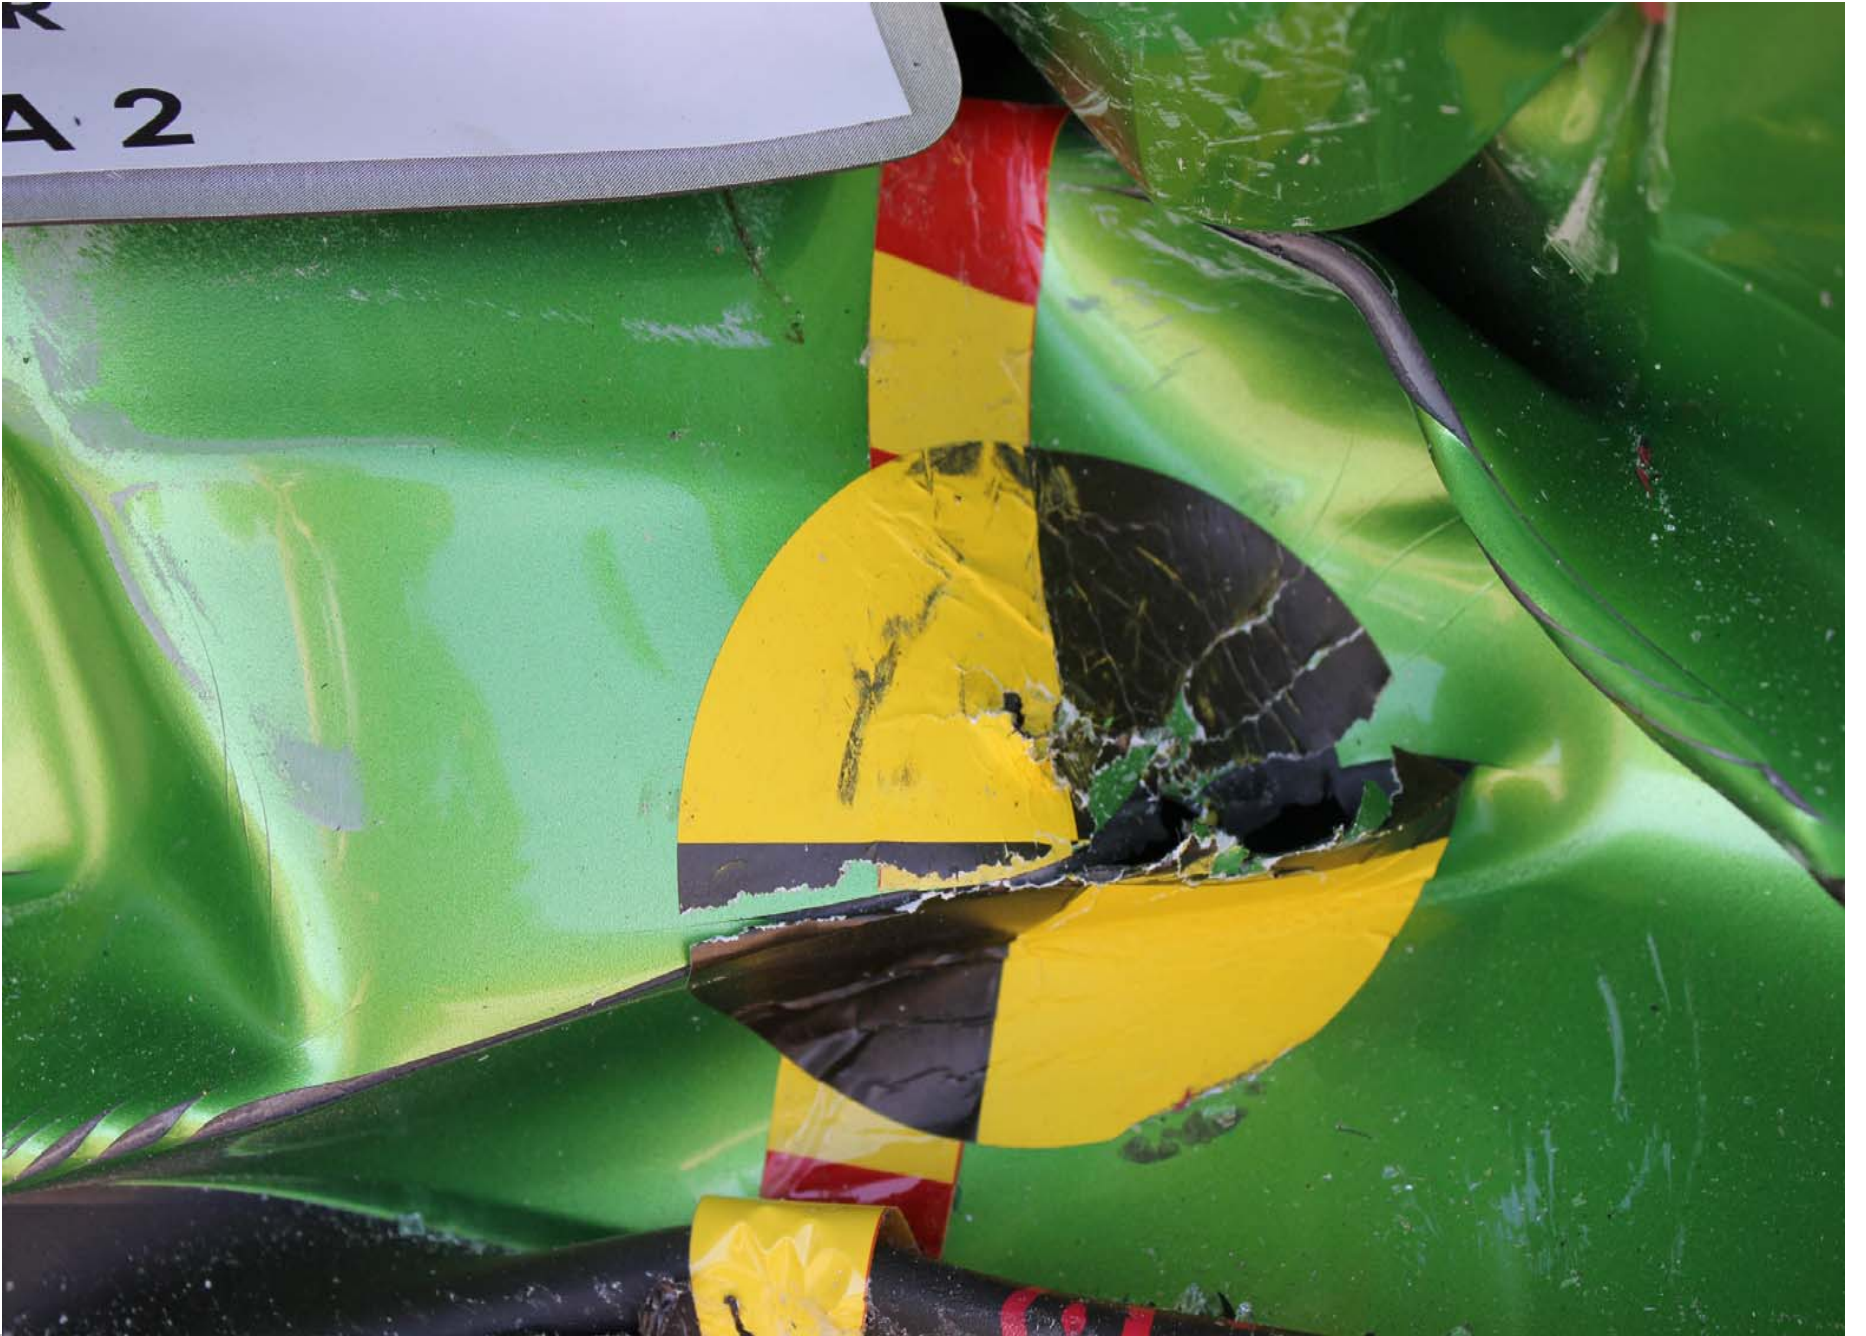
A-22.

Units: mm
Vertical distance from target center (+ above target / - below target)	15 up
Horizontal distance from target center (+ to the right / - to the left)	7 Right

Post-Test Impact Point

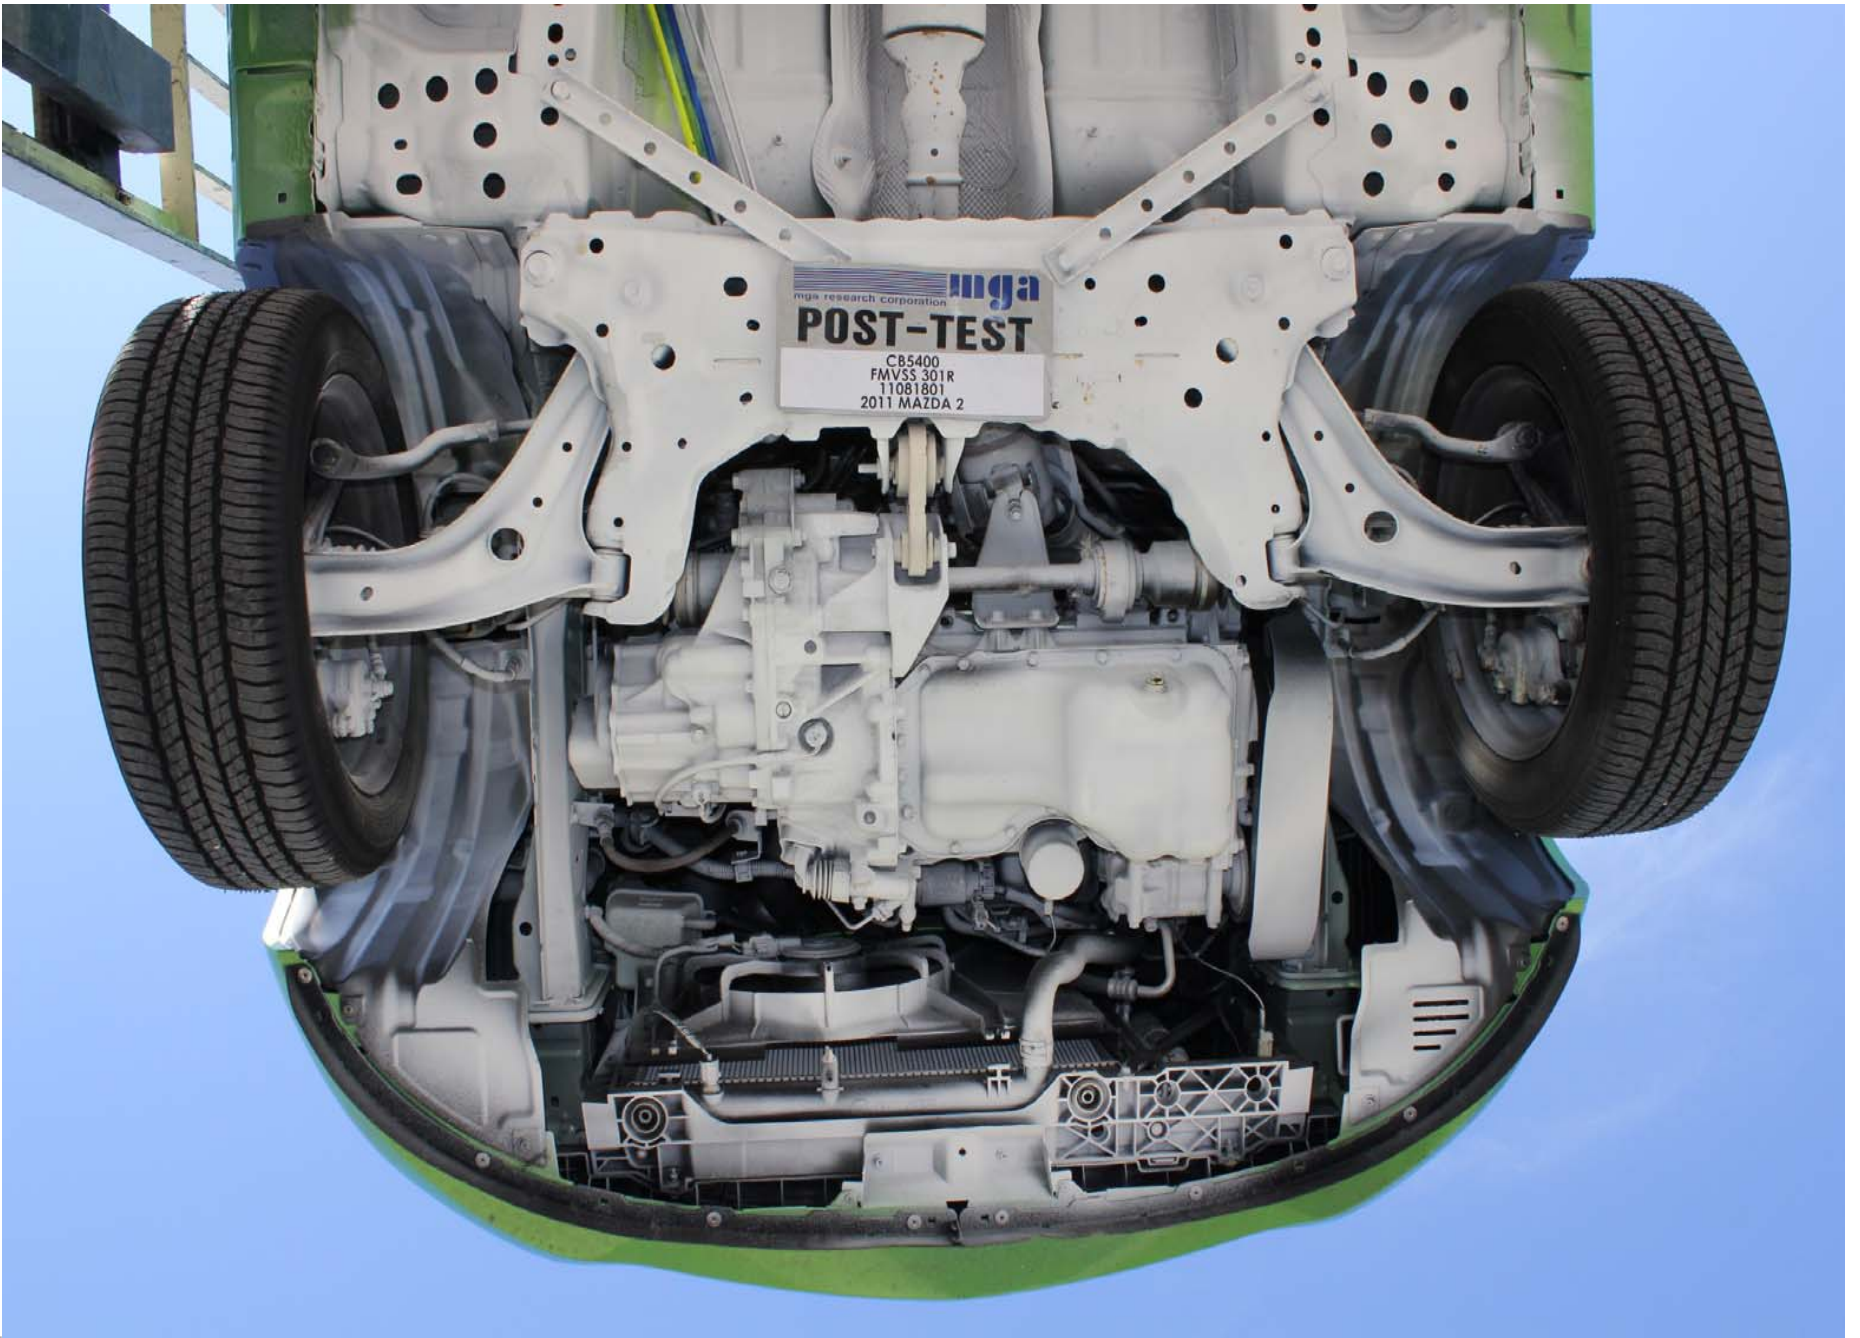
A-24.

Post-Test Underbody View 1

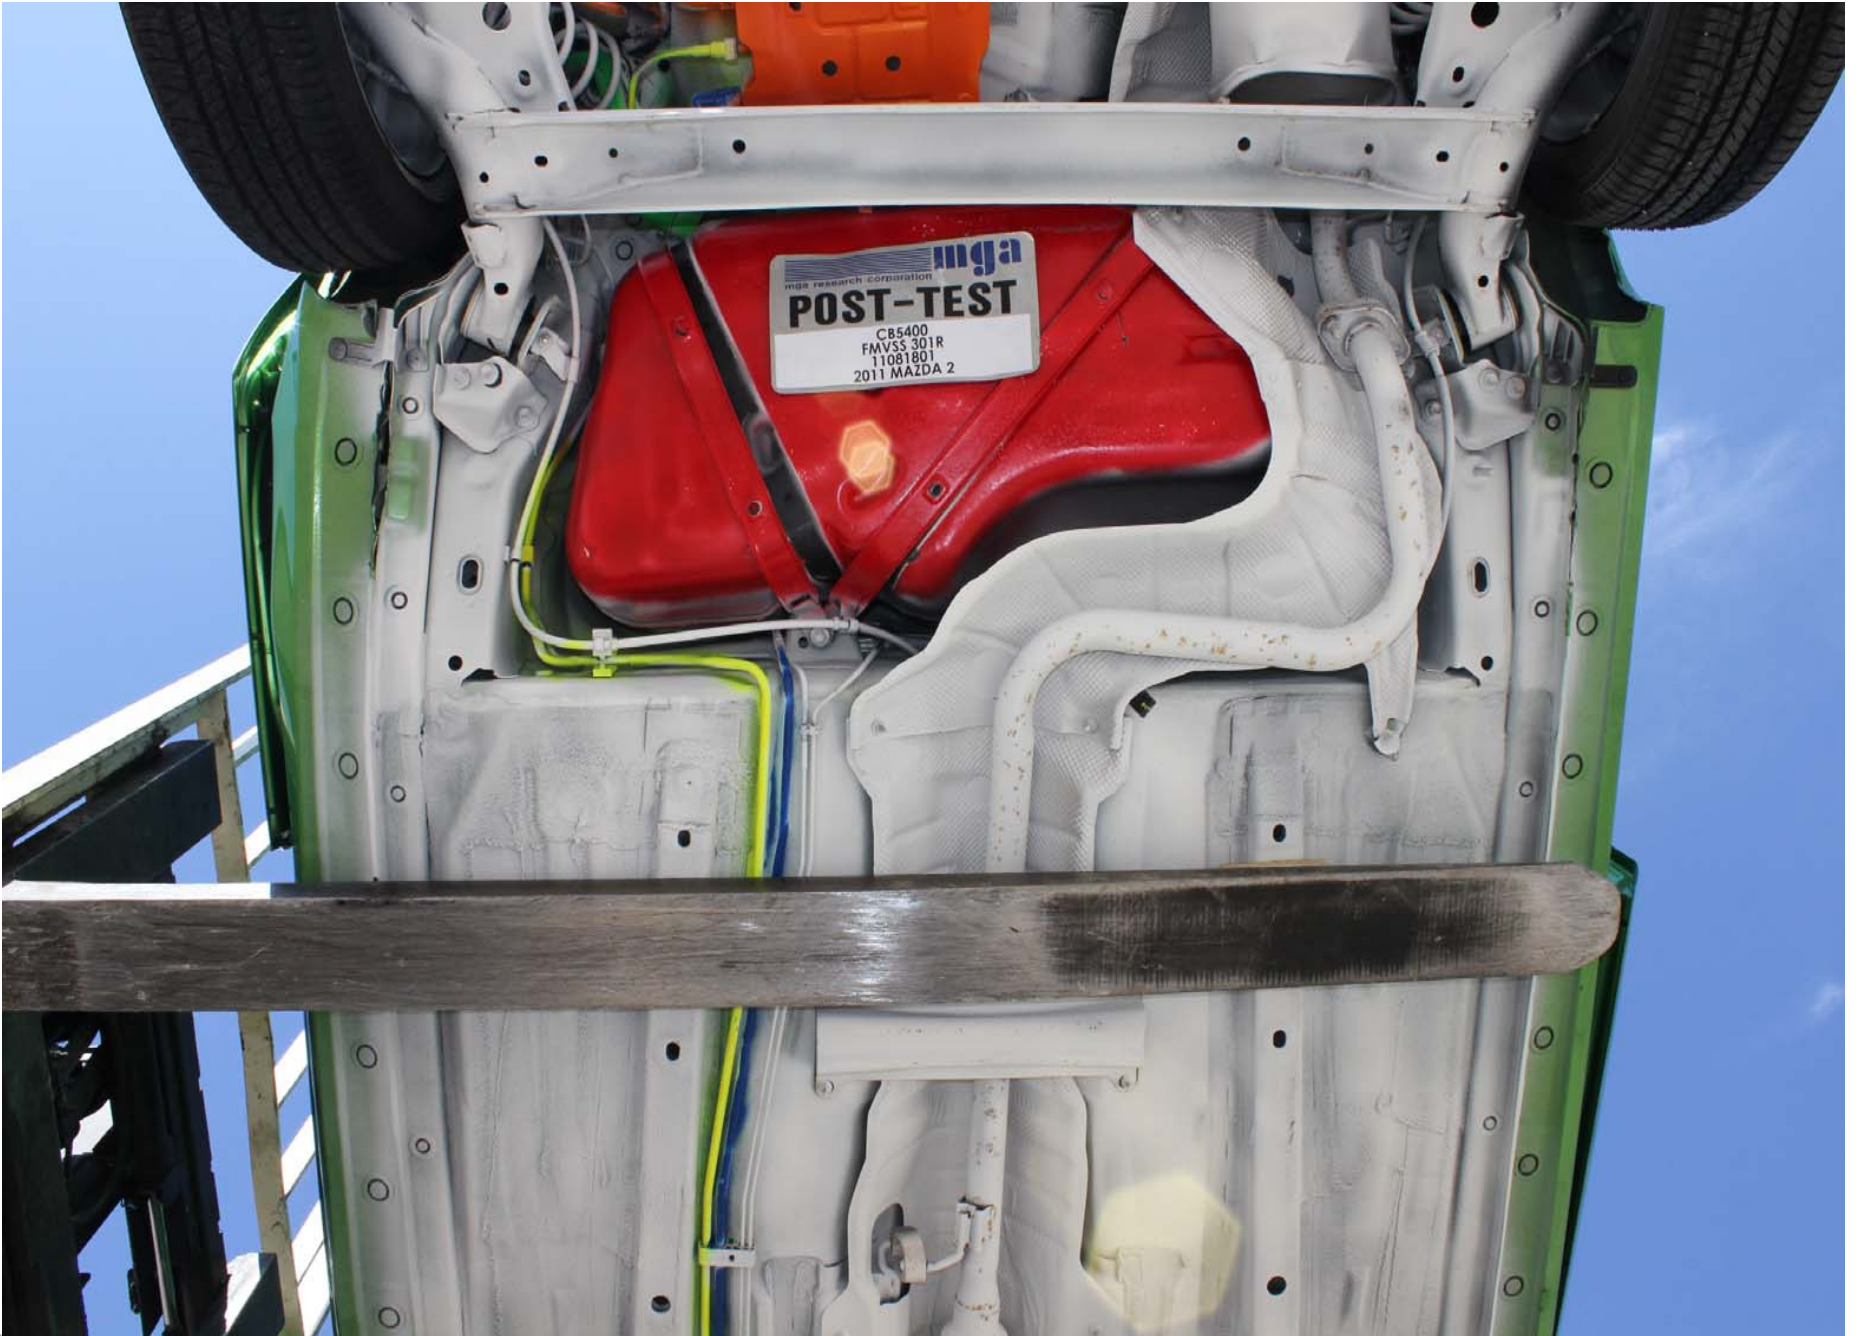
A-26.

Post-Test Underbody View 2

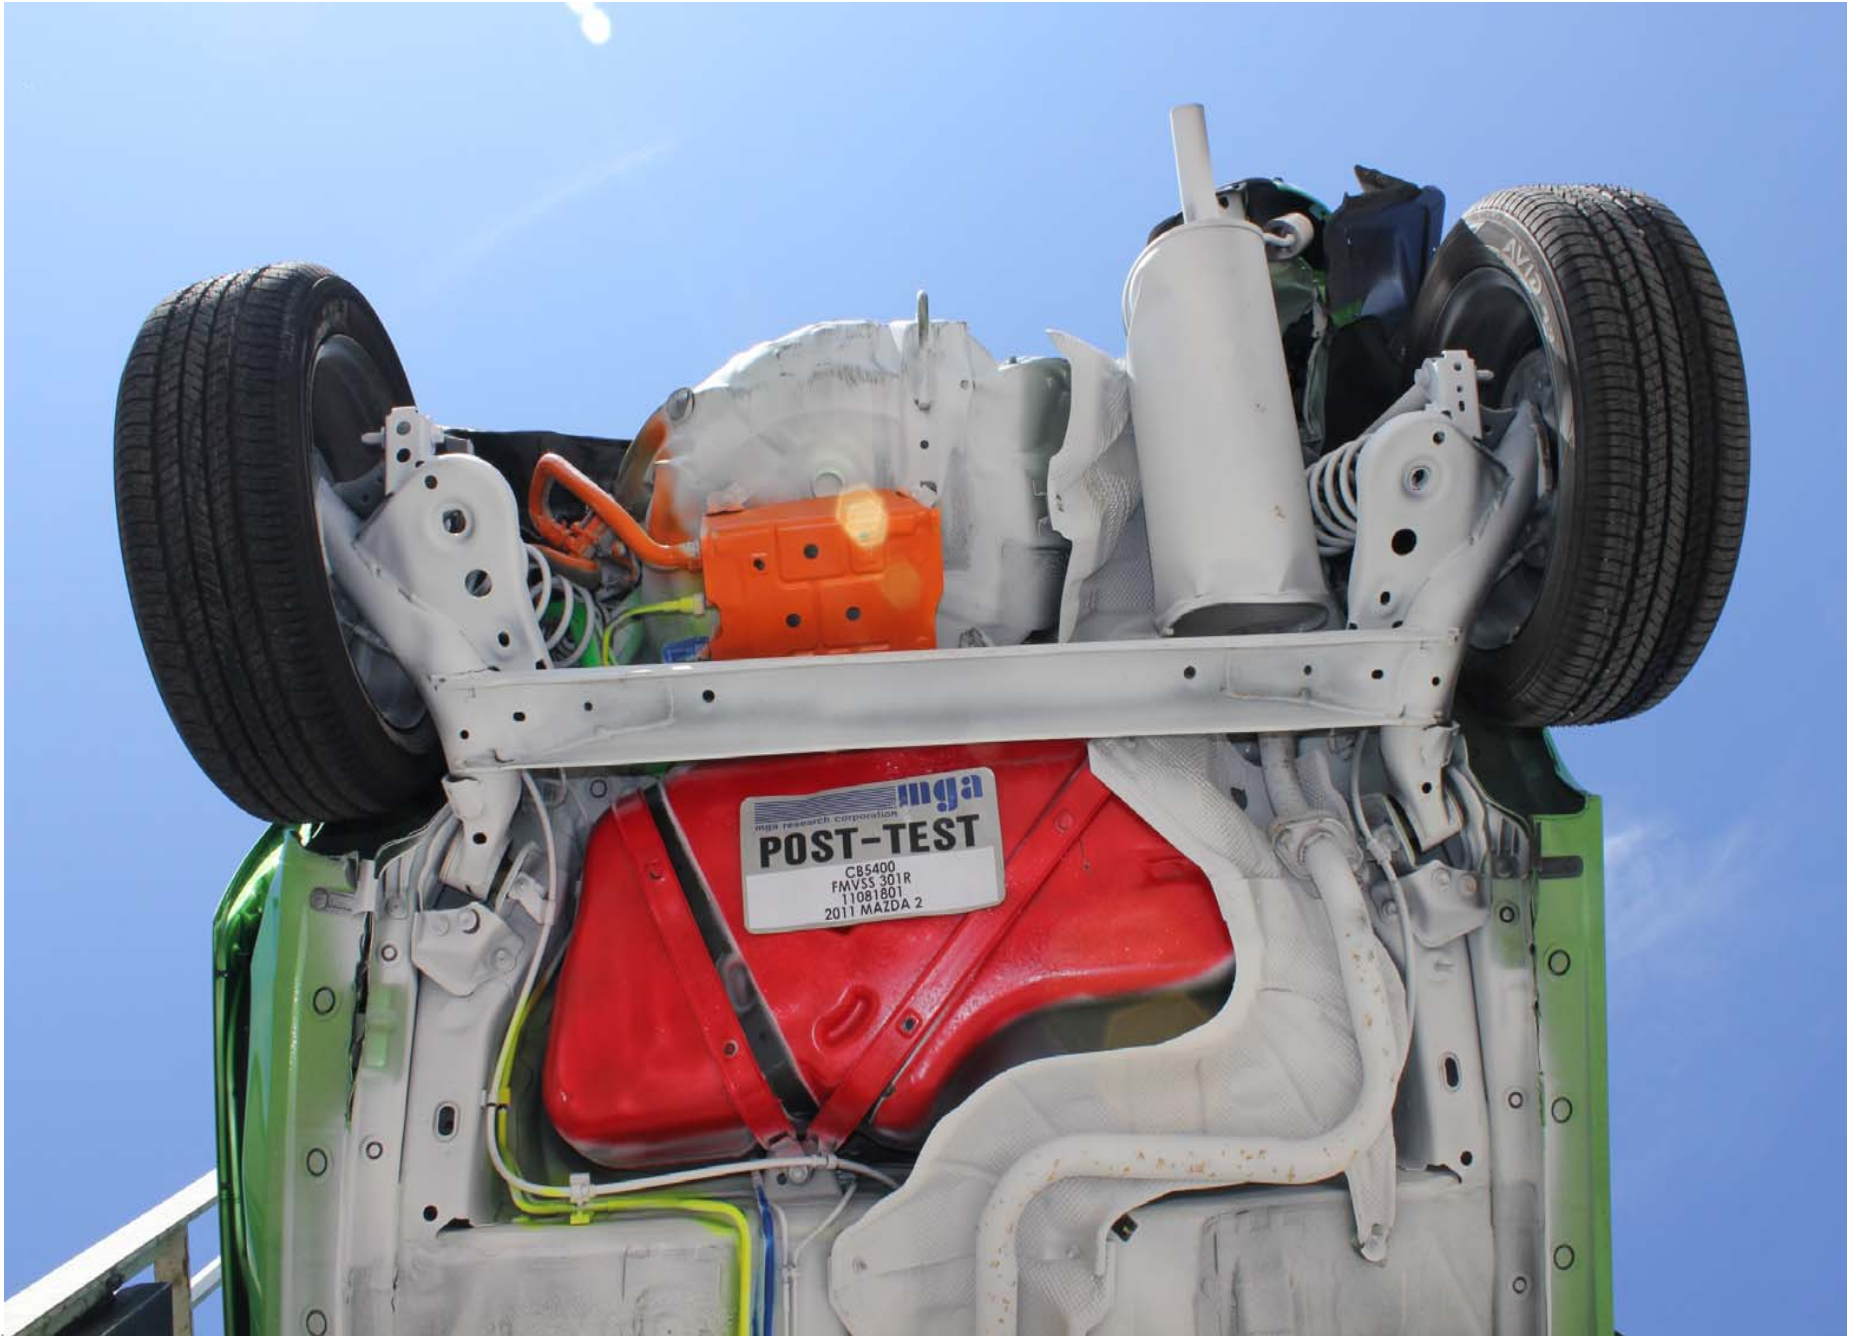
Post-Test Underbody View 3

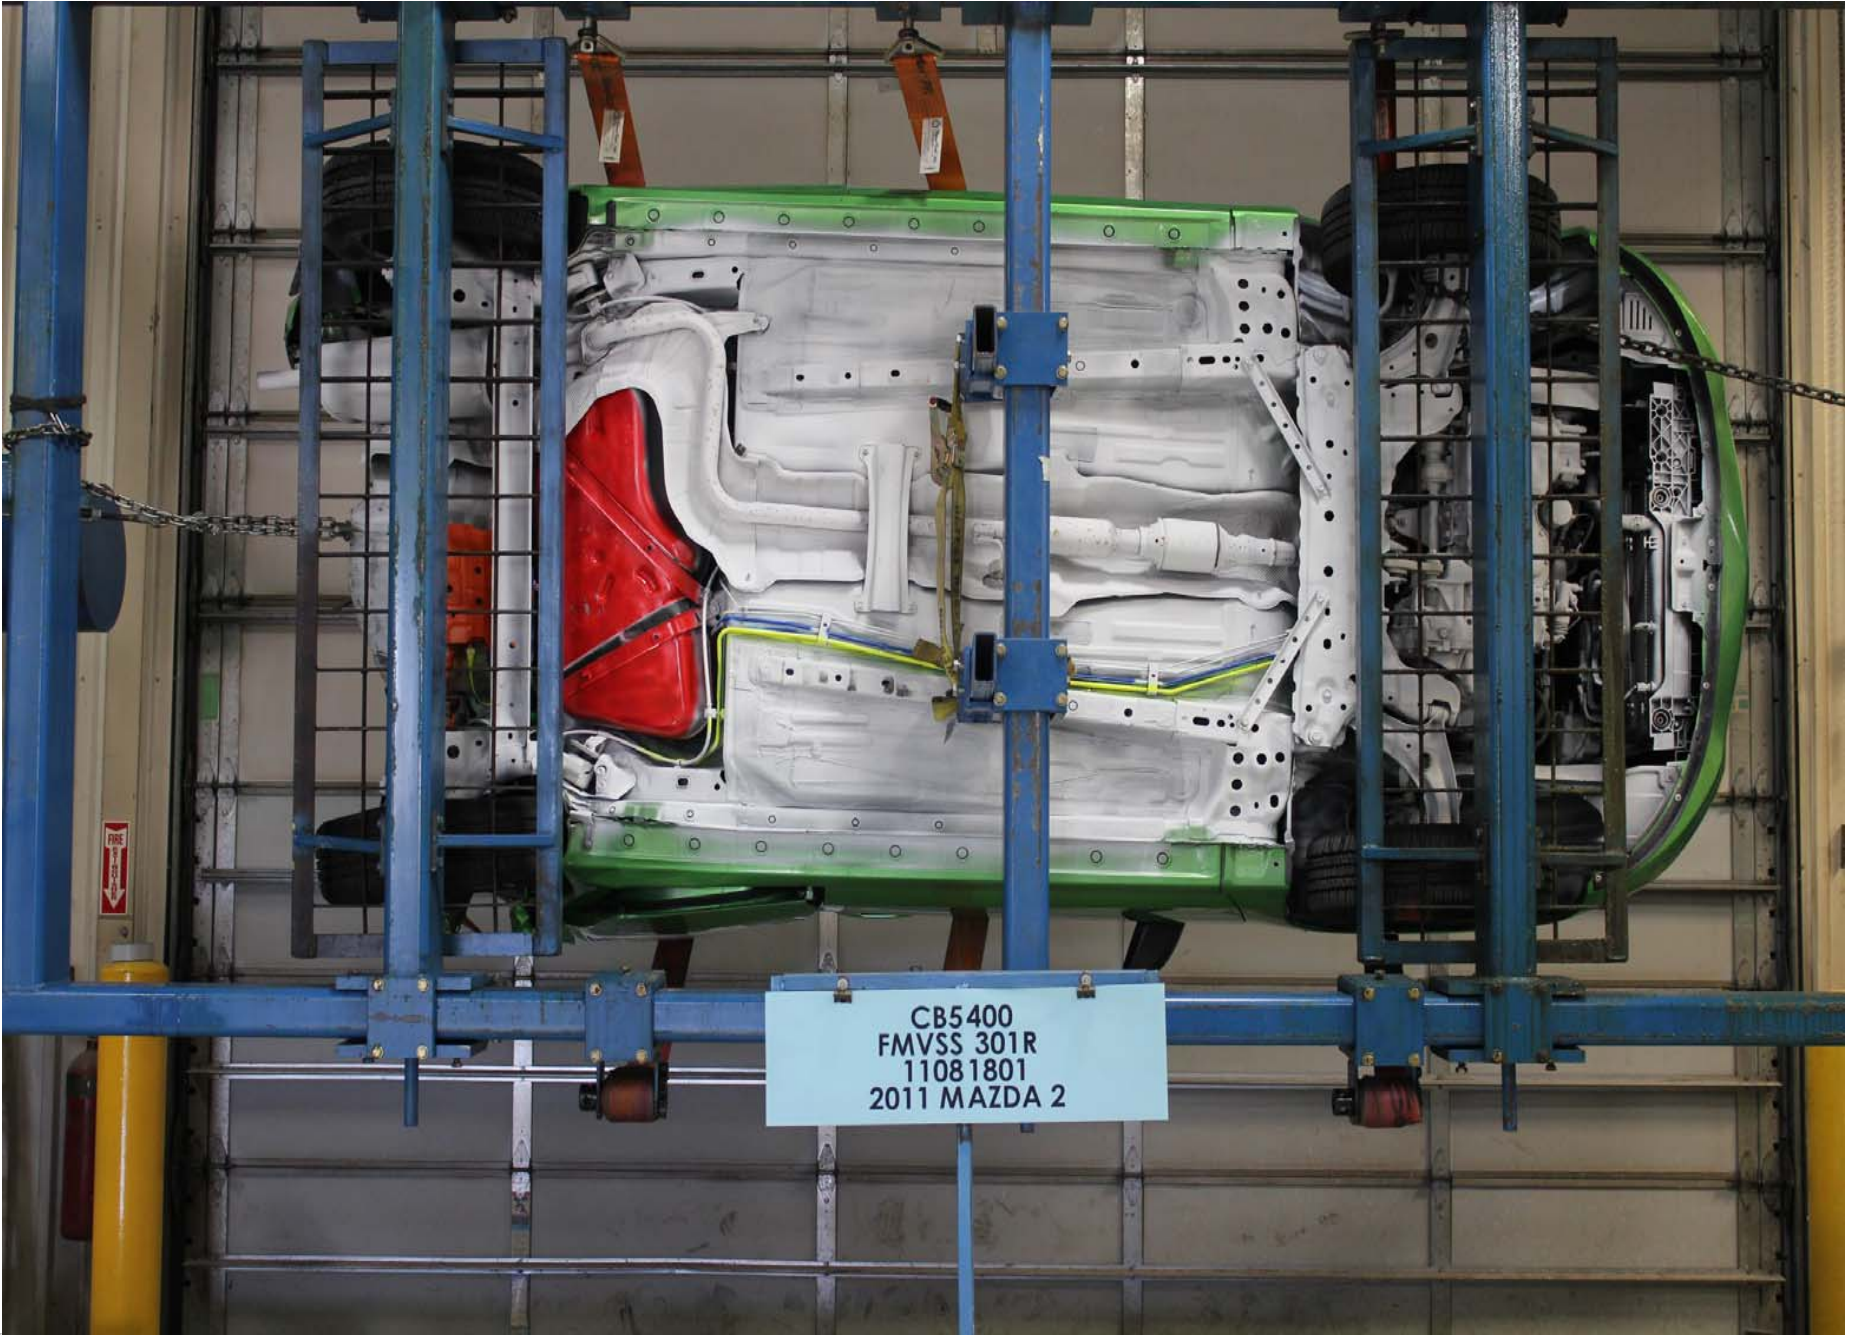
A-37.

Test Phase	Spillage (g)	Spillage Details
First 5 minutes from onset of rotation	0	
Sixth minute from onset of rotation	0	
Seventh minute from onset of rotation	0	
Eight minute if required	N/A

Static Rollover at 90 Degrees

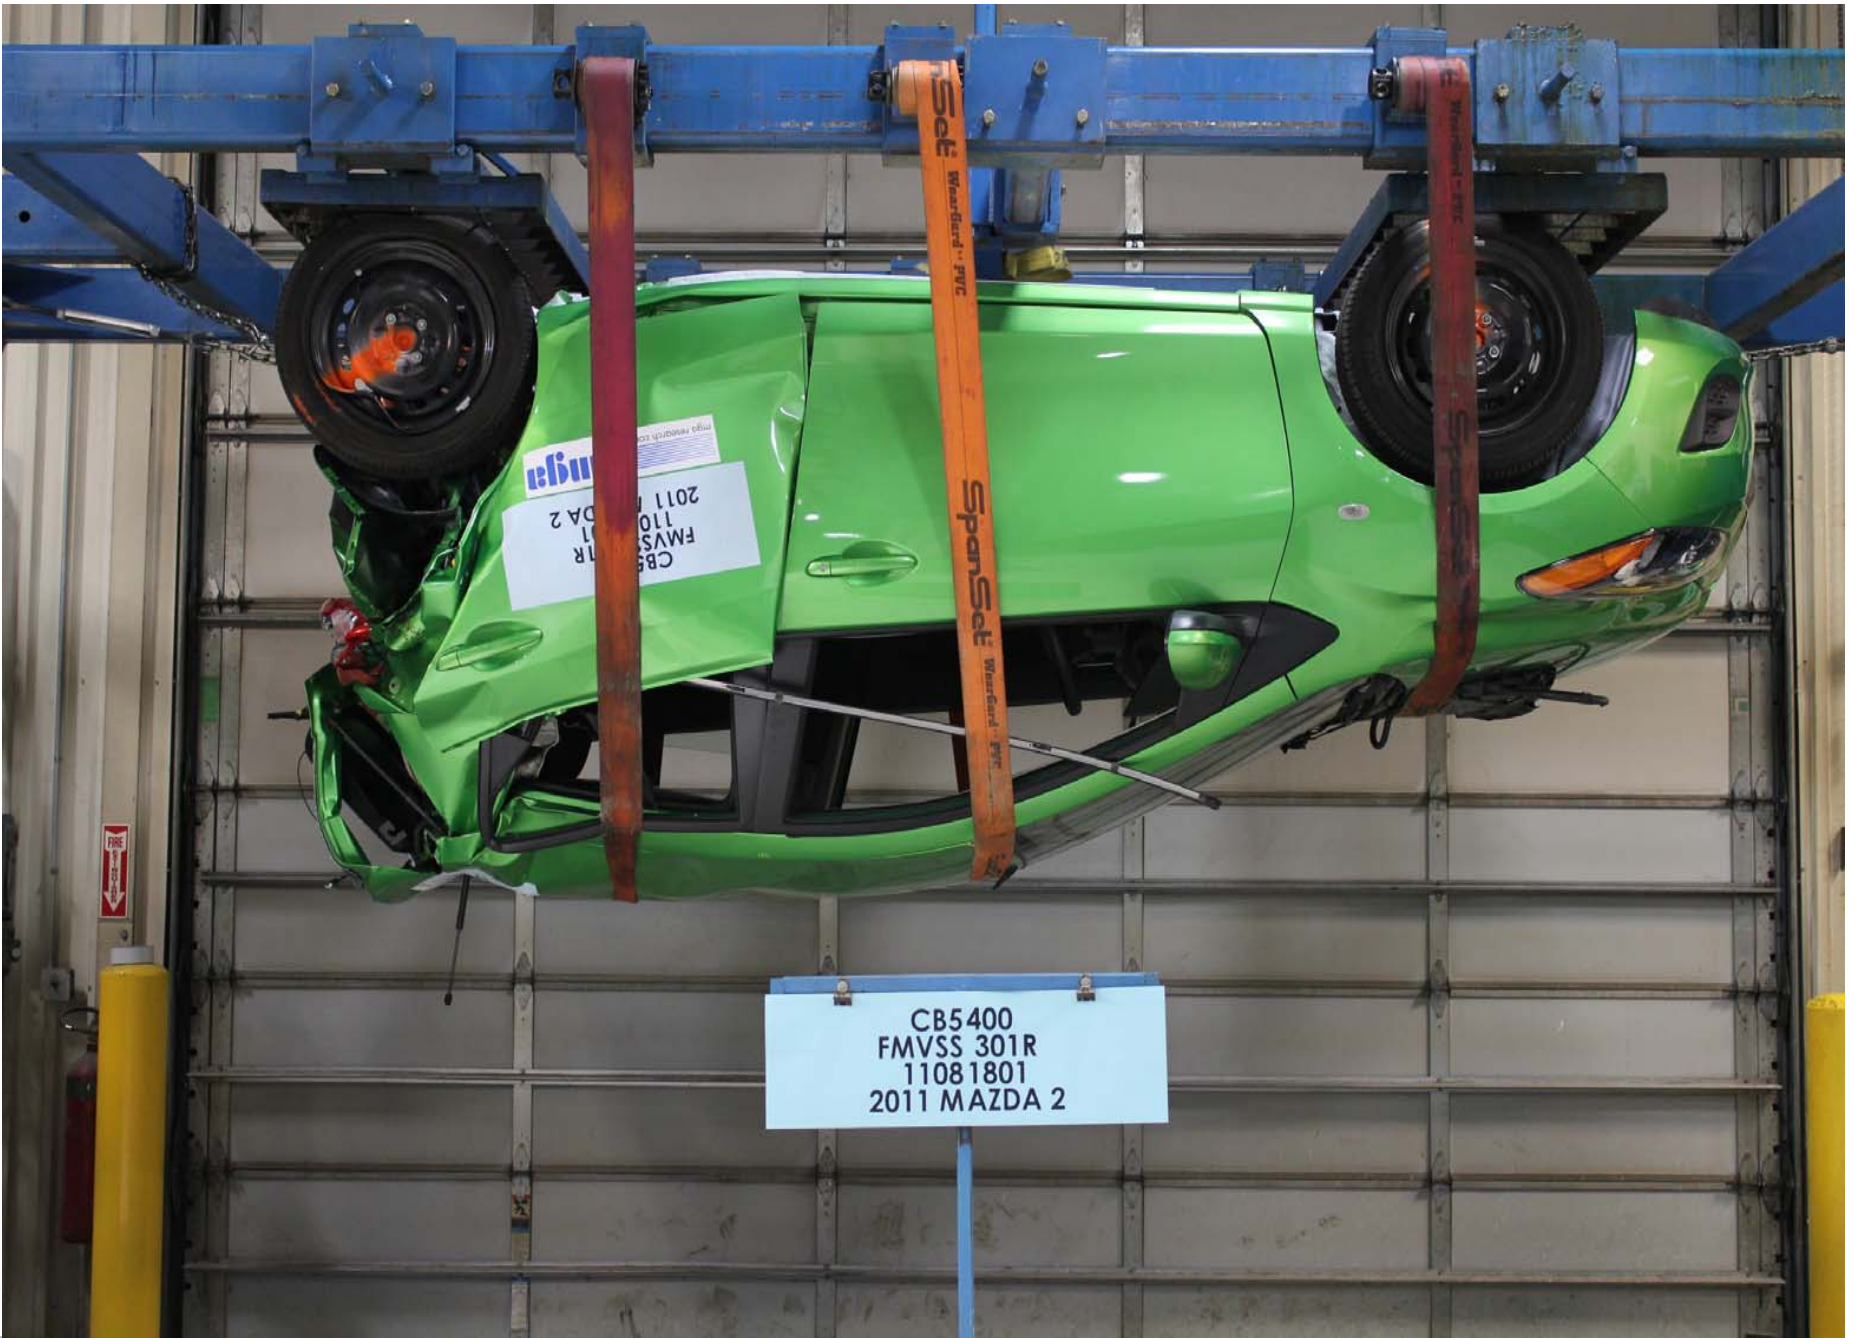
A-38.

Test Phase	Spillage (g)	Spillage Details
First 5 minutes from onset of rotation	0	
Sixth minute from onset of rotation	0	
Seventh minute from onset of rotation	0	
Eight minute if required	N/A

Static Rollover at 180 Degrees

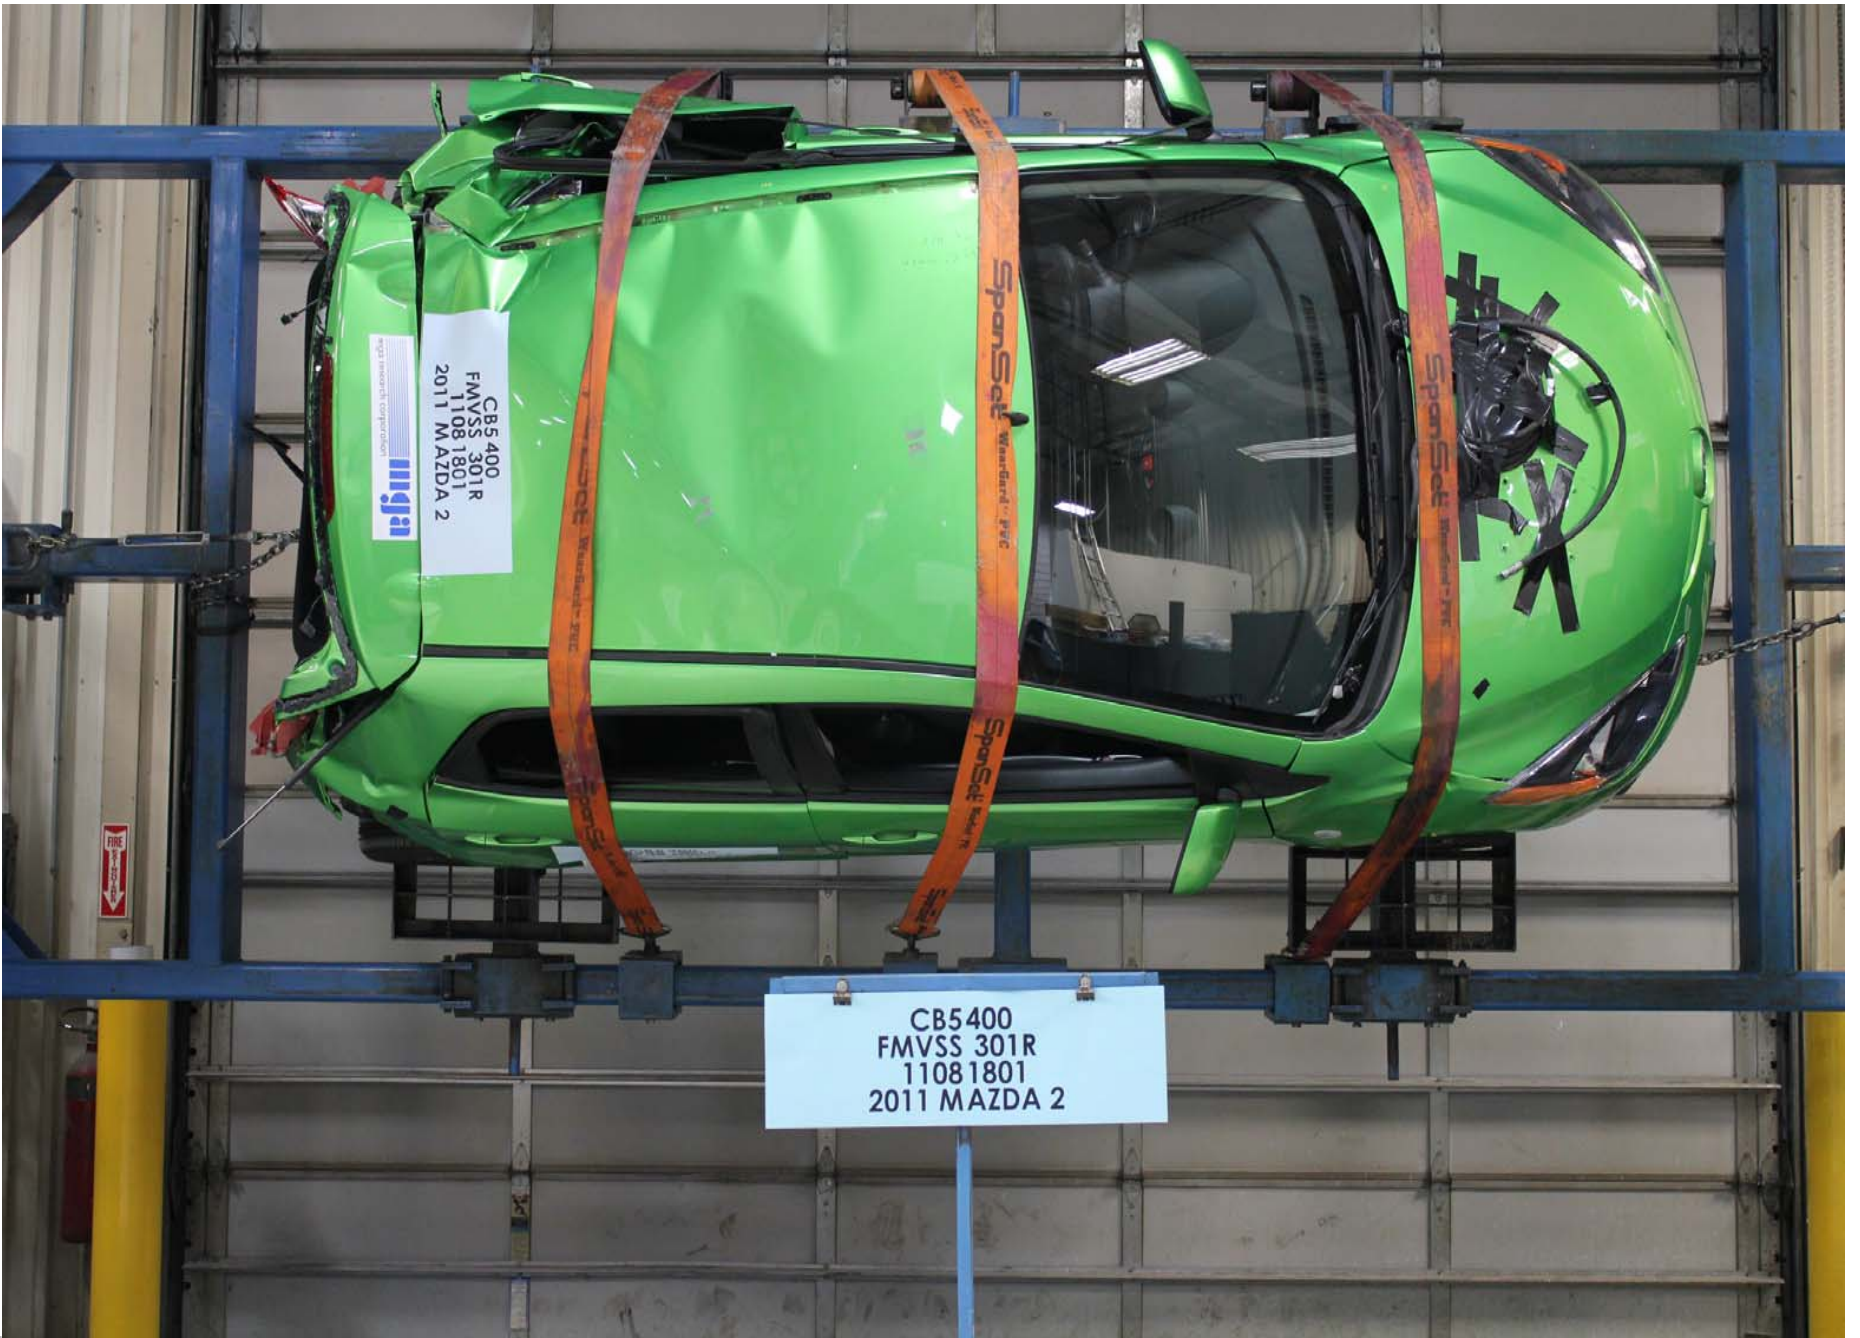
A-39.

Test Phase	Spillage (g)	Spillage Details
First 5 minutes from onset of rotation	0	
Sixth minute from onset of rotation	0	
Seventh minute from onset of rotation	0	
Eight minute if required	N/A

Static Rollover at 270 Degrees

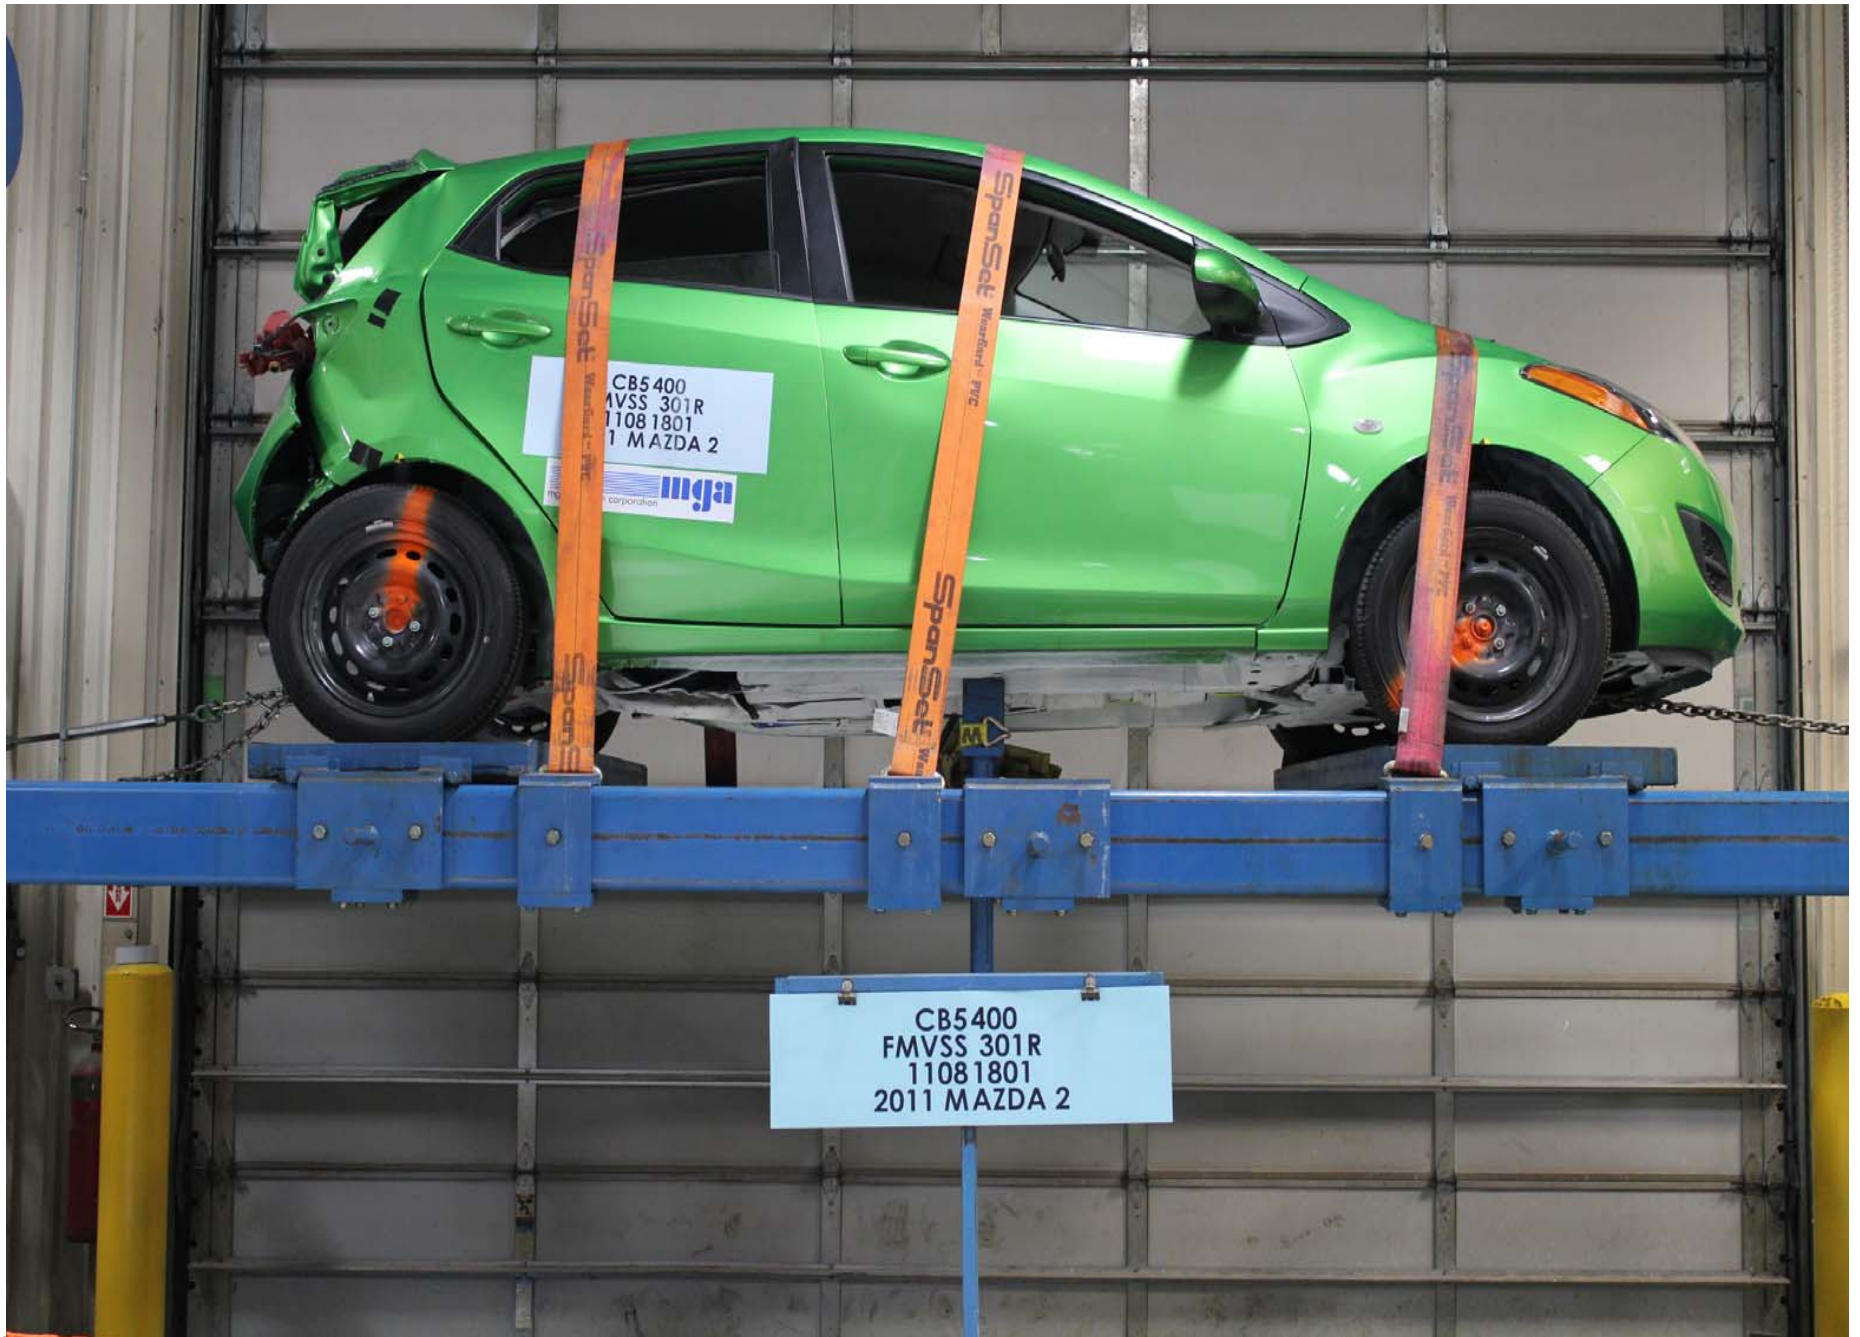
A-40.

Test Phase	Spillage (g)	Spillage Details
First 5 minutes from onset of rotation	0	
Sixth minute from onset of rotation	0	
Seventh minute from onset of rotation	0	
Eight minute if required	N/A

Static Rollover at 360 Degrees
