**NOT-IN-TRAFFIC SURVEILLANCE
CALSPAN REMOTE CARBON MONOXIDE POISONING
KEYLESS IGNITION INVESTIGATION**

SCI CASE NO.: CA12013

VEHICLE: 2006 LEXUS IS250

DATE: AUGUST 2010

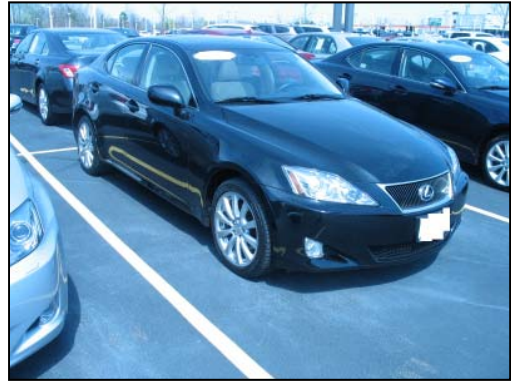
Figure 1: Right front oblique view of an exemplar Lexus IS250.

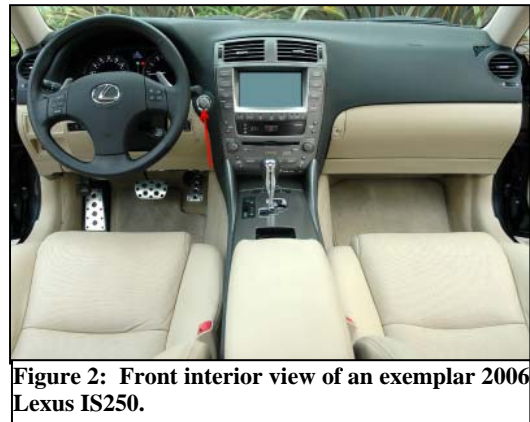
The victim's vehicle was a 2006 Lexus IS250. The Vehicle Identification Number was redacted in the police incident report and is unknown. Research conducted by the SCI team at a local Lexus dealership determined that this vehicle was manufactured with a single trim level and was equipped with 2.5-liter V6 engine. The Lexus was equipped with an OEM keyless ignition (**Figure 2**). Police images of the vehicle were not available.

Figure 2: Front interior view of an exemplar 2006 Lexus IS250.

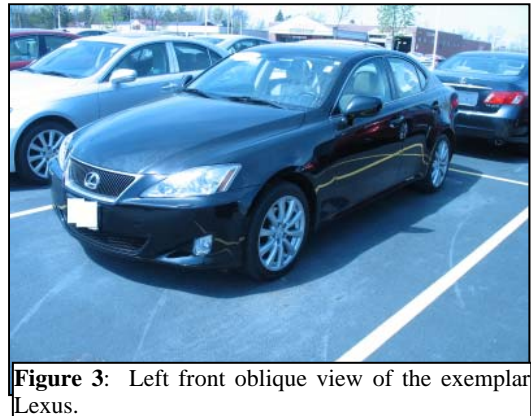
Lexus was a 2007 model year vehicle, the sales manager of the dealership reported that the Lexus IS250 model was unchanged from model years 2005 to 2008. Decibel readings were measured by a calibrated standard sound level meter. During the measurements, the Lexus remained parked in the dealership parking lot. The environmental conditions during the testing were clear skies, 24 degree Celsius (75 degree F) temperatures and light winds estimated at 1.6 km/h (10 mph). The ambient noise level measured 55 - 56 decibels in the parking lot.

Figure 3: Left front oblique view of the exemplar Lexus.

The engine of the Lexus was started. The sound level at the exhaust (on the back plane) measured 70 - 71 decibels at high idle (approximately 1200 RPM) and 65 decibels at the 700 RPM low idle. The sound level of the low idle operation attenuated to 58 decibels approximately 2 m (6 ft) away from the exhaust pipe. Standing adjacent to the engine compartment, the sound level at the low engine idle setting measured 62 - 63 decibels.

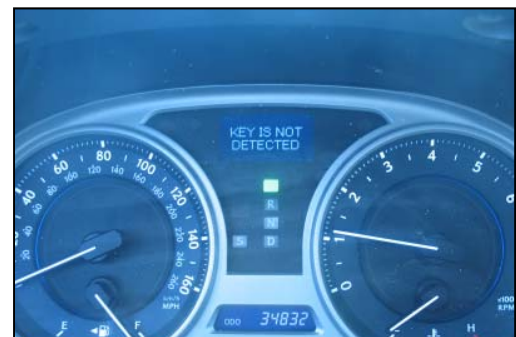
With the engine running, the key fob was removed from the vehicle. The door chime sounded three times and a warning illuminated on the message center within the instrument cluster. The message read "Key Is Not Detected" (**Figure 4**). The sound level of the active door chime did not register above the sound level produced by the idling engine.

Figure 4: Warning message displayed by the Lexus when the key fob is removed from the running vehicle.
