CALSPAN ON-SITE BACKOVER CRASH INVESTIGATION

SCI CASE NO: CA12011

VEHICLE: 2003 HYUNDAI SANTA FE

CRASH DATE: FEBRUARY 2012

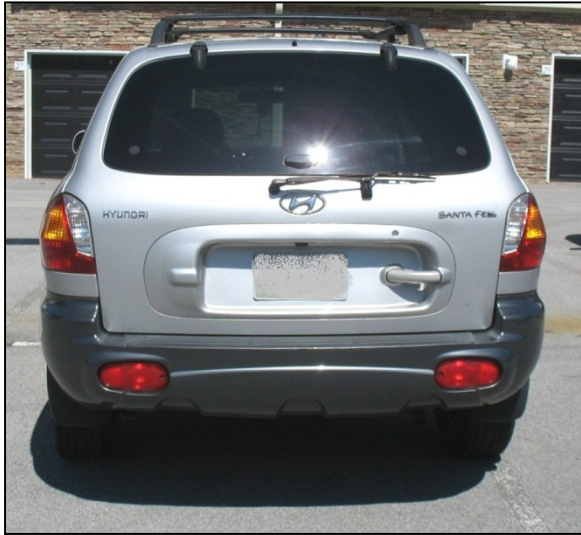
Figure 6: Rear plane of the 2003 Hyundai at the time of the SCI inspection.

The subject vehicle was not physically damaged in the crash. An area of fingerprints on the left lower aspect of the backlight glazing was referred to by the driver at the time of the vehicle inspection; However, due to the time elapsed between the crash and the SCI vehicle inspection, any fingerprint or contact evidence was long since masked by water, dust, and dirt residue.

Figure 6 depicts the rear plane of the Hyundai at the time of the SCI inspection.

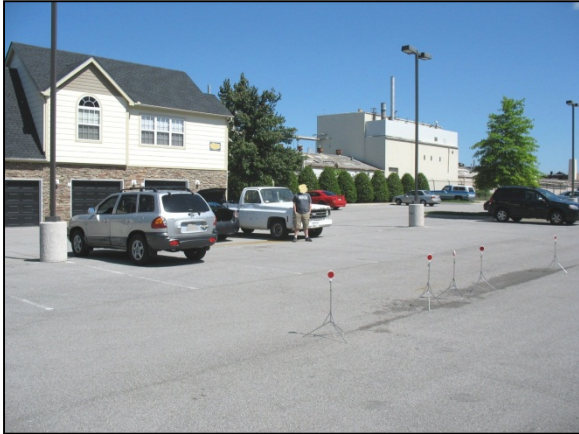
Figure 8: Oblique view depicting the distance from the Hyundai's rear bumper to the reference targets.

A 71 cm (28 in) tall red reflective target was placed on the vehicle's centerline and moved rearward to a location where the driver could first see the red target by looking through the rear view mirror (**Figure 7**). The centerline distance measured from the rear bumper to the reflector was 6.1 m (20 ft). The driver's line of sight through the rear view mirror projected to the ground was an additional 10.1 m (33.1 ft) for a total distance of 16.2 m (53.1 ft). Cones of visibility were established using the outside mirrors. These lateral visibility measurements were established at the centerline reference distance of 6.1 m (20 ft). By using the mirrors, the driver located the 71 cm (28 in) targets that were placed laterally relative to the centerline from his normal seated position. The visibility for the left mirror began 0.8 m (2.6 ft) left of center and ended 3.2 m (10.5 ft) left of center. The cone for the right mirror began 1 m (3.3 ft) right of center and ended 5.3 m (17.4 ft) right of center.

Figures 8 and 9 depict the location of the targets relative to the parked Hyundai. These visibility measurements are depicted graphically in a Rear Visibility Diagram on Page 10 of this technical report.

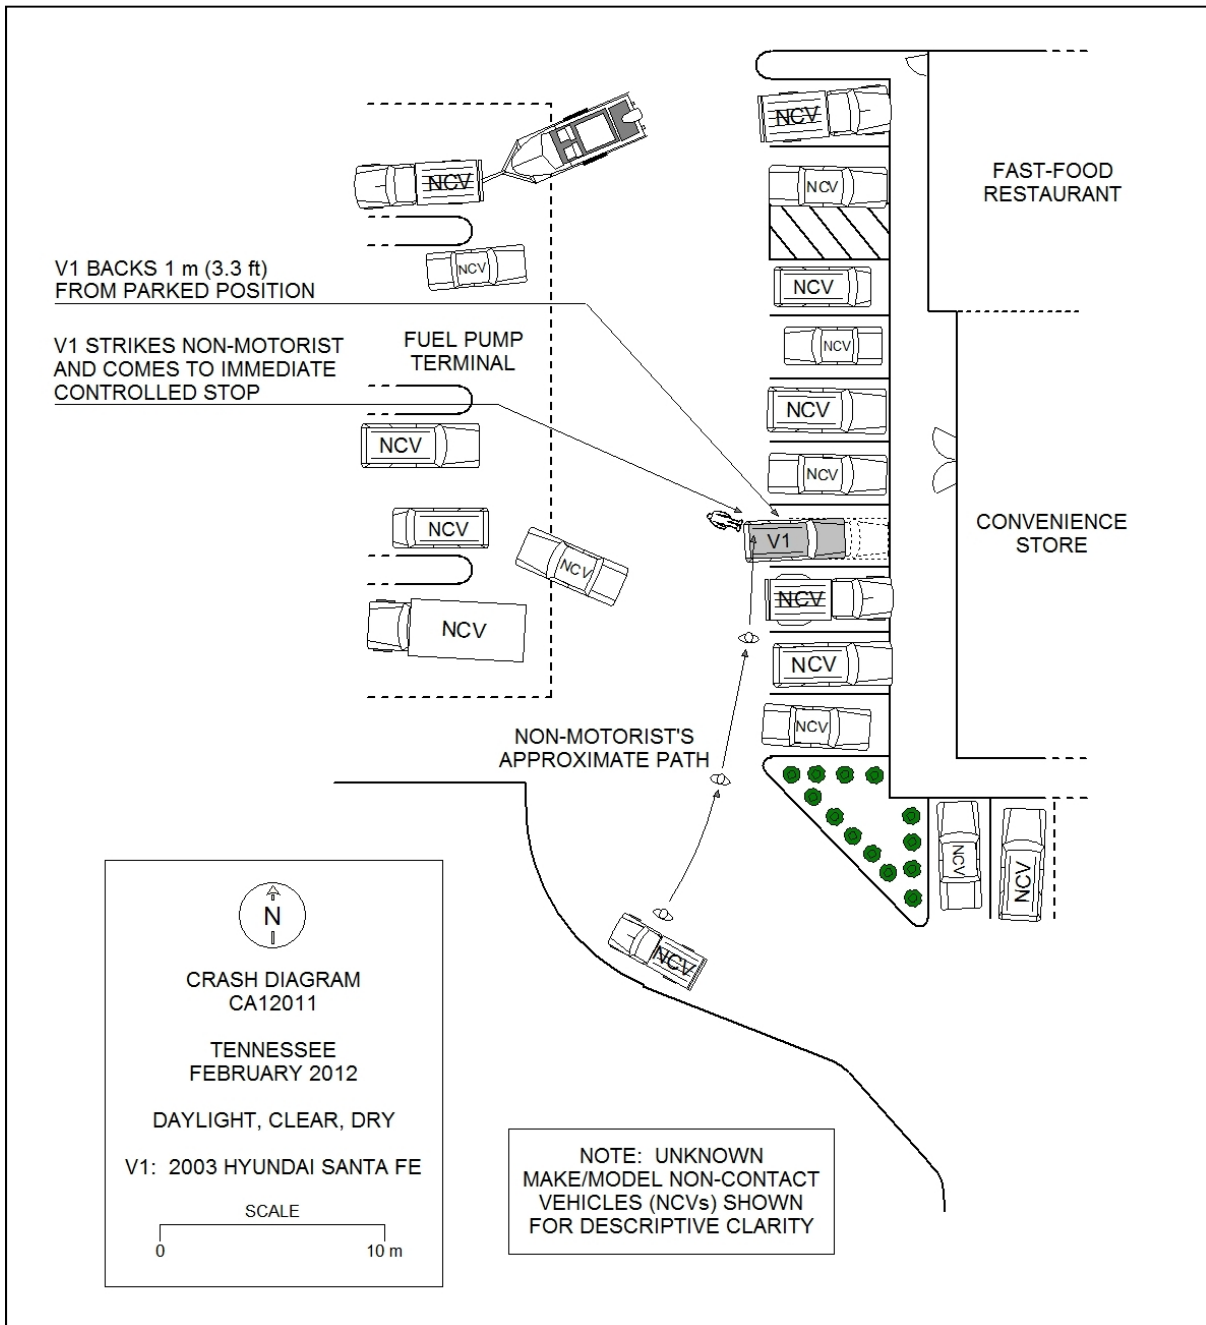
CRASH DIAGRAM

The crash occurred as the left aspect of the Hyundai's rear plane contacted the non-motorist's right flank. The driver of the Hyundai detected an audible sound that he described as a "thud" related to this contact and subsequently re-applied pressure to the brake pedal and immediately brought the Hyundai to a controlled stop within a distance of 0.3 m (1 ft). In an attempt to locate the source of the audible sound, the driver again looked through both side mirrors and observed the non-motorist in the Hyundai's left side mirror, lying on the ground.

At impact with the Hyundai's rear plane, the non-motorist was redirected from his standing position and initiated a left lateral trajectory. Accordingly, the non-motorist lost his balance and fell to the ground. His left flank and head contacted the asphalt surface of the parking lot.

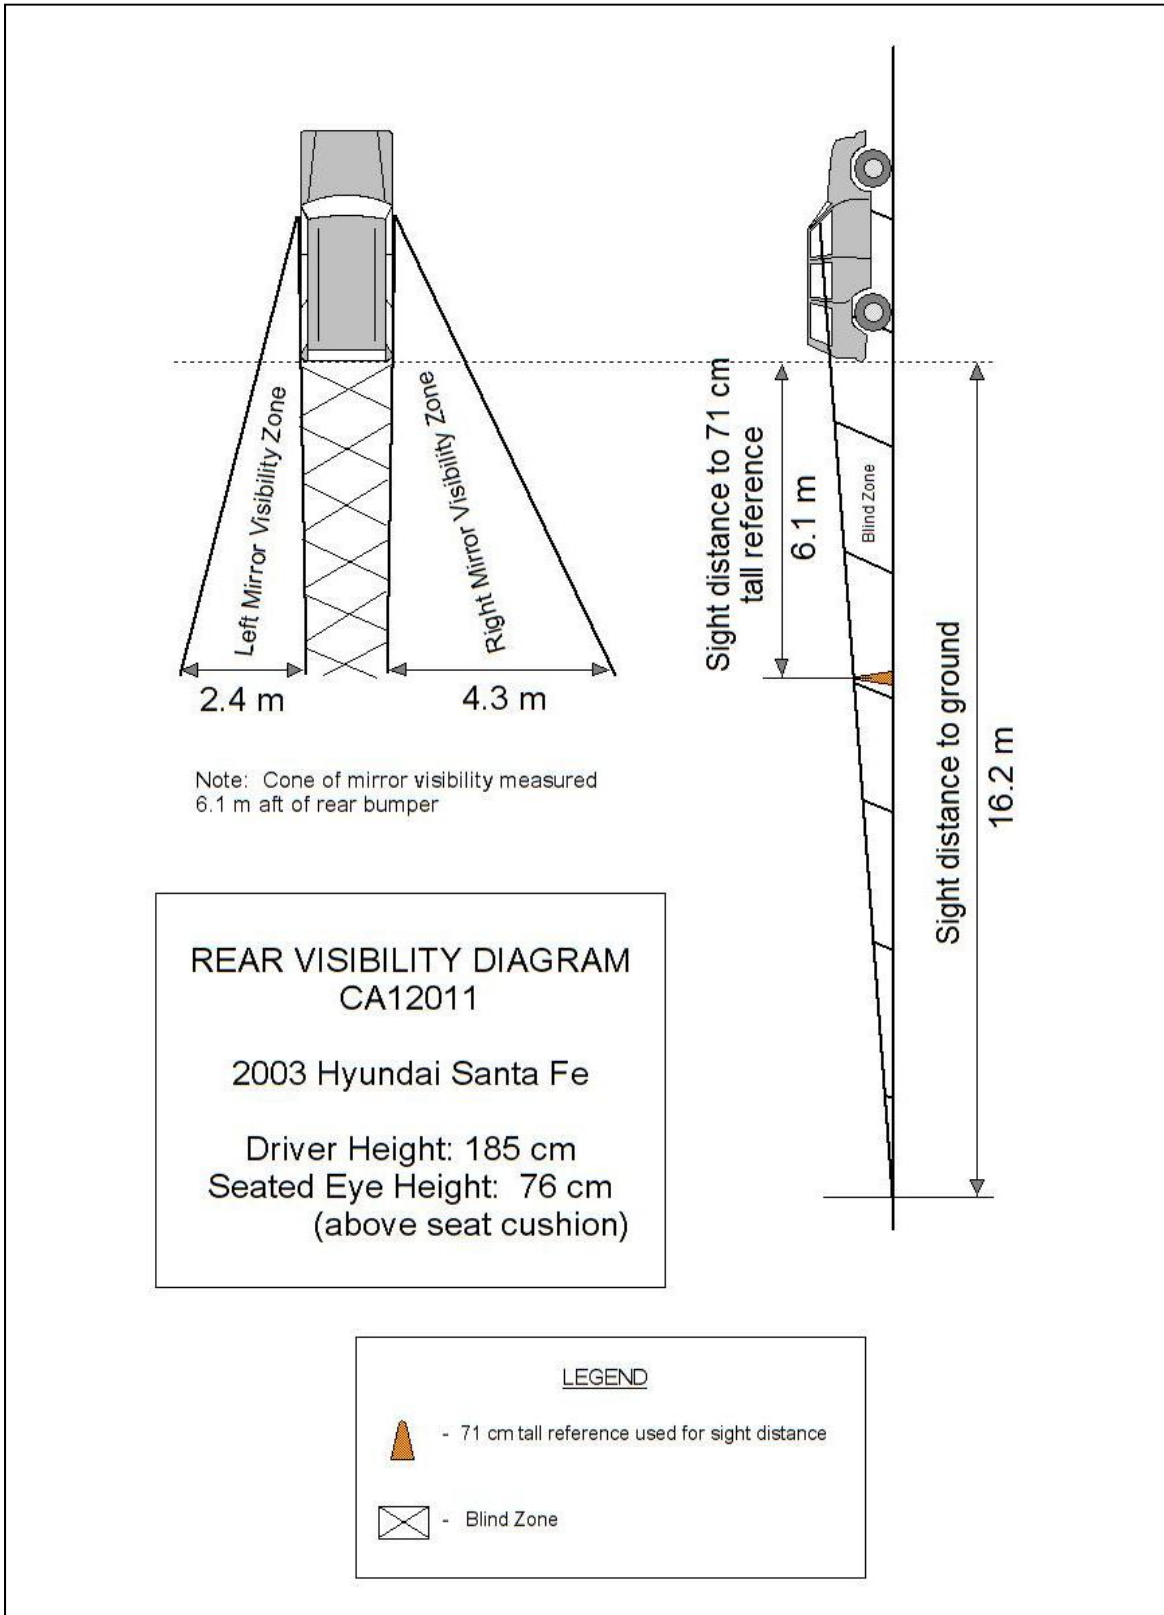
REAR VISIBILITY DIAGRAM

The Hyundai's rear visibility was measured utilizing the driver in a vacant, level parking lot. The driver's eye height measured 76 cm (30 in) above the seat cushion with the seat adjusted to the same settings as it was at the time of the crash. This included the seat track at a middle position, the seat back slightly reclined, the head restraint fully down, and the driver restrained by the 3-point lap and shoulder safety belt with the D-ring adjusted to its full-down position.
