## ON-SITE ROLLOVER INVESTIGATION

CASE NUMBER - IN11040  
LOCATION - OHIO  
VEHICLE - 2006 Honda CR-V EX  
CRASH DATE - October, 2011

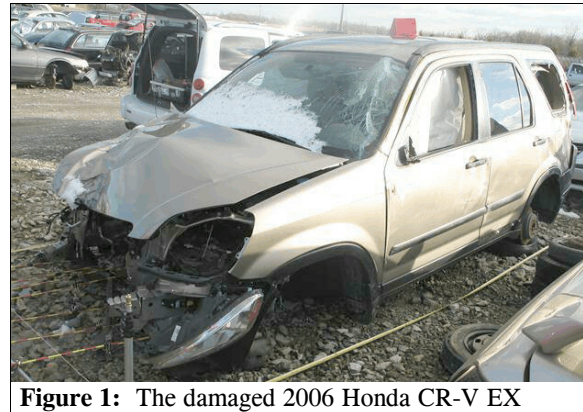
**Figure 1:** The damaged 2006 Honda CR-V EX

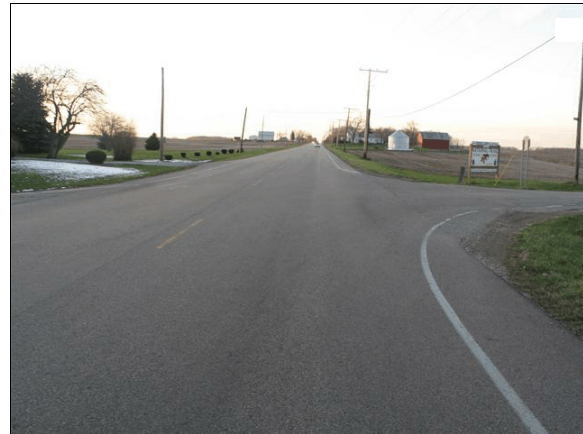
**Pre-Crash:** The Honda was traveling west approaching the intersection (**Figure 2**) and was behind a tractor semi-trailer. The driver of the Honda intended to continue traveling straight through the intersection. The Geo was traveling east and the driver intended to turn left at the intersection and travel north on the rural roadway. The driver of the Geo initiated the left turn immediately after the tractor semi-trailer traveled through the intersection. The driver of the Honda stated during the SCI interview that she had no time to take any avoidance actions.

Figure 2: Westbound approach of the Honda; the Geo was heading east approaching the Honda

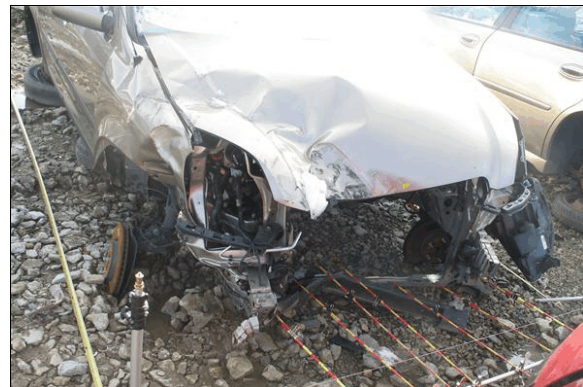
**Crash:** The front plane of the Honda (**Figure 3**) impacted the right plane of the Geo (event 1). The force direction on the Honda was within the 11 o'clock sector and the impact triggered deployment of the driver's frontal air bag. The missing Vehicle Algorithm of the WinSMASH program calculated the total Delta V for the Honda as 35 km/h (21.7 mph). The longitudinal and lateral velocity changes were -30 km/h (-18.6 mph) and 18 km/h (11.2 mph), respectively. Following the impact, the Honda rotated clockwise approximately 110 degrees and rolled over (event 2), left side leading, four quarter turns. The rollover event triggered deployment of both IC air bags. The vehicle departed the right side of the roadway during the rollover (**Figure 4**) and came to final rest on its wheels heading north.

Figure 3: Damage to the front plane of the Honda from the impact with the right plane of the Geo

***Exterior Damage Event 1:*** The Honda sustained damage to the front plane during the impact with the right plane of the Geo. The front bumper, right headlamp/turn signal assembly, hood, and grille were directly damaged. The direct damage began at the front right bumper corner and extended 69 cm (27.2 in) across the front plane. The front bumper had been removed so the crush measurements were taken at the lower radiator frame support. The maximum residual crush was 35 cm (13.7 in) located 11 cm (4.3 in) left of C<sub>5</sub>. The Field L was 99 cm (39 in). The crush values were: C<sub>1</sub>= 14 cm (5.5 in), C<sub>2</sub>= 15 cm (5.9 in), C<sub>3</sub>=22 cm (8.7 in), C<sub>4</sub>= 31 cm (12.2 in), C<sub>5</sub>= 28 cm (11 in), C<sub>6</sub>= 25 cm (9.8 in).

**Damage Classification Event 1:** The Collision Deformation Classification (CDC) was 11FZEW2 (330 degrees). The missing Vehicle Algorithm of the WinSMASH program calculated the total Delta V as 35 km/h (21.7 mph). The longitudinal and lateral velocity changes were -30 km/h (-18.6 mph) and 18 km/h (11.2 mph), respectively. The results appeared reasonable.

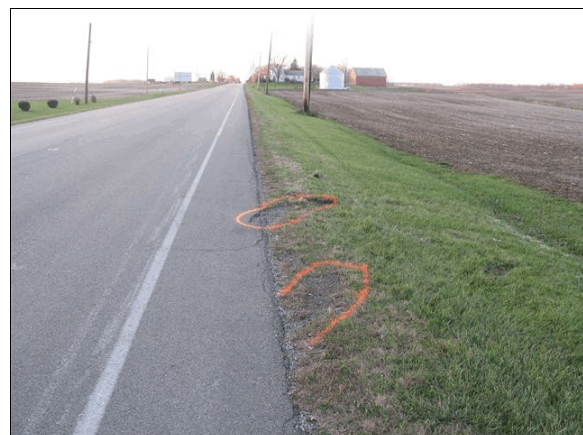
Figure 4: View west to area of the Honda's rollover

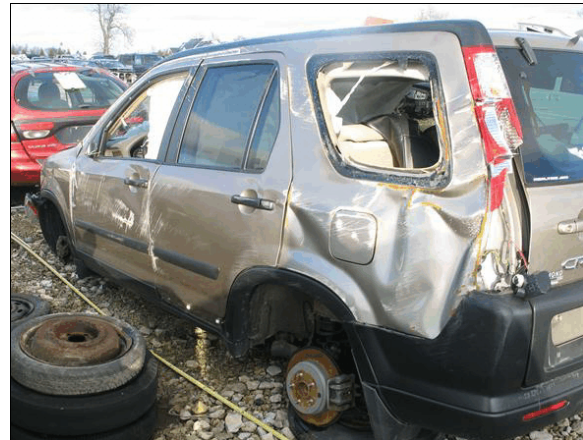
**Exterior Damage Event 2:** The left plane sustained direct damage during the rollover from contact with the roadway pavement. The direct damage began 35 cm (13.8 in) forward of the bottom of the right A-pillar and extended 334 cm (131.5 in) rearward along the left plane (**Figure 5**). The last three quarter turns of the rollover occurred on the grass covered roadside and there was no direct damage on the top and right planes. The maximum lateral crush was approximately 2 cm (0.8 in) occurring at the top of the left A-pillar (**Figure 6**). There was no vertical crush to the roof.

**Damage Classification Event 2:** The CDC for the rollover was 00LDAO2. Based on the extent of the crush, the severity of the damage was minor.

**Figure 5:** Damage to the left plane of the Honda from the rollover

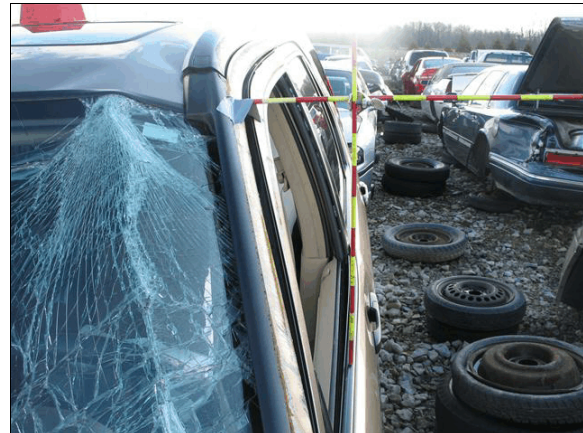
**Figure 6:** The maximum lateral crush to the Honda's roof structure occurred at the top of the left A-pillar

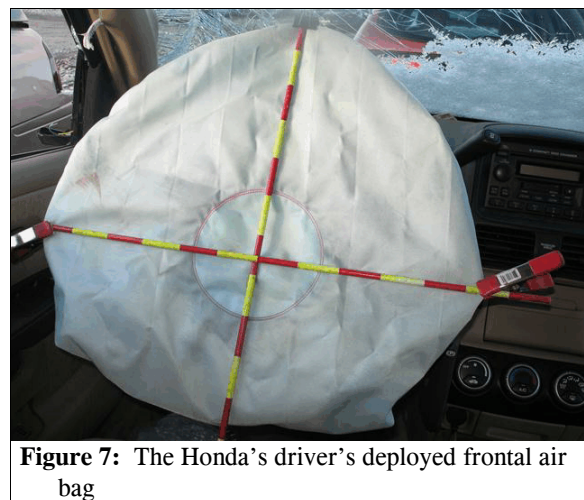
The driver's frontal air bag was located within the steering wheel hub. The air bag module cover was a two-flap configuration constructed of pliable vinyl. The top flap was 16 cm (6.3 in) in width and 7 cm (2.8 in) in height. The bottom flap was 16 cm (6.3 in) in width and 6 cm (2.4) in height. The cover flaps opened at the designated tear seams and were undamaged. The deployed air bag (**Figure 7**) was 59 cm (23.2 in) in diameter and had two 5 cm (2 in) diameter vent ports on the back of the air bag at the 11 and 1 o'clock positions. There were also two internal tethers sewn to the center of the air bag. Each tether was 7 cm (2.8 in) wide. A blood transfer

was located on the upper left quadrant of the air bag. There was no other discernable evidence of occupant contact and no damage to the air bag.

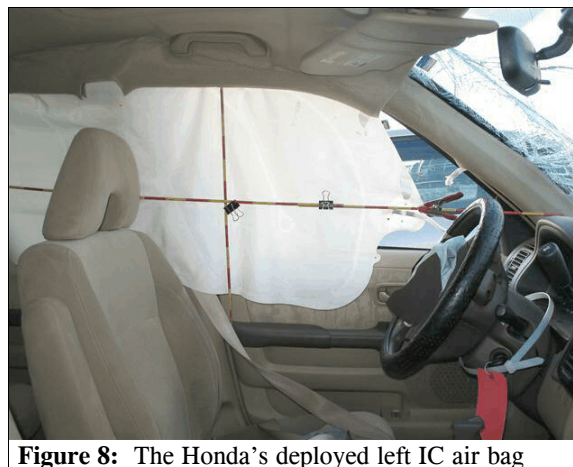
The IC air bags were located along the roof side rails inside the headliner and extended from the A-pillar to the C-pillar. The deployed left IC air bag (**Figure 8**) was 167 cm (65.7 in) in width and 46 cm (18.1 in) in height. It was attached to the A-pillar by a 15 cm (5.9 in) long nylon tether and to the roof side rail between the C- and D-pillars by a 27 cm (10.6 in) long tether. The gap between the front of the IC air bag and the window frame at the beltline was 32 cm (12.9 in). The distance the IC air bag extended below the beltline was 12 cm (4.7 in). There was no discernable evidence of occupant contact and no damage. The right IC air bag was of the same features and dimensions. The right IC air bag sustained no damage during the crash.

**Figure 8:** The Honda's deployed left IC air bag
