REPORT OF INVESTIGATION: HYBRIDS PLUS PLUG IN HYBRID ELECTRIC VEHICLE

**National Rural Electric Cooperative Association, Inc.
And
U.S. Department of Energy, Idaho National Laboratory**

June 26, 2008

Revision 1

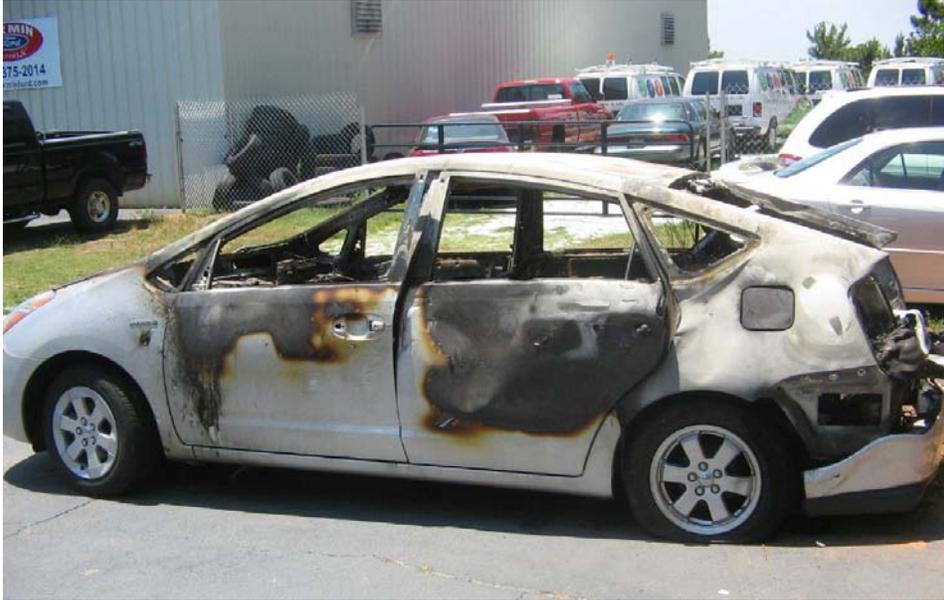
Figure 1--Fire Damaged PHEV Prius

On Saturday, June 7, 2008 a CEPCI engineer was driving the PHEV Prius. The reported high temperature that day was 98F. After approximately 40 miles of highway driving, The driver noticed a warning light on the Prius's display screen and simultaneously noticed that the combustion engine was operating at high rpm. He pulled the vehicle to the shoulder, turned the car off and inspected the vehicle. At that time, he noticed an acrid smell but attributed that to the high rpm operation of the engine. The driver restarted the vehicle and pulled back onto the highway, accelerating quickly to achieve highway speed. After another four-to-five miles, the driver again experienced a warning light on the vehicle display (although the engine did not operate at high rpm this time) and noticed a strong odor of burning material. He opened the windows and began to pull over. When the windows were opened, a significant amount of smoke was pulled forward to the driver's area. The driver exited the vehicle and noted a fire at the right side in the rear (cargo) compartment of the vehicle which eventually consumed the vehicle. Figure 1 shows the results of the fire (See Appendix A for additional images of the fire-damaged vehicle).

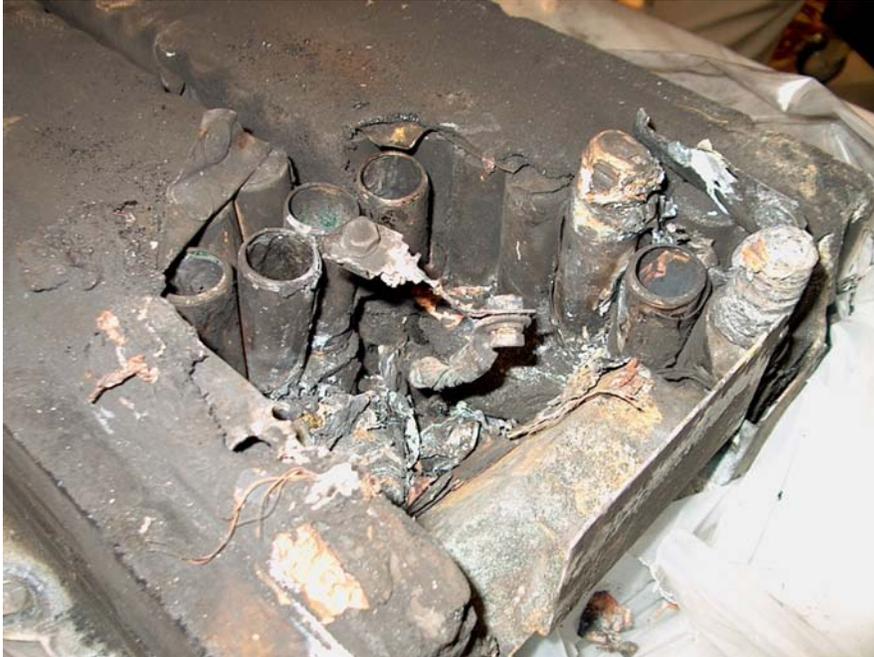
Figure 10--Empty Battery Cells

The battery was wrapped in plastic sheet and located on a table in A123 Systems' assembly area. The plan of action was to slowly and methodically inspect, document and remove components from the battery pack to look for the initiating point. Upon initial viewing, it was apparent that the right end of the battery pack was most severely damaged in the cavity that is formed between the front and rear batteries (the batteries are designed so that a U-shaped pocket is formed on the right end to provide clearance for cables that attach from front to rear batteries). Much of the clamshell was missing or severely melted in this area. Several cells from both the Front and Rear top batteries were found open with their contents missing or protruding from the can. See Figure 10.

In the middle of Figure 10, a heavy cable can be seen with the remnants of a fuse connected to it. This is the Cross Connect Cable that connects the Front Bottom battery to the Rear Top battery. The plastic housing of the fuse is missing (melted or baked away) but the fuse is still intact. In fact, all of the three intact battery fuses were still electrically conductive. The main pack fuse (125A) was also electrically conductive. The cable connecting the Rear Bottom battery to the Front Top battery was not attached to the assembly but was present (loose) with the battery. This assembly had the fuse from the Rear Bottom battery still attached and a portion of the Front Top fuse attached (Figure 11).

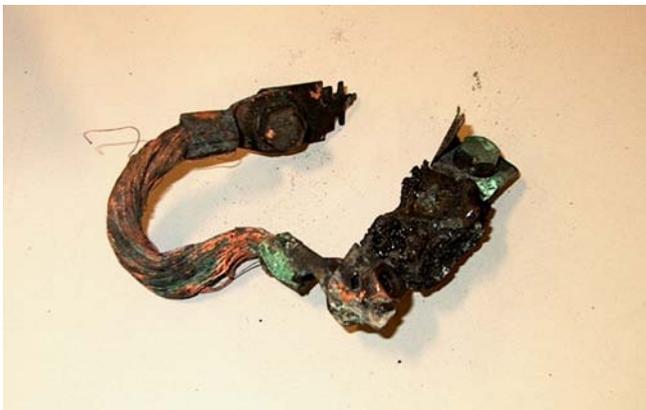
Figure 11--Interconnect Cable

Again, the intact fuse had a severely melted housing but the fuse was still electrically conductive. A microscope examination of the partial fuse shows that the fuse suffered a mechanical break and likely did not melt in an overcurrent condition (Figure 12). Examination of photos taken of the vehicle shortly after the fire show that this fuse was intact after the vehicle was towed to Firmin Ford. The fuse was likely broken during the vehicle investigation in South Carolina.

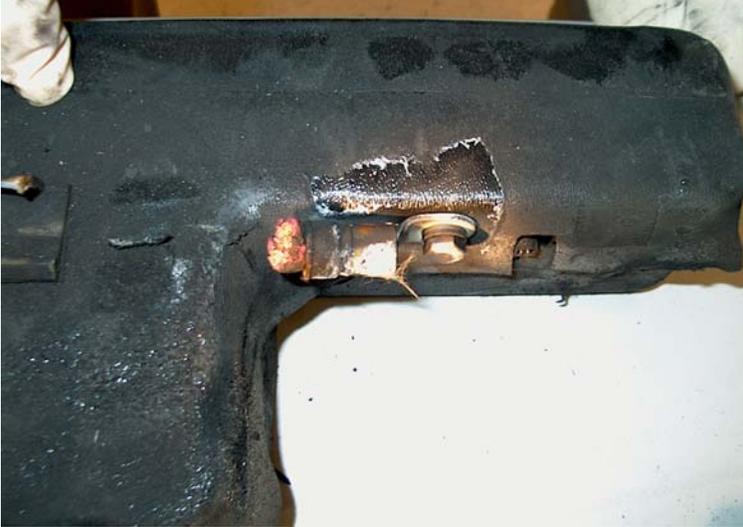
Figure 14--Non-fused Terminal

With the batteries removed from the tray, the terminals on the left-hand end (non-fused) could be more closely examined. On all four batteries, these connections were found to be loose (Figure 14).

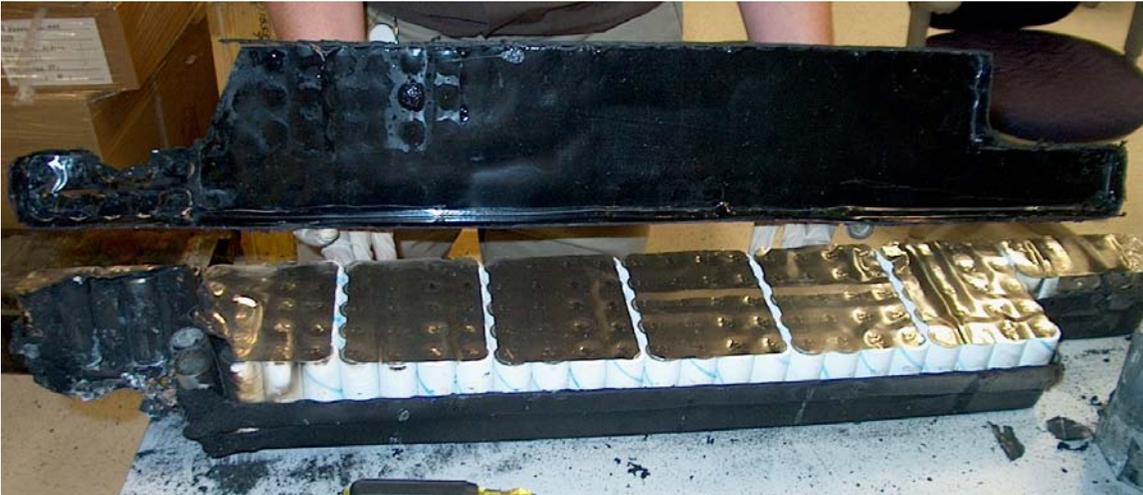
Figure 15--Burn Pattern in a Battery

With the clamshell removed, all cells inside that battery could be visualized. It was noted that significant burning was present at the right-hand end, some heat deformation of the plastic and soot on the cells at the left-hand end and little damage in the middle except at the front face where a significant amount of melting occurred (Figure 15).

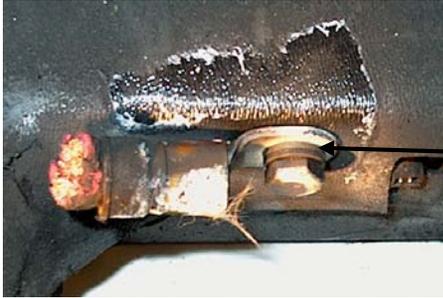
Figure 16--Terminations

Following the cell inspection, the lugs/fuse/bus bar interfaces were examined. During the design review, it was noted that the clamshell design creates a situation where the plastic clamshell is placed between the fuse blade and the interconnecting cable terminal. Mr. Lawrence of Hybrids Plus indicated that the design required that a bushing or spacer be placed between the fuse blade and the terminal so that the plastic would not be placed in compression. Upon inspection of the various connections no spacers were found between the terminal and the fuse (or the bus bar tab in the case of the non-fused locations. See Figure 16 for some examples and Appendix C for an assembly diagram.

Spacer (washers) placed between bolt head and lug—lug contacting plastic housing

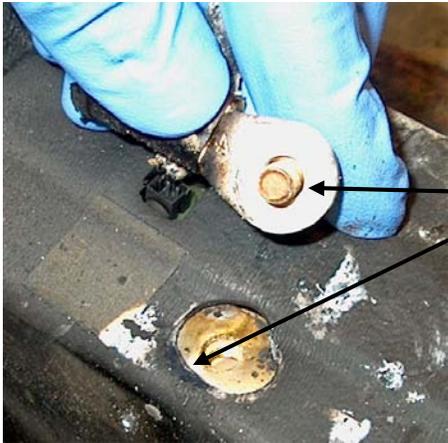
No spacer under lug. Note witness marks where lug rubbed on plastic

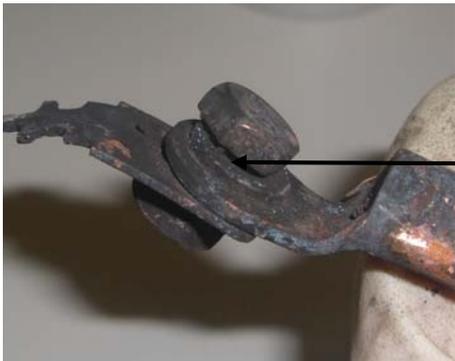
Washer located under bolt head. No spacer between lug and fuse blade

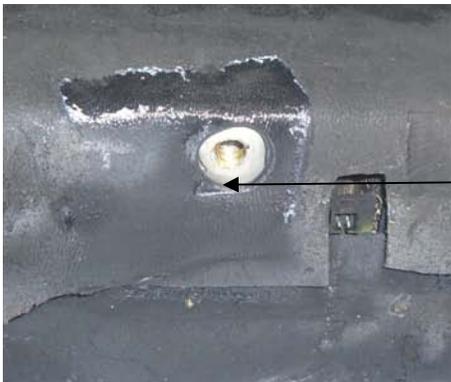
Note witness marks left by lug compressing plastic housing

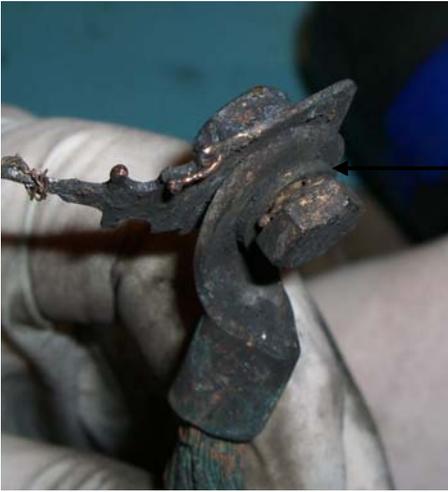
Washer placed under bolt head. No spacer between lug and fuse blade.

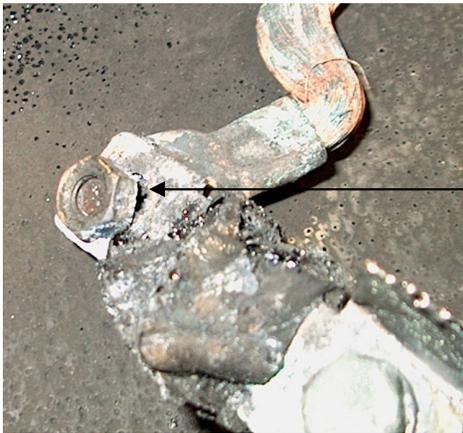
Figure 17--Loose Terminations

While examining the various terminations, several of the fused connections were found to be loose (Figure 17).

Bolt not protruding through nut. Obvious gap in the bolted joint.

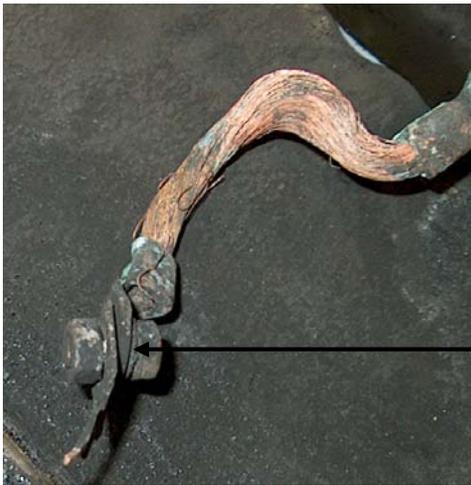
Gap between lug and fuse blade

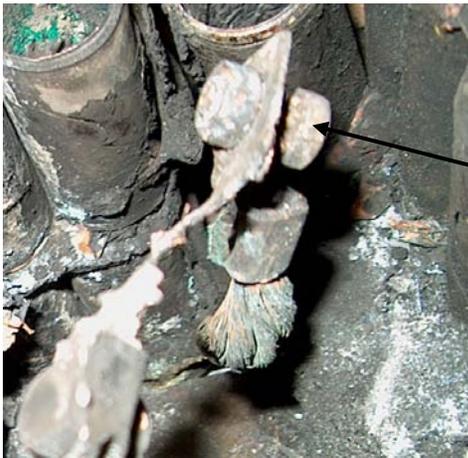
Gap between bolt head and lug

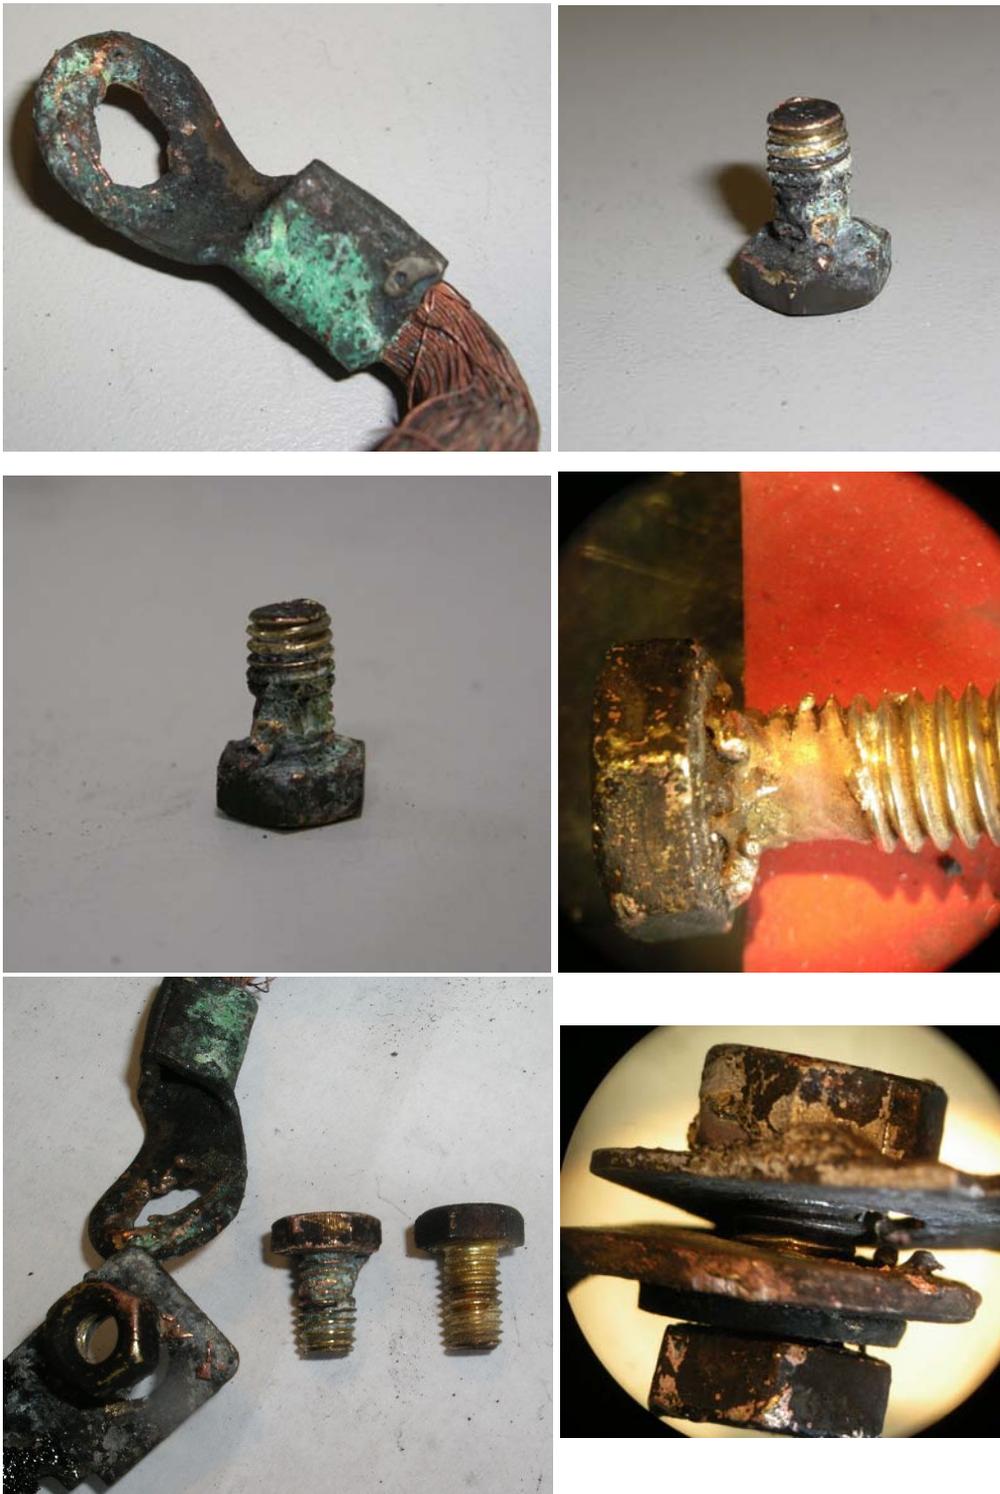
Figure 18--Material Transfer at Terminations

During this inspection, it was also noted that there was significant transfer of material between the brass bolts and nuts, the cable terminals and the fuse blades (Figure 18). This material transfer is indicative of significant electric arcing and very high temperatures.

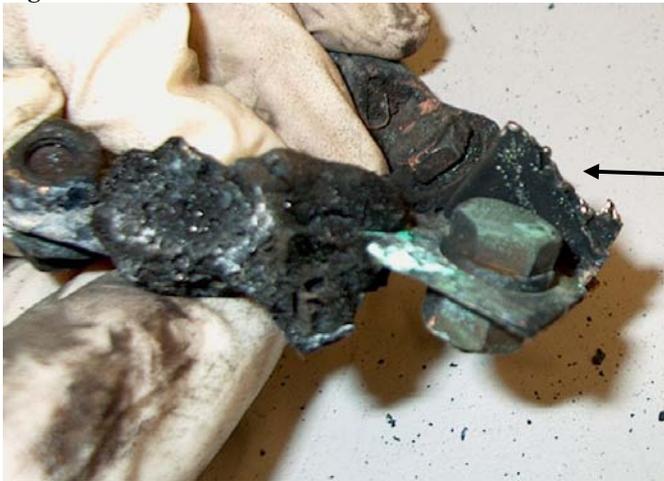
Figure 19--Torn Tabs

The Nickel sheet bus bars were also closely examined. The great majority of spot welds appeared to be intact. Where cells ejected their contents, some spot welds were torn where the Nickel sheet was lifted up and away from those cells. In some cases, the spot welds were intact and the Nickel disks used at the ends of the cells were still attached to the sheet Nickel. It was also noted that the tabs on the Nickel sheets formed to be the attachment location for the fuses were all missing. They were found still attached to the fuse blades. All of these remnants exhibited signs of melting at their edges as opposed to stretch or fracture marks. See Figure 19.

Tab remnant with melted edge

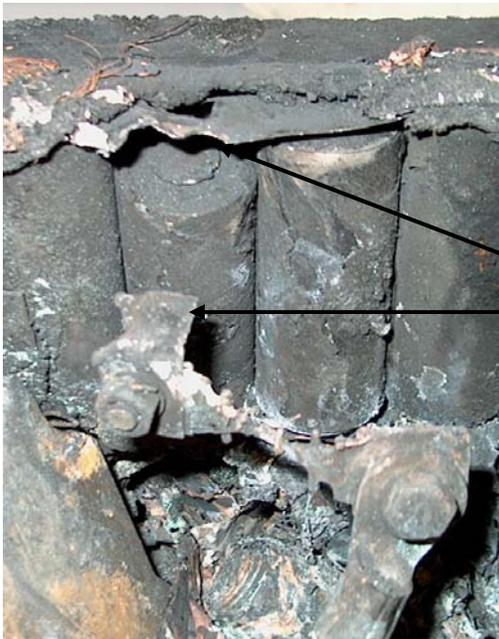
Tab remnant connected to fuse blade. Location on Nickel sheet where tab was originally located.

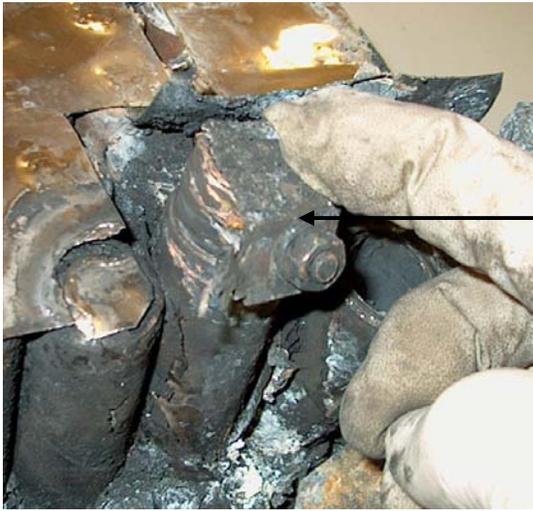
Tab remnant with a portion of the Nickel sheet. This remnant includes the other half of the fuse from Figure 11.

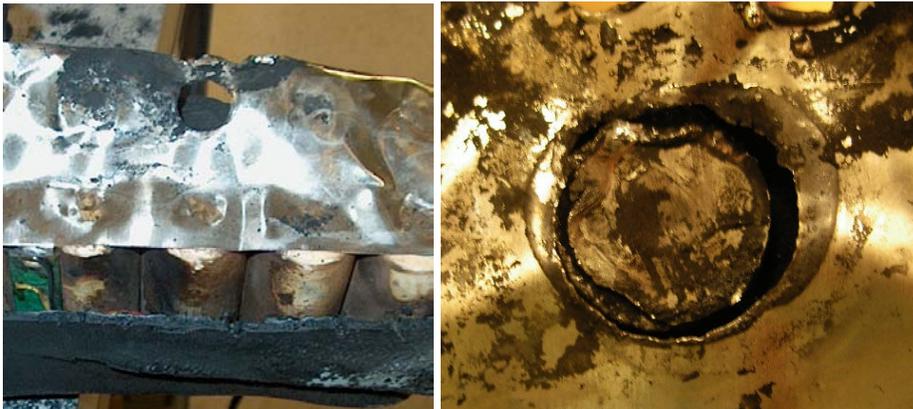
Figure 20--Circular Feature³

During this inspection, two curiosities were noticed with regard to the Nickel bus bar sheets. The first was at the Top Rear battery on the right-hand side. The Nickel sheet was no longer attached to a cell. Instead, the Nickel sheet had a circular hole in it and the missing portion of the sheet was still attached to the top of that cell (Figure 20). The area around the circular hole show signs characteristic of excessive heating.

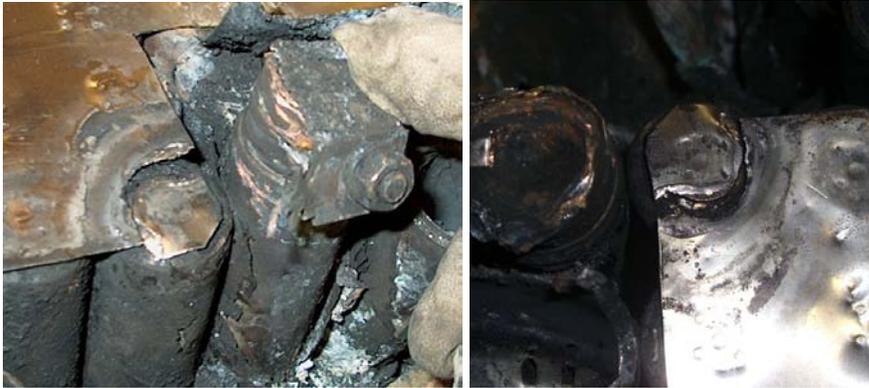
Figure 21--Torn Corner Cell

The second feature was located at the Top Front battery on the right-hand side. A cell at the corner of the second series group and located at the corner of a Nickel sheet had become disconnected from the rest of its group, taking the corner of the Nickel sheet with it (Figure 21). The crescent-shaped area on the remaining Nickel sheet shows characteristic signs of excessive heating.

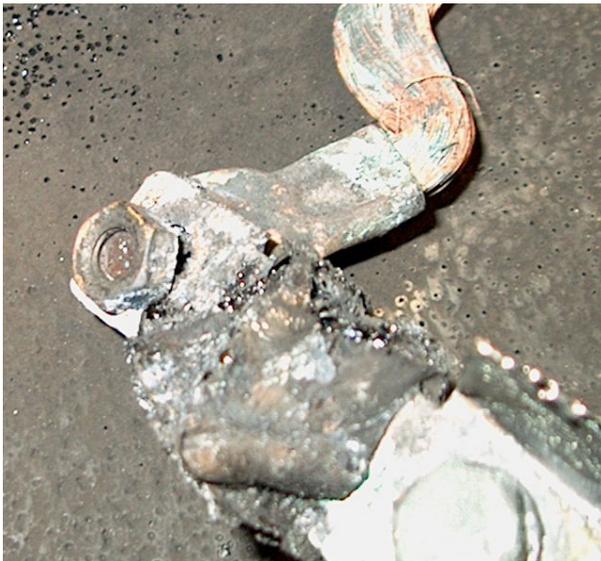
Figure 22--Loose Connection

The inspection of the battery led to the conclusion that the fire was most likely the result of a loose connection, probably at the right-hand side of the Bottom Rear battery. This connection was found to have a nearly 0.1” gap between the bolt head and the lug (Figure 22).

As can be seen in the photo, this assembled joint was found with the bolt screwed only partially into the nut. It is unlikely that this occurred during either of the vehicle or battery inspections as it required wrenches to remove the nut from the bolt. More likely, this was a result of a) the lack of a locking device to prevent the bolt from backing out, b) the lack of a spacer between the fuse blade and the lug which placed the plastic of the clamshell housing in compression between the two and c) vibration from normal vehicle operation causing the bolt to back off from its original installed position. This joint was found to have approximately 0.16” clearance in the assembly. Assuming that the

clamshell plastic was nominally 0.06” thick, the clearance at the time of the fire would be approximately 0.1”.

As a current-carrying joint becomes loose, the resistance of the connection increases. The power dissipated in heat by a resistor is given by $P=I^2R$. Therefore, a doubling of the resistance increases the power dissipated by heat by a factor of two. The battery pack will experience a maximum discharge current somewhere near 100A during normal driving. Given that the power dissipated by heat is proportional to the square of this current, an increase in resistance to even a few Ohms will result in extreme heat generation. Experience shows that loose connections can lead to temperatures over 250°F.

the four batteries. Any improperly assembled joints should be disassembled and reassembled as per the design documents.

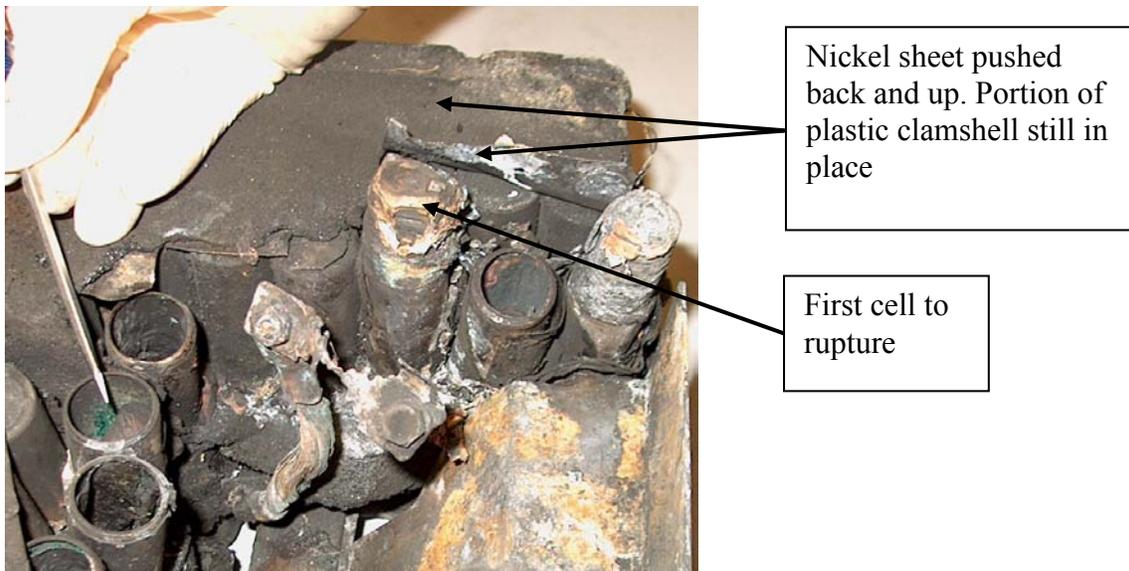
Figure 23--First Rupture Site

Once the cell built up enough pressure, the pressure vent ruptured and the contents of the cell were ejected with great force; enough to rip the tab off the end of the sheet (the fuse was captured inside the clamshell next to the cells), to pull the Nickel sheet off several adjacent cells and to punch through the plastic clamshell cover (likely softened due to the heat). See Figure 23.

It is likely that the tab on the Nickel sheet was ripped off first as there is evidence of melting, a sign that current was passing through this area which resulted in arcing as the tab became separated from the sheet.

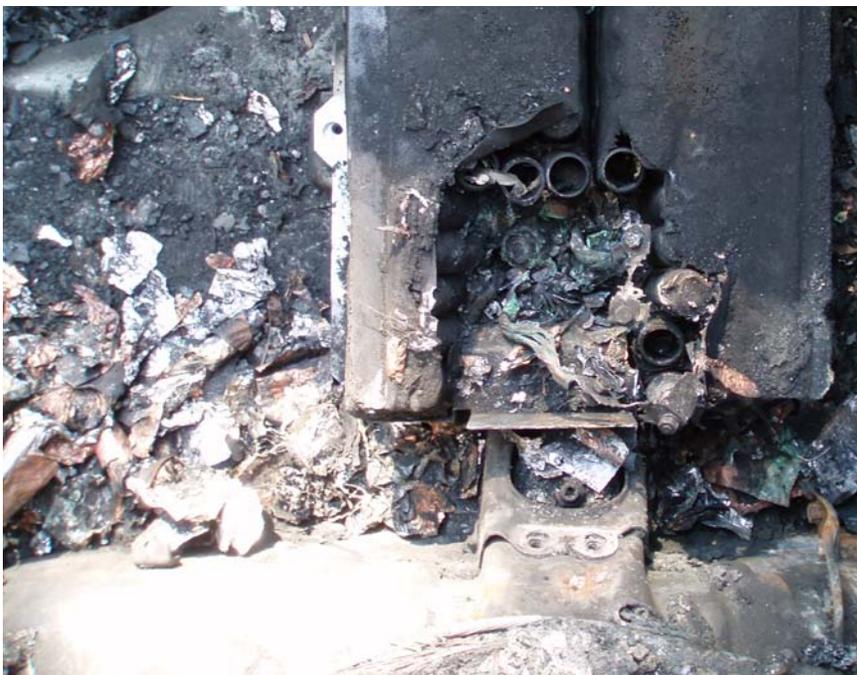
Figure 24--Ejected Cell Material⁴

At this point, there was enough conductive material to start short circuits across batteries and cells (Figure 24).

Arcing would have occurred at any area where a short circuit occurred. The ejected material contains electrolyte so it would catch fire in the presence of this arcing. These short circuits along with any burning material caused additional cells to rupture. The inspection showed that all of the ruptured cells were immediately adjacent to this cavity area, indicating that they were exposed to enough heat to cause the rupture.
