DOT HS 812 583

# **Special Crash Investigations On-Site Ambulance Crash Investigation**

**Vehicle: 2013 Chevrolet  
Express 3500 Type II  
Ambulance**

**Crash Date: May 2017**

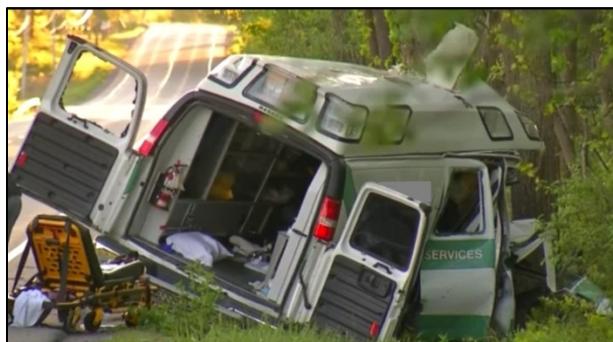
**Figure 1:** View of the ambulance at final rest (*on-scene image obtained from an online news source*).

by law enforcement and confirmed by data in this report, it was determined that the driver was fatigued and fell asleep while operating the vehicle. This resulted in the ambulance's right roadside departure, where the vehicle struck a large-diameter tree at the roadside (**Figure 1**). The wheeled ambulance cot came free from its securement and was displaced in the interior during the crash. The patient, who had previous medical diagnosis including cancer and sepsis, also became displaced from the wheeled ambulance cot and suffered multiple traumatic injuries in the crash. He was pronounced deceased at the crash site. Both 20-year-old emergency medical services (EMS) crewmembers were transported by other ambulances to local hospitals for treatment and released within hours of the crash.

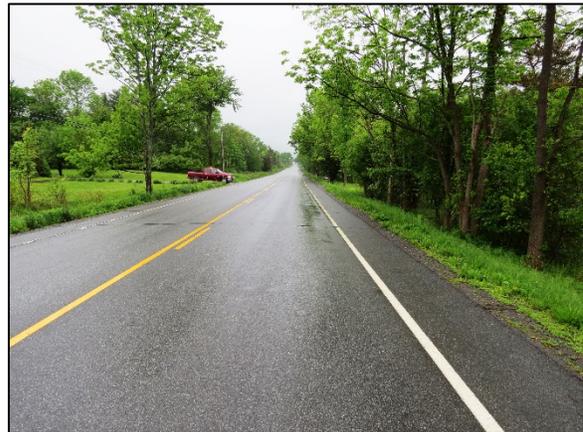
**Figure 2:** West-facing view of the roadway for the ambulance's pre-crash travel trajectory.

grass vegetation with a tree line located an average of 4.0 m (13.1 ft) from the north road edge. A particular hardwood tree with a trunk diameter of 50 cm (19.7 in) was located 3.4 m (11.2 ft) north of the road edge, leaning approximately 12 degrees to the south (toward the roadway). Speed was regulated by a posted limit of 89 km/h (55 mph). A crash diagram is included at the end of this report.

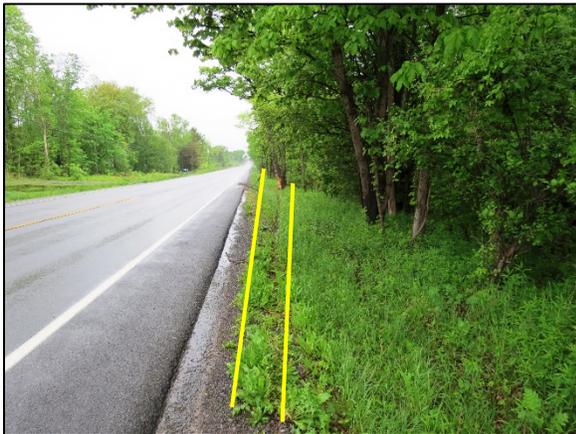
**Figure 3:** West-facing view of the ambulance's right front tire mark (highlighted) through the roadside.

A 34 m (111.5 ft) long rotating tire mark from the ambulance's right front tire evidenced the vehicle's trajectory as it approached the large diameter tree at the roadside. This single tire mark (**Figure 3**) was documented during the SCI crash site inspection, and revealed a departure angle for the ambulance of 7 degrees. Undulation of the right front tire through the terrain of the roadside evidently alerted the driver to the errant trajectory of the vehicle. Pre-crash EDR data indicated that the driver applied the brakes at 0.5 seconds prior to AE. At that time, the vehicle's speed was 77 km/h (48 mph). Law enforcement

reported to the SCI investigator that the driver stated during interview that he "dozed off for a few seconds and woke up when he felt the rumble strips." As referenced in the crash site description, there were no rumble strips.

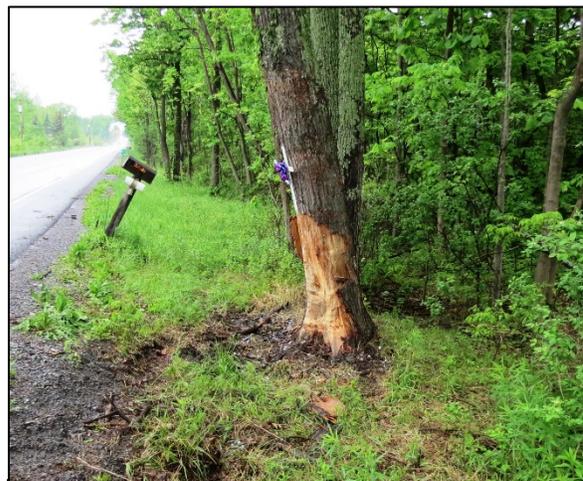
The crash occurred as the right aspect of the Chevrolet's front plane struck the tree (**Figure 4**). Impact forces were in the 12 o'clock sector for the ambulance. As the frontal structure of the Chevrolet crushed, the leading edge of the right front fender and the right front tire/wheel engaged the tree. The front suspension separated and the tire/wheel and brake assembly struck the lower right A-pillar and sill. The Chevrolet continued forward as the right A-pillar, windshield header, and fiberglass roof extension struck the tree. Frontal components of the vehicle were crushed past the location of the Chevrolet's

**Figure 4:** West-facing view of the struck large diameter tree.

right B-pillar. The right front door was compressed and jammed closed against the B-pillar, which deformed the double doors on the right plane of the patient compartment. The latch of the forward right door released as the door was displaced rearward. The aft door was jammed closed. The ambulance came to rest against the tree, with penetration of the tree extending beyond the right B-pillar.

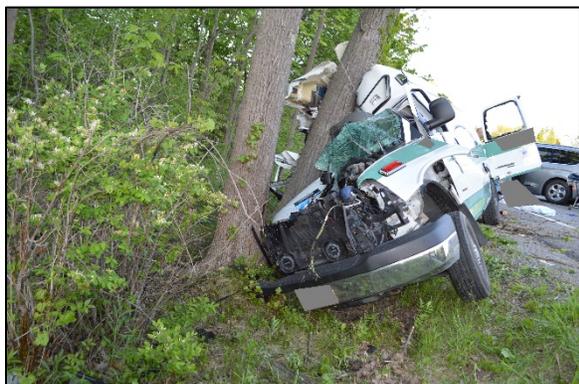
**Figure 5:** East-facing view of the ambulance against the large diameter tree at final rest (*on-scene law enforcement image*).

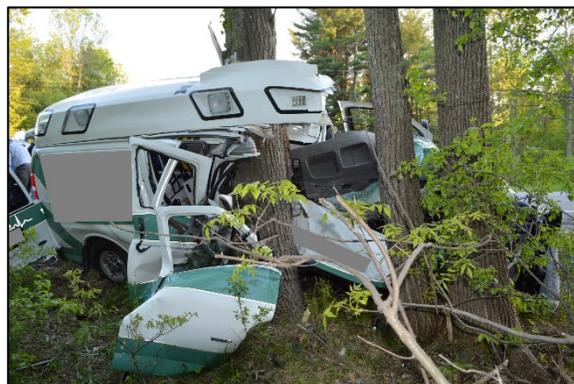
**Figure 6:** South-facing view of the ambulance at final rest and crushed against the tree (*on-scene law enforcement image*).

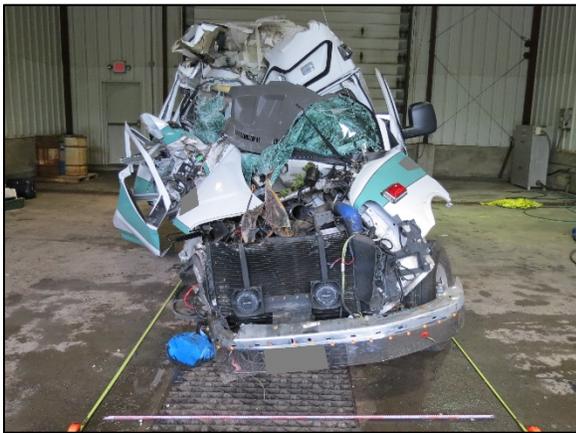
The Chevrolet sustained severe damage to its front plane, right aspect. This included extensive crush and deformation. Direct contact damage began 65 cm (25.6 in) right of centerline and extended to the right front bumper corner. Based on the undeformed end width of the bumper beam of 184 cm (72.4 in), the maximum width of the direct damage was 27 cm (10.6 in). In the damage pattern was longitudinal deformation to the bumper, grille/fascia, right headlight assembly, right front fender, hood, engine compartment components, windshield header, roof, and surrounding components (**Figure 9**).

**Figure 9:** Front plane view of the 2013 Chevrolet Express 3500 Type II ambulance at the time of the SCI inspection.

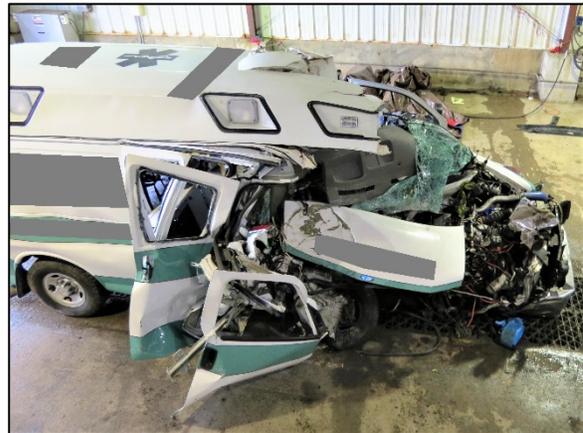
**Figure 10:** Right overhead perspective view of the ambulance and the magnitude of the damage extent.

A residual crush profile was obtained using a direct and induced damage length (Field-L) across the width of the damaged bumper beam. Accounting for free space due to the contour of the bumper beam, the profile produced the following resultant measurements: C1 – C3 = 0 cm, C4 = 2 cm (0.8 in), C5 = 4 cm (1.6 in), and C6 = 47 cm (18.5 in). This crush profile grossly underestimated the severity of the damage, due to the angle of the vehicle and struck tree (which largely missed the bumper beam). As is visible in **Figure 10**, the SCI investigator observed maximum direct contact and crush that extended rearward 298 cm (117.3 in) from the front plane.

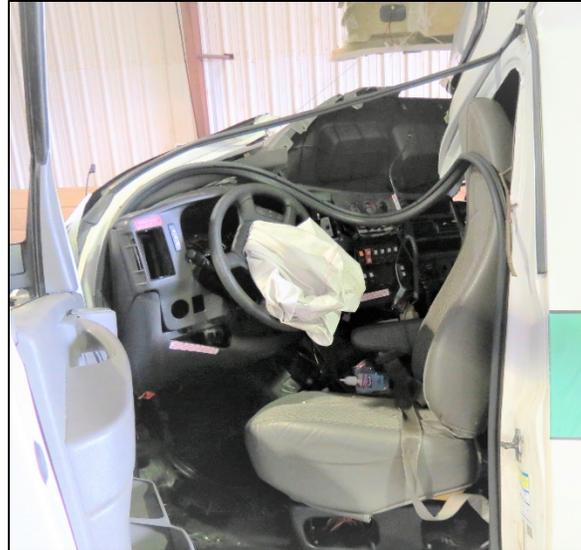
The extreme magnitude of the Chevrolet's deformation hindered a precise assessment of its intrusions. Longitudinal intrusions observed included greater than 100 cm (39.4 in) to the right instrument panel, more than 150 cm (59.1 in) to the right A-pillar and right windshield header, and more than 60 cm (23.6 in) to the center instrument panel. In its intruded state, the right aspect of the instrument panel protruded through the cab's pass-through and into the patient compartment, with complete collapse of the right front position (**Figure 11**). The severe deformation to the windshield header and roof had separated the header, roof, and left A-pillar at their junction, and deformed the entire roof to the right.

**Figure 11:** Crossing view of the ambulance cab and the severe interior damage/intrusion

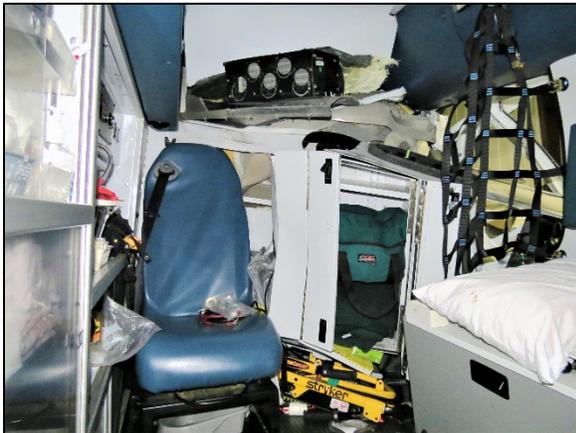
**Figure 12:** Forward-facing view of the patient compartment interior and crash-related damage.

Significant damage of the interior occurred at the forward right aspect of the patient compartment. The entire stack of cabinetry adjacent to the right loading doors was displaced rearward and deformed such that it was engaged against the right C-pillar and forward aspect of the bench seat. This resulted from the rearward displacement of the right front position of the cab and corresponding intrusion of the large diameter tree during the impact engagement. Equipment in the cabinetry was entrapped and entangled in the deformed components. Overhead structure of the roof was fractured and separated, with the heating, ventilation, and air conditioning system

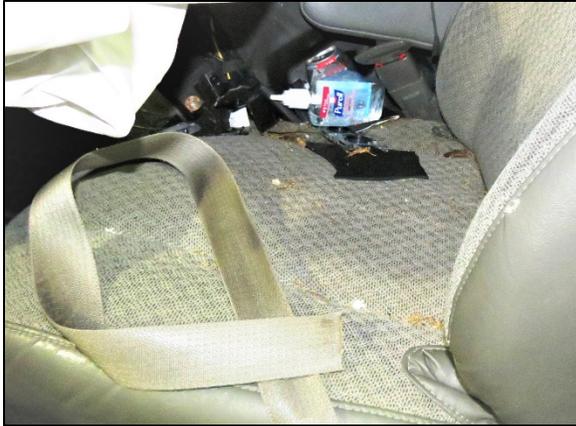
**Figure 13:** View of the cut portion of the driver's seat belt system and the latch plate engaged in the buckle.

The driver's seat belt webbing was cut, with the shoulder portion spooled onto the retractor and concealed in the left B-pillar of the vehicle. The exposed webbing contained a minor abrasion from loading in the belt path of the latch plate, and had heavy evidence of historical wear. The latch plate remained engaged in the buckle. Based on the condition of the driver's seat belt system (**Figure 13**), it was evident that the driver was restrained at the time of the crash. This determination was supported by the data imaged from the Chevrolet's EDR.

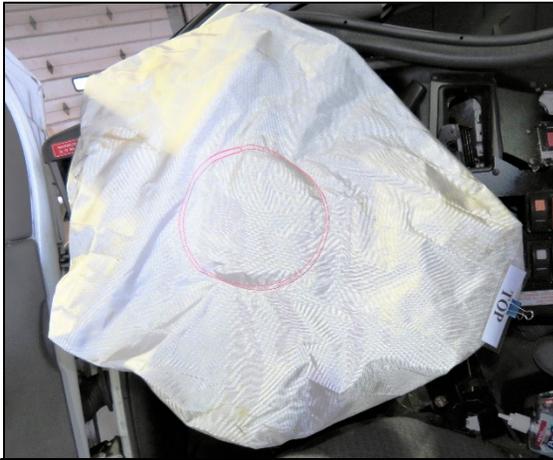
The deployed driver's frontal air bag measured 70 cm (27.6 in) in overall diameter in its deflated state. It was vented by a pair of 4 cm (1.6 in) diameter vent ports on the back side of the air bag. Tethering was internal, with two straps sewn to the interior aspect of the air bag's center circumference. There was no damage or discernable occupant contact evidence to the deployed driver's air bag (**Figure 14**).

**Figure 14:** Deployed driver's frontal air bag in the 2013 Chevrolet ambulance.

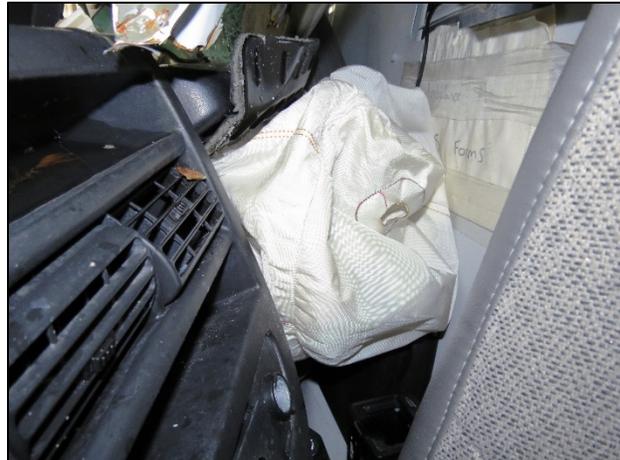
**Figure 15:** View of the deployed front right passenger's air bag at the time of the SCI inspection.

The passenger's frontal air bag also deployed in the crash. However, the severe intrusion displaced the instrument panel such that the passenger's frontal air bag was not accessible by the SCI investigator for detailed inspection (**Figure 15**).

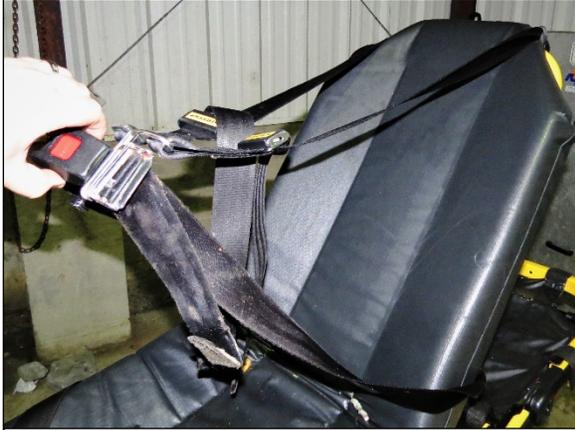
**Figure 17:** Shoulder harness straps of the Stryker cot after being buckled together by the SCI investigator.

The Stryker cot was equipped with a multipoint harness system for manual restraint of its occupant (patient). This system consisted of a lateral lower extremity strap, a lateral lap/thigh strap, and an upper torso harness which incorporated two shoulder straps that buckled into a lateral chest strap. All straps were constructed of fixed length webbing that included either locking latch plates or sewn buckles. At the time of the SCI inspection, all straps of the system were unbuckled and hanging loosely from the frame. Extensive historical wear on the exposed surfaces of the webbing evidenced

habitual historical use, but there was no discernable evidence of crash-related loading on any of the systems' straps. Given the frontal nature of the crash forces and the kinematic response of the occupant that would have resulted, no significant loading to the lateral restraint straps would likely have occurred. The SCI investigator buckled the shoulder harness straps together (**Figure 17**) and noted that the design of the system placed extensive space between the shoulder straps, their anchorage, and the occupant. The shoulder straps were designed to be affixed to the top of the mattress platform frame at the head end of the cot. The length of the frame meant that, in order to be in contact with the shoulder straps in such a manner that they could have restricted the occupant's movement, the occupant would have had to be displaced forward/upward along the mattress platform a significant distance.

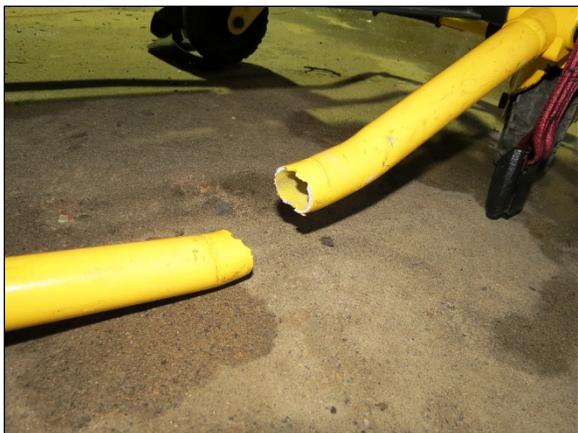
The patient cot sustained minor damage attributable to occupant loading in relation to the crash event. The occupant responded toward the frontal crash force and his back/torso compressed against the mattress platform and inclined back support, which translated a loading force into the cot's frame. The moment (torque) of this force created a load at the locking clamp mechanism that exceeded the shear strength of the tubular aluminum frame. This caused the frame rail to shear at the securement location of the locking pin (**Figure 18**). Following the shear of the

tubular aluminum frame rail, the cot became dislodged from the fastening system and was subjected to unrestricted movement in the patient compartment. The locking pin was found loose on the floor in the patient compartment at the time of the SCI inspection (**Figure 19**).

**Figure 18:** View of the sheared lower right frame rail of the wheeled ambulance cot.

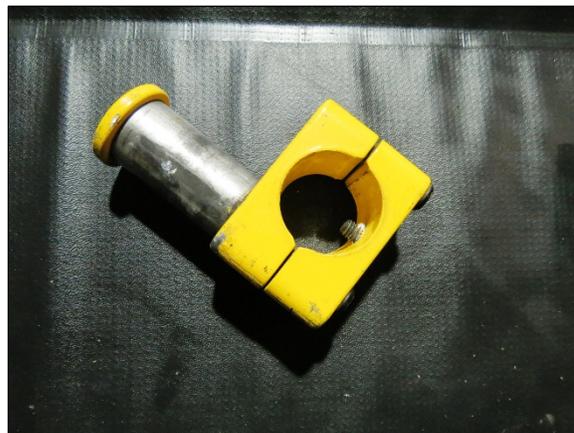
**Figure 19:** Separated locking pin found loose in the patient compartment during the SCI vehicle inspection.

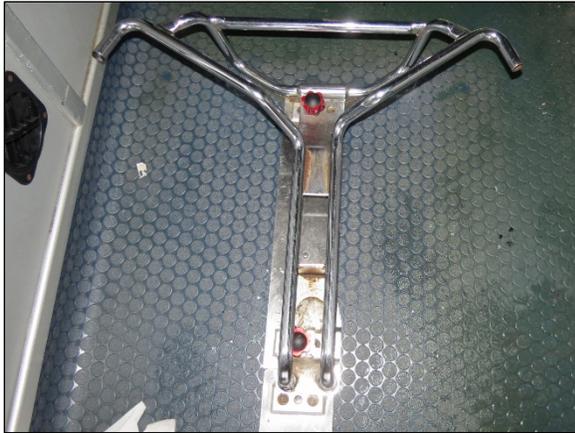
The antler bracket was secured to the floor of the patient compartment by two specifically-designed hand-tightened bolts that were in-line at the forward and aft aspect of the steel tube bracket. Four bolts held the rectangular base of the clamp to two vertical supports. Combined, these two components were intended to restrict the lateral and longitudinal movement of the cot in the ambulance during transport. **Figures 20 and 21** depict the antler bracket and locking clamp mechanism as observed by the SCI investigator during the vehicle inspection.

**Figure 20:** Antler bracket of the cot fastening system mounted in the Chevrolet ambulance.

The SCI investigator observed that the bolts of the antler bracket remained intact and the bracket was in place and not deformed. The rail clamp mounting bracket, bolts, and clamp mechanism also remained intact, with the clamp in the unlocked position. On-scene images depicted the clamp in the open position, with the fractured locking pin displaced and lying loosely on the floor at the right rear aspect of the patient compartment. The SCI investigator concluded that the clamp had possibly released during the crash as a result of loading by the combined forces of the mass of the cot, mass of the occupant, and crash.

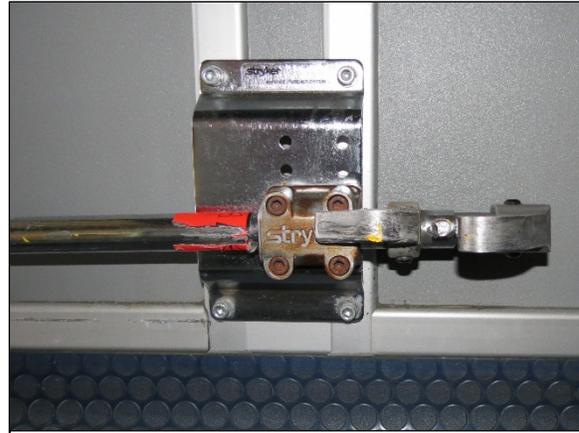
**Figure 21:** Disengaged locking clamp mechanism in the patient compartment.
